# Technical report

## IN-006/2020

Incident involving a Boeing 767-375ER aircraft operated by Air Canada, registration C-GHOZ, at Madrid-Adolfo Suárez Airport (Madrid) on 03 February 2020

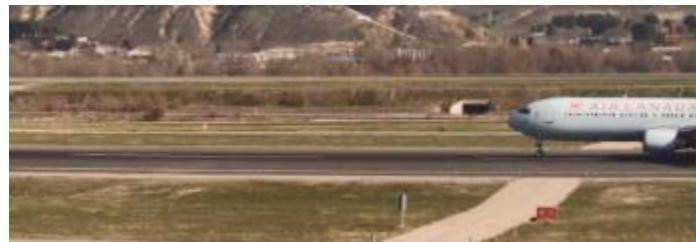
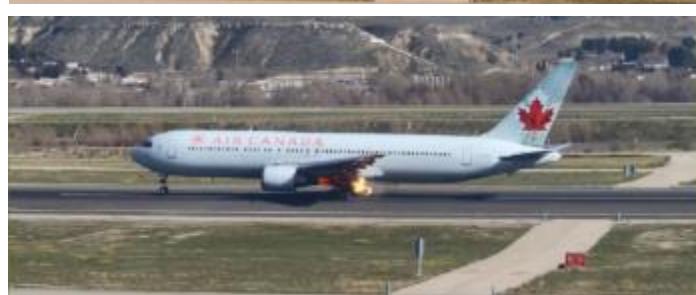
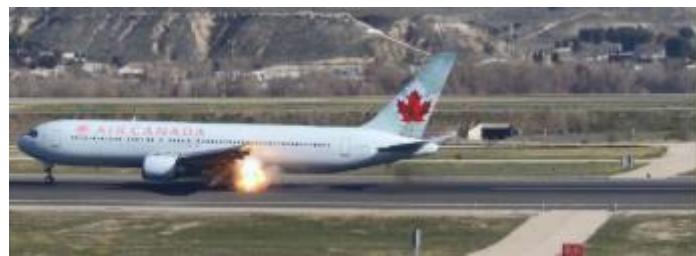
Figure 1. Sequence between 14:58:03 (explosion) and 14:58:05 (rotation begins)

At 14:58:00, the aircraft reached  $V_1$  (158 kt), and at 14:58:03, two seconds before rotation, the tyre on the left rear wheel of the main landing gear burst (tyre number 5). The footage from the airport's surveillance cameras allowed to confirm that the left engine ingested several of the shredded tyre tread fragments and, together with the data from the flight data recorder (FDR), to reconstruct the following sequence of events, where  $t=+0$  s is the moment the tyre burst (14:58:03).

$t=+0$  s    tyre burst and fragments  
ingested by the left engine  
(14:58:03)

$t=+1.2$  s    first flame  
(14:58:04)

$t=+2$  s    rotation begins (nose  
landing gear sensor in AIR  
mode) and second flame  
(14:58:05)
