**Incident** to the AIRBUS - A330 - 200  
registered **F-GZCJ**  
operated by Air France  
on 31 December 2020  
en route, FL 380 (Chad)

**Fuel leak en route, diversion, both engines kept in operation up to  
taxiing to parking area.**

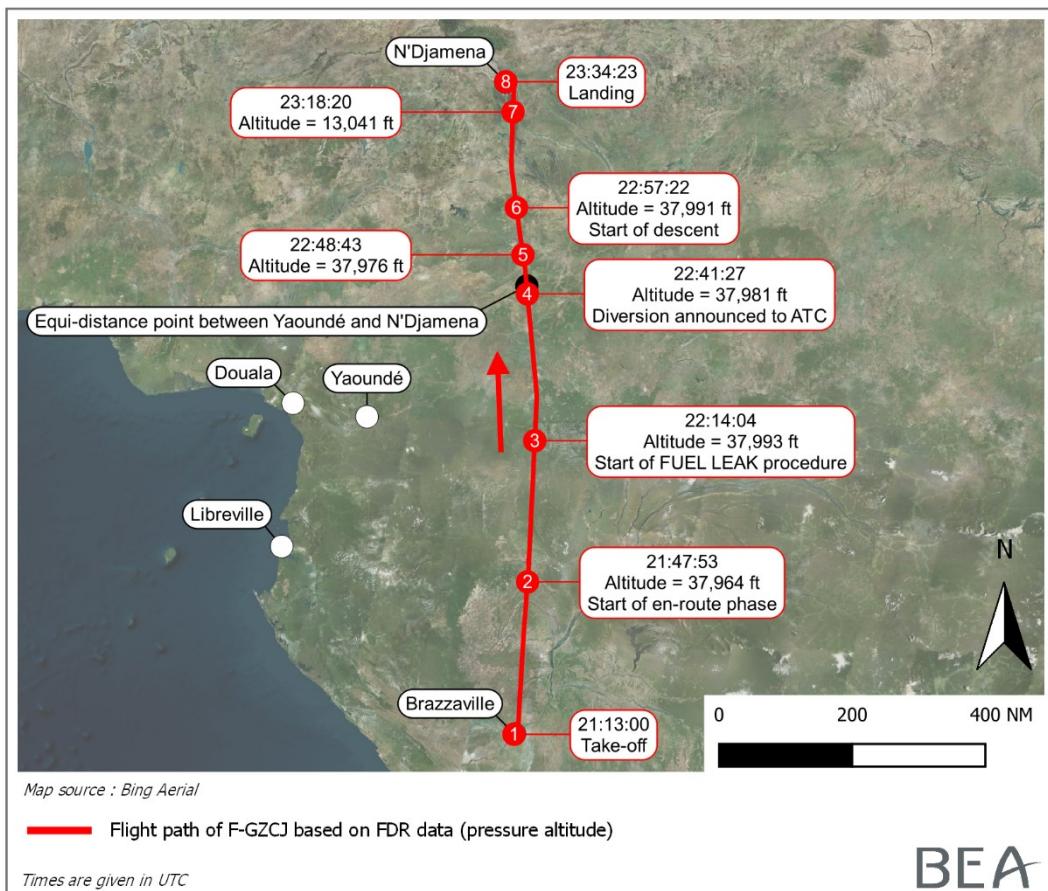
Figure 1: F-GZCJ's flight path

Thirty-five minutes after taking off, at the start of the en-route phase at FL 380, the first checks were carried out (refer to figure 1, point 2). The captain observed that they were lacking 1.4 t of fuel without this creating a visible lateral imbalance between the fuel tanks. He attributed this difference to the fuel transfers that were in progress from the inner wing tanks to the trim tank. He shared this information with the co-pilots and left the cockpit for his rest period a few minutes later, asking the two co-pilots to monitor the evolution of the fuel.

Around twenty minutes after the captain's departure, the co-pilots called him back. At this point, they were lacking around 2.1 t of fuel with a difference in weight of about 400 kg between the two inner tanks. This pointed to a possible leak on the left side, the engine 1 side.

At 22:43, the captain informed the N'Djaména control of the diversion and announced that they were in an emergency situation with a MAYDAY message (refer to Figure 1, point 4).

The **FUEL F. USED/FOB DISAGREE** alert appeared on the Electronic Centralized Aircraft Monitoring (ECAM) display at 22:48 (refer to Figure 1, point 5). This alert refers the crew to the FUEL LEAK procedure. The captain deleted the ECAM page, and in the absence of a "STATUS" indication, considered that the alert had been processed. The relief pilot then asked that they agree on the moment when the engine would be shut down. The captain indicated that he preferred keeping the engine in operation for as long as there was fuel available.

At 23:18, the **FUEL IMBALANCE** advisory alert was activated (refer to Figure 1, point 7), referring the crew to the FUEL LEAK procedure which involves shutting down the engine concerned. The captain questioned the danger of keeping the engine operative and concluded that it was not specified in the check-list that it had to be shut down<sup>7</sup> and that there was no notion of a possibility of a fire, *"A priori ce n'est pas écrit dans la check qu'il faut impérativement le couper... il n'y a pas de notion de possibilité de feu."* The relief pilot then intervened, specifying that he thought that shutting down the engine was not a bad idea but that it was a good idea to keep it running for the time being because they were in the air and there was no emergency, *"Je pense que l'idée de couper, ce n'est quand même pas une mauvaise idée... autant c'est bien de le garder pour l'instant, parce qu'on est en l'air et qu'il n'a pas d'urgence... une fois au sol..."* He finished by saying that "once on the ground", without continuing his line of thought.
