Investigation Report

Type: Boeing 777F

State File Number: BFU22-0927-1X

After a Boeing 777F began taxiing on taxiway N-North of Frankfurt Main Airport, several empty airfreight containers were blown from pallet trailers at parking position F234 by the jet blast.

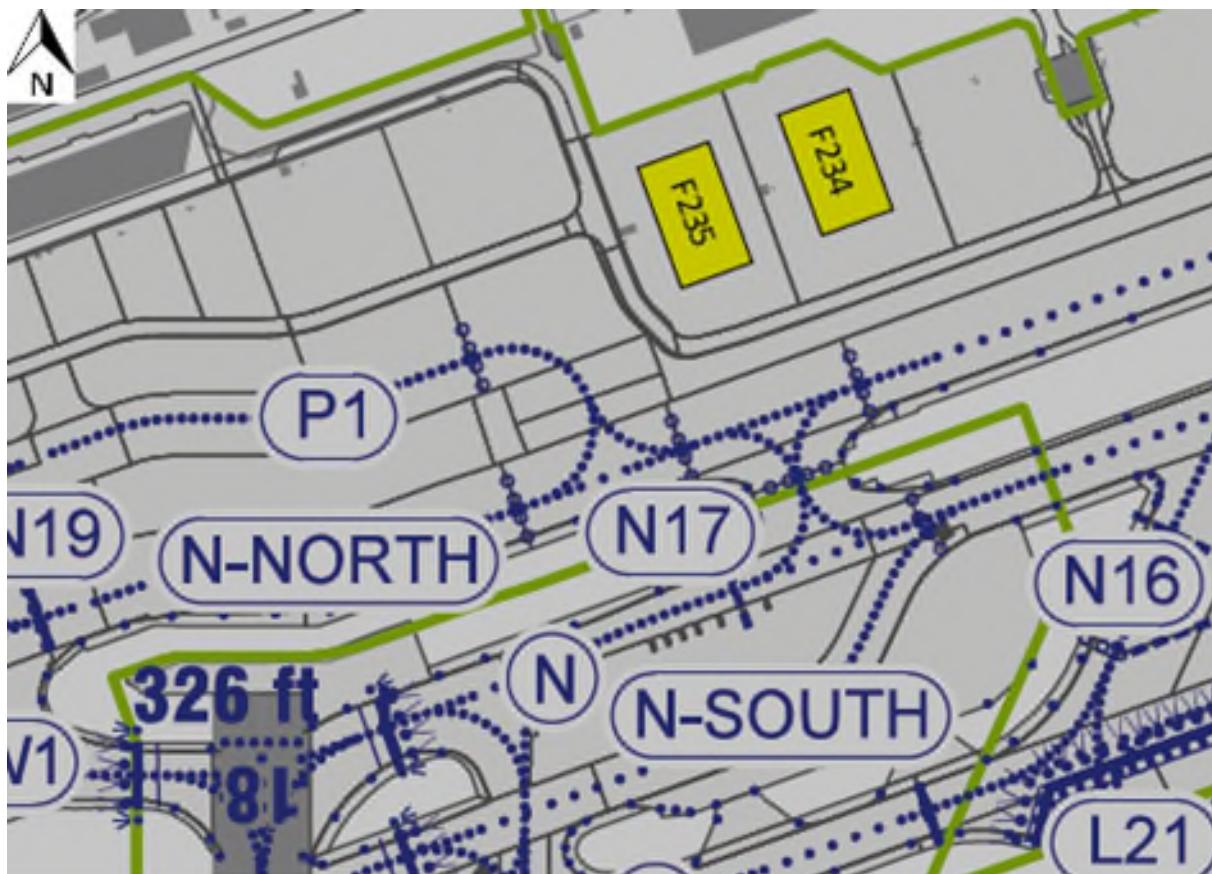
Fig. 1: Excerpt Aerodrome Chart - ICAO, Frankfurt Main Airport

While the right engine was running up, its jet blast pointed towards parking position F234 (Fig. 1). Another freighter airplane stood at this parking position being loaded.

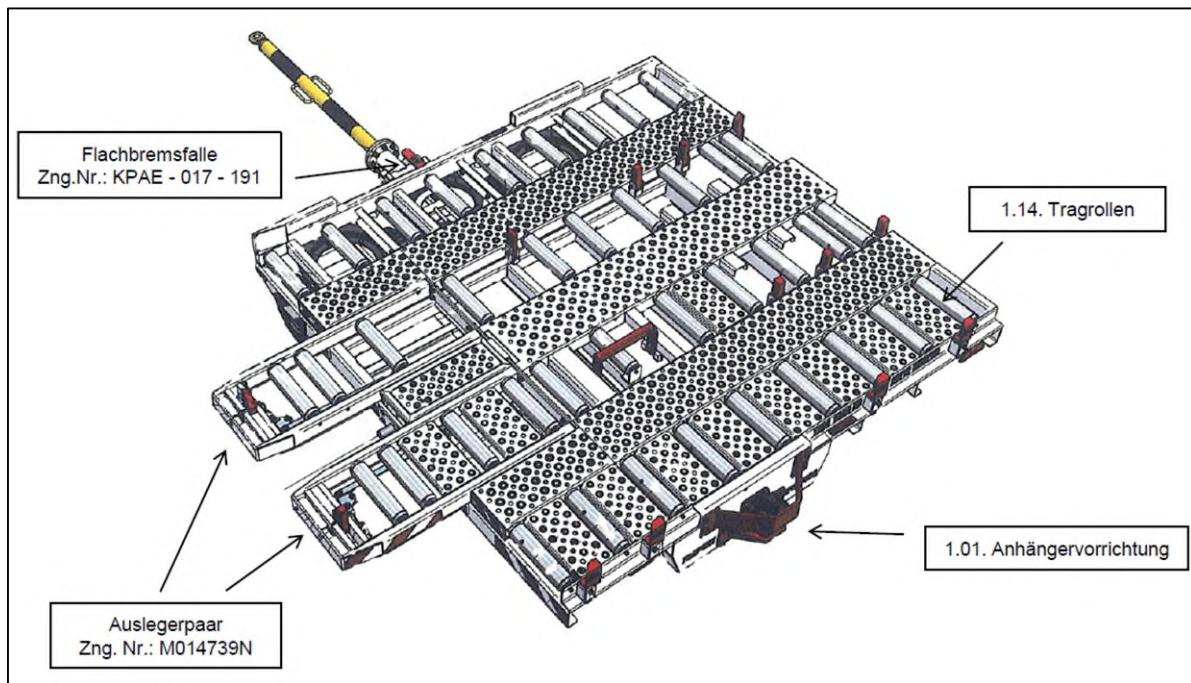
Fig. 6: Schematic drawing of a pallet car

Pallet cars were used to transport freight containers. Hinged safety locks prevented the containers from sliding around during transport (Fig. 6 and 7). According to witnesses' statements, these safety locks were open at the time of the occurrence.
