Safety Investigation Report - Final

Accident File No. 31-18

Collision between two aircraft during pushback

Date	28.3.2018
Between	
Aircraft	BOEING 767
Registration	4X-EAK
And	
Aircraft	BOEING 737
Registration	D-ABLB
Location of event	Taxiway M, LLBG

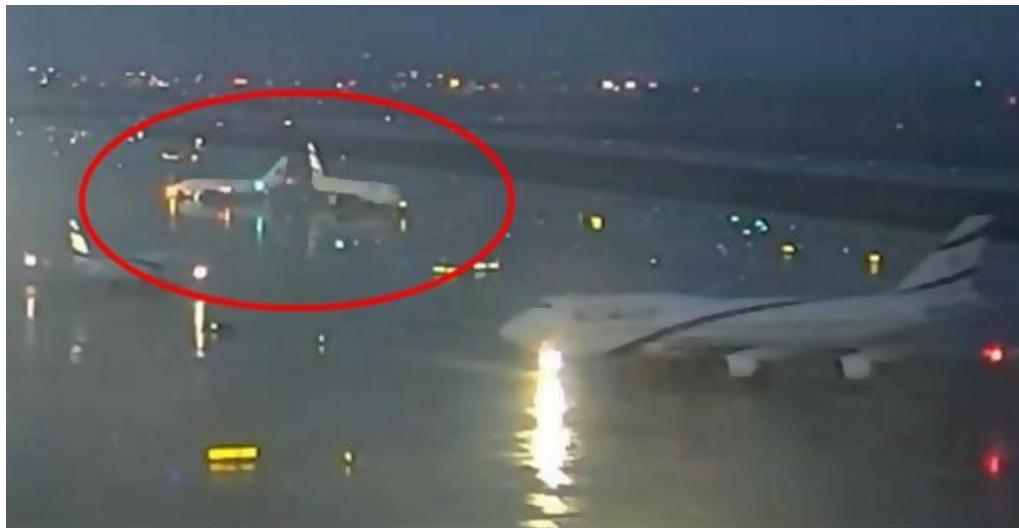
Accident site viewed from south-east (from secondary tower)

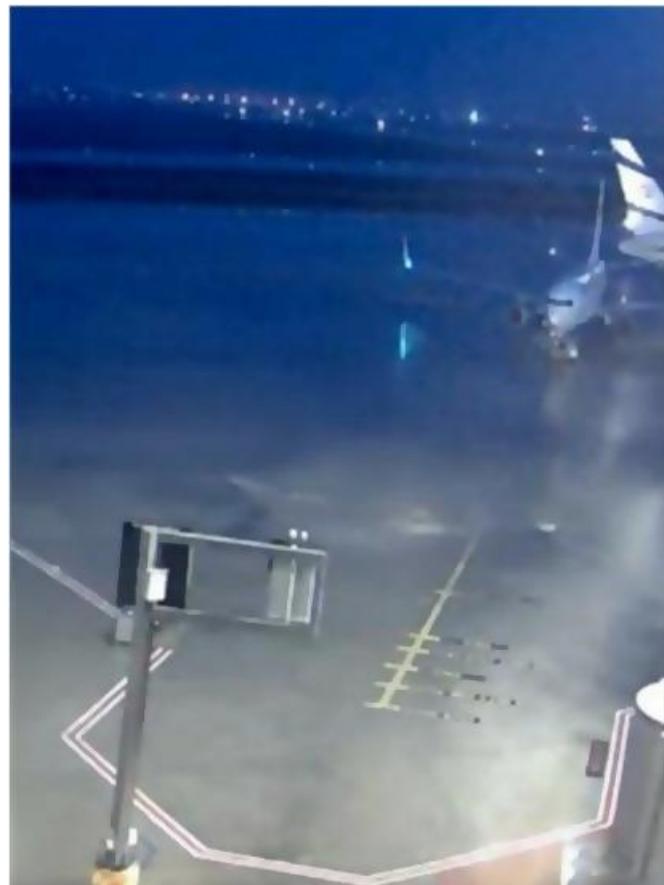
Seconds before the accident

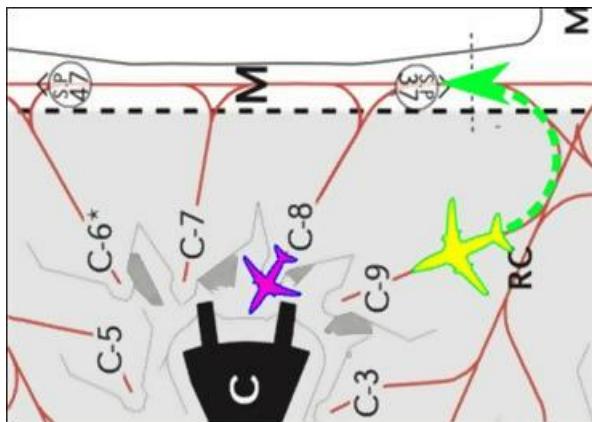
1. The 767 a/c pushback commencement from gate C9 to start-up position 37

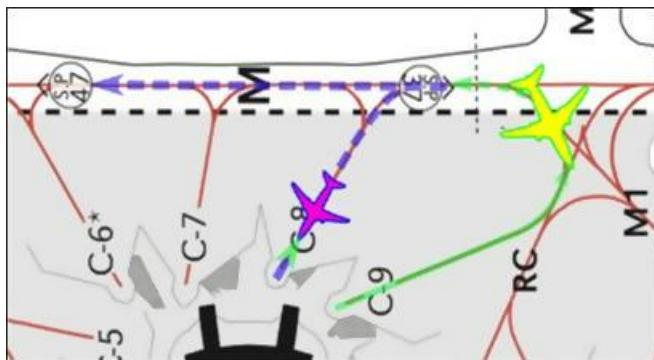
2. The 737 a/c pushback commencement from gate C8 to start-up position 47, while the 767 a/c is near the end of its push back

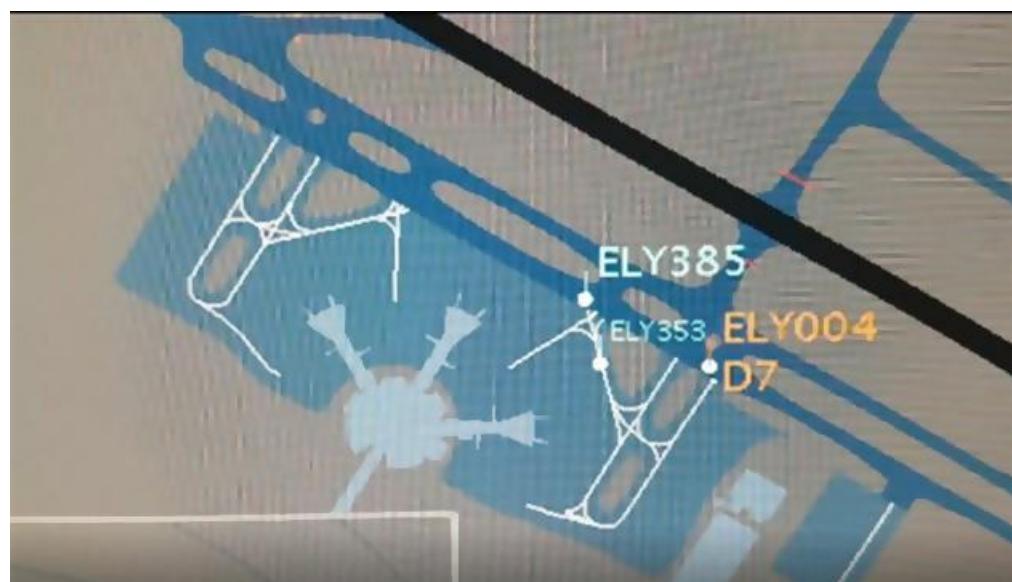
The system's Level 1 & 2 are implemented at various locations, including Ben Gurion. System definitions state that vehicles and aircraft which are within a 50 meter radius from terminal 3 will not be displayed on the ground controller's monitor. Therefore, no system warnings are provided for this area.

A-SMGCS monitor image (1.5 minute before the accident)

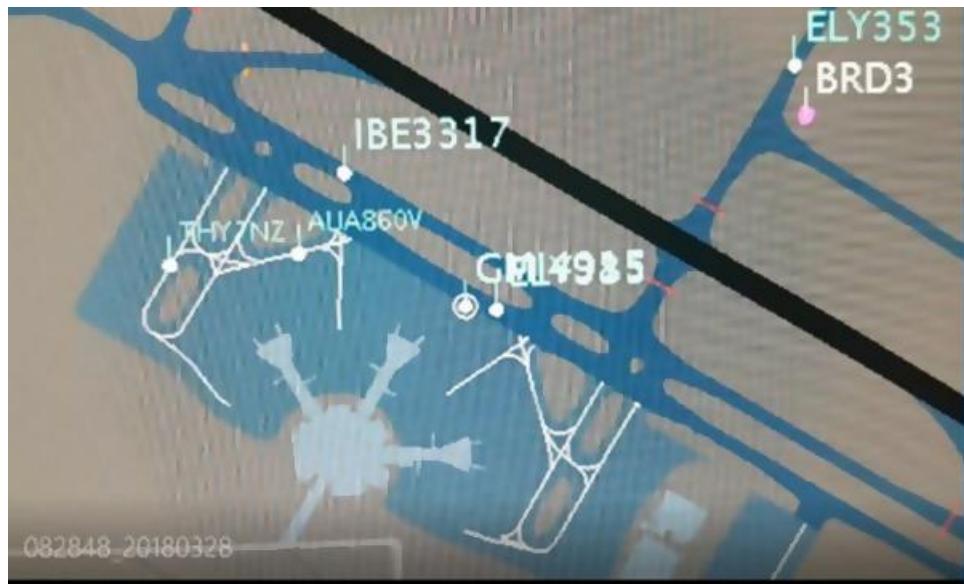
A-SMGCS monitor image (at the time of the accident)

At the center of the above illustration, the silhouettes of ELY385 and GER4915 are overlapping. Also visible are aircraft of Iberia, Turkish, Austrian and Elal, as well as the vehicle for preventing wildlife hazards (BRD3).

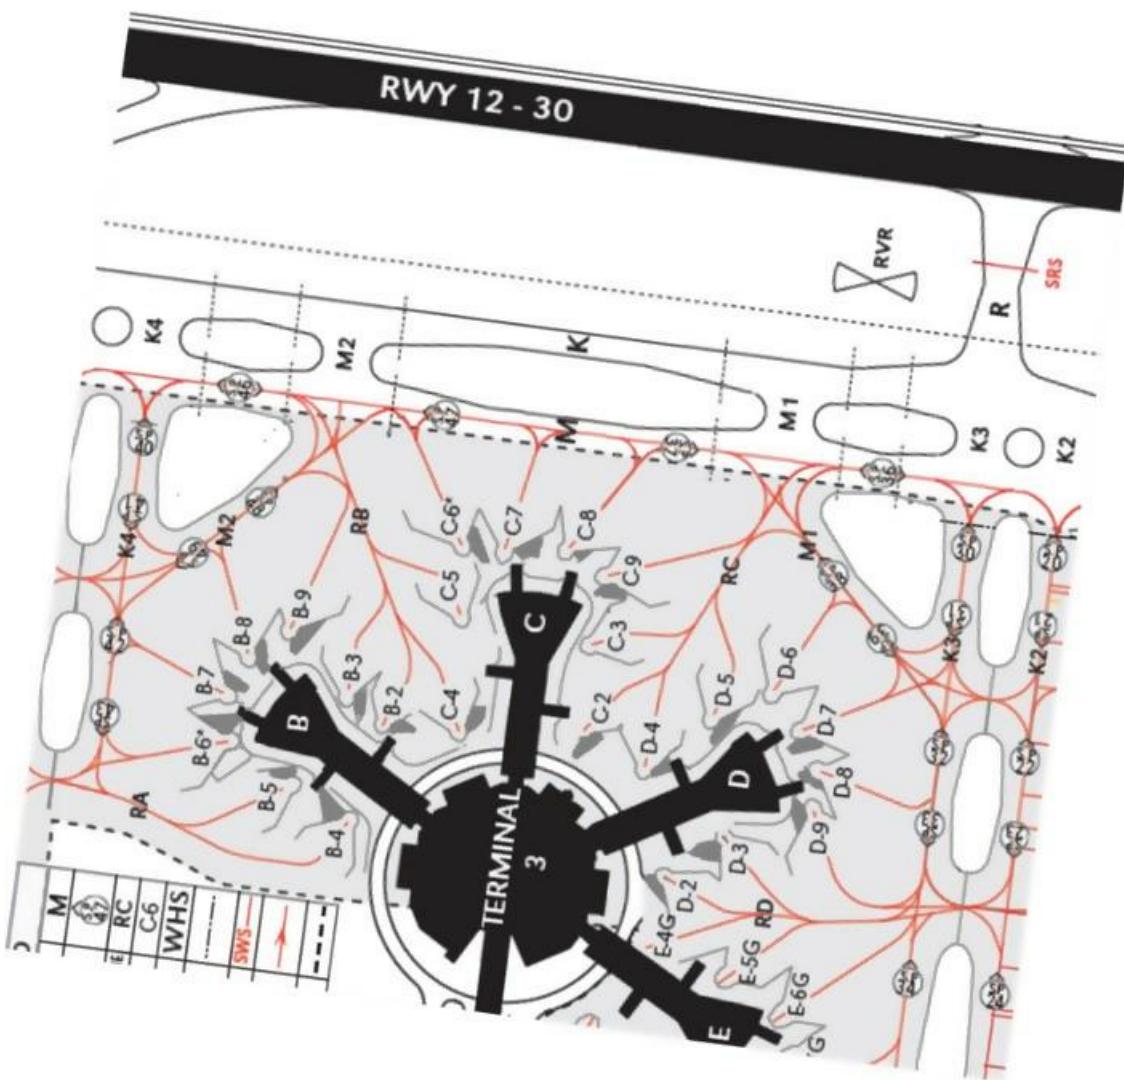
Diagram of the parking positions area and accident site

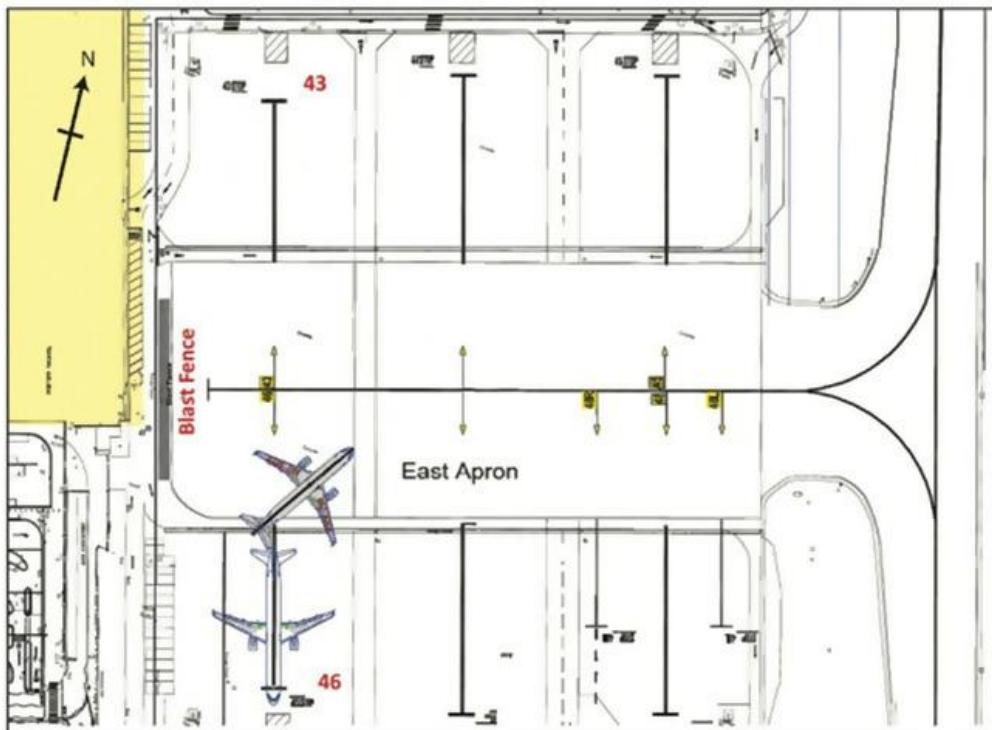
An aircraft was pushed back, began turning towards the apron axis, but the tow driver misjudged the axis position and pushed the aircraft beyond it. After turning about 40 degrees, the tow truck stopped and began pulling forward. The RH horizontal stabilizer promptly impacted the tail cone and APU of the other airplane of same model, which was parked at a parking position.

The tow driver's complete attention was directed to the proximity to a fence on the airplane's LH side. He misjudged the position of the apron center line and did not pay attention to the RH side where the other airplane was parked.

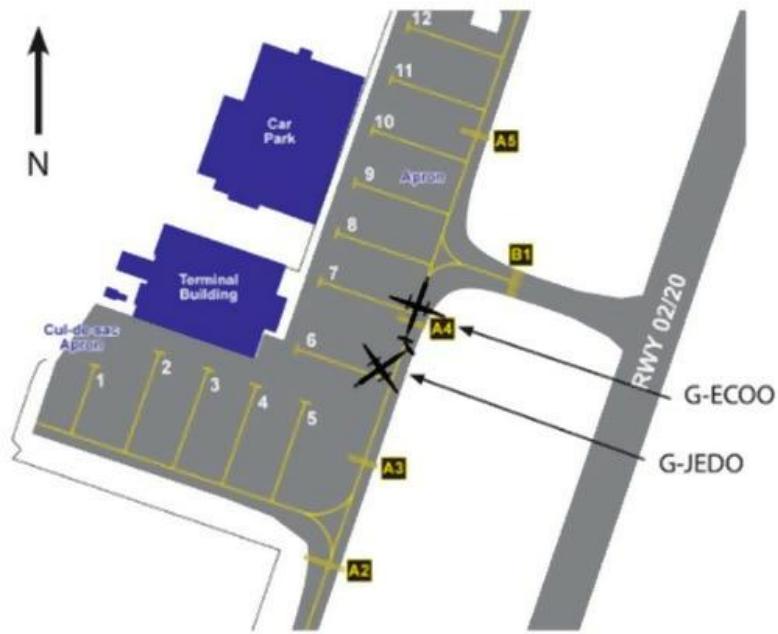
Example 2

- ✓ Southampton international airport, UK, 16 Jan 2012.
- ✓ Aircraft: 2 DHC-8.
- ✓ Weather conditions: shortly after first light, just prior to sunrise, CAVOK.
- ✓ Damage: RH elevator and tail cone (not specified which aircraft).

A serial terminal, supposedly contributes to reduction of problems. An aircraft was pushed from parking position 9 to start-up position A4, disengaged from the tow vehicle and began the engines start process. It was a non-standard pushing in order to enable a Jetstream aircraft parked at position 11 to taxi for holding position B1 and then to the runway. At this stage the Dash 8 in position 6 requested clearance for pushback and was told to standby. The Jetstream received a taxi clearance to holding position B1 and from there to the runway. The controller then cleared the Dash 8 for pushback from position 6. The “headset man” hand signaled the towing direction to the tow truck driver and positioned the wingtip walker to the south of the airplane. The controller asked the first Dash 8, which was during engines start up in start-up position A4 whether they are ready to taxi. He was told that they will be ready within 30 seconds and told them to please taxi to holding position B1 when ready. At this stage the Dash 8 of position 6 began the turn and the wingtip walker left for another task. During the turn, with the aircraft at a heading of about 220, the airplane slowed down and stopped. The “headset man” requested the captain to confirm that the parking brakes are not engaged, because at that time nobody has yet realized that a collision has occurred.

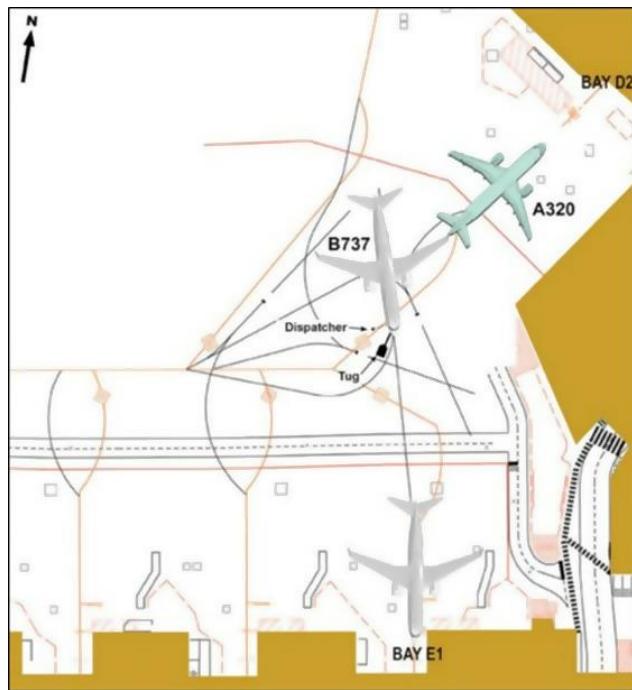
Example 3

- ✓ Melbourne international airport, Australia, 10 Aug 2013.
- ✓ Aircraft: Airbus A320 and Boeing B737.
- ✓ Weather conditions: clear and lucid.
- ✓ Damage: B737 winglet and A320 tail cone.

The A320 entered parking bay D2 by means of automatic guidance system (NIGS), which instructed it to hold short of the gate. The 737 requested pushback clearance and was told by the controller that they are cleared for pushback once the A320 taxiing behind them entering bay D2 will stop at the gate. The 737 captain conveyed the message to the tow truck driver and notified the controller that he saw the A320 passing behind them, by means of a reflection in the terminal windows in front. This message was not received due to concurrent radio transmissions. The tow truck driver managed to see the A320 and noticed that it stopped, assumed it is already at the gate and without actually having eye contact with the 737 LH wing tip, began pushback until the winglet impacted the A320's tail. None of the involved personnel has reported his position in the various communications.

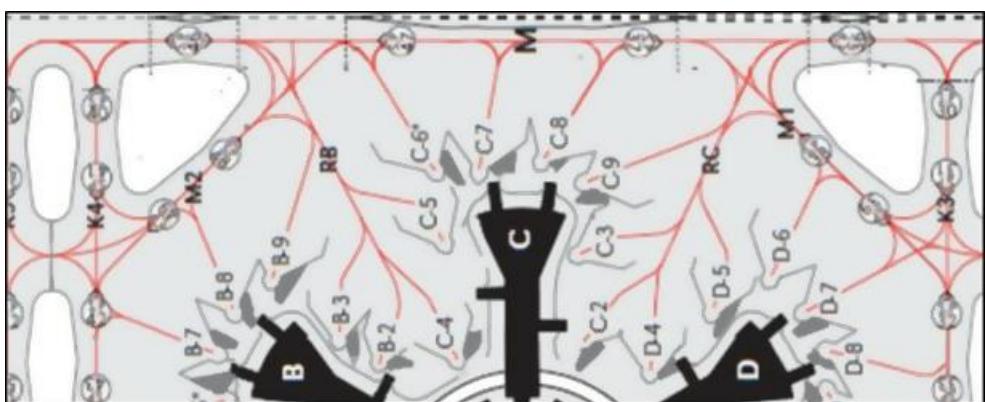
Terminal 3 concourse C northern tip includes several gates marked C6 through C9, from east to west. Aircraft pushed from these gates are typically served by starting points SP37 and SP47, which are on taxiway M and sometimes by adjacent starting points such as SP48. SP37 is defined as one where the starting aircraft is facing east, while at SP47 the aircraft starting is facing west.

The start-up positions on the illustration represent the aircraft nose wheel location. Consequently, for instance, the fuselage of an aircraft starting at SP37 is practically blocking the turning point of aircraft pushed back from gate C8, regardless of his destination SP. Similarly, a pushback from C8 to SP47 requires getting onto taxiway M, pushing with the tail facing east until aligning with M centreline, and then pulling westbound to SP47. During the alignment on M, the pushed aircraft is within the area of SP37.

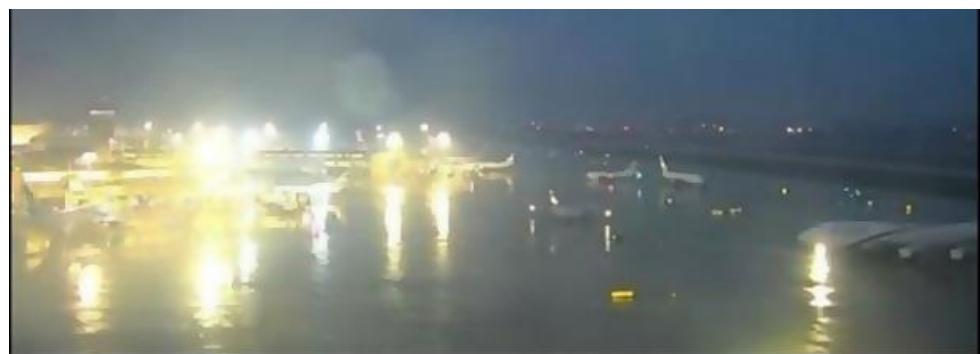
On the morning of the accident, before first light it was dark and rainy. Visibility was reasonable for aircraft operations, but none of the aircraft pushed had wing walkers. Because of the rain, the escorts of both tow crews have huddled in the cabins together with the tow truck drivers. Visibility was reasonable, but from inside the cabins it was limited, considering the rain drops on the windows and maybe vapour condensation, to an extent. The drivers had difficulties in seeing the markings on the wet surfaces, which are sometimes hard to see on a sunny day. The escorts essentially saw nothing.

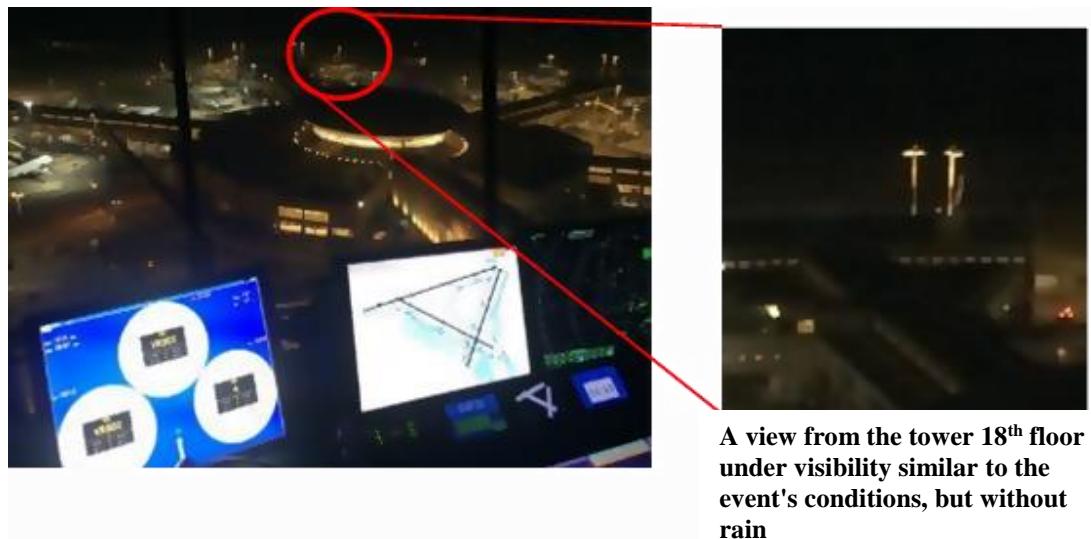
Seeing an aircraft fuselage parking at gate C8 or C7 was difficult even at noon on a summer day. The aft section of a large airplane could be seen, while for small aircraft, such as B737 only a small portion of the tail tip was visible. The aircraft could be seen clearly only after it was pushed back a substantial distance. In darkness it is much worse and it takes a substantial effort to see the tail navigation light of the airplane at the gate. In darkness and rain, and certainly in fog it is almost impossible for the controller to see an airplane at these gates.

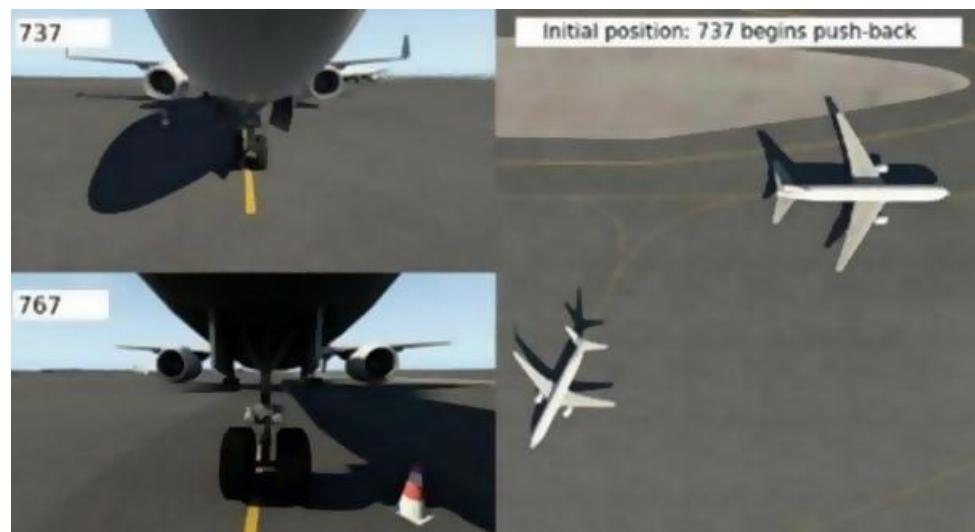
The tow driver's field of view is limited: The tow truck connects with the nose landing gear by means of a tow bar or by wrapping and lifting (TBL). Either way the tow truck is very close to the nose gear, which blocks a certain sector of his field of view, a sector which is sometimes significant. In low aircraft such as B737 the aircraft belly and engines further reduce the operator's field of view. With higher aircraft such as B767 the view is broader. In order to overcome the restricted view and see directly forward, the operator is sometimes executing "S" motions. Concurrently the escorting person is supposed to move aside in order to obtain a larger field of view of the area forward and to have continuous eye contact with the wing walkers, if present, especially when there are obstacles on the sides.

Depiction of fields of views from both tow truck cabins - before impact

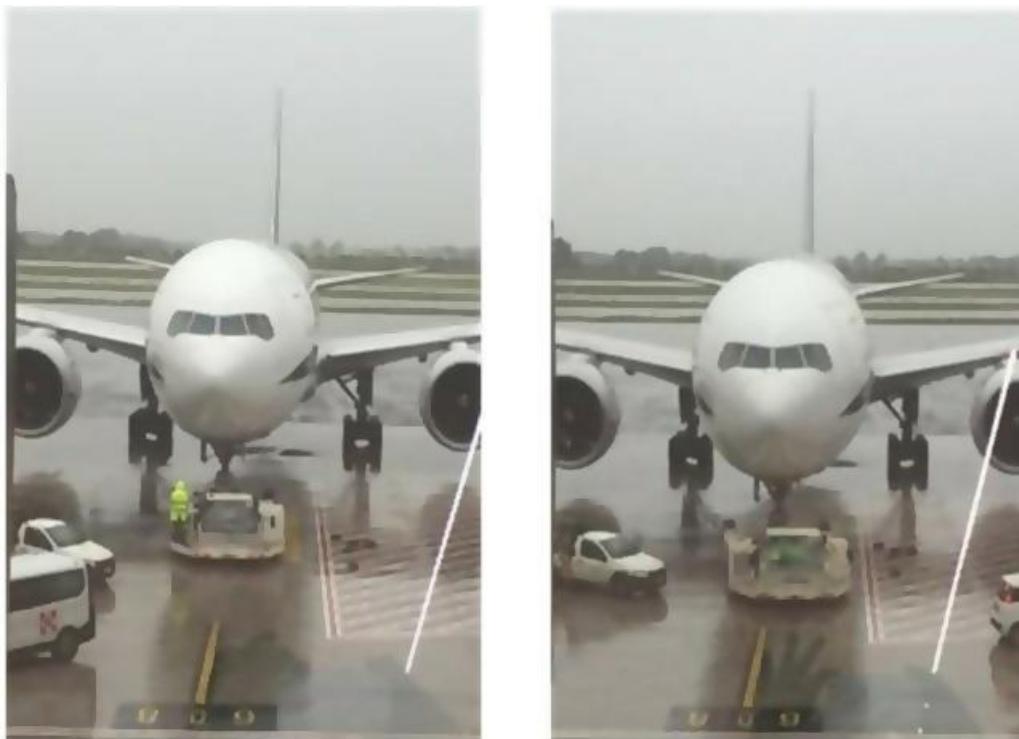
Example of correct actions by a tow crew

Prior to push back, the ramp supervisor goes out and stands outside of the tow vehicle cabin, to obtain maximum field of sight

2 tow crew members huddling inside the tow vehicle cabin, waiting for the pushback to begin

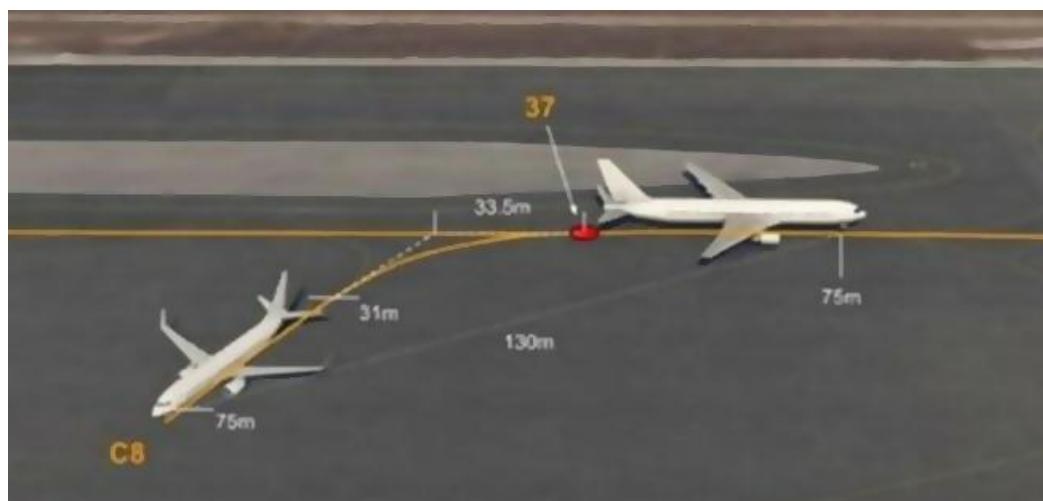
The pushback was very slow: In reconstructions and observations made by the investigating team, similar routes required 26 seconds on average, while at the subject event the pushback took 58 seconds, i.e. a speed slower by more than a half of normal towing speed. The slow speed was most probably an outcome of the tow drivers' difficulties in following the lines on the ground and push accordingly.

With 14 meters remaining for the B767 a/c to reach the start-up position and stop, and with the 737 a/c about to turn for lining up and its tail penetrating taxiway M, the 737 a/c's tow driver briefly noticed a white silhouette.
