AIRCRAFT ACCIDENT REPORT 1/2023

Report on the accident to
Leonardo AW169, G-VSKP
at King Power Stadium, Leicester
on 27 October 2018

Air Accidents Investigation Branch

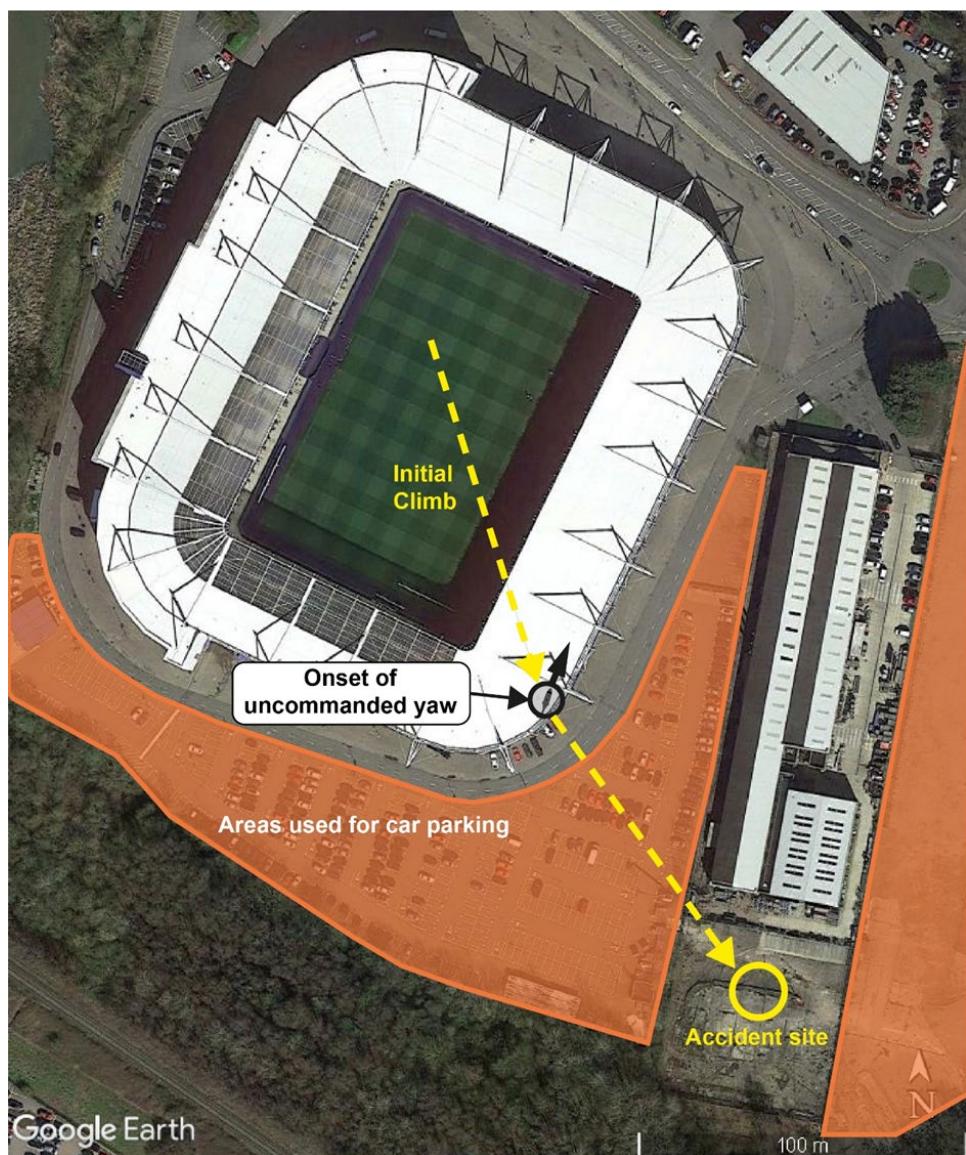
Figure 2
Approximate trajectory of G-VSKP on the accident flight
Map data © 2021 Google

The helicopter struck the ground on a stepped concrete surface, while still rotating and with the landing gear retracted (Figure 2). It came to a stop and then rolled onto its left side and was rapidly engulfed in an intense post-impact fire. Stadium staff and emergency services were quickly at the scene but were not able to gain access to the helicopter because of the intensity of the fire.

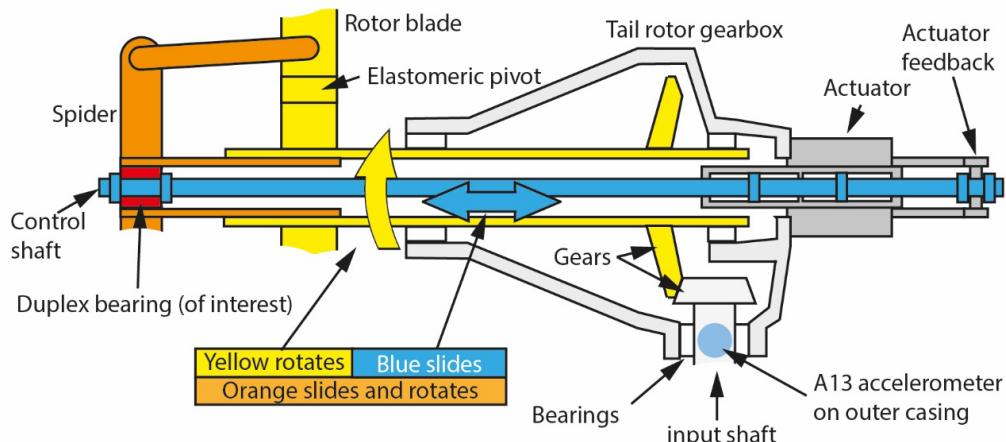
Figure 18

There is also a biaxial accelerometer on the tail rotor gear box for the purpose of monitoring the rotor track and balance. None of these were positioned to monitor for problems in the duplex bearing as there was no requirement to do so. The location of the accelerometer meant that vibrations generated by the duplex bearing were obscured by the vibration of other components between the bearing and accelerometer.

Simple schematic of the tail rotor gearbox showing the relative locations (viewed from forward looking aft) of the vibration sensing accelerometer and the failed critical duplex bearing. Not to scale.

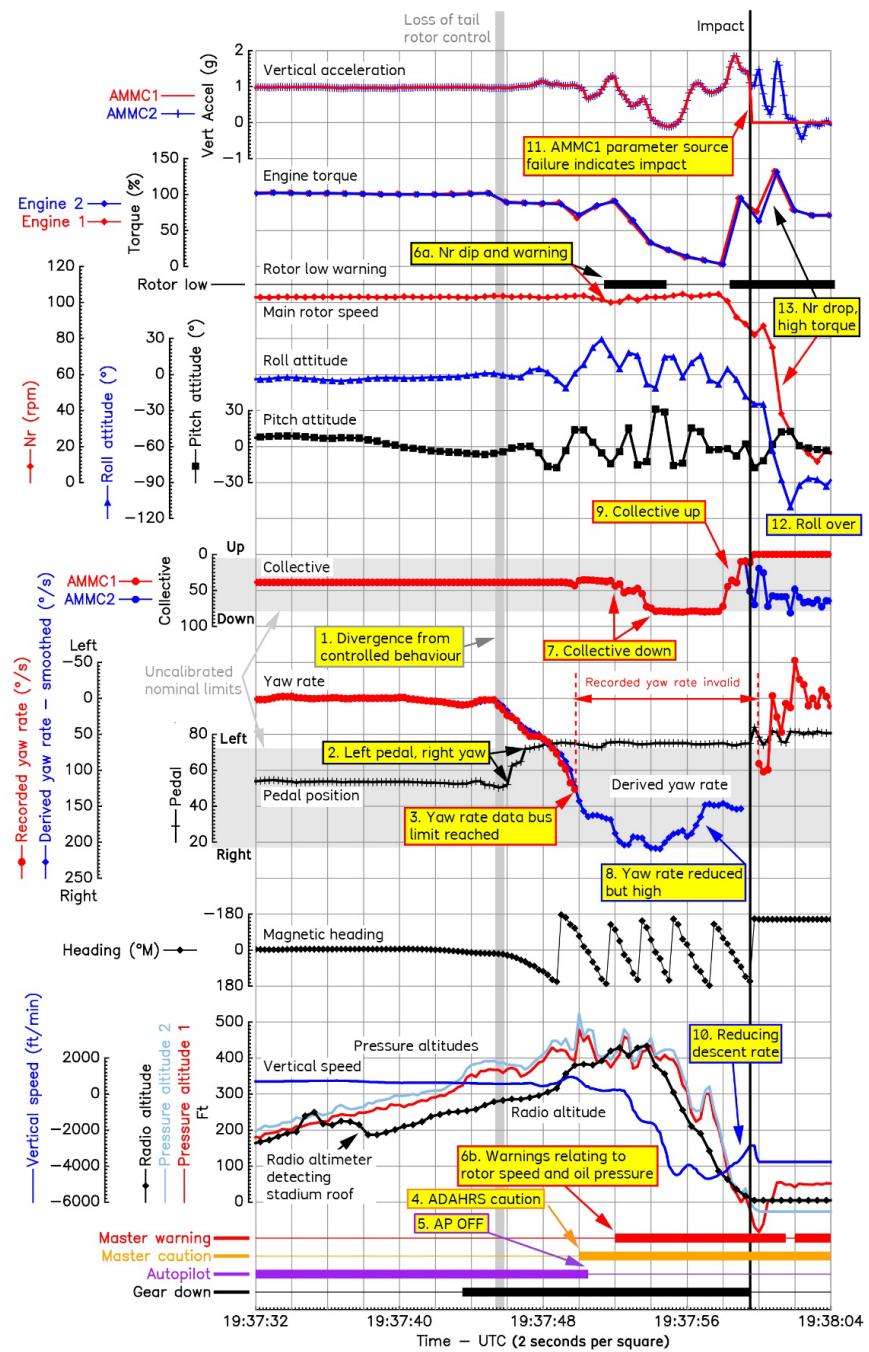
Figure 20
Pertinent extracts from the flight recorder

Passing approximately 300 ft, a heading change to the right was initiated and stopped followed by another heading change in the same direction (note 1 in Figure 20) which carried on accelerating despite opposite pedal being applied (note 2 in Figure 20).

After the yaw rate reached 128°/s (note 3 in Figure 20), the recorded yaw rate became invalid. ap ahrs 1 fail, ap ahrs 2 fail (note 4 in Figure 20) and 1-2 ap off (note 5 in Figure 20) cautions were recorded.

There was a small movement in the collective at the same time as the yaw rate became invalid, followed by a very slight increase. At this point the yaw rate was in excess of 160°/s and the rotor speed decayed to a recorded value of 99.75% after previously having been holding at approximately 103% (this equates to 348 rpm or nearly 2,100°/s). A ROTOR LOW warning was triggered (notes 6a and 6b of Figure 20). The collective was partially lowered for approximately one second and then fully lowered (note 7 of Figure 20). The rotor speed recovered.

The radio altimeter height had peaked at about 430 ft agl. The yaw rate started to reduce and plateaued at about 150°/s (note 8 of Figure 20).

After the collective was lowered the helicopter started to descend. The descent rate increased and stabilised at approximately -4,000 ft/min until the collective was pulled up prior to impact (notes 9 and 10 of Figure 20). There was then an associated drop in rotor speed and engine output speed with increased engine torques.

After ground contact the helicopter rolled left (note 12, Figure 20) and pitched up, with a peak left roll of 110° and a nose-up attitude of 13° recorded two seconds after impact. It then rolled back to 83° of left roll and pitched to 6° nose-down in a similar time frame.

The quick roll over correlated with a recorded audio associated with the rotors striking the ground. The small reversion of pitch and roll ceased approximately as the sounds of the rotor strikes ceased. A sharp drop in rotor speed and increases in engine torque values were also recorded during this period (note 13, Figure 20).

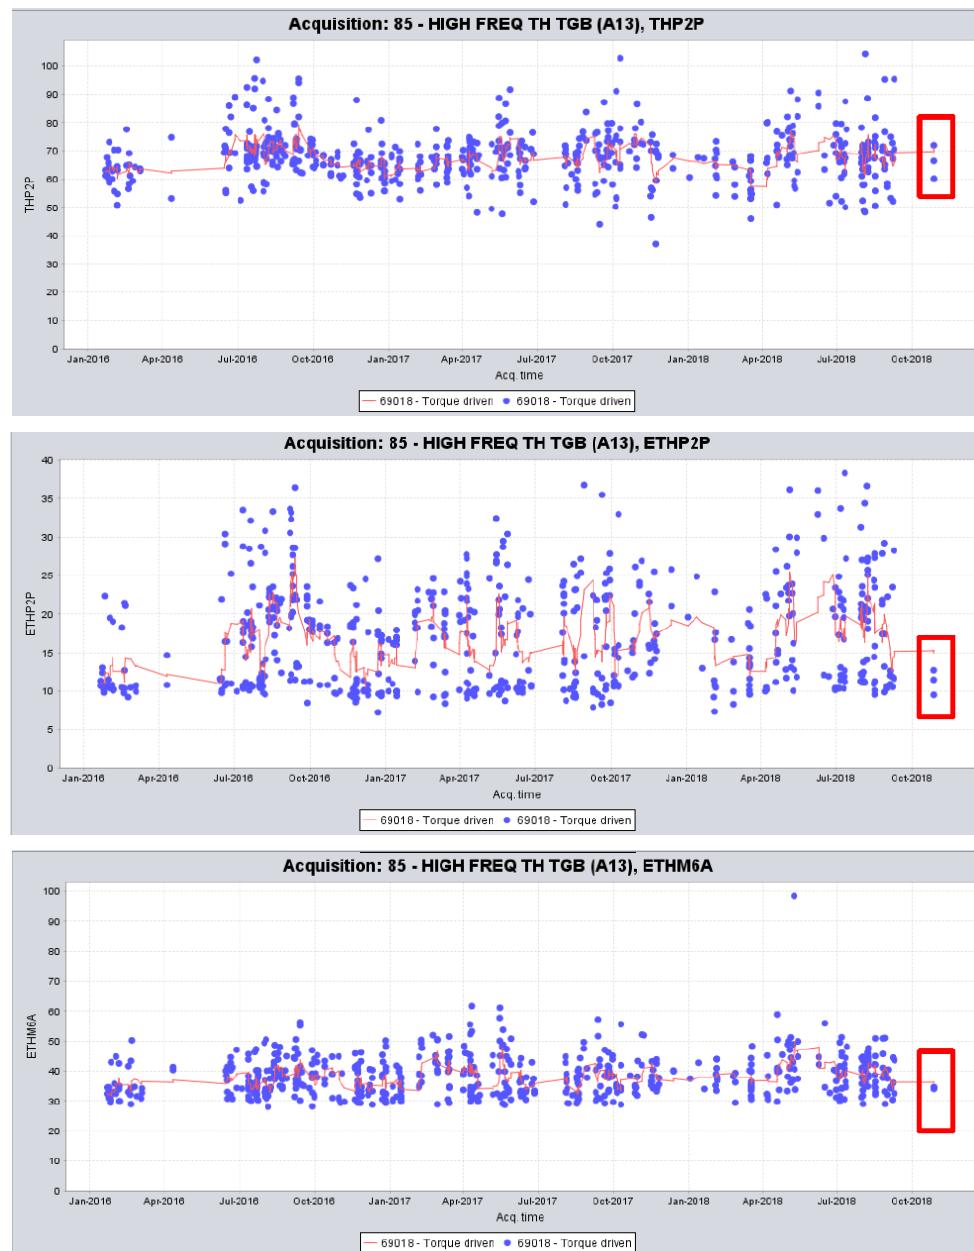
Figure 24

Example TGB Accelerometer A13 derived HI trends.
The red box highlights the results from the accident flight

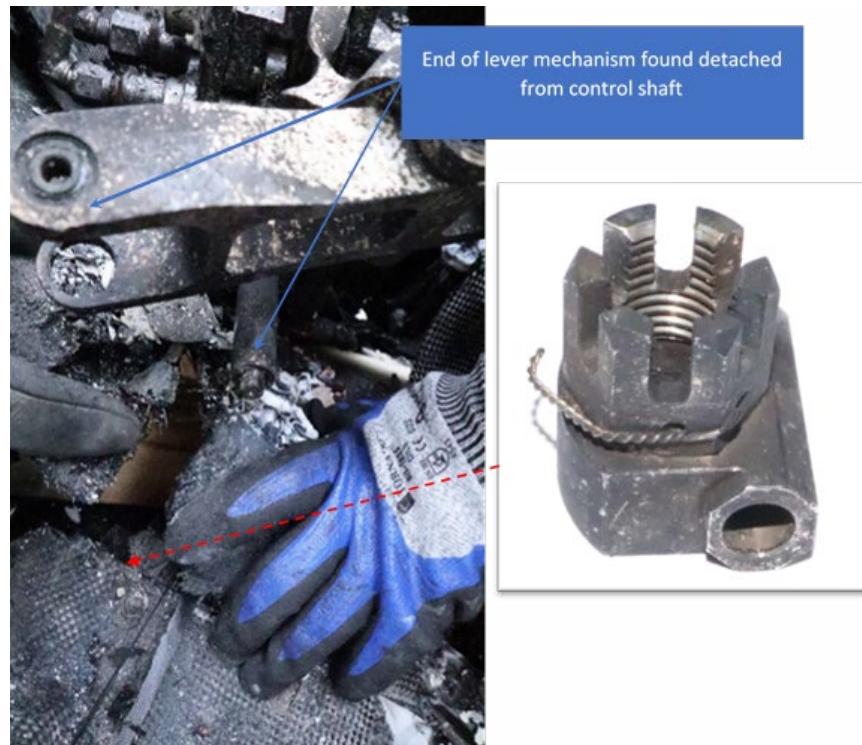
Figure 25

Initial evidence obtained from video footage of the accident, focussed attention on the tail rotor of the helicopter. The tail section of the helicopter where the tail rotor was located was less damaged by the fire than other sections of the helicopter. Onsite inspection of the tail rotor control mechanism identified that the servo actuator lever mechanism was no longer attached to the TRA control shaft. The castellated nut and pin carrier were found bonded to each other but detached from both the lever mechanism and the control shaft and lying in the remains of the vertical tail carbon fibre skin panel (Figure 25).

Disconnected lever mechanism, TRA control shaft and detached but fused nut and pin carrier

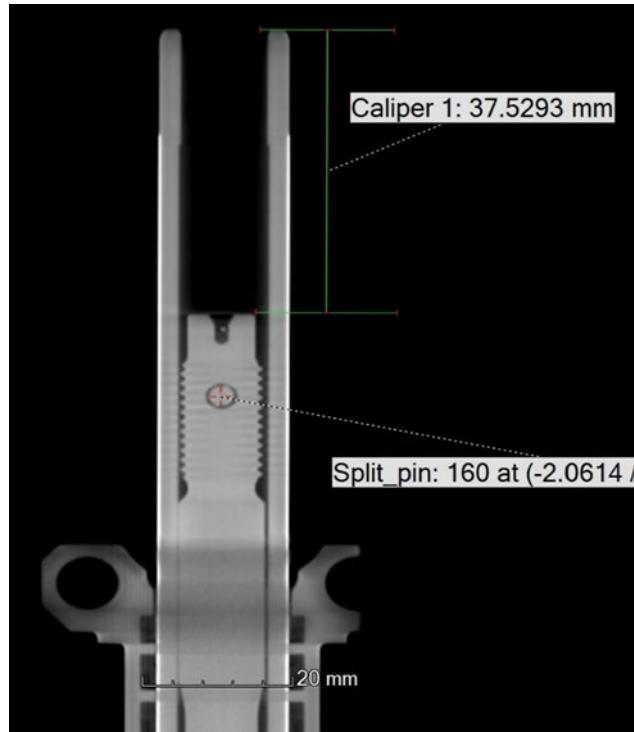
Figure 27

The shaft was imaged using the CT scanner, which confirmed the threaded portion of the control shaft was inside the outer shaft and contained the remains of the split pin. The top and bottom of the split pin had been sheared off in rotation (Figures 27 and 28).

CT scan of threaded section of control shaft and split pin

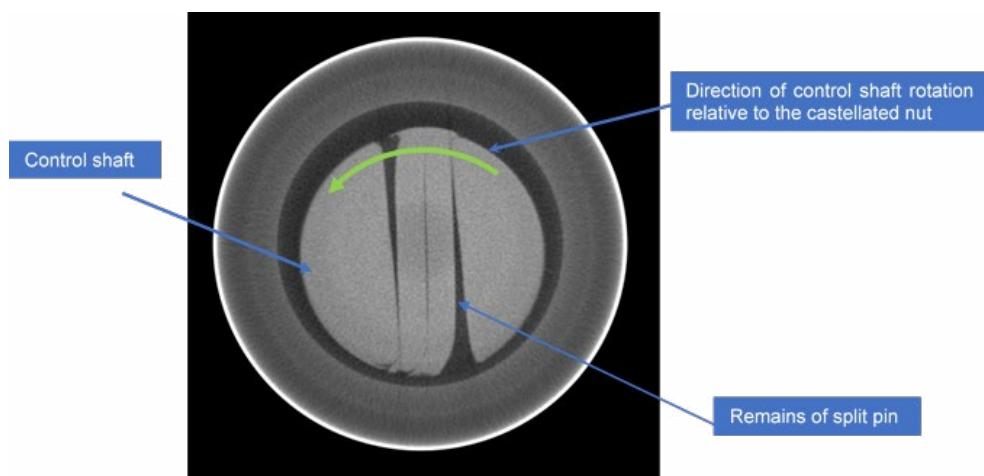
Figure 28

CT scan through tail rotor actuator control shaft
(viewed from bearing end)

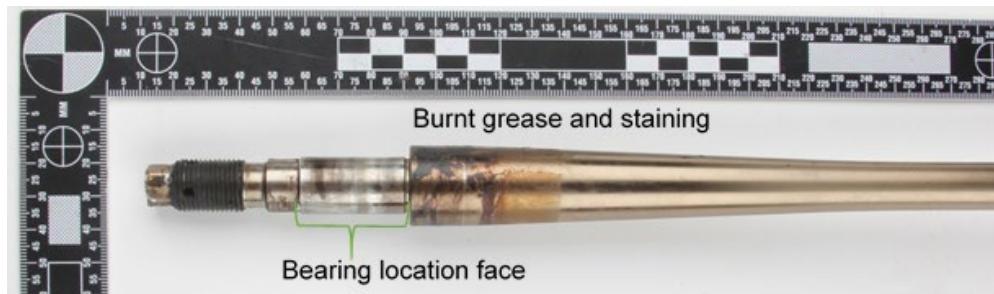
Figure 29

At the other end of the control shaft, the section adjacent to the duplex bearing face showed evidence of burnt-on grease and was discoloured along its length (Figure 29).

Duplex bearing location on tail rotor actuator control shaft
after removal of the bearing

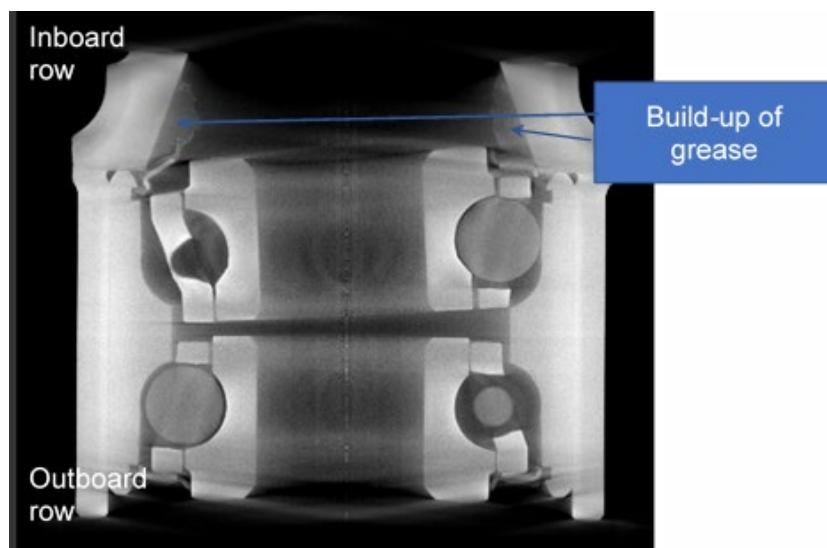
Figure 30

Following removal from the control shaft, the inner races of the bearing could only be rotated a few degrees in either direction by hand. There was also a small build-up of black grease inside the slider unit around the inboard face of the duplex bearing. The spider assembly was removed, and the slider/bearing assembly was CT scanned⁵¹ (Figure 30).

CT scan of bearing/slider assembly

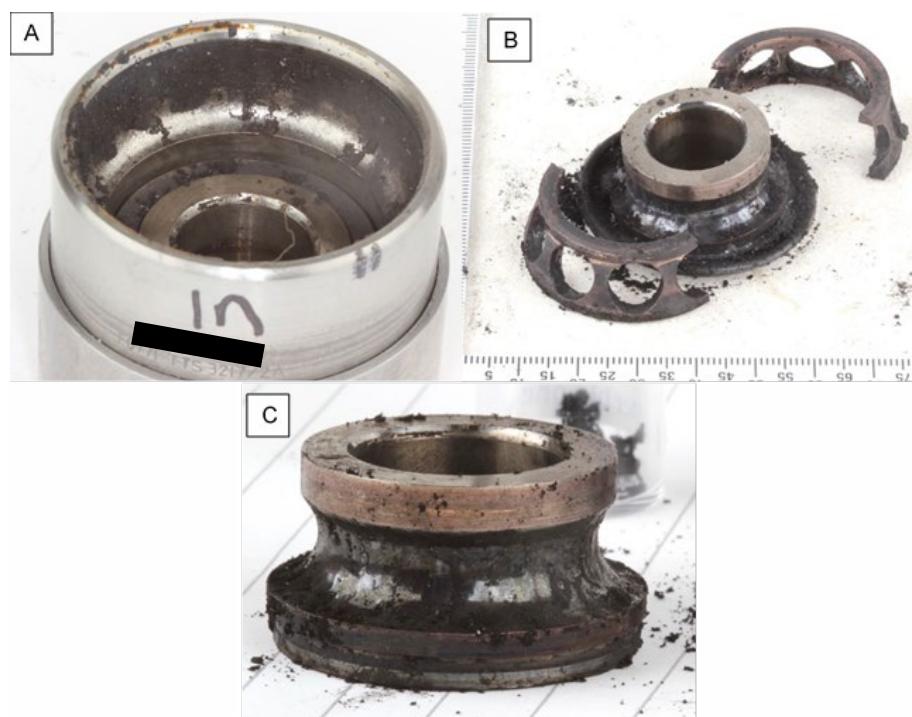
Figure 33

outer ring. The debris present on the CT scan was identified as a combination of black dust and metallic particles. No grease, in its original form, remained in the bearing but there was black dust in and around the bearing races and cage (Figure 33). The seal on the inboard side of the bearing exhibited wear marks on its inner surface from contact with the cage. Visual inspection of the surface of the bearing races confirmed the extent of the damage seen in the CT scans. The surface of each of the balls from both sides of the bearing was crazed and exhibited areas of matt white surface finish, but none of the balls were spalled.

- (A) Inboard row, outer race (B) inboard row inner race and fractured cage
(C) inboard row inner race

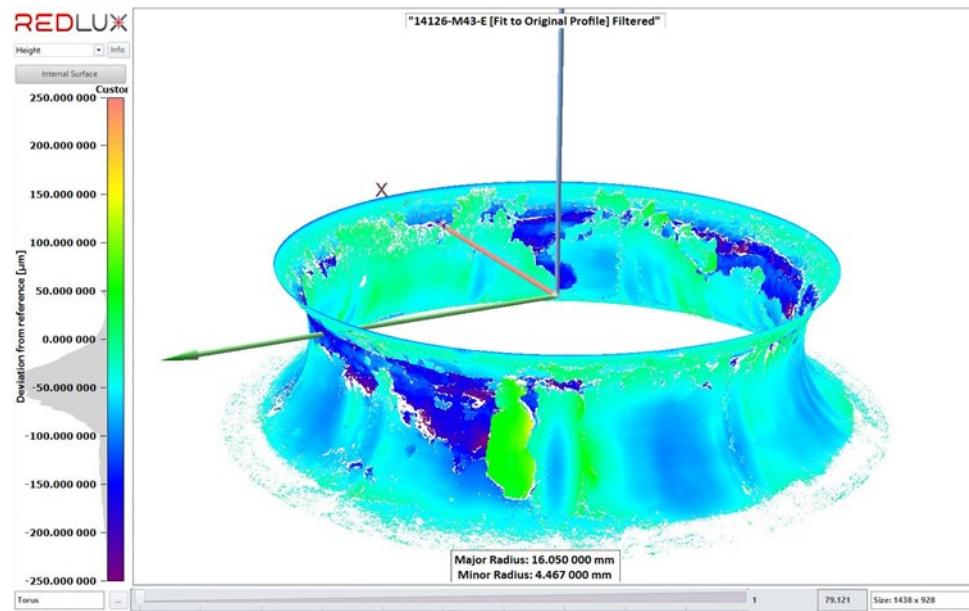
Figure 34

The duplex bearing was subjected to a sequence of detailed analysis techniques to document its condition. Initially the surface of the inner and outer races was scanned using a high resolution, non-contact, optical scanning technique to record the topography of the running surfaces (Figure 34). This was combined with higher resolution CT scans to identify the extent of the damage. The inner races were examined further using a Scanning Electron Microscope (SEM). This confirmed the presence of step-like features with striations, indicating that they were formed by a cyclic failure mechanism consistent with rolling contact fatigue.

Optical measurement of the rolling surface of the inner race showing heavy wear, with large pits (blue areas), but also areas raised higher than the original surface (green/yellow)

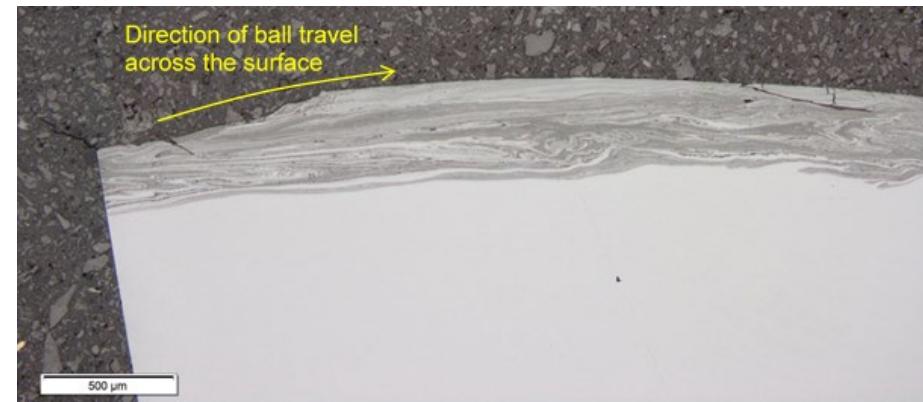
**Figure 37**

The sections were then polished and viewed under an optical microscope (Figure 37). On the inboard inner race this revealed that the surface in the centre of the race, down to a depth of approximately 0.5 mm, had a swirling, layered structure with extensive cracks in many locations (Figure 38). The surface of the polished sections were then etched using various reagents and again viewed under an optical microscope.

Optical microscopy view of circumferential slice from inboard inner race of bearing following polishing to show the layered surface

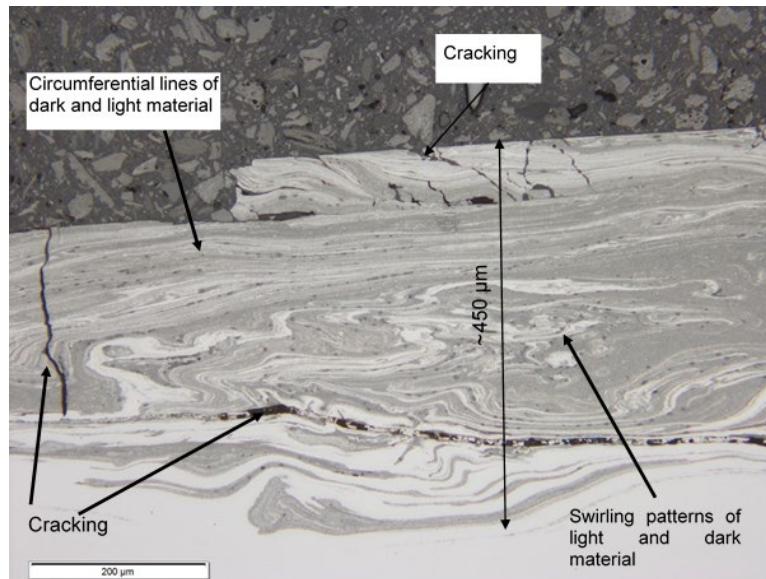
**Figure 38**

Magnified view of inboard inner race of bearing showing cracking of material

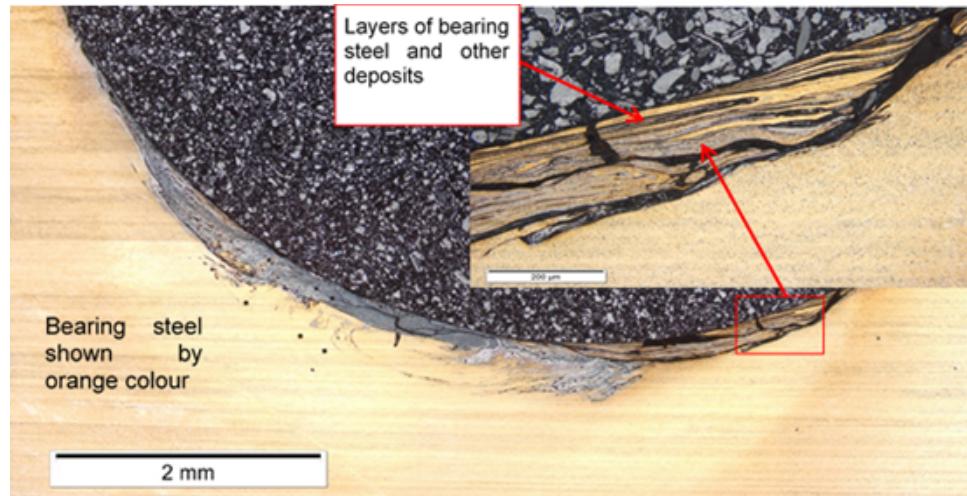
**Figure 39**

The outboard inner race showed evidence of a heat affected zone and a Dark Etched Region⁵³ (DER) below the surface. A combination of the reagents used and EDAX⁵⁴ analysis confirmed that the various layers on the inboard inner race were formed from different materials including carbon, steel and copper, which had been deposited and compressed (Figure 39).

Optical microscopy views of etched (Murakami's reagent) radial slice from inboard, inner race showing mix of materials in the layer

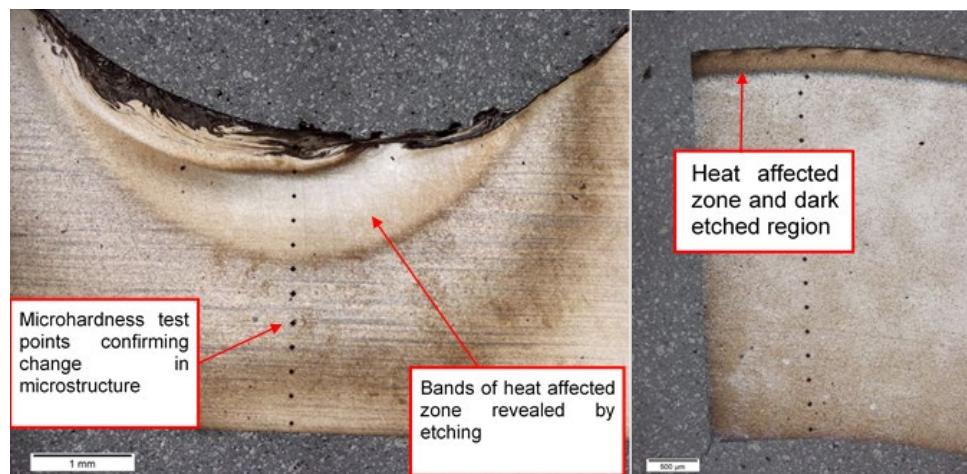
**Figure 40**

Below this layer of mixed material, was the original bearing steel material. However, use of etchant on the section surface identified a heat affected zone where the material microstructure had changed (Figure 40). Microhardness profiling was conducted both radially and circumferentially. The results confirmed that the steel had softened compared to a new bearing, but closest to the surface the material had rehardened. This suggested that the temperature at

High magnification light microscopy views of etched (Vilella's reagent) radial slice of inboard inner race (left) and circumferential slice of outboard inner race (right), showing heat affected zones, DER and microhardness testing points

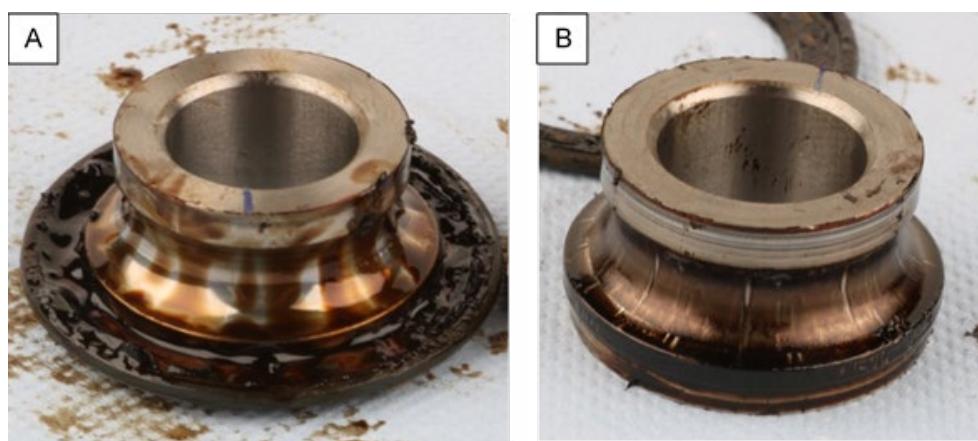
Figure 45

Once the bearing had been weighed and CT scanned, it was opened for detailed inspection. Visually there was evidence of degradation of the grease. The grease on the outboard inner race appeared brown but still moist, suggesting the presence of lubricating oil but no longer in the solid grease form. The inboard inner race was also brown but with a tacky rather than moist residue over the race surface (Figure 45). There was no evidence of any damage to the balls, but the cages showed evidence of wear in the ball 'pockets' and witness marks indicating a 'running line' around the circumference where the cage had been in contact with the inner race.

A) Outboard inner race of bearing showing evidence of moist lubricant residue. B) Inboard inner race showing tacky residue coating the race surface

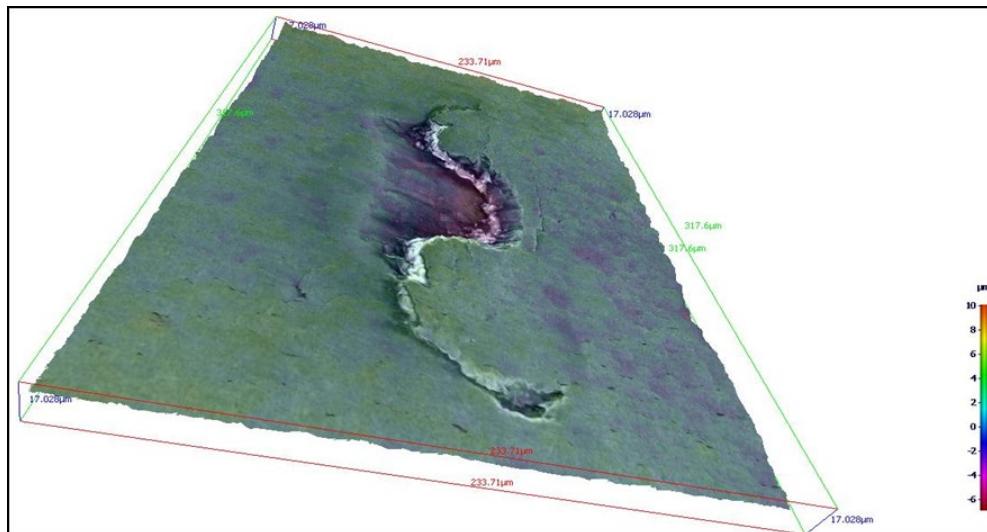
**Figure 48**

The inner races were inspected using an SEM, with the images then processed using MeX software to create height maps. The outboard inner race showed evidence of the original manufacturing grinding marks across the race surface, except for the running area band, where they had been worn smooth. The inboard inner race exhibited crack features, which displayed the same orientation and aspect ratio but varied in size (Figures 47 and 48).

MeX height map of crack feature 1 showing measurements and pitting

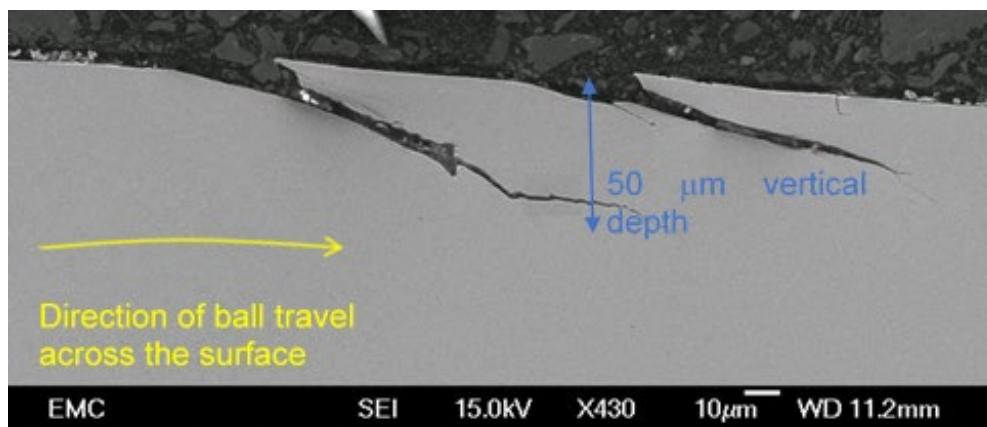
**Figure 49**

A circumferential and radial section was cut from the inboard inner race and inspected using the SEM. This showed that the larger cracks extended to a depth of 50 μm and were consistent with those seen on the accident bearing (Figure 49).

SEM image of circumferential section showing crack depth and orientation

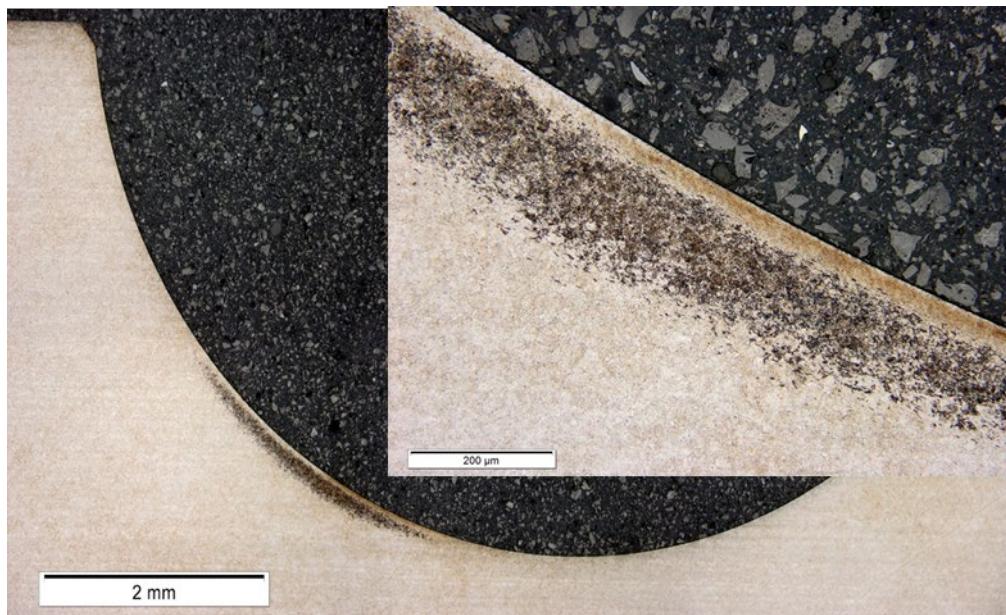
Figure 50

Etching of the sections from both the inboard and outboard inner rings confirmed a DER of microstructural change within a band from the surface to 0.2 mm down. (Figure 50). Nano hardness testing confirmed a reduction in hardness through this region. The area of microstructural change on the inboard race was deeper and more consistent than on the outboard race, but both showed

evidence of change consistent with the early stages of a surface origin, rolling contact fatigue mechanism.

Etched radial section from inboard inner race showing area of microstructural change (DER)

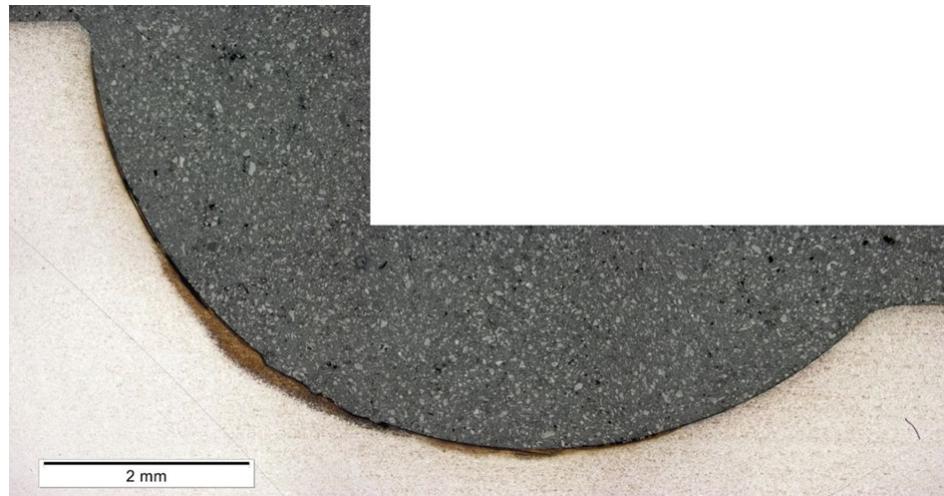
**Figure 53**

Macroscopic view of etched (Vilella) radial section from outboard inner race, showing change in microstructure (DER)

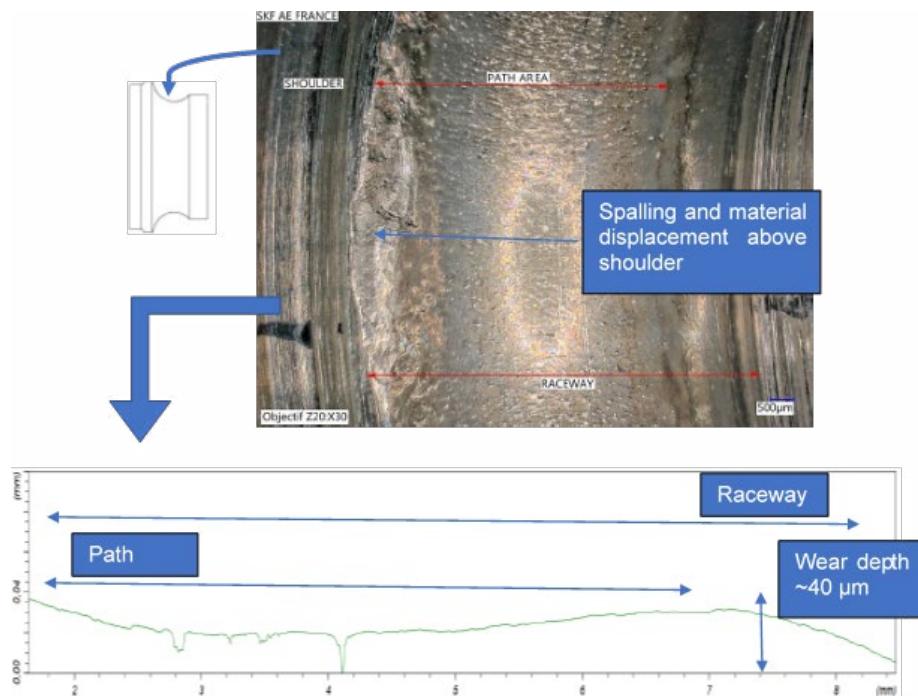
**Figure 56**

When the bearing was opened, it was found to have significant damage over the whole running surface of the bearing on the inboard row, inner and outer races (Figure 55). Material had been displaced from a wear path the same radius as the radius of the balls and pushed up above the shoulder of the race (Figure 56).

Inboard inner race showing wear path created by the balls and material displacement

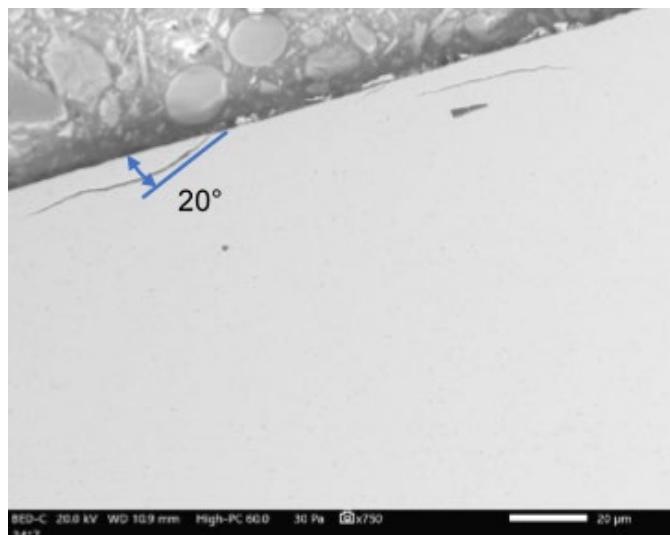
Figure 59

surface and extensive micropitting (Figure 59). However, there was no DER below the surface as found on the other bearings (Figure 58).

Inboard inner race surface initiated cracking

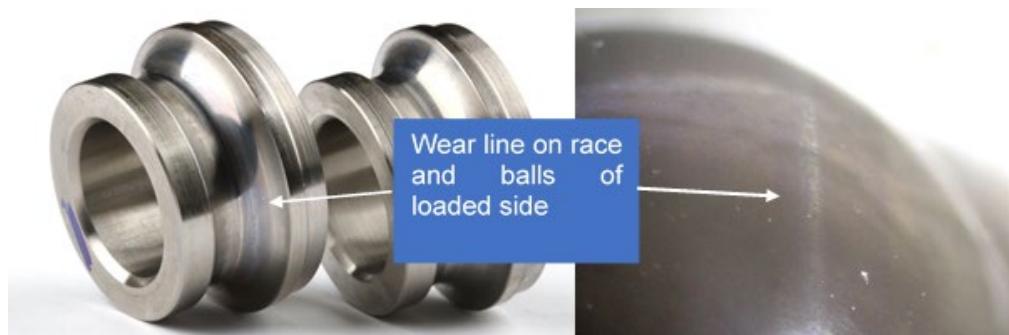
Figure 66

The races of the loaded side of the bearing showed evidence of a wear line created by the balls, but no evidence of fatigue damage. The balls also exhibited a 'run' line, which was off centre, but no spalling (Figure 66). The cages had witness marks in the pockets, which were more pronounced on the loaded side of the bearing, but no significant damage.

Wear on inner race and balls of the loaded side of the test bearing

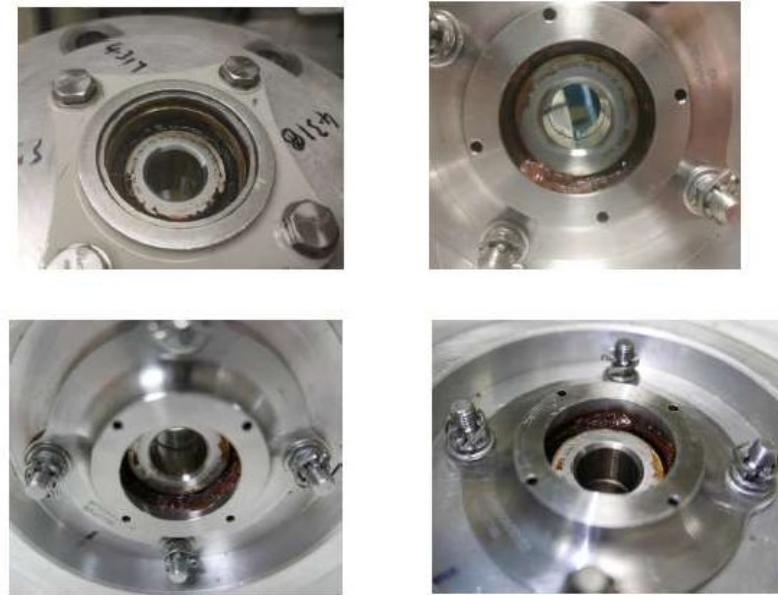
**Figure 71**

The inspection conducted at the first stop indicated that a 'collar' of grease extruded from the bearing had built up around the inboard bearing face where the seal had been removed (Figure 71). The volume of grease remained the same throughout the test.

Grease extruded from the bearing during the first 290 hours of testing.
(original image courtesy of the manufacturer)

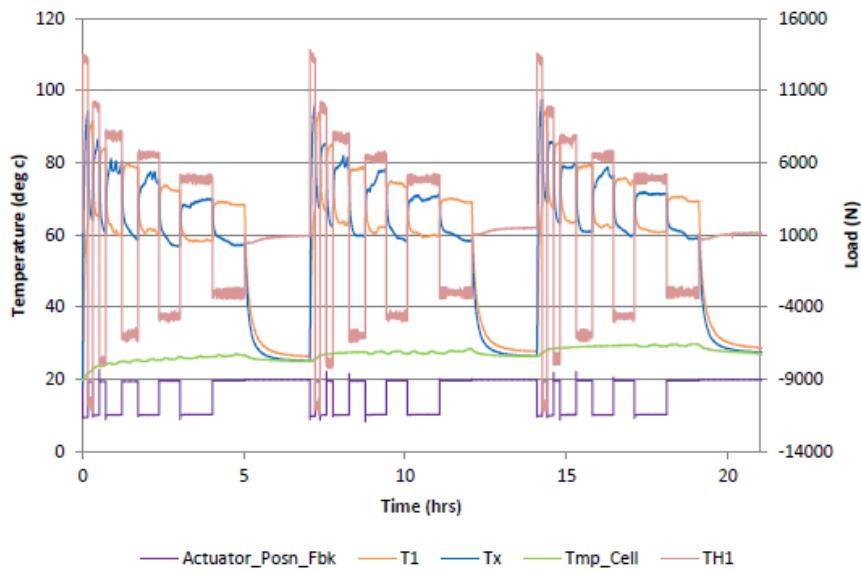
**Figure 72**

Graph showing temperature increase with load application during three blocks of the rig test
(original image courtesy of the manufacturer)

Plotting the load and temperature sensor readings showed that the temperature on each side of the bearing increased proportionately to the load magnitude and direction applied. Figure 72 shows the two temperature sensors T1 and Tx and the load being applied TH1.

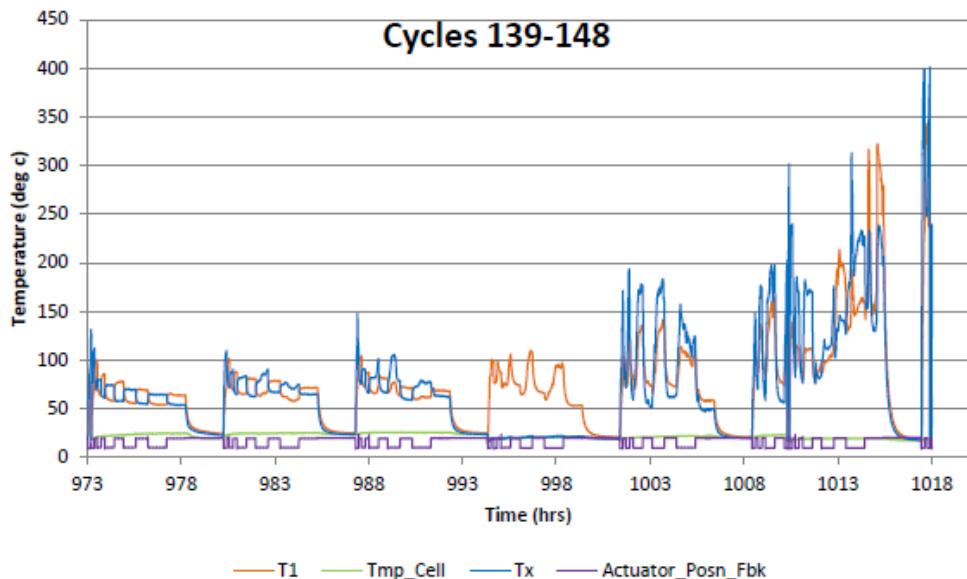
**Figure 73**

Towards the end of the test the temperature increase seen each time the load was applied began to increase significantly more than seen at the start of the test, until the torque alarm was triggered, and the test was stopped (Figure 73).

Graph showing rise in temperature increase with load application at the end of the test
 (original image courtesy of the manufacturer)

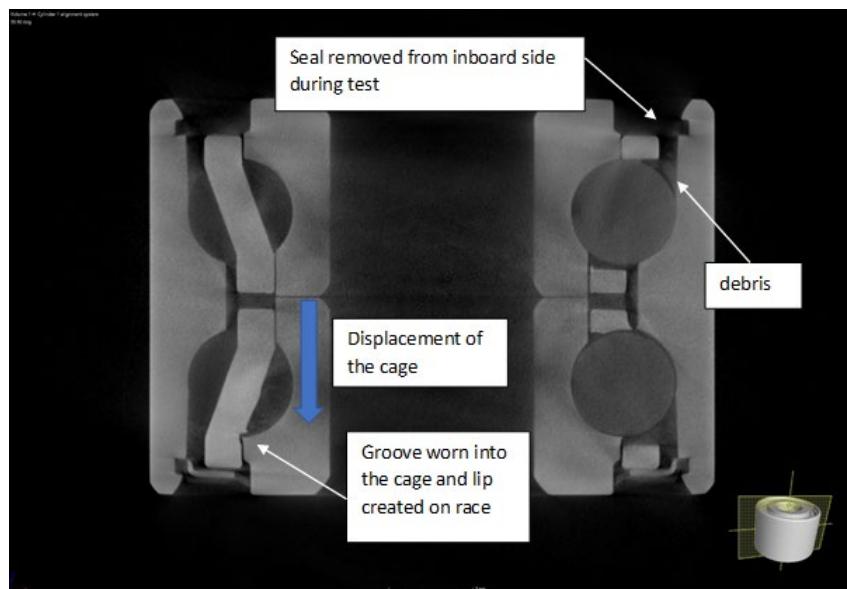
**Figure 74**

A groove had been worn in the cage and a lip worn on the race where they were in contact (Figure 74). Large amounts of debris were also seen within the bearing races.

CT scan of bearing 16141 showing wear interaction on the outboard cage and race

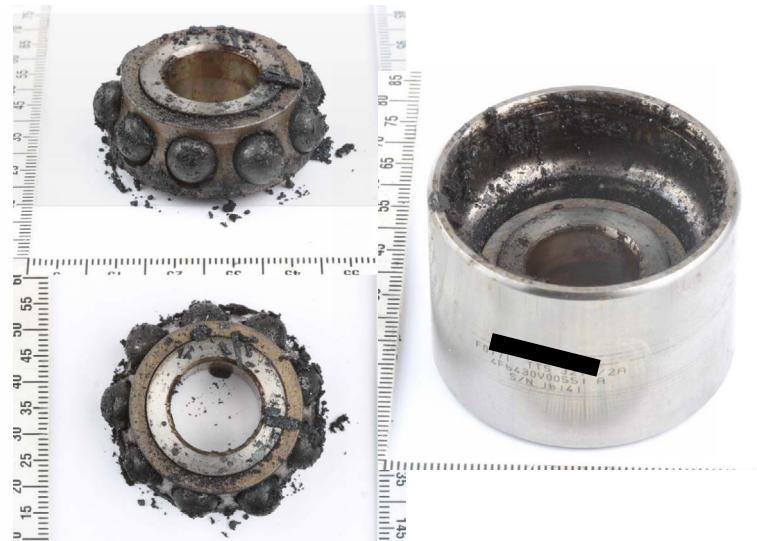
Figure 75

The inboard side of the bearing, which had operated with the seal removed, was disassembled and inspected. The grease had degraded to the extent that it was black, dry and powdery but it was still present (Figure 75).

Condition of the inboard side of the bearing which was operated with the seal removed

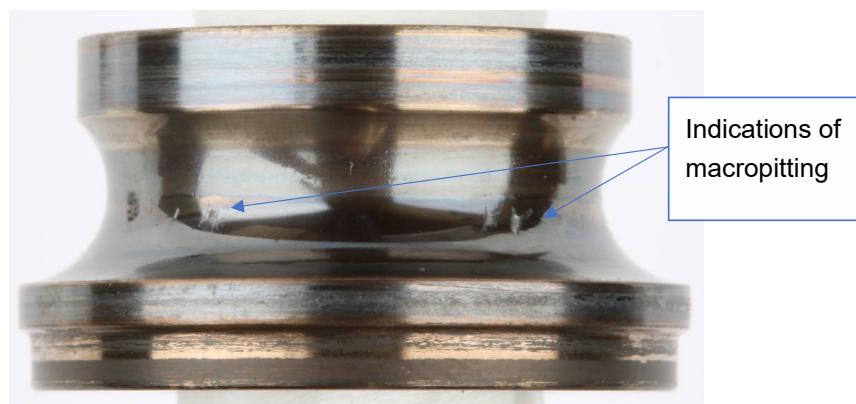
Figure 76

The inner race of the inboard side showed discreet areas of macropitting and high temperature induced permanent change in colour (Figure 76).

Inboard inner race showing discrete areas of macropitting and permanent colour change

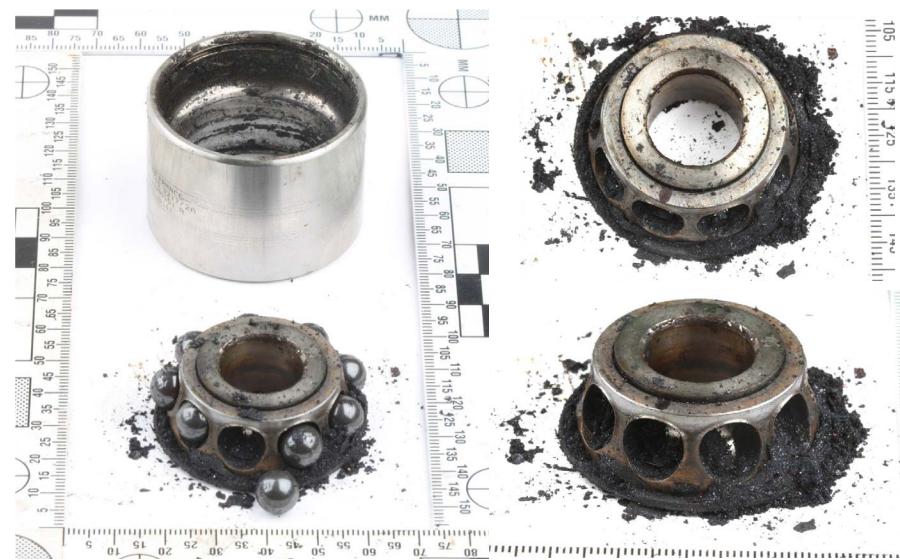
Figure 77

Condition of the outboard side of the bearing operated with the seal in place

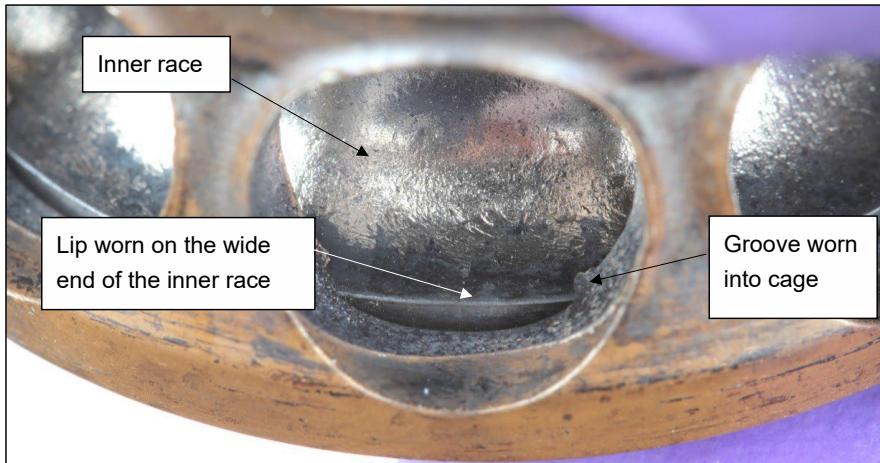
Figure 78

The cage could be rotated independently but not separated from the inner race due to the groove and lip worn into the cage and race (Figure 78).

Image showing the groove and lip worn into the cage and inner race of the outboard side of the bearing and the damage to the race running surface (post-cleaning)

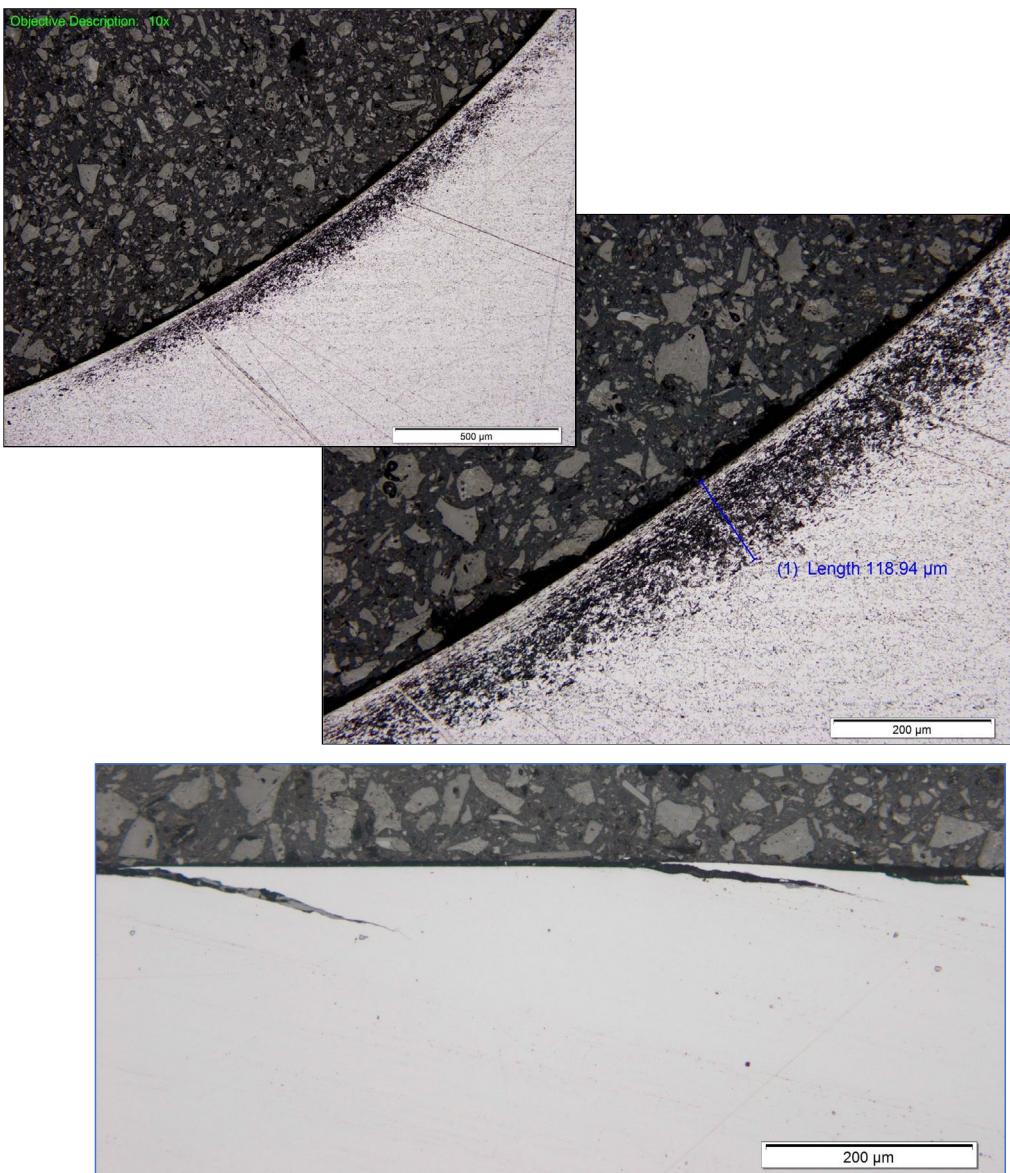
Figure 79

The inner races from both sides of the bearing were also sectioned and inspected using an SEM. The inboard side (no seal) showed discrete micro and macropitting consistent with surface initiated RCF. The cross sections were etched and polished to show a DER was present below the surface of the race (Figure 79), with compression and deformation of the microstructure immediately below the surface. Shallow angle surface initiated cracks were also present.

DER layer identified on the radial section and surface cracks shown on circumferential section of the inner race, inboard side
