AIRCRAFT ACCIDENT REPORT 1/2023

Report on the accident to
Leonardo AW169, G-VSKP
at King Power Stadium, Leicester
on 27 October 2018

Air Accidents Investigation Branch

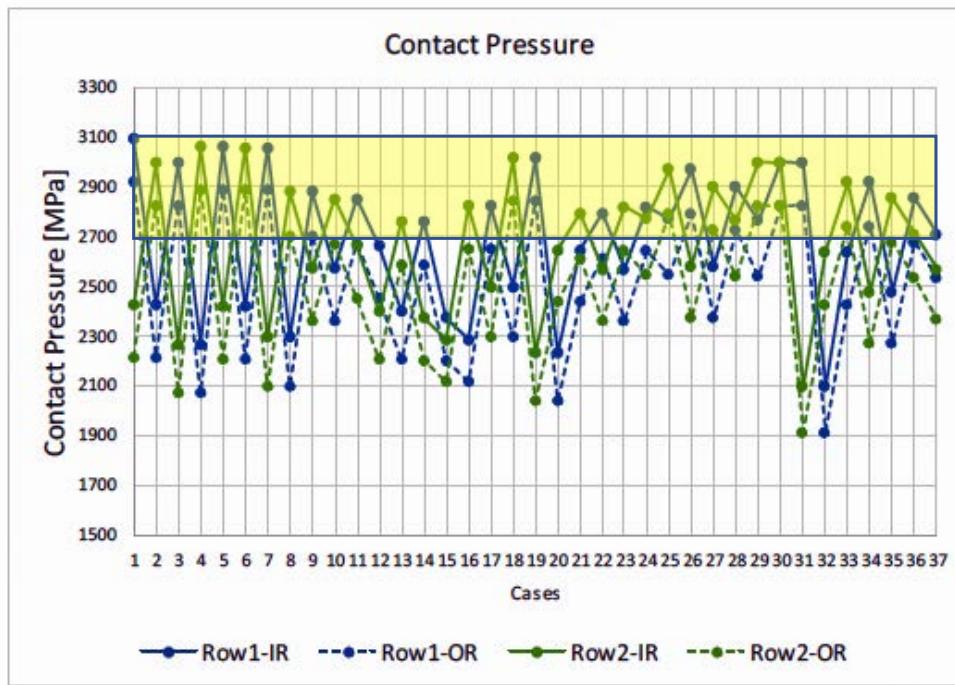
Figure 81
Significant flight test points calculated contact pressures

As a comparison the maximum contact pressure in the bearing certification specification was stated as 3,340 MPa, with a PV_{\max} of 440 on the inner ring for the extreme axial load case of 13,300N FZ (axial load) and 34.4 Nm Bending Moment (Table 4). However, this contact pressure was calculated using the less accurate modelling software available at the time the AW169 was developed.

Reassessment of the contact pressure using the current, more accurate, simulation software gave a revised contact pressure of 3,100 MPa and PV_{\max} of 400 for this load case⁶⁹ (the top line of each yellow highlighted box), showing it to be comparable to the highest contact pressures identified in the flight test results, which were achieved with much lower axial loads around 7,000N to 8,000N as shown in Figure 81 and [Appendix E](#).

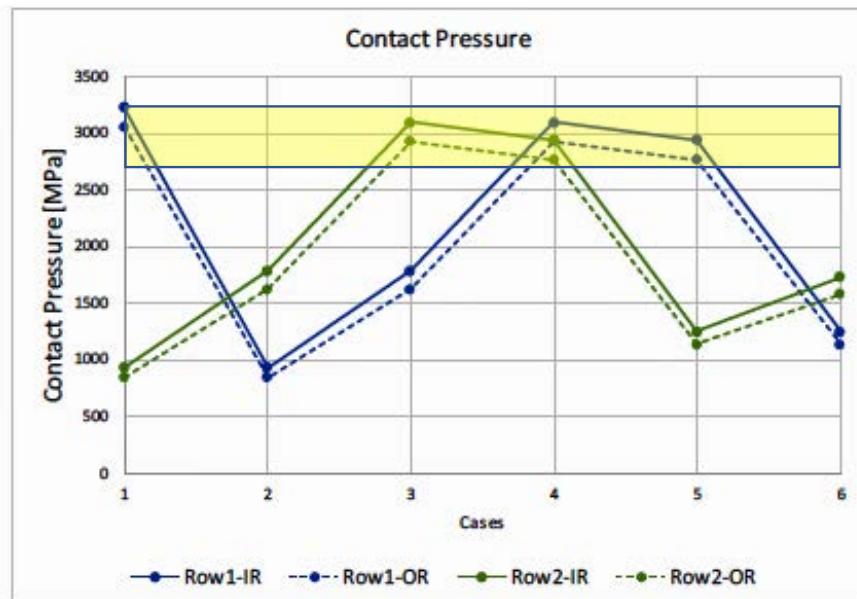
Figure 85
Rig test actual contact pressure (averaged data)

Again, most of these load cases are comparable with the contact pressures and PV_{\max} calculated for the flight test data group.

None of the contact pressures generated by the actual test load conditions were in excess of the contact pressures considered by the original development load spectrum, as calculated by the standard of bearing modelling software available at that time. However, the highest actual test point contact pressure was higher than the highest contact pressure in the development spectrum after it was reassessed with the latest standard of bearing modelling software now available.

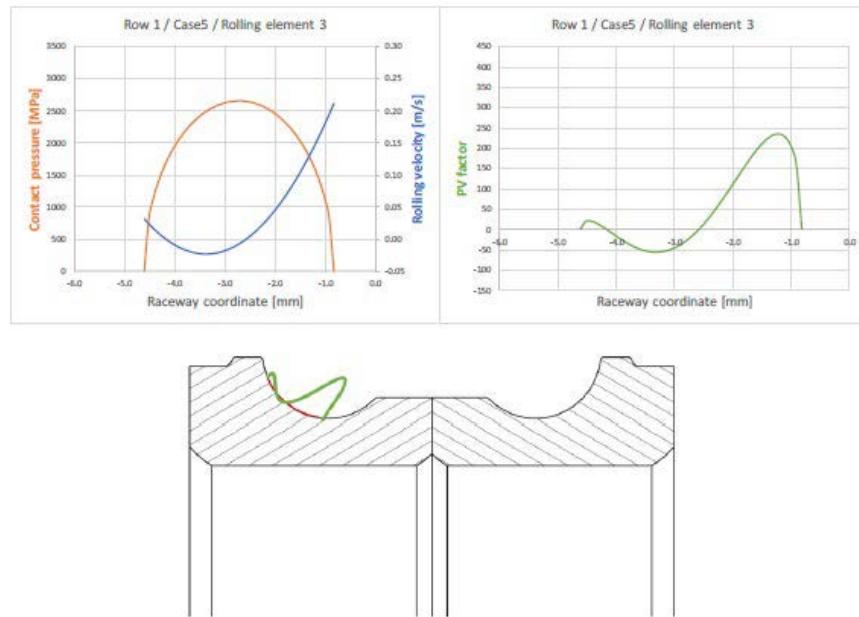
Figure 87
PV distribution relative to the inner race curvature

The graphs and illustration of the inner race profile in Figure 87 show how contact pressure and PV vary across the race profile and where the peak values occur (PV_{\max}). The location of these peak values correlates closely with where the first evidence of surface initiated rolling contact fatigue appeared on the inner races of bearing s/n 16141 used in the rig test, shown in Figures 76, 79 and 80⁷¹. And the inner races of bearing s/n 14134 which was removed from service, shown in Figures 46 and 50⁷².

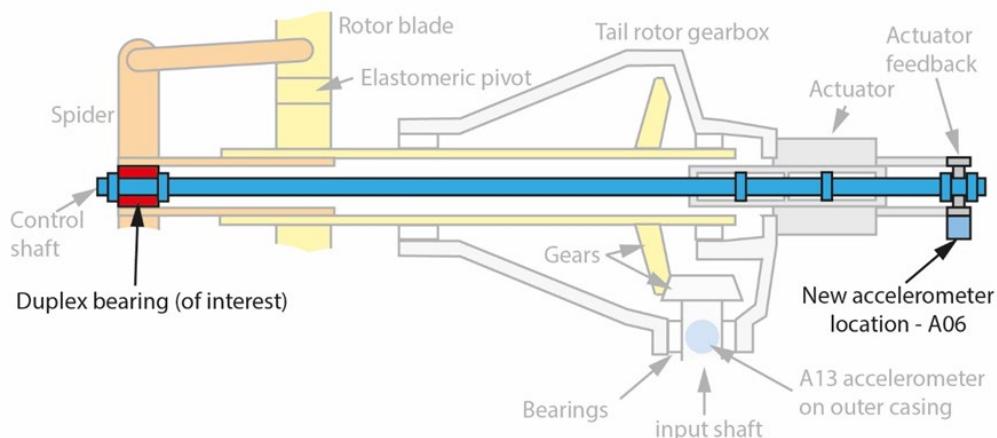
**Figure 94**

Simple schematic of the new accelerometer location relative to the duplex bearing of interest

The Health Indicator algorithms were applied to the gathered data. The most reactive to the degradation were linked to low frequency energy, though others also detected issues. It was decided that all their standard bearing Health Indicators would be used on the helicopter, coupled to a new sensor on the lever in the A06 location (Figure 94). Field experience would determine which are the most effective Health Indicators in practice.

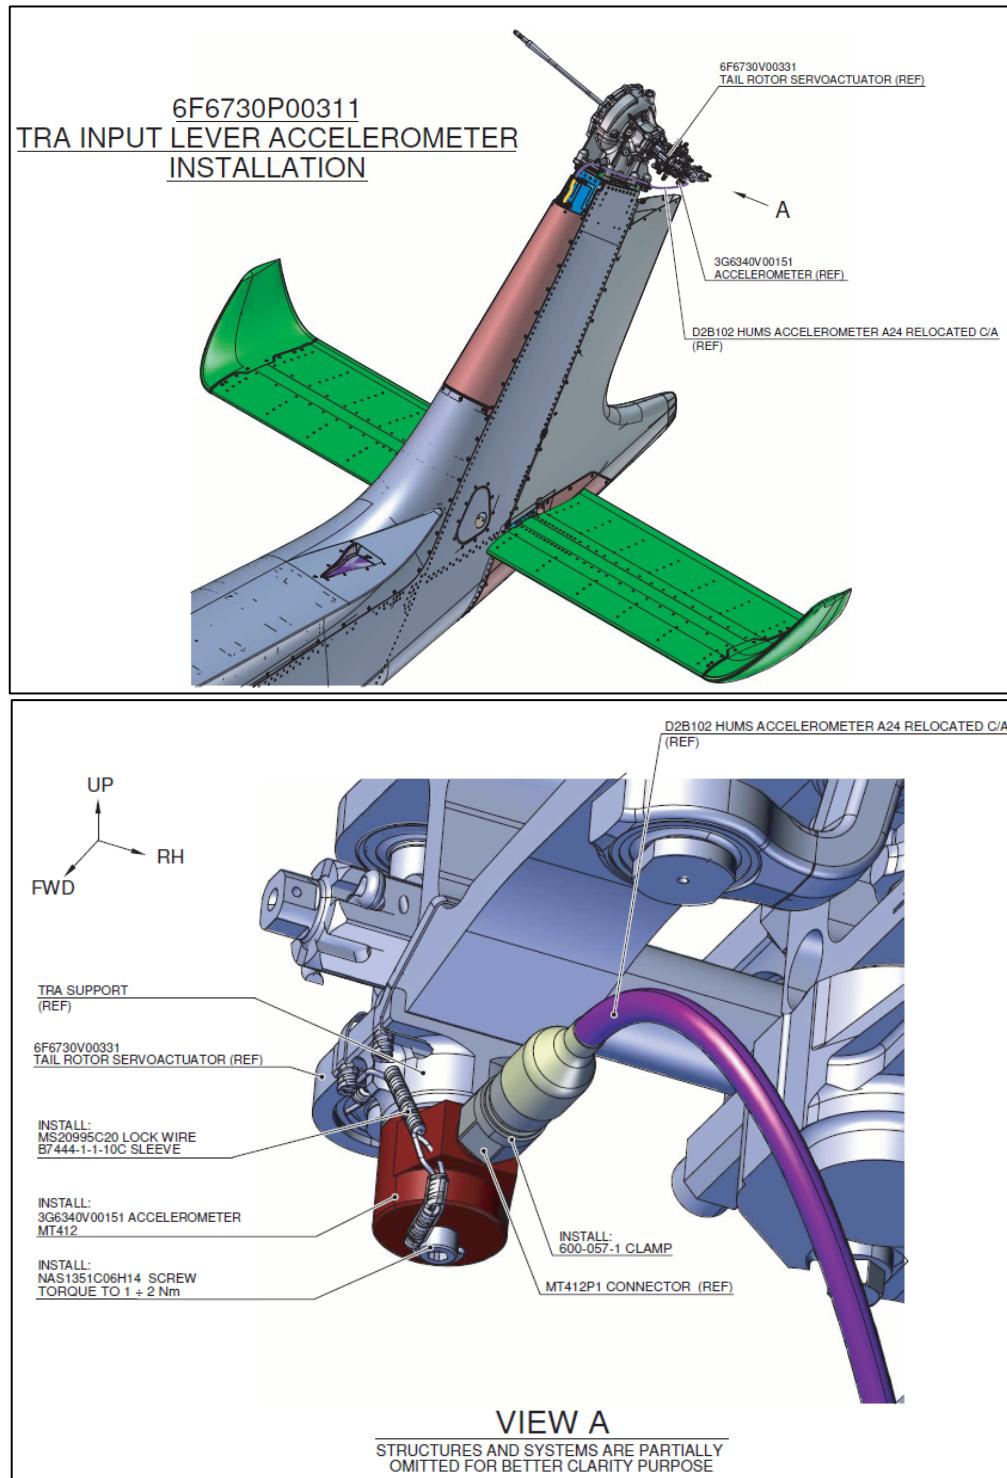
**Figure 95**

Extracts from manufacturer's modification document SB 169-140
 (Image courtesy of the manufacturer)

These detail the relocation of an accelerometer to the TR actuator lever assembly feeding into the onboard vibration monitoring systems (Figure 95). The change is on production aircraft and available for retrofit through the Service Bulletin.

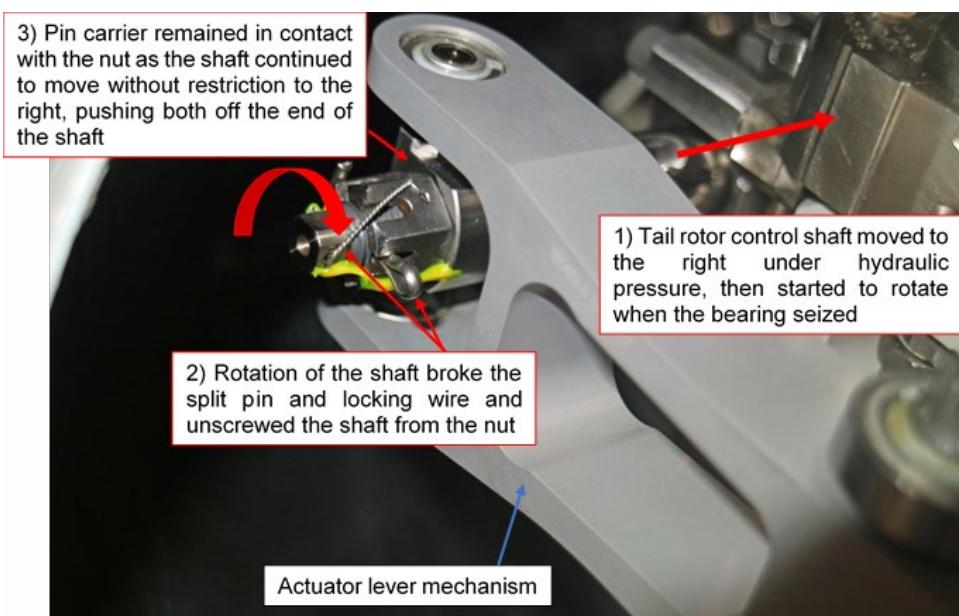
Figure 96

The locking nut at the actuator end of the control shaft clamped the pin carrier to the outer shaft of the hydraulic actuator, with the pin in the carrier providing the pivoting connection to the control system linked to the pilot's pedals. The now rotating inner shaft had enough torque to break the locking wire and shear the installed split pin on the nut. Continued axial movement of the control shaft under hydraulic pressure maintained the contact pressure between the nut and the pin carrier, allowing the threaded portion of the shaft to 'unscrew' completely from the nut². In the process, friction heated the nut sufficiently for localized melting to occur, effectively welding it to the pin carrier. Both the nut and pin carrier were pushed off the end of the control shaft as it continued to move (Figure 96).

Sequence of disconnection of the TRA control shaft from the pilot's controls

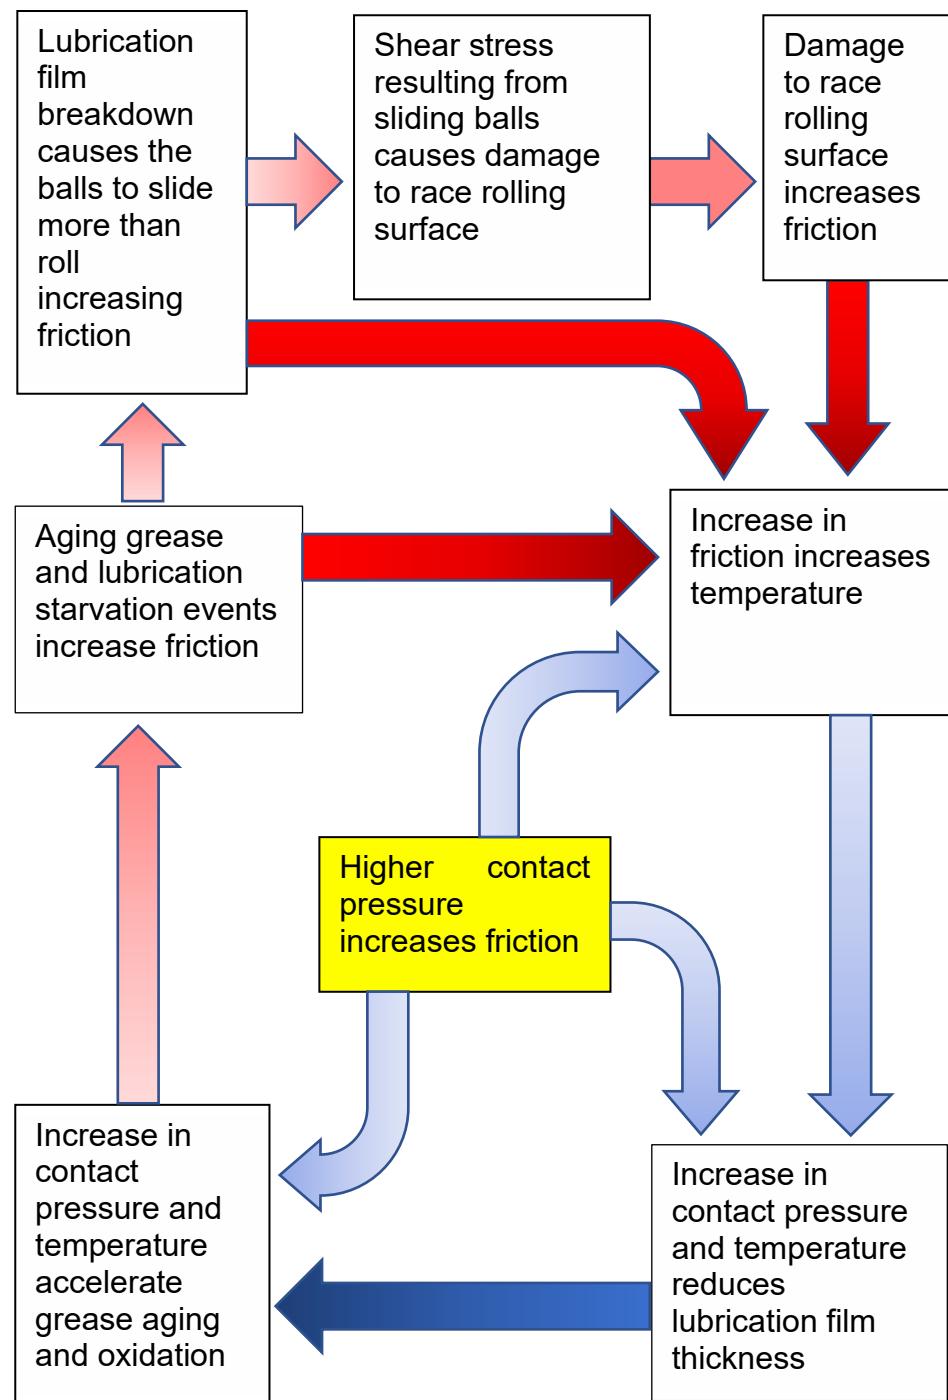
Figure 97

Loss of lubrication effectiveness either by momentary reductions in film thickness, which can result in lubrication starvation events, or by degradation of the grease, or by a combination of both, increases friction between the bearing race and the balls, leading to a further increase in temperature. This cycle also results in an increase in the amount that the balls slide which creates high shear stresses at the surface of the bearing race material, further increasing the temperature. Initially the increase in surface shear stress will manifest as subsurface microstructural change but this will progress under continued high stress to form distinctive surface initiated cracks and material loss, which also increases friction. This cyclic process eventually causes sufficient damage to the bearing race surface that it results in a self-perpetuating downward spiral of

reducing lubrication effectiveness, increasing friction, temperature and damage to the bearing until it seizes (Figure 97).

Cycle of increasing friction, grease deterioration and surface damage in bearings due to high contact pressure, resulting in premature failure

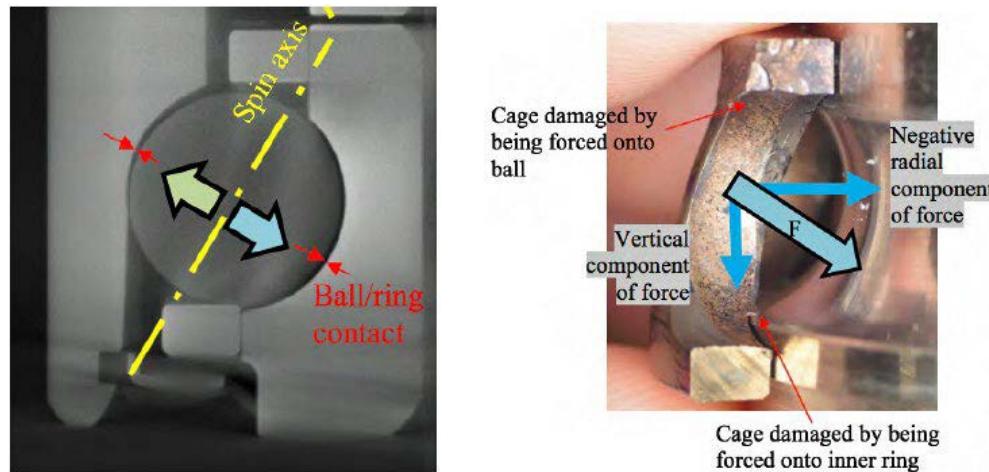
**Figure 99**

The geometry of the bearing inner and outer races results in an angled spin axis for the balls. The scoring and witness marks within the pockets confirmed that the balls had been in contact with the sides of the pockets, resulting in a friction force that pushed the cage towards the seal, causing the narrow ends of the cages to be forced against the balls and the wide ends against the inner ring.

This force occurred whenever the cage rotational speed varied relative to the balls (Figure 99), but may also have been exacerbated by the bending moments acting on the bearing.

On the accident bearing the outboard cage, although fractured through three pockets at the narrow end, remained in one piece, whereas the inboard cage had broken completely into two sections. Where the fracture surfaces were not smeared, it was possible to identify fracture features consistent with fatigue. Momentary but repeated speed differences between the balls and the cage, driven by disruption to the procession of the balls, resulted in contact between the balls and the cage and generated tension across the pockets, creating the cyclic loading required to drive the fractures. Once the inboard cage broke into two sections it moved outwards against the outer race due to inertia, resulting in the wear mark on the outward side of the narrow end of the cage.

Ball spin axis and force generated by friction between the balls and the cage pocket

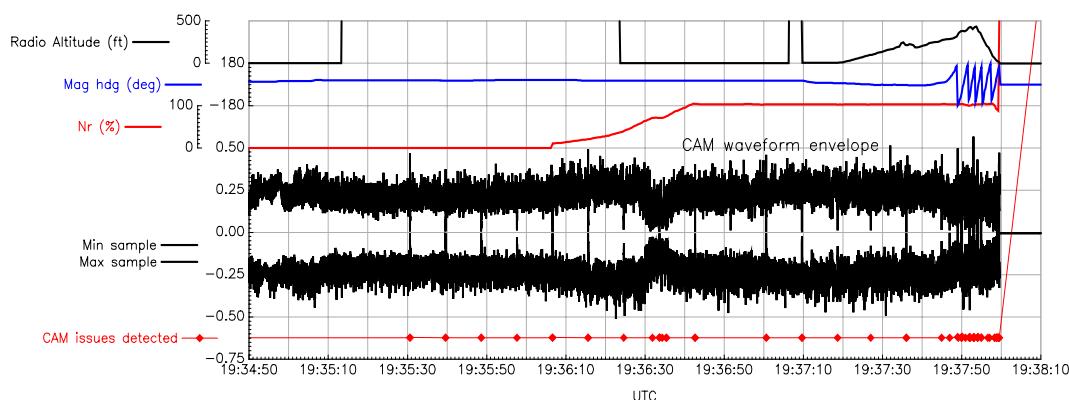
Figure D2
Envelope of the CAM audio, the detections of CAM audio issues and recorded parameters for the accident flight

Figure D2 shows the CAM waveform envelope from when the first engine was being started for the accident flight, to the impact. Parameters are added to provide some reference to the timeline. This also shows the results of an algorithm designed to detect periods when the waveform has stopped crossing the zero value for an extended number of audio samples. Periodic disruptions, occurring every nine seconds can be seen to initiate in the waveform envelope, detected by the algorithm. It also shows two other periods of more erratic problems. The first is during the rotor run-up on the ground and the second is after the bearing failure in the air.

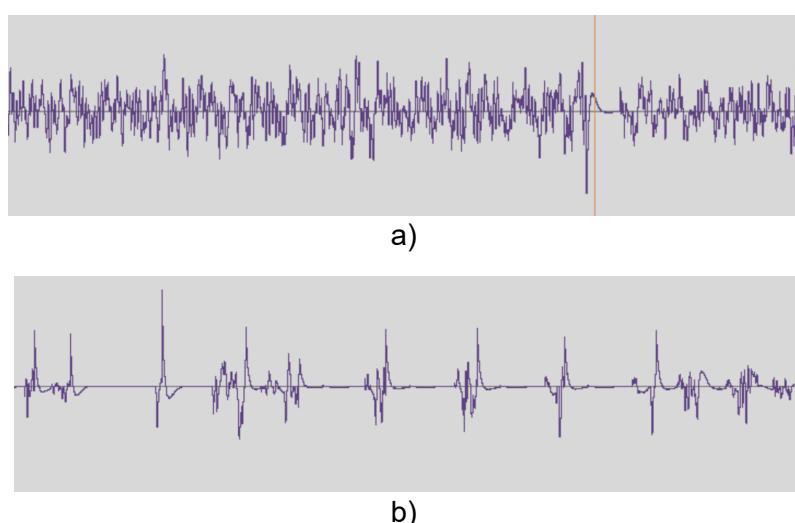
Figure D3
Two extracts of CAM audio of 0.3 second duration, a) during one of the typical 9 second periodic disruptions, and b) during the accident flight.

The CAM channel should be showing continuous activity during these periods. Given the use of active gain control in the acquisition of the audio, the absolute values of the amplitudes are not relevant, the repeated loss of signal is the key issue.

Figure D3 shows the extent of the problem during the accident flight, after the loss of control and before impact. This degraded audio analysis techniques.
