The unknown risk of a flash flood

Safety Forum – June 19th 2024

Cpt Frank BAETENS
Safety Manager – TUI Airlines Belgium

- To reveal the consequences of flash floods on aviation operations
 - by demonstrating the facts of a real incident
 - the subsequent investigation carried out
- Presentation of a TUI fly Belgium B737-700 incident *“Collision with obstacle on runway after landing”*, where the aircraft suffered damage after hitting debris upon landing onto OUD RWY 13 (September 2nd 2023).

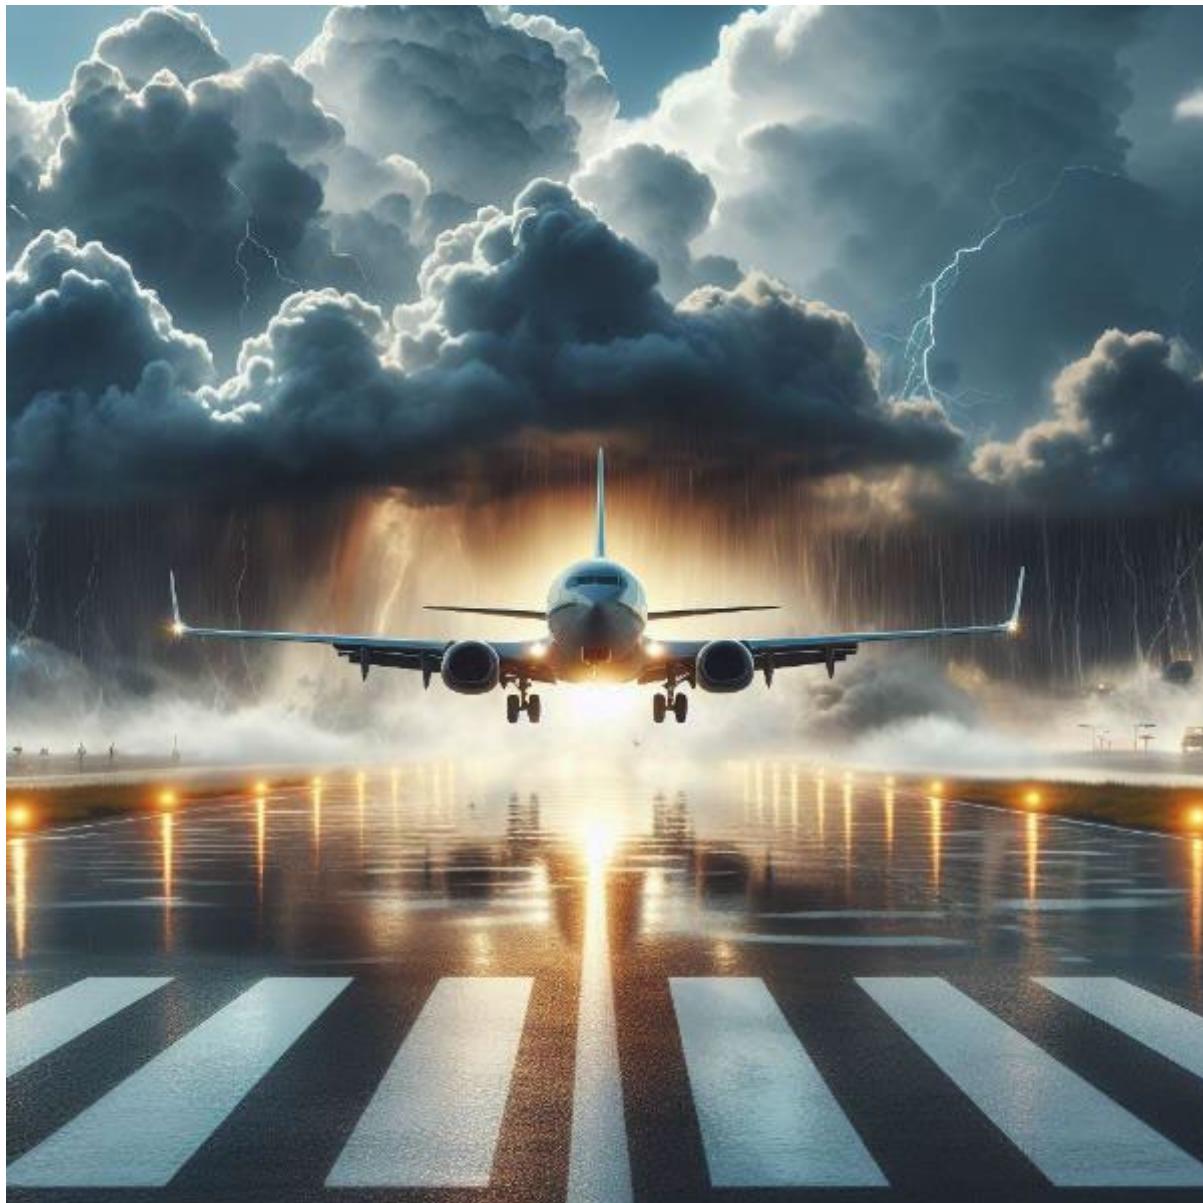
- Flight: TB7242, from LFQQ (LIL) to GMFO (OUD), Oujda airport (evening flight).
- Aircraft Information:
 - OO-JAO, B737 – 700 NG
- Actual weather reported to the crew:
 - Wind 050°10kts, Clouds: Overcast 500ft
 - Temp.: 17°, Vis.: 8000m
- Just after touch down on Rwy13 at GMFO (OUD) Oujda airport, the flight crew noticed an object looking like a large branch or small tree just left of the centerline.
- After impact, a scraping noise was heard for a few seconds.

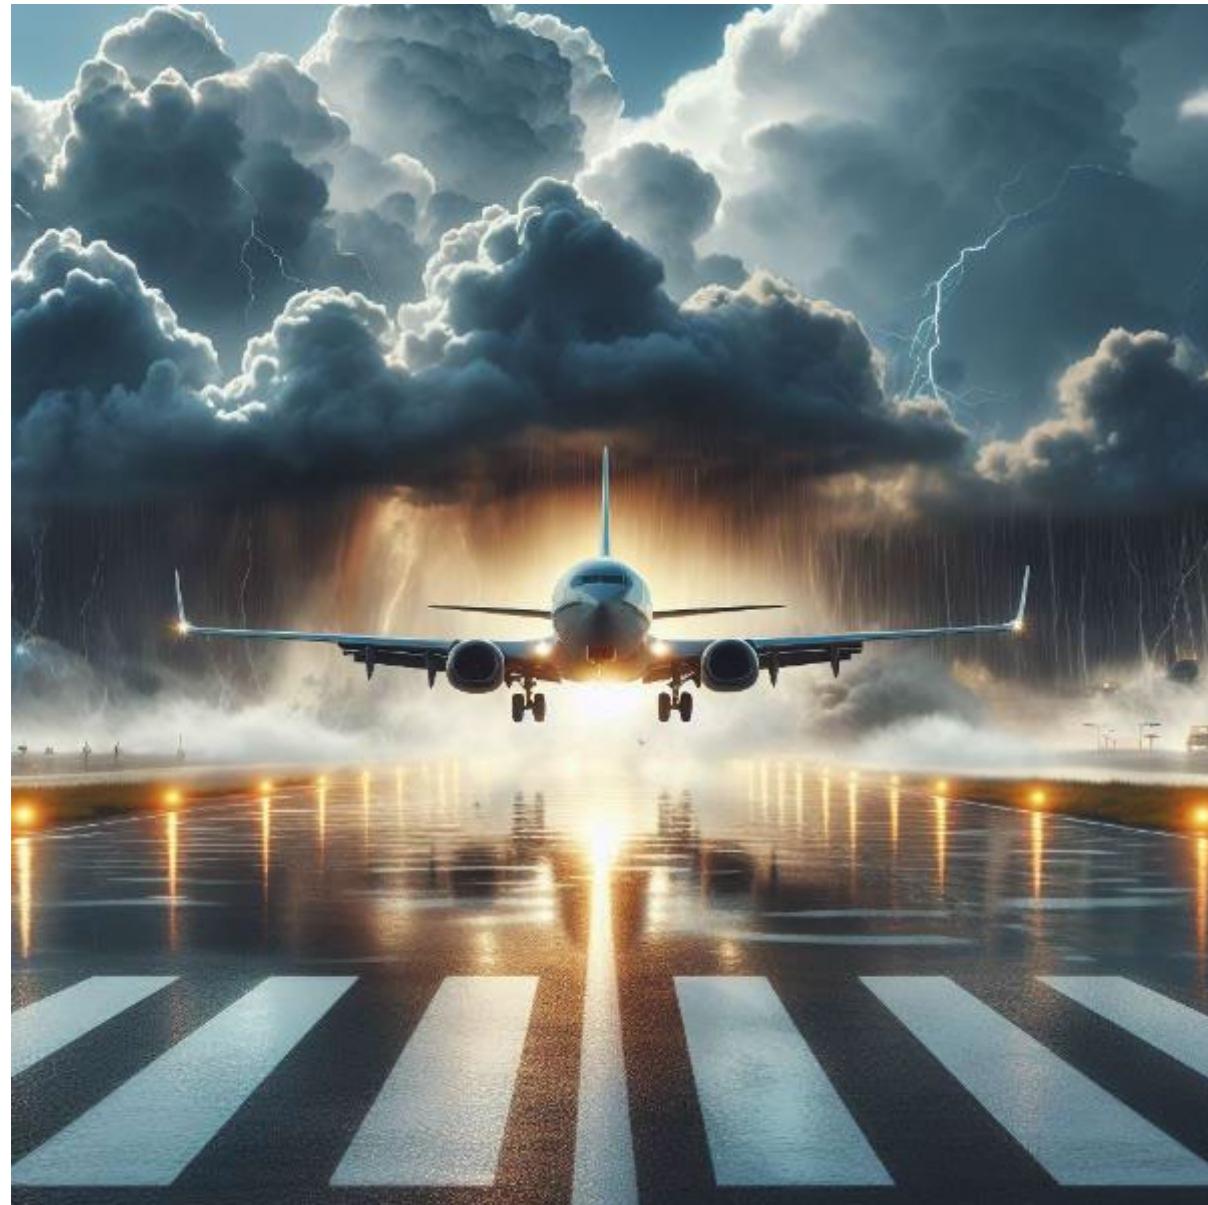
- During roll out, several master caution lights and non-normal indications popped up in the cockpit.
- After coming to a full stop, the crew decided to shut down the engines and ask for a technical inspection (on the runway) followed by a tow towards the apron.
- Damage occurred to the aircraft, debris and dirt on the runway seemed having caused the damage.

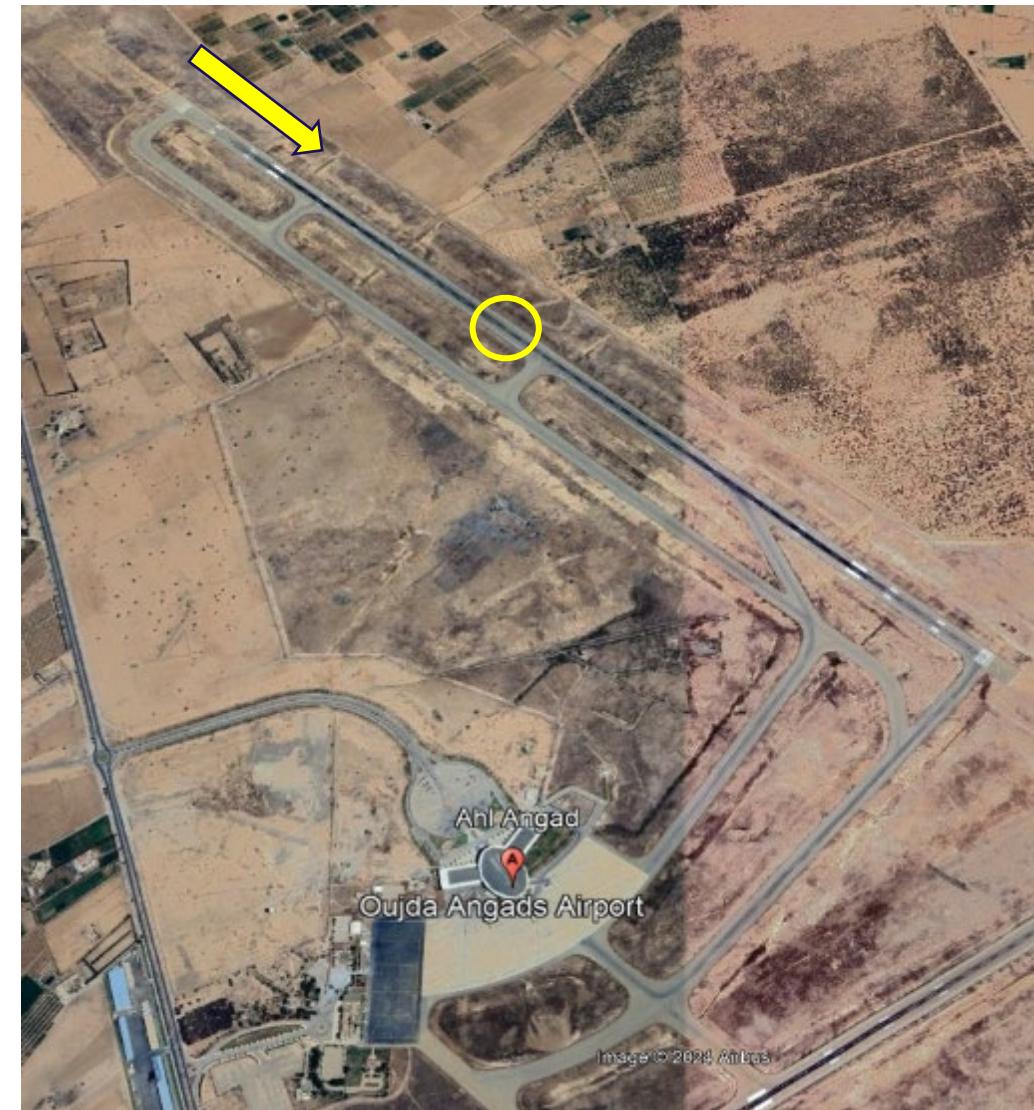
- Normal touchdown, obstacle observed just left of the centerline.
- A scraping noise was heard for a few seconds, deceleration was stronger than normal with autobrakes 2 selected.
- Directional control, braking and thrust reverser operation observed as normal.
- Normal engine parameters.

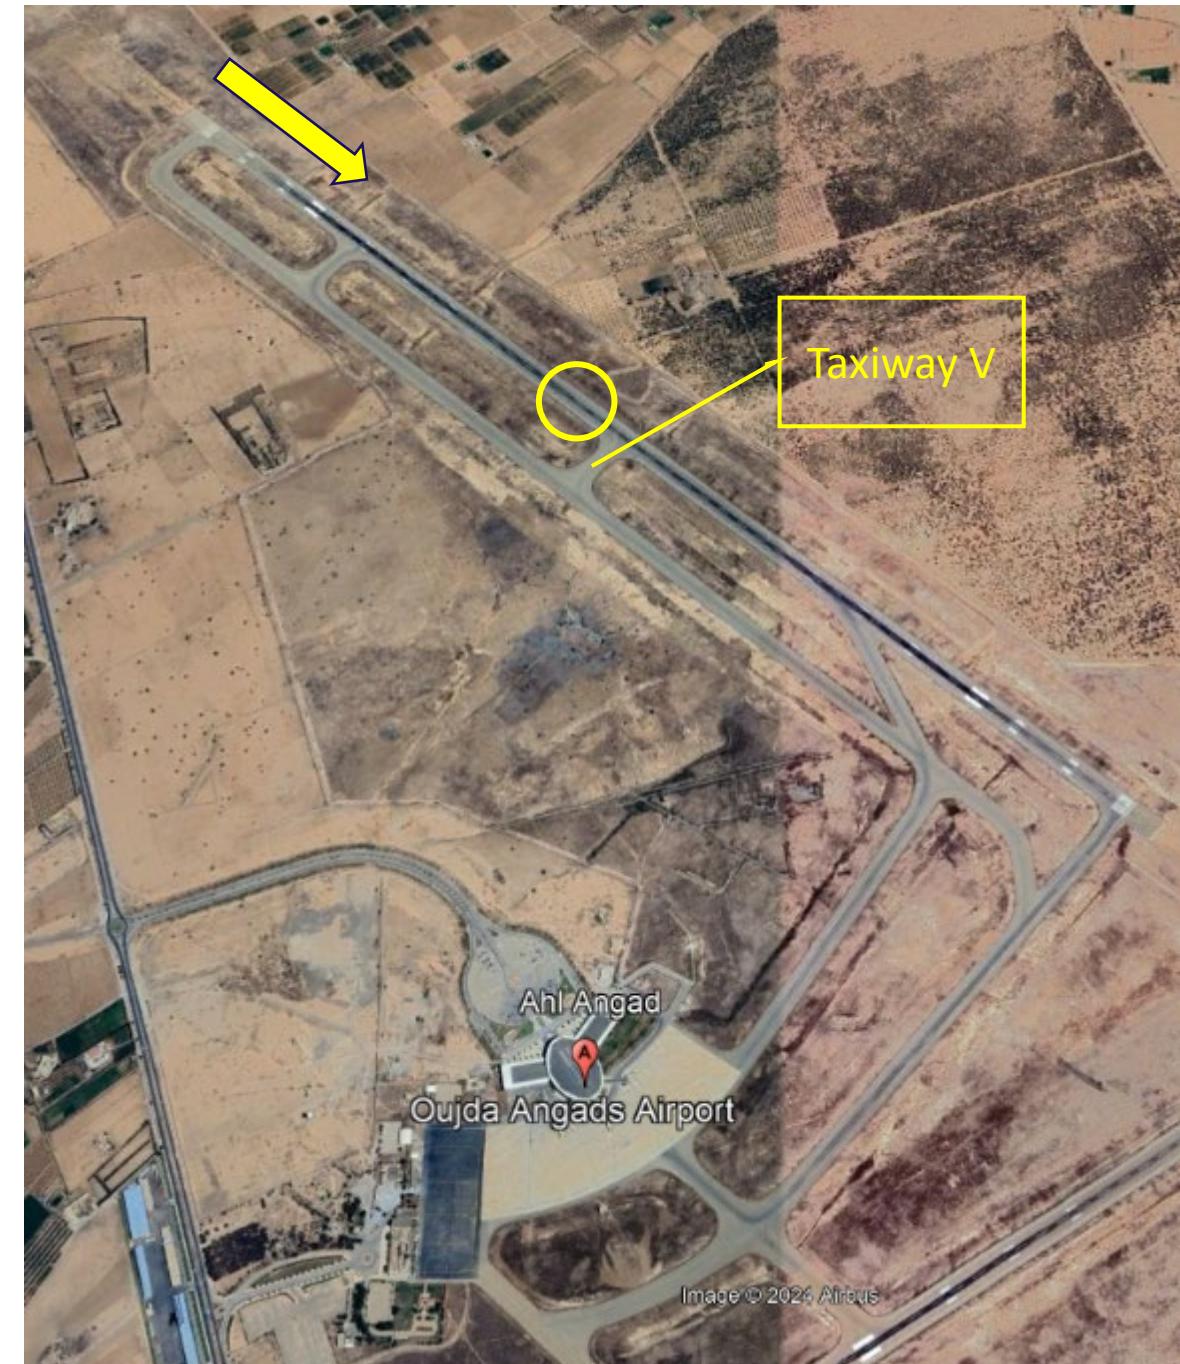
- Several amber caution lights came on, aft cargo fire warning.
- Aircraft stopped on the runway just before taxiway V, appropriate calls to ATC and cabin were immediately performed.
- The cargo fire warning stopped by itself, a test proved the system was functional and working properly.
- The cabin crew reported all normal.

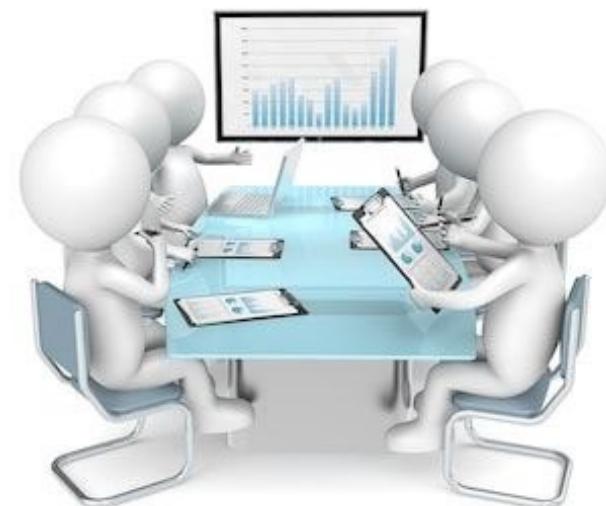
- The root cause of the event can be described as a “flash flood”.
- Debris and dirt were carried on the runway by a large flow of water that caught all parties involved by surprise.
- This was caused by heavy rainfall during the day.
- The amount of water was too much for the airport drainage system to handle.
- A runway inspection took place at 21:25z and found RWY 13 operational.
- OO-JAO landed at 21:43z and sustained substantial damage from dirt and debris.

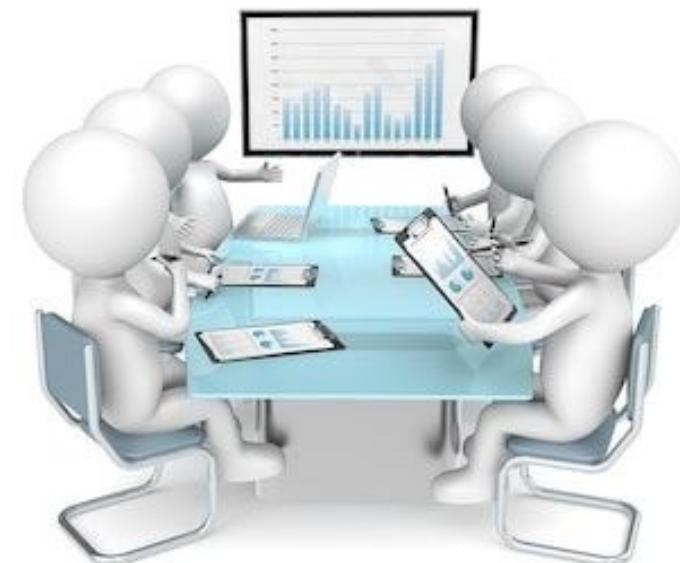
- OUD airport is a fairly dark place at night, a flooded runway is very difficult to see from the cockpit during the (final) approach phase.
- We are convinced that the airport authorities were overwhelmed by events.
- The investigation reveals that the flash flood must have happened a few minutes before landing.
- *Note:*
 - The crew acted in a very professional way, during all phases of this event.
 - The damage was repaired and the aircraft was put back into service.
