**Havarikommissionen**

## Report 2022-150

**Serious incident to CS-TNV (Airbus A320-214) in Copenhagen/Kastrup (EKCH) on 8-4-2022**

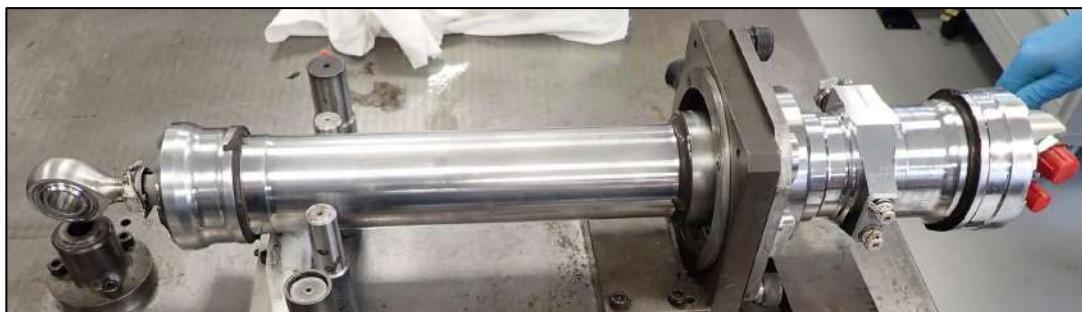
Figure 20. Actuator

To test the actual load capability, each actuator was tested to retract under different loads to find the maximum capability using the nominal recorded hydraulic pressure of the aircraft system (178 bar) at the time of the serious incident. Whether the actuator was able to retract and lock (internally/secondary) and the time taken to retract was recorded.

During the tests, all actuators behaved very similar and produced very similar results:
