Touchdown before threshold

Risks associated with a large aircraft
landing on a short runway

The Hague, 18 July 2024

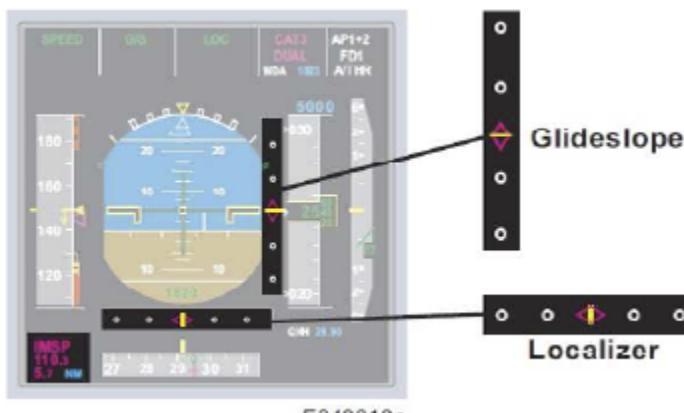
▲ Figure 1: PFD Glideslope and Localizer indications. (Source: Operator Flight Crew Operating Manual)

The glideslope indication⁶ on the pilot's primary flight displays (PFD) (see figure 1) was now ½ dot below the glideslope and the aircraft continued to deviate further from the glideslope to 2 dots below the glideslope. The augmented first officer stated during the post-incident interview that he was confident that the captain was in control of the flight's trajectory.

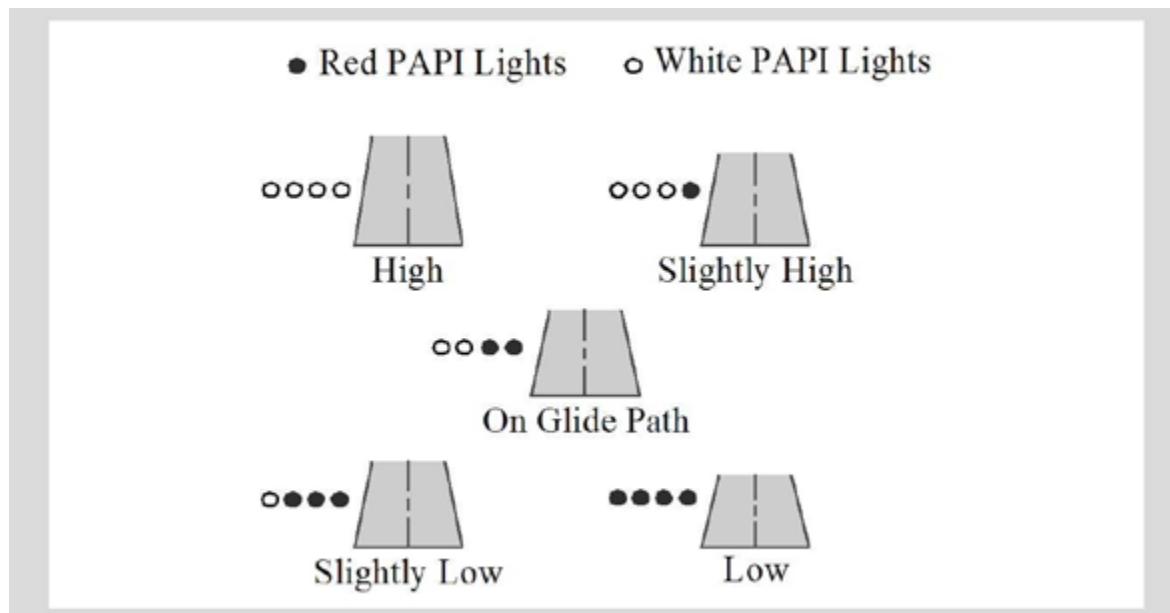
▲ Figure 2: PAPI Landing Geometry. (Source: Operator Flight Crew Training Manual)

The captain and the augmented first officer noticed the deviation below the glidepath also evidenced by the PAPI indicating three red lights and one white light (see figure 2).

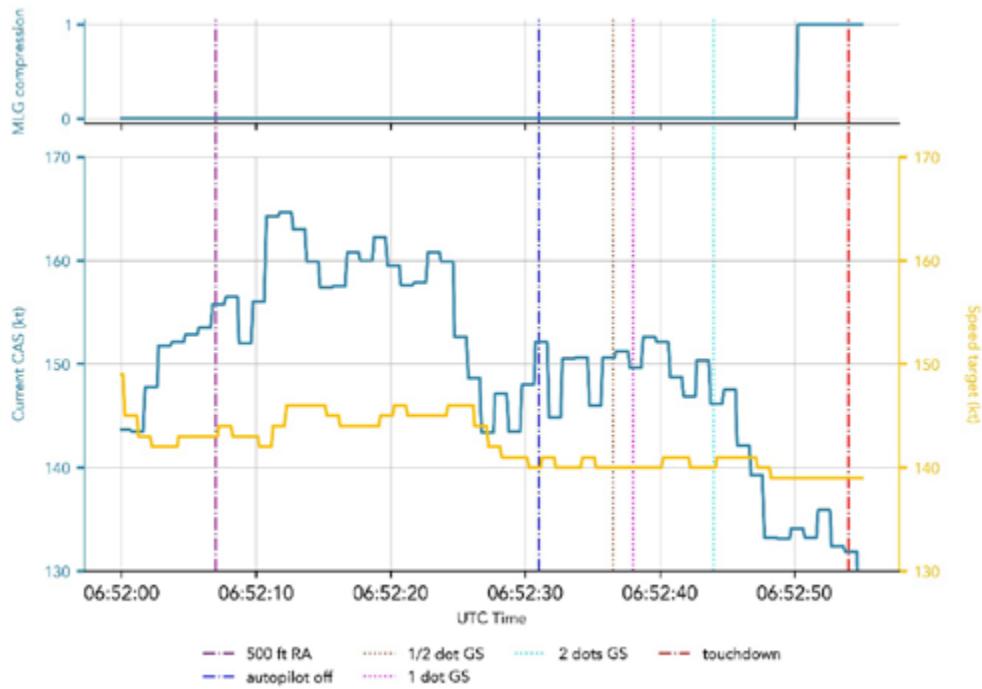
▲ Figure 10: FDR data prior to touchdown showing main landing gear compression (top graph) and the current CAS and speed target (bottom graph). (Source: FDR data and Airbus analysis)

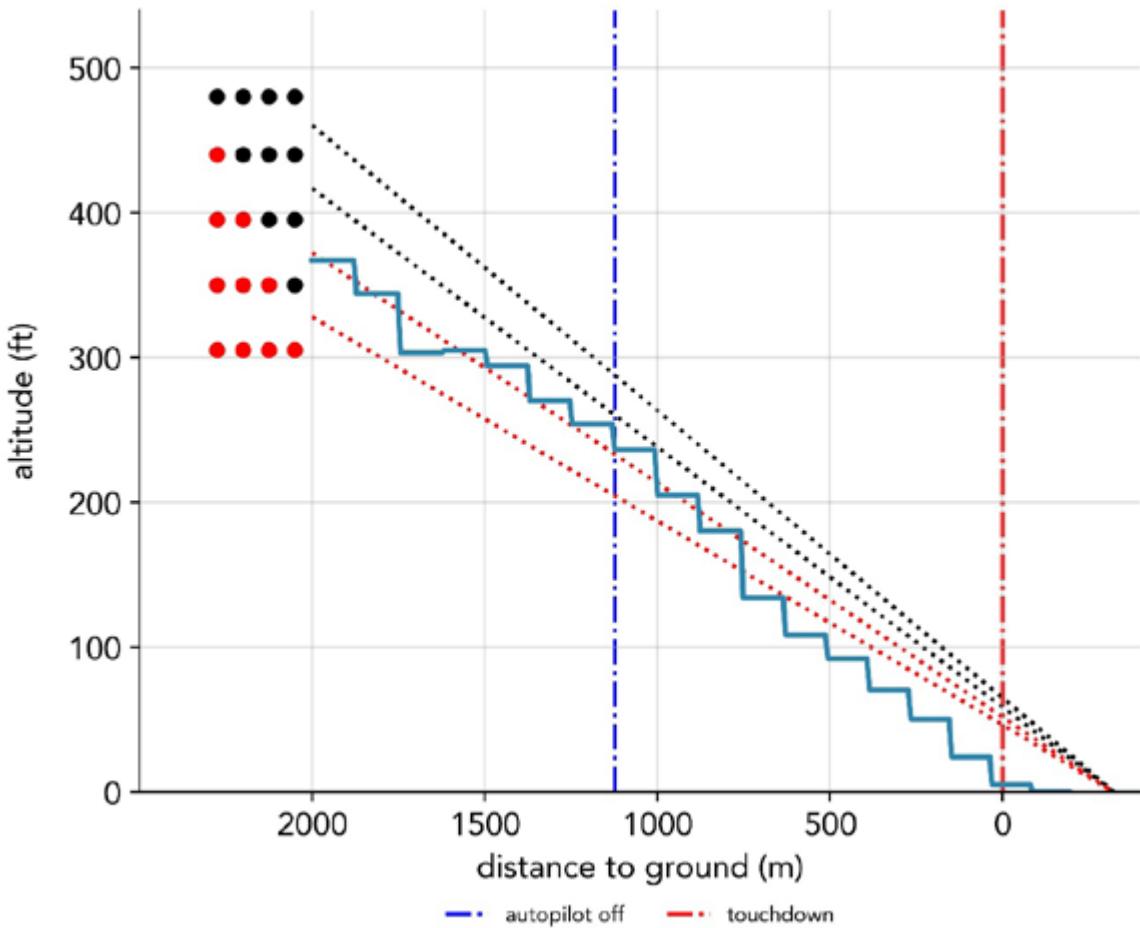
▲ Figure 12: FDR data of aircraft descent including the PAPI. (Source: FDR data and Airbus analysis)
