Investigation Report

Type of Occurrence: Accident

Date: 2 March 2023

Type: A330-900

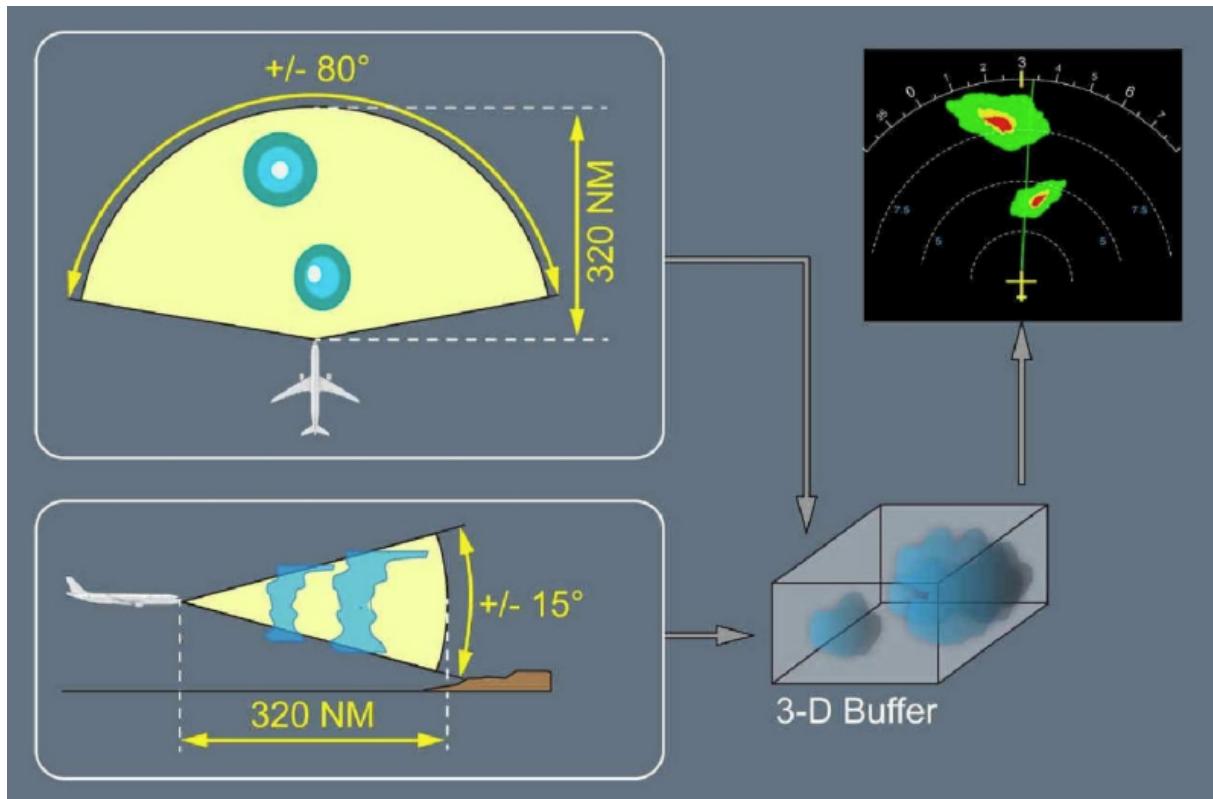
Fig. 2: 2D weather depiction

The indication WX depicts the precipitation in different colours. The colour depends on the intensity of the precipitation (red means high reflectivity and green low). The weather radar in this version did not have a vertical display.

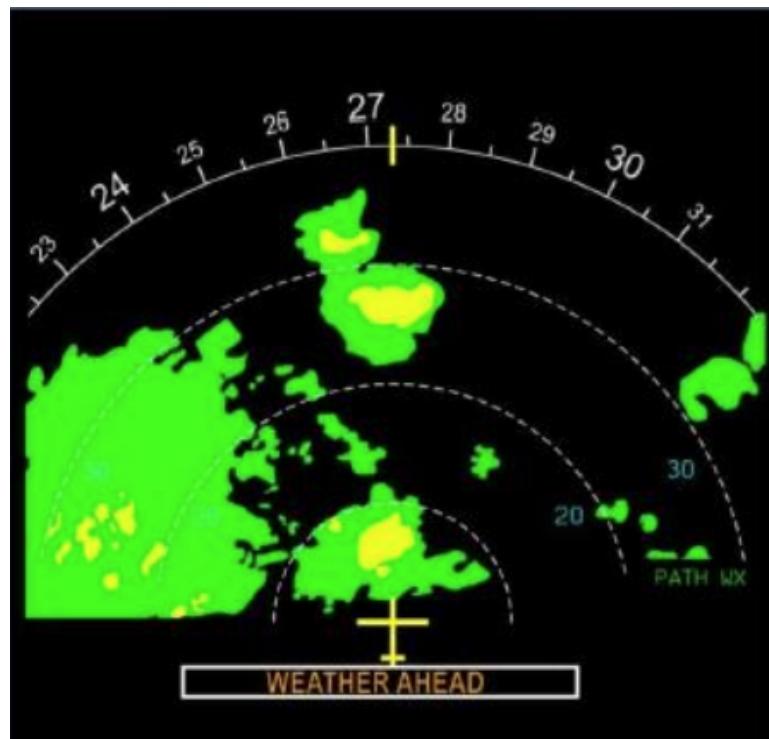
Fig. 3: Example of the Weather Ahead Function

- 3 min ahead of the aircraft
- 2 NM left and right of the current flight path
- 4,000 ft above and below the current flight path

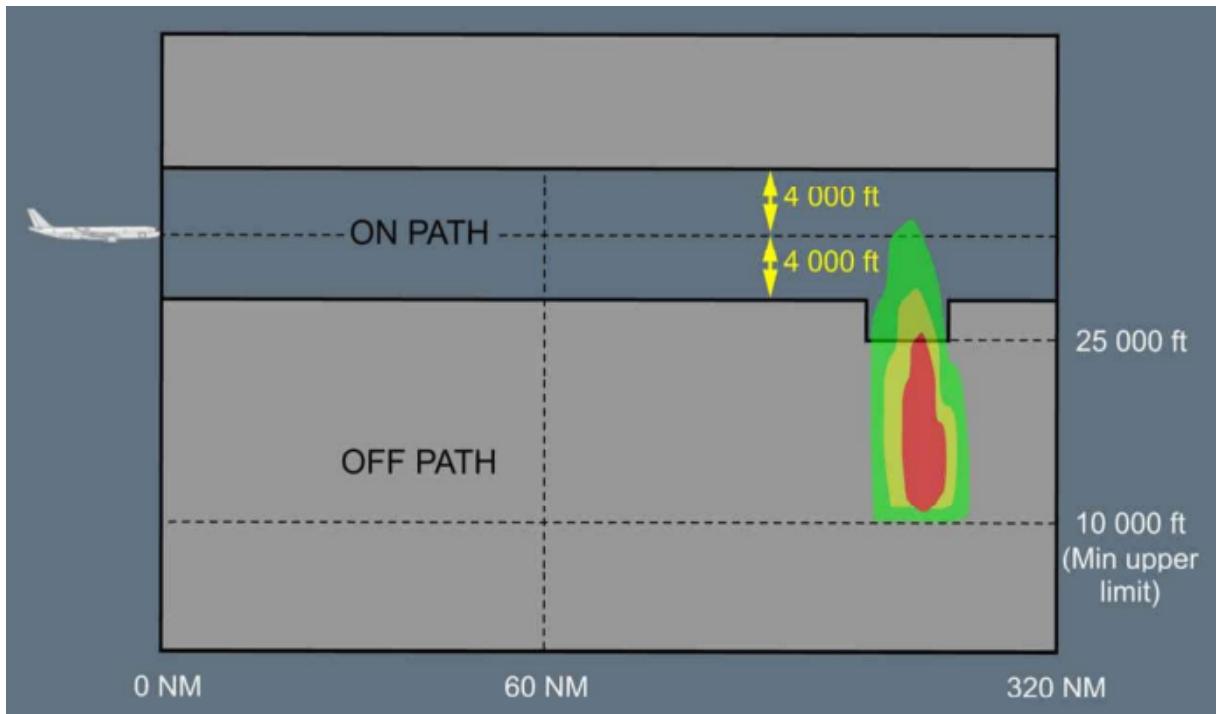
Fig. 5: ON PATH weather depiction

In horizontal flight, the ON PATH envelope stretches from 4,000 ft above to at least 4,000 ft below the aircraft's altitude. In the presence of a column of convection, the weather is shown below the aircraft's altitude to 25,000 ft MSL.

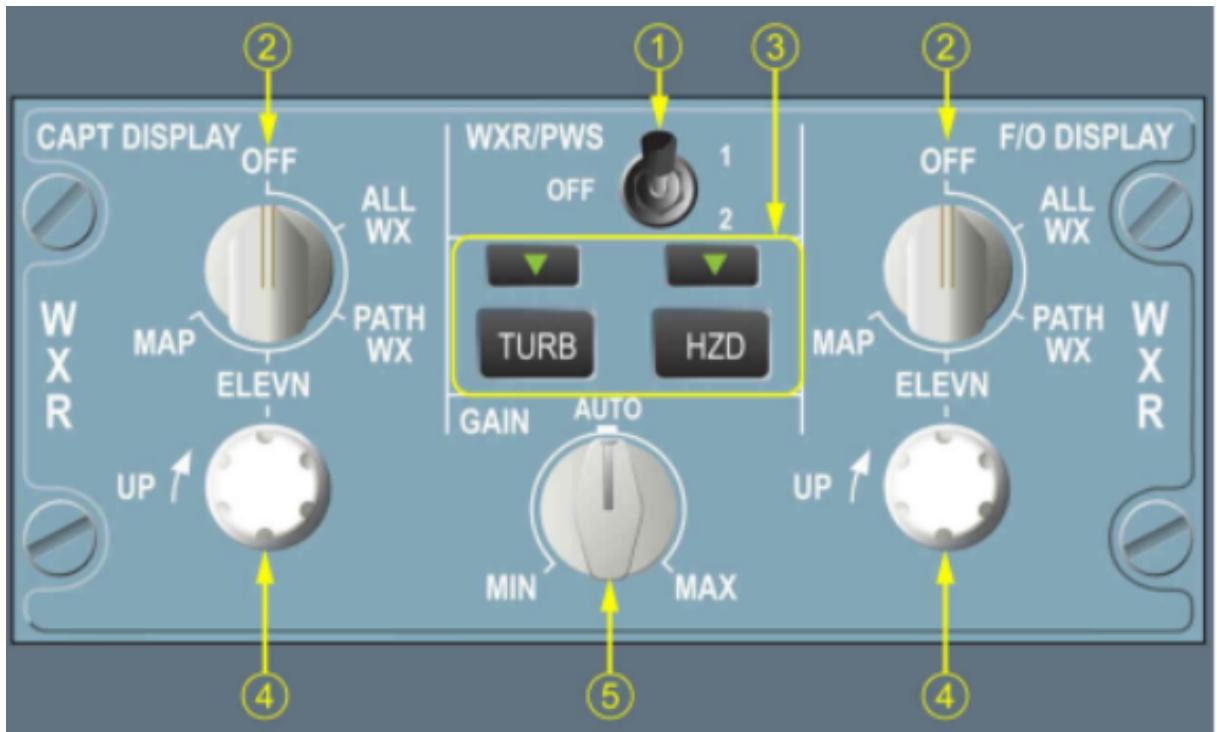
Fig. 6: Control panel and switch designation of the weather radar RDR-4000.

As excerpts, the switch positions ALL WX and PATH WX are described. In the switch position ALL WX weather data for both ON PATH and OFF PATH envelopes are indicated. With the switch position PATH WX only the ON PATH weather is depicted. In both modes, the functions Predictive Windshear and detection of turbulence are active.

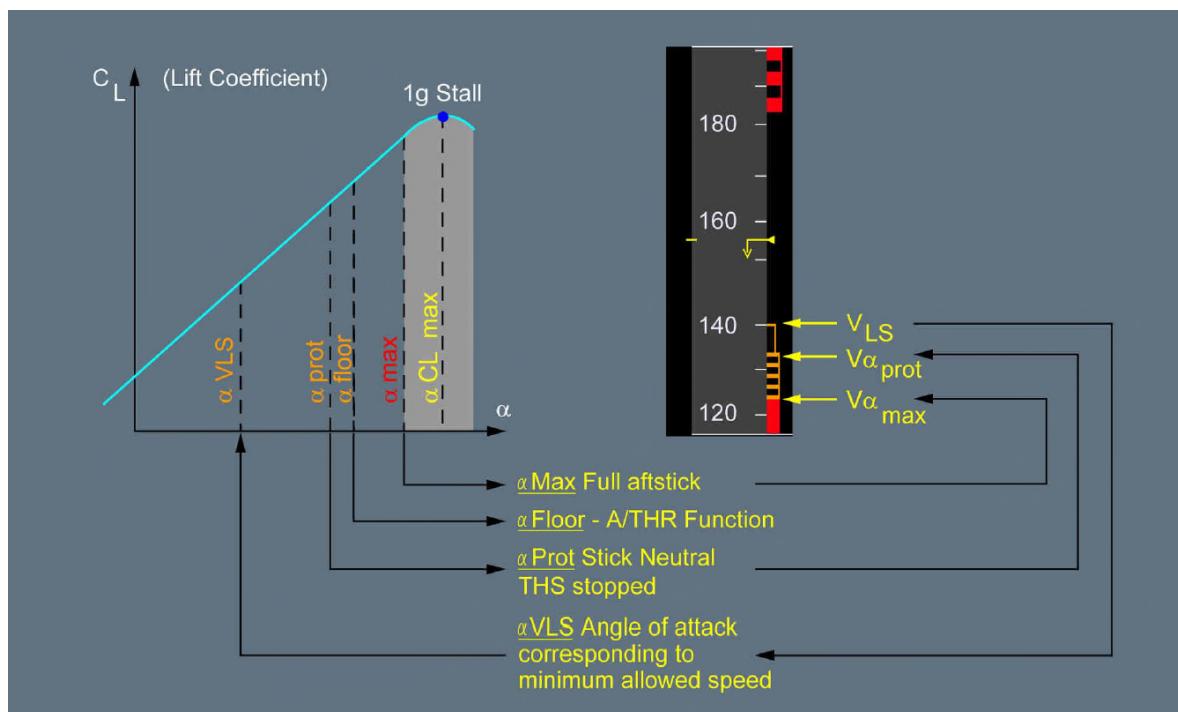
Fig. 10: Connection between certain angle of attack values and speeds

The speed band in the PFD shows the speeds $V_{\alpha_{prot}}$ und $V_{\alpha_{max}}$ which correspond with the aircraft's speed if it is flying in stabilised flight conditions (α_{prot}) and at maximum permissible angle of attack (α_{max}), respectively.

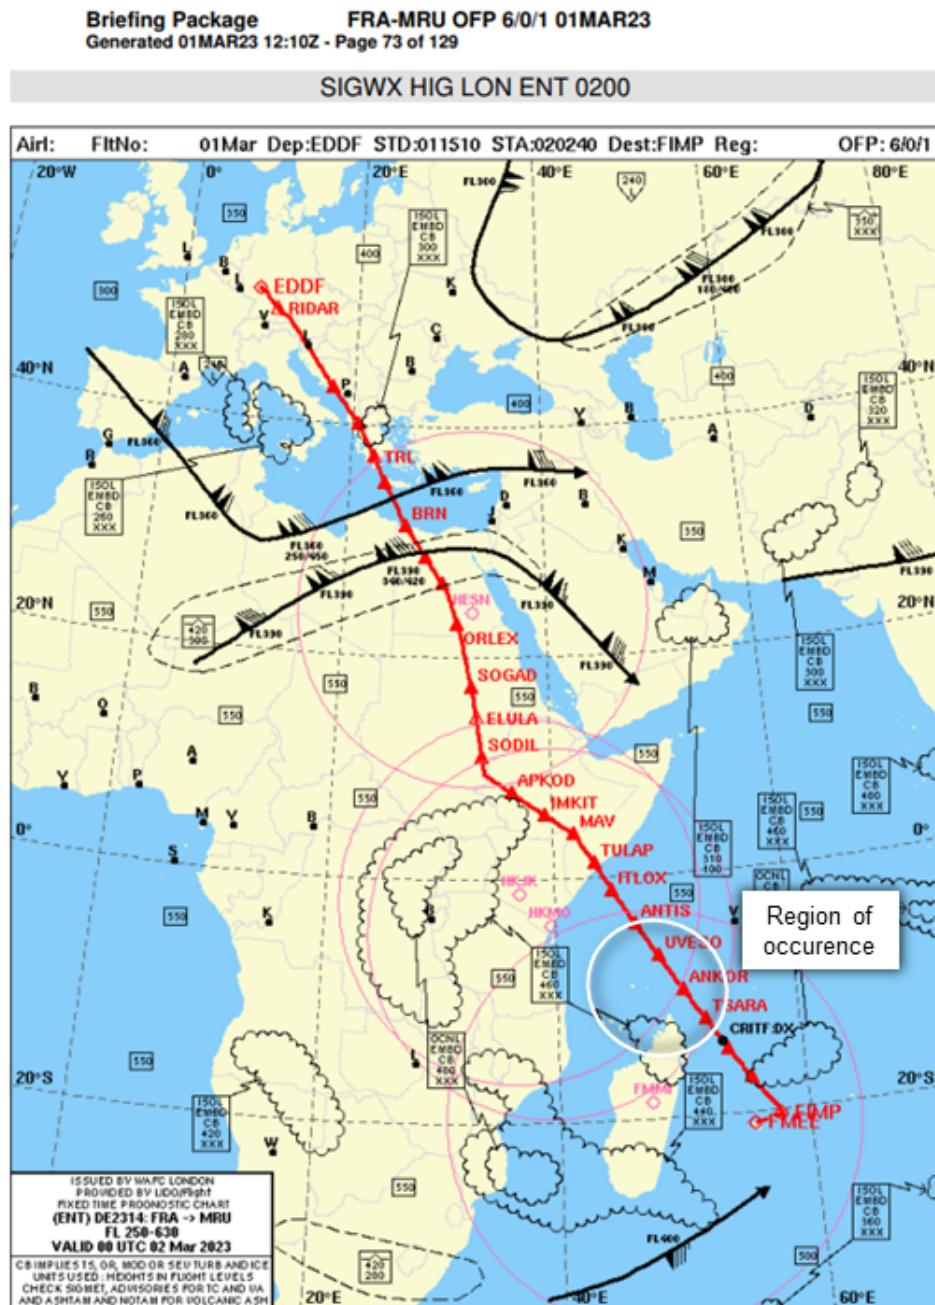
Fig. 16: SIGWX weather chart with planned flight path

The Significant Weather Chart (SIGWX) HIG LON ENT 0200, with the planned flight path (red), showed embedded cumulonimbus clouds in the northern part of Madagascar.
