# Aviation Short Investigation Final Report

Abrupt Maneuver (Aborted Takeoff)

Boeing 737-900ER – N900DU

**AAIA Aviation Occurrence Investigation**  
**Report # OCC-2024/0011**

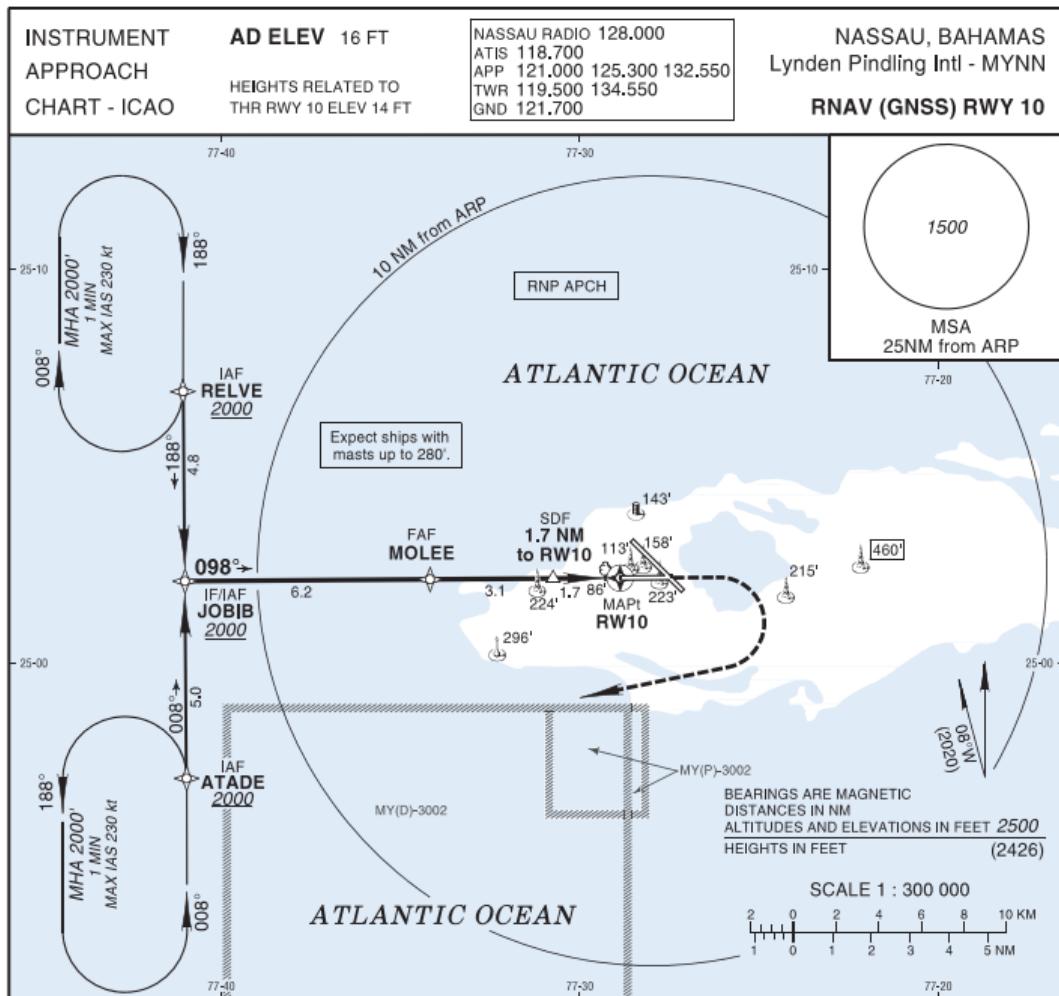
**Fig.1 Plan view of Instrument Approach Procedure (RNAV Runway 10) at MYNN showing MAPt RW10**

The next aircraft in sequence for landing runway 10 at MYNN, a Bombardier CRJ200 with Canadian registration C-GDTD, operating as FEX850, subsequently was forced to execute a go around at approximately 1:31 pm (1831 UTC) as the aerodrome controller had not issued a landing clearance at the point of the aircraft reaching the published missed approach point (as identified by "MAPt" on figures 1 and 2).
