# Aviation Investigation Preliminary Report

| <b>Location:</b> | Louisville, KY | <b>Accident Number:</b> | DCA26MA024 |
| <b>Date &amp; Time:</b> | November 4, 2025, 17:14 Local | <b>Registration:</b> | N259UP |
| <b>Aircraft:</b> | McDonnell Douglas MD-11F | <b>Injuries:</b> | 14 Fatal, 2 Serious, 21 Minor |

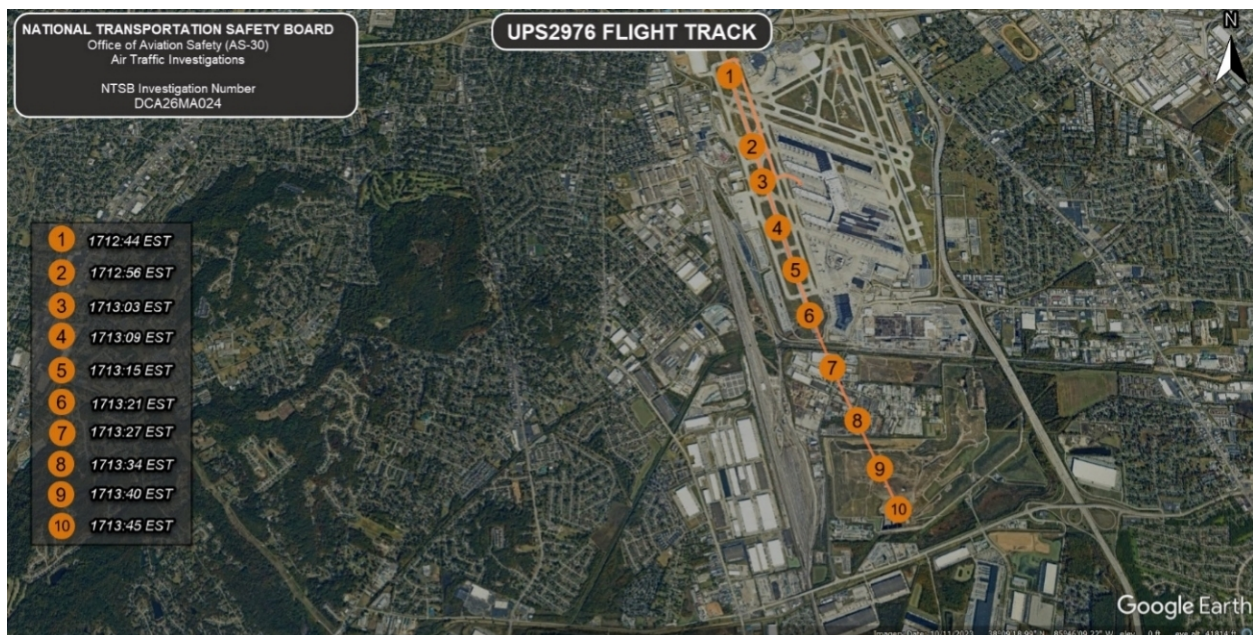
**Figure 3.** Graphic depicting the flight track of UPS flight 2976 based on ADS-B data.
