Aircraft Accident Report

**Crash into the sea during takeoff climbing
The National 119 Rescue Headquarters
EC225LP, HL9619
The East Sea near Dokdo, Ulleung-gun, Gyeongsangbuk-do
October 31, 2019**

**Aviation and Railway
Accident Investigation Board**

Aviation and Railway Accident Investigation Board, crash into the sea during takeoff climbing, the National 119 Rescue Headquarters, EC225LP, HL9619, October 31 2019, aircraft accident report, ARAIB/AAR1903, Sejong City, Republic of Korea

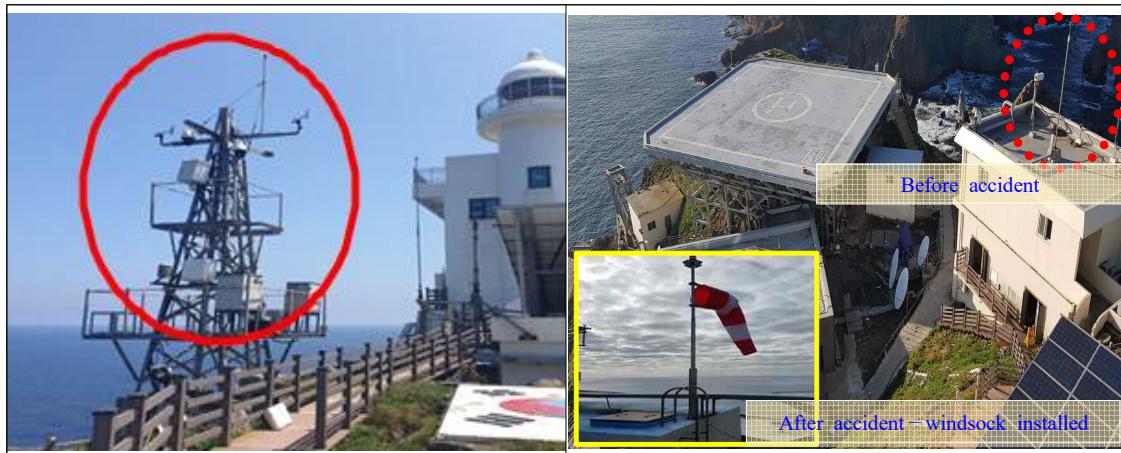
Figure 8. ASOS and windsock

Windsock as a wind direction indicator (WDI) was at the rooftop of a building 15 m away from the Dokdo helipad. However, only the pole existed at the time of impact, without a windsock and LEDs⁴⁰⁾. See Figure 8 for the

40) The L-806 (international standard no. 2) requires the installation of a windsock attached to the stainless steel pole, with the sock having 4 LEDs attached to the bigger aperture.

windsock installation status of each pre and post-accident.

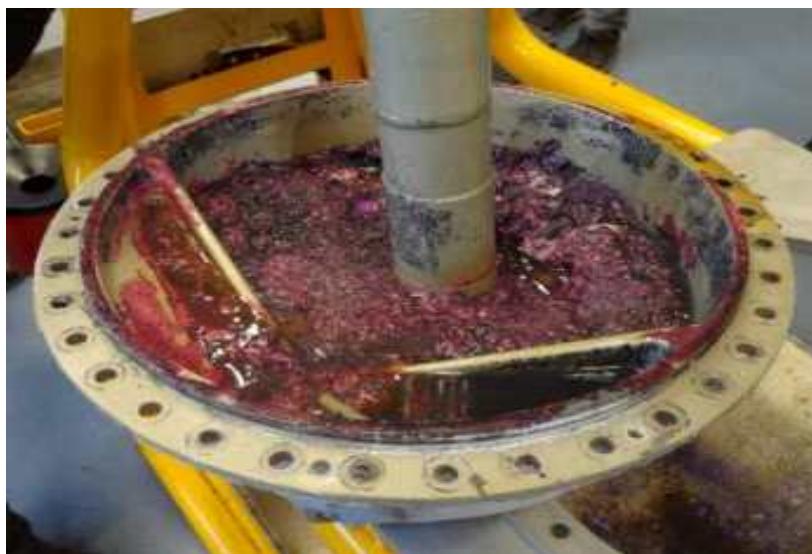
Figure 22. The lower section of MGB

The lower section of MGB was disassembled and examined. Magnesium powder due to corrosion by sea salt was observed, but no magnetic particles were identified (see Figure 22).

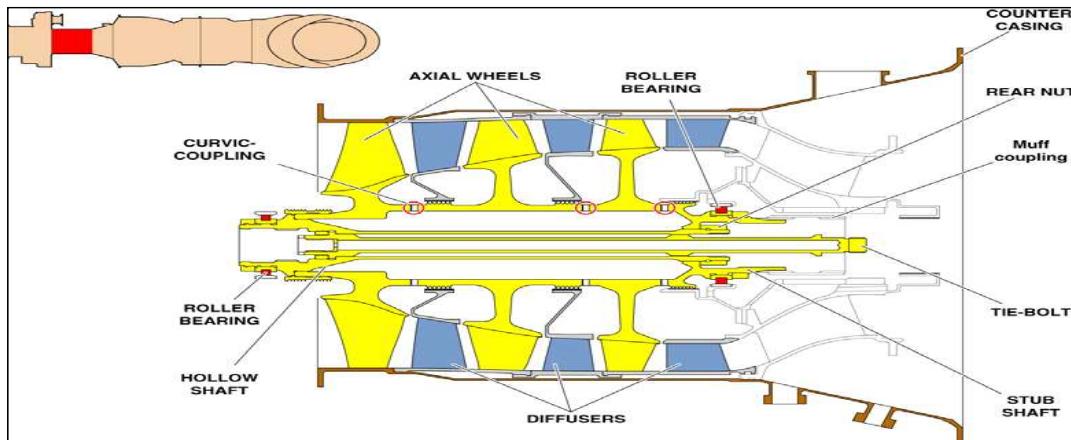
Figure 28. Module 2 configuration diagram

In module 2 (axial compressor), damage, scratch, spalling, and impacts were examined by checking component conditions such as axial wheels, diffuser vanes, front and rear roller bearings, and muff coupling. See Figure 28 for the configuration diagram and Table 11 for the examination result.

Makila 2A1	# 13 441 (T1)	# 13 440 (T2)
Axial wheel 1 st stage	Some blades found bent – No trace of FOD (foreign object debris) Note : The deformation was most probably the consequence of the hydraulic over-load during the injection of water at the moment of the impact with the water	Some blades found bent – No trace of FOD Note : The deformation was most probably the consequence of the hydraulic over-load during the injection of water at the moment of the impact with the water
Axial wheels 2 nd and 3 rd stage	Visually in good condition No trace of impact (FOD) / no trace of contact on the top of the blades	Visually in good condition No trace of impact (FOD) / no trace of contact on the top of the blades
Diffusers	Visually in good condition – No FOD / no erosion	Visually in good condition – No FOD / no erosion
Front and rear bearings	Traces of corrosion on the balls but free in rotation with no hard point / no rubbing marks on the outer race / no rubbing marks on the inner race faces	Traces of corrosion on the balls but free in rotation with no hard point / no rubbing marks on the outer race / no rubbing marks on the inner race faces

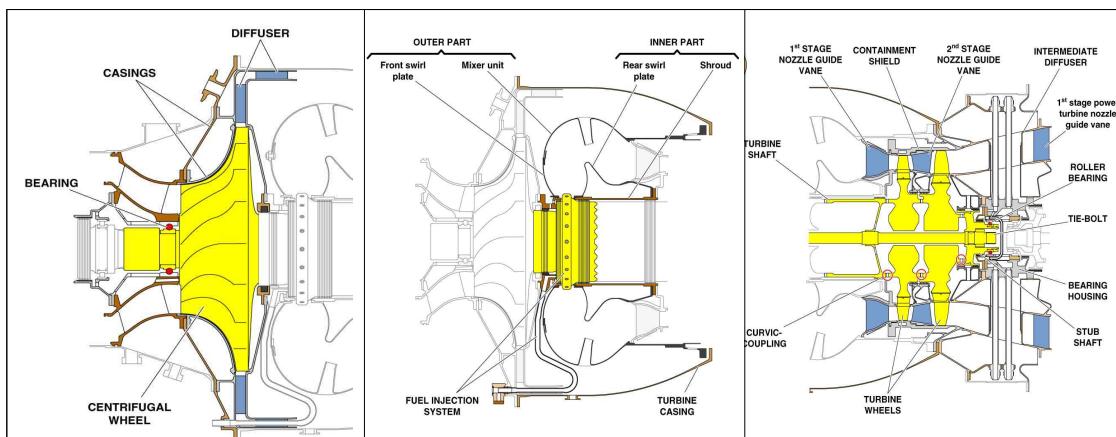
Figure 29. Module 3 configuration diagram

In module 3 (gas generator), centrifugal compressor, combustion chamber (inner and outer parts), fuel injection wheel, HP (high pressure) turbine blades 1st and 2nd stages, HP nozzle guide vanes 1st and 2nd stages, front and rear roller bearings, and others were visually inspected whether damage, scratch, spalling, and impacts observed. See Figure 29 and Table 12 for the configuration diagram and the examination results, respectively.

Makila 2A1	# 13 441 (T1)	# 13 440 (T2)
Centrifugal compressor	<p>All the main blades found bent (except one)</p> <p>Note: The deformation was most probably the consequence of the hydraulic over-load during the injection of water at impact</p>	<p>All the main blades found bent (except two)</p> <p>Note: The deformation was most probably the consequence of the hydraulic over-load during the injection of water at impact</p>
Compressor cover	<p>Traces of rubbing with deterioration of the coating, at leading edge and trailing edge sides, but no rub in between.</p> <p>Note: The deterioration of the coating was probably the consequence of the forward movement of the Gas Generator mobile at the moment of the impact.</p>	<p>Traces of rubbing with deterioration of the coating, at leading edge and trailing edge sides, but no rub in between.</p> <p>Presence of corrosion deposit (red)</p> <p>Note: The deterioration of the coating was probably the consequence of the forward movement of the Gas Generator mobile at the moment of the impact.</p>

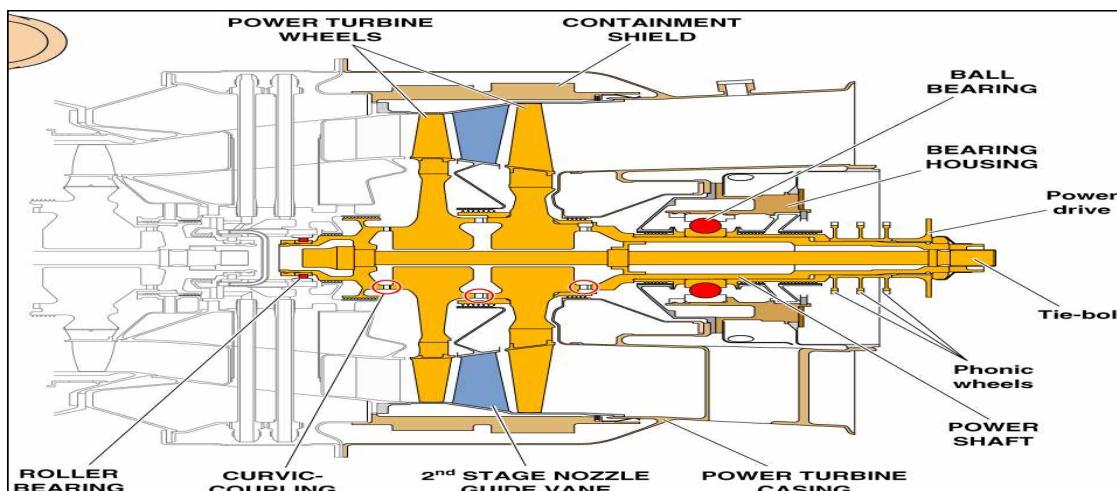
Figure 30. Module 4 configuration diagram

In module 4 (power turbine), power turbine (PT) 1st and 2nd stage, PT nozzle guide vanes 2nd stage, labyrinth, front and rear bearings, curvic coupling, and assembly shaft were visually inspected to see if there are any damage, scratch, spalling, and impacts. See Figure 30 and Table 13 for the configuration diagram and the examination results.

Makila 2A1	# 13 441 (T1)	# 13 440 (T2)
Power Turbine (PT) 1 st and 2 nd stage	Visually in good condition – Presence of shiny particles on the blades Note: These particles came from the compressor cover coating, which deteriorated during the contact of the centrifugal compressor blades with the compressor cover (forward movement of the Gas Generator mobile)	Visually in good condition – Presence of shiny particles on the blades Note 1: Very light rubbing marks on the rear face of the PT 1 st stage disk, which occurred most probably at the moment of the impact Note 2: Presence of contact on the tip leading edge of PT 2 nd stage blades
PT nozzle guide vanes 2 nd stage	Visually in good condition	Visually in good condition Note: Very light rubbing marks on the front face of the PT Nozzle Guide Vane 2 nd stage as a consequence of the contact with the PT 1 st stage.
Labyrinth	Visually in good condition – No trace of contact Presence of green deposit in the lips (corrosion)	Visually in good condition – No trace of contact

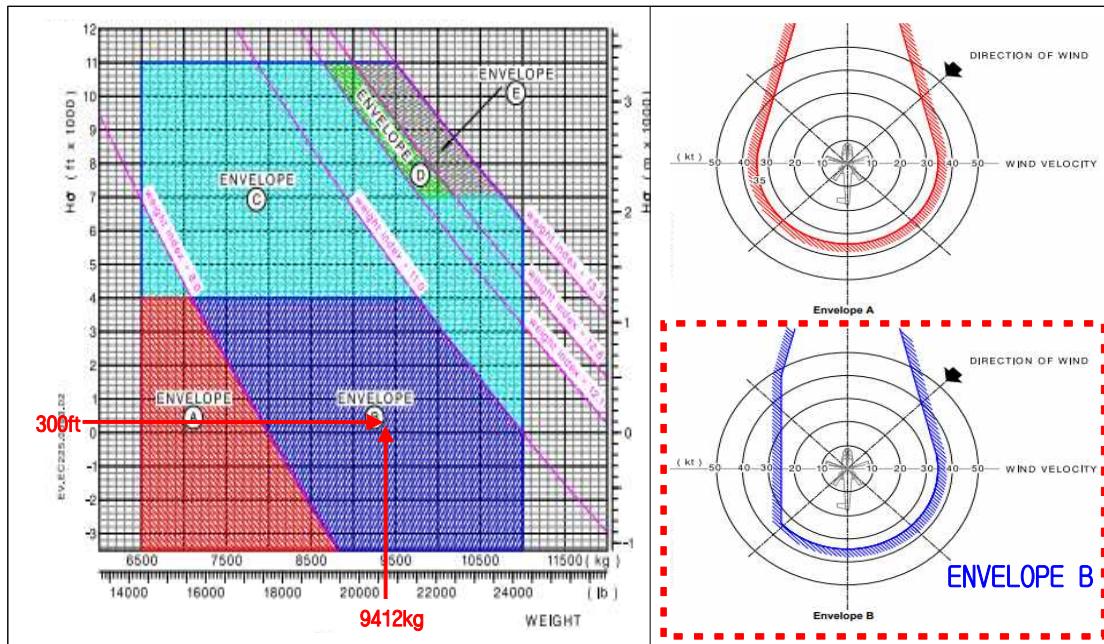
Figure 33. Demonstrated wind envelope in hover flight

The gross weight of the HL9619 when taking off the Dokdo helipad was 9,412 kg. Based on the 300 feet above sea level, the aircraft was in ENVELOPE B presented in its flight manual (see Figure 33). The demonstrated wind envelope in hover flight in envelope B has upwind 50 kt, right crosswind 35 kt, downwind 35 kt, and left crosswind 25 kt.

The KMA issued the maximum gust of 18.6 kt at the time, which did not go over the demonstrated wind envelope. However, it is believed that the HL9619, while passing across the steep slope of Dokdo near the helipad on approach and takeoff, had difficulties using its power and had vibrations in the airframe.

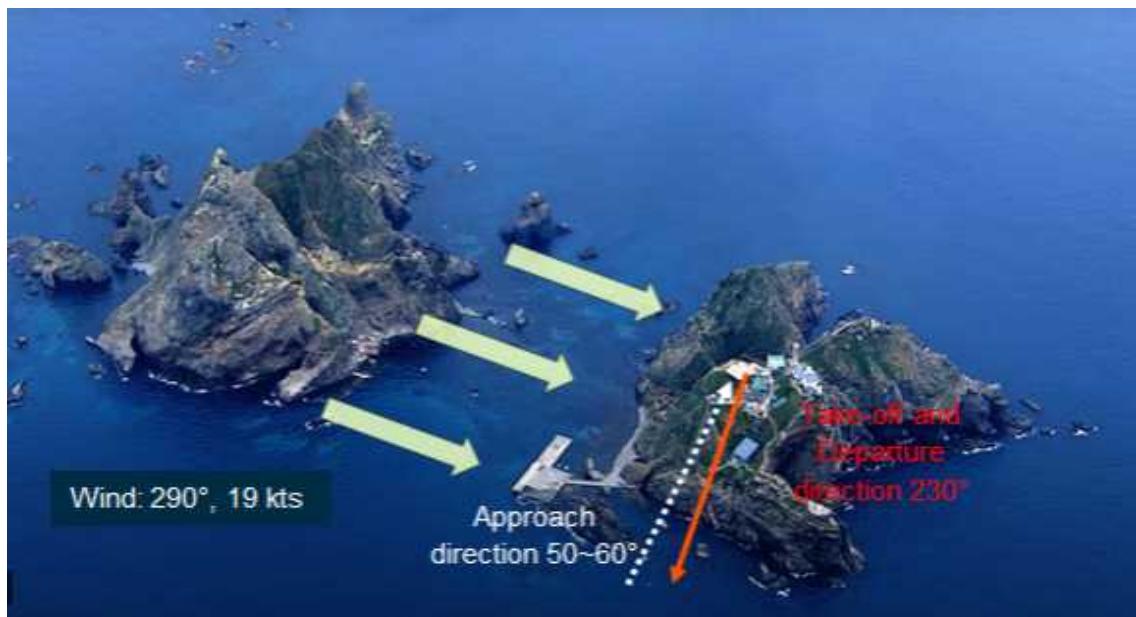
Figure 34. Takeoff/landing directions and the wind conditions

The HL9619 took off the helipad in a 230° direction. The wind was blowing from 290° direction, so it became right crosswinds at about 60° from the aircraft aspect (see Figure 34). During the pre-takeoff hover, the co-pilot informed the pilot that the helicopter left drifted, which also appeared to be the cause of the right crosswind.

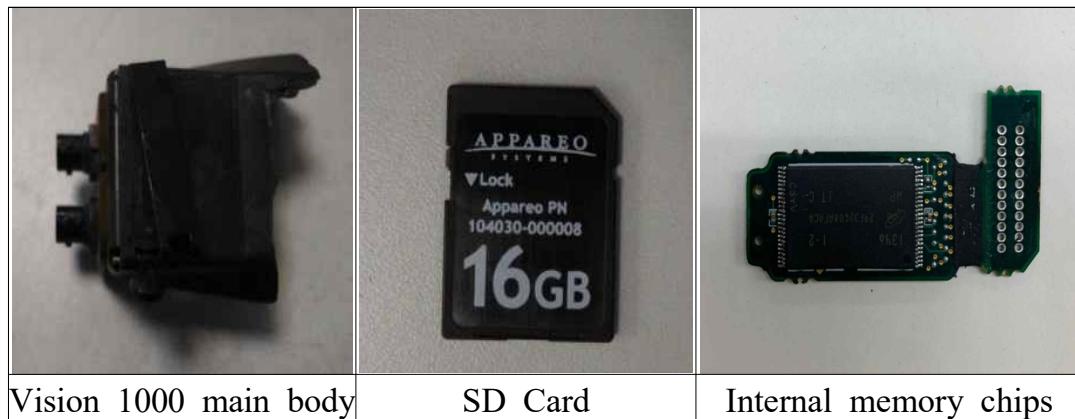
Figure 36. Vision 1000

The ARAIB tried to restore the video data of Vision 1000 installed in the cockpit (see Figure 36). It asked for technical support primarily from the BEA and secondary to NTSB, and yet it failed to restore the video data of the residual part.

The recording stopped at 920.6 m altitude, 149.7 kts speed, 9.3° pitch, and 0.2° roll. The reason why the recording did not be saved in the internal memory chips and SD card are not determined.

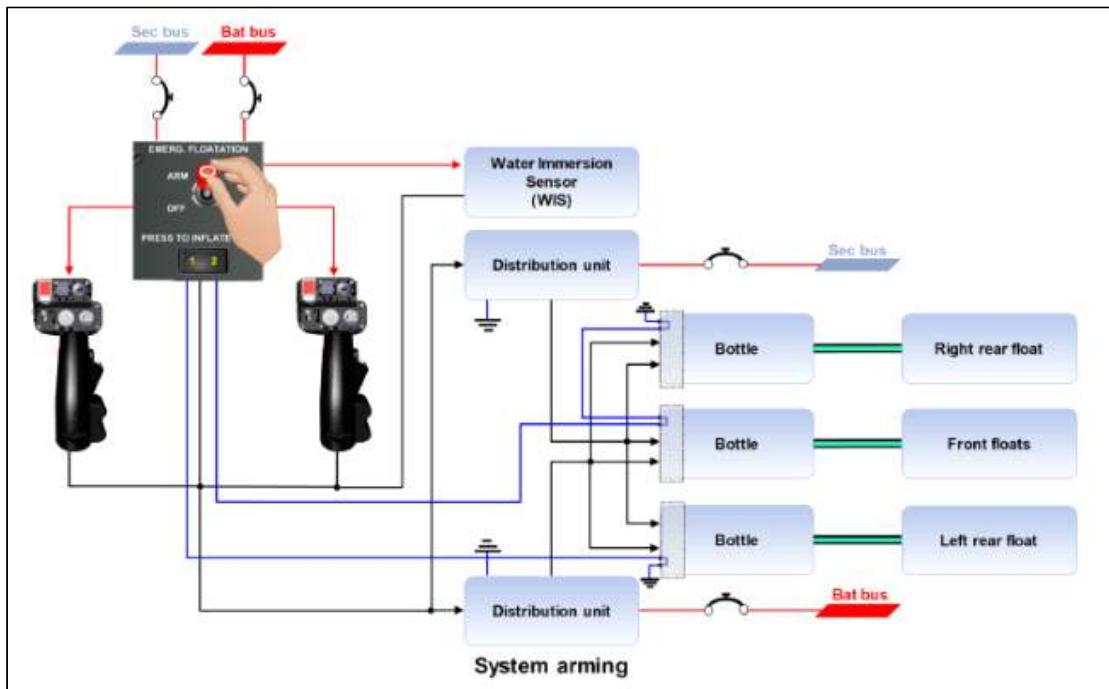
Figure 38. EFS operation principle

The CVR recorded the pilot turning the EFS switch ON while entering above the sea from the sky of Pohang. The reason for the failed EFS operation, however, even if switched on, may be due to the too-intense HL9619's fall energy; the sudden destruction of structures would render the power connections to helium gas cylinders incapable.

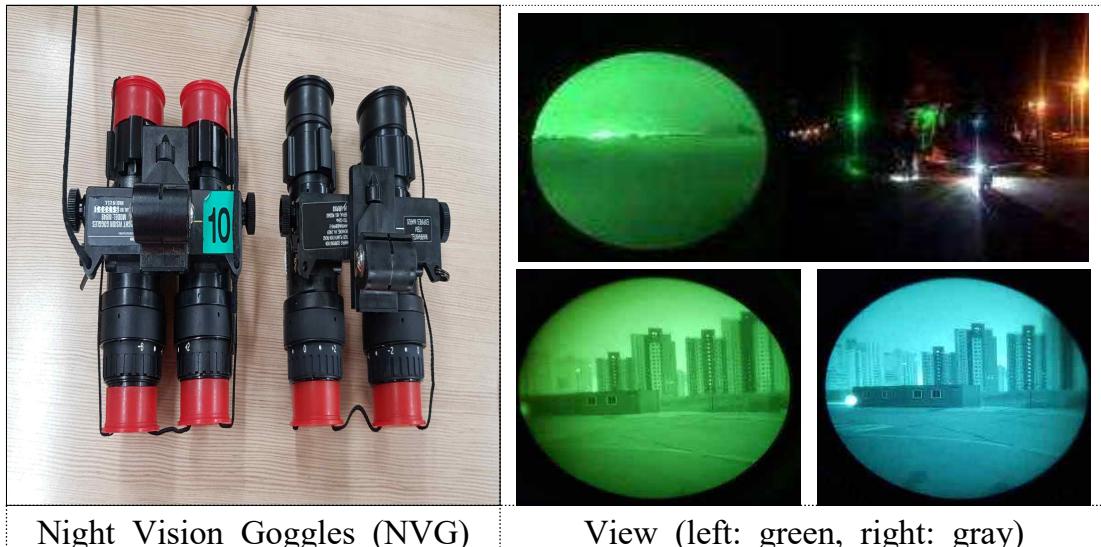
Figure 39. NVG and the view

The National 119 Rescue Headquarters provide NVG to each pilot for night flight missions. The pilot of HL9619 was provided with a gray phosphor NVG in 2018, and the co-pilot received a green phosphor NVG in 2013 (see Figure 39).

At this time, the pilot said, "Aw, the light should not flash upon us." Seemingly, the portable searchlight flashed and was waved by a standby worker who intended to guide the helipad's location. However, it seems the light indirectly illuminated the cockpit and temporarily affected the pilots wearing NVG.

helipad. If worn, it would more likely overcome the darkness, for example, by magnifying starlight. Although using NVG is a pilot's choice, the Agency should train them for proficient use whenever necessary.

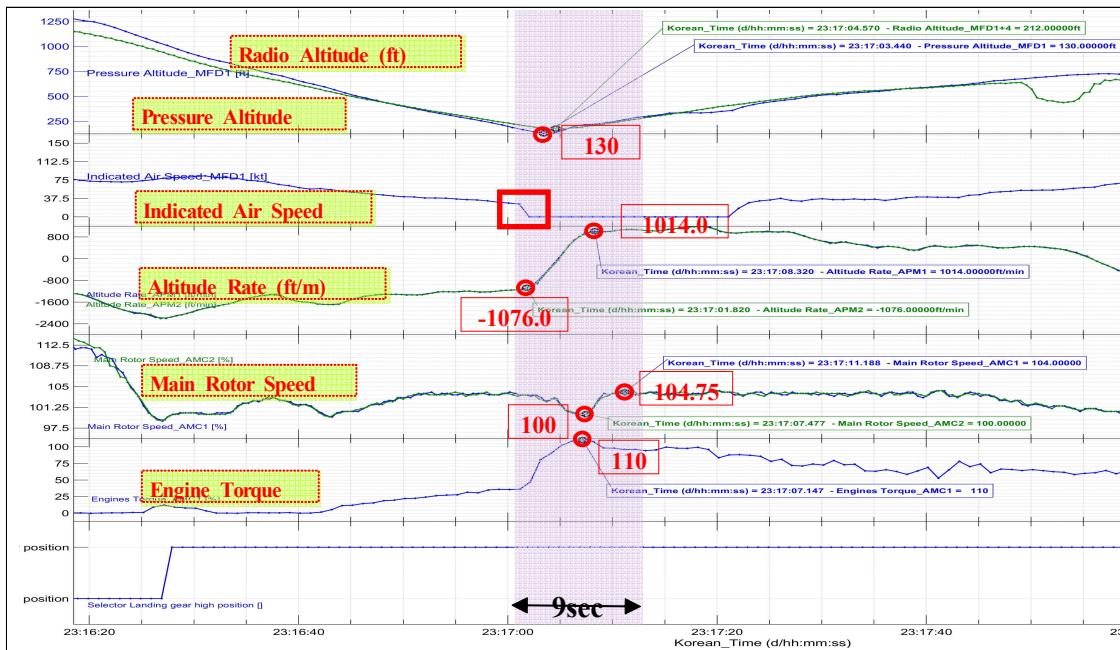
Figure 40. Temporary excess of engine limits while approaching

The pilot communicated with the Dokdo Operations Center⁷⁷⁾ and notified them, "Landing, 3 minutes left." While approaching, engine limits were temporarily exceeded, as shown in the extracted FDR (see Figure 40).

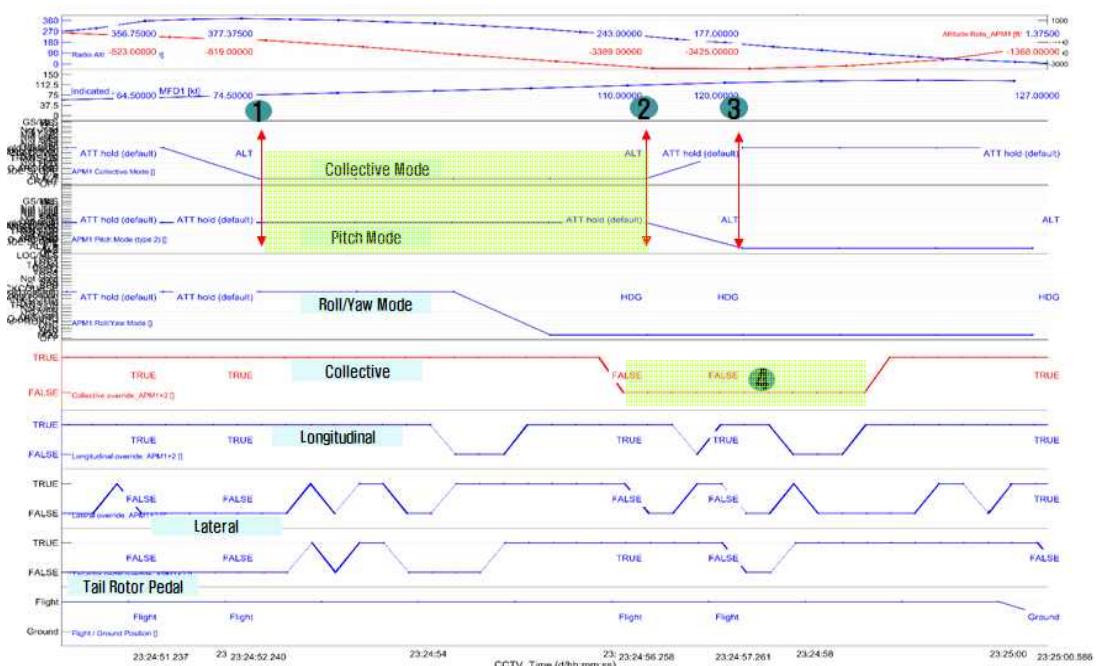
Figure 43. Pitch changes

The FDR (see Figure 43) showed the HL9619 used a collective axis from sections 1 to 2 as in the manufacturer's flight manual. The control through the collective axis (1 to 2) remained for 4 seconds. The pitch axis was used in section 4, and section 3 is the time taken to change into the pitch axis. When transitioning from collective to pitch, the aircraft speed rapidly increases, as does the descent rate.

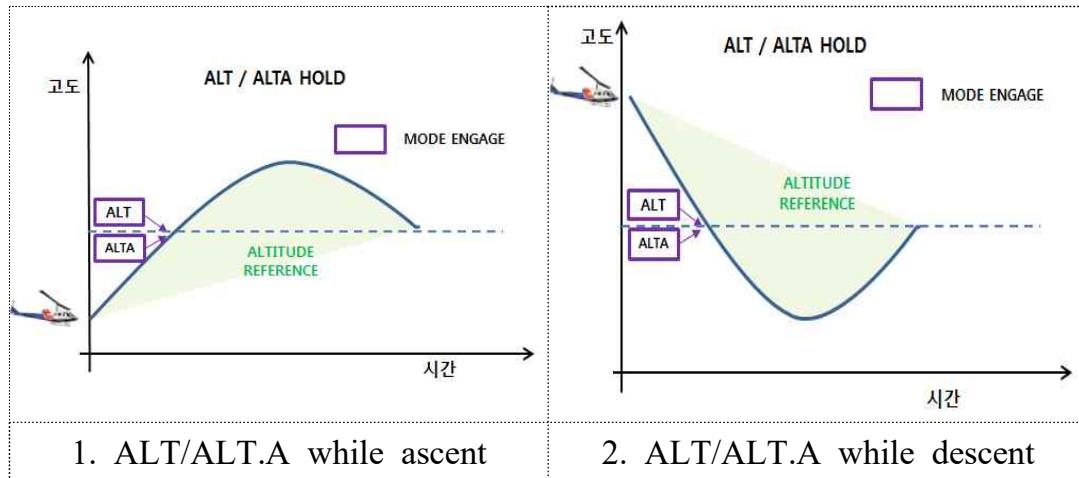
Figure 44. Applying ALT/ALT.A while ascent/descent

Pilots use ALT to remain flying at their current altitude, meanwhile pressing ALT.A to acquire and hold a pre-selected altitude (see Table 23). The left image of Figure 44 shows the aircraft's response to the ALT, or ALT.A, while ascending. On the one hand, maintaining an intended altitude cannot be accomplished right away. Though different regarding ascent pace and rate, the aircraft reaches a higher altitude before lowering to the set altitude.

The image on the right of Figure 44 indicates when an aircraft is

descending. Either the ALT or ALT.A button is activated, it will first descend below the set altitude at a varying pace and rate.

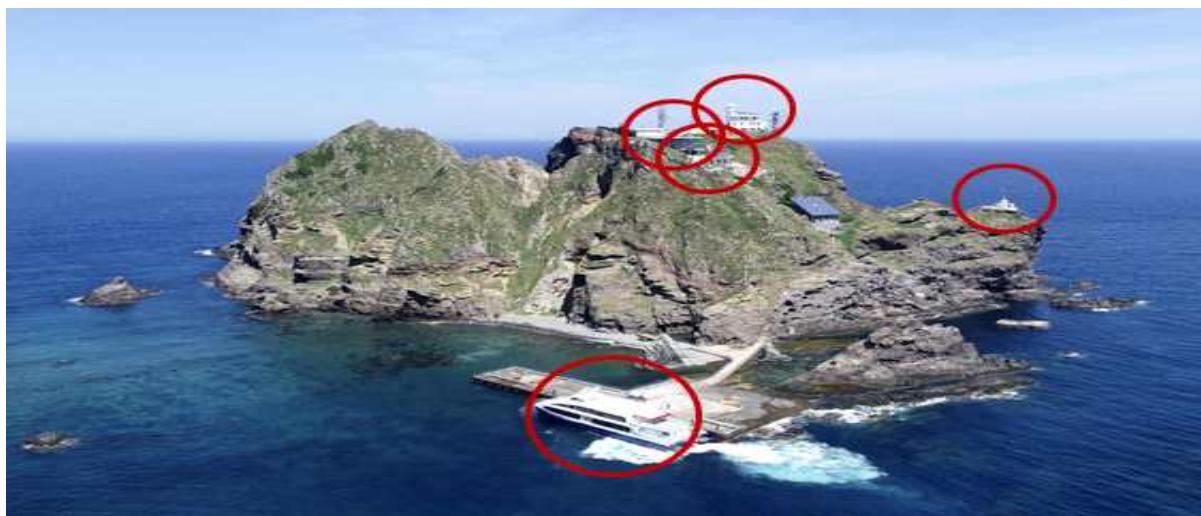
Figure 45. Lights from Dokdo during the approach

Many lights affected the vision of the HL9619 crewmembers when approaching and taking off from Dokdo. The surroundings of the dock were prone to obscure the pilot's vision and create an illusion with the lights from the Daewangho fishing vessel, buildings, helipad, and the beacon-type lighthouse (see Figure 45).

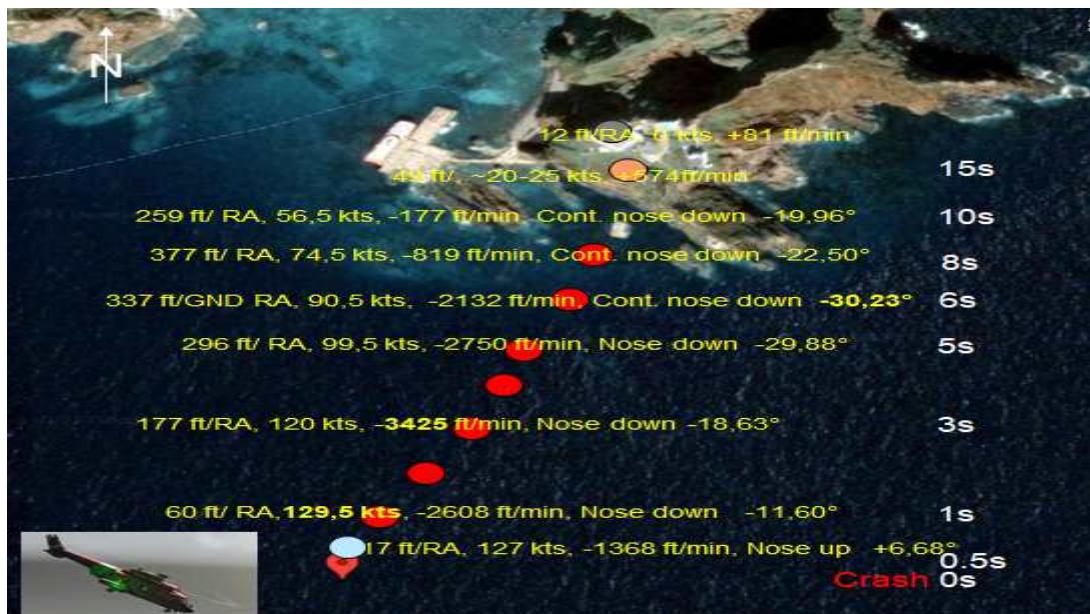
Figure 46. HL9619 attitude changes

At the altitude of 177 ft in the air, the airframe was fully tilted forward with a descent rate of -3425 ft/min and the nose down to -18.63° . Without any visual references, the perceptual error would arise, resulting in perceiving the aircraft as ascending and thus, pushing the cyclic.

See Figure 46 for the HL9619's changes in altitude, speed, descent rate, and the airframe attitude from its Dokdo takeoff to the crash. Also, see Figure 47 for the power limitation occurrence and EGPWS warning.
