Investigation Report

| Kind of Occurrence: | Accident |
| Location: | Nthungwa Forest, Nkhata Bay (Republic of Malawi) |
| Type: | Dornier 228-202(K) |

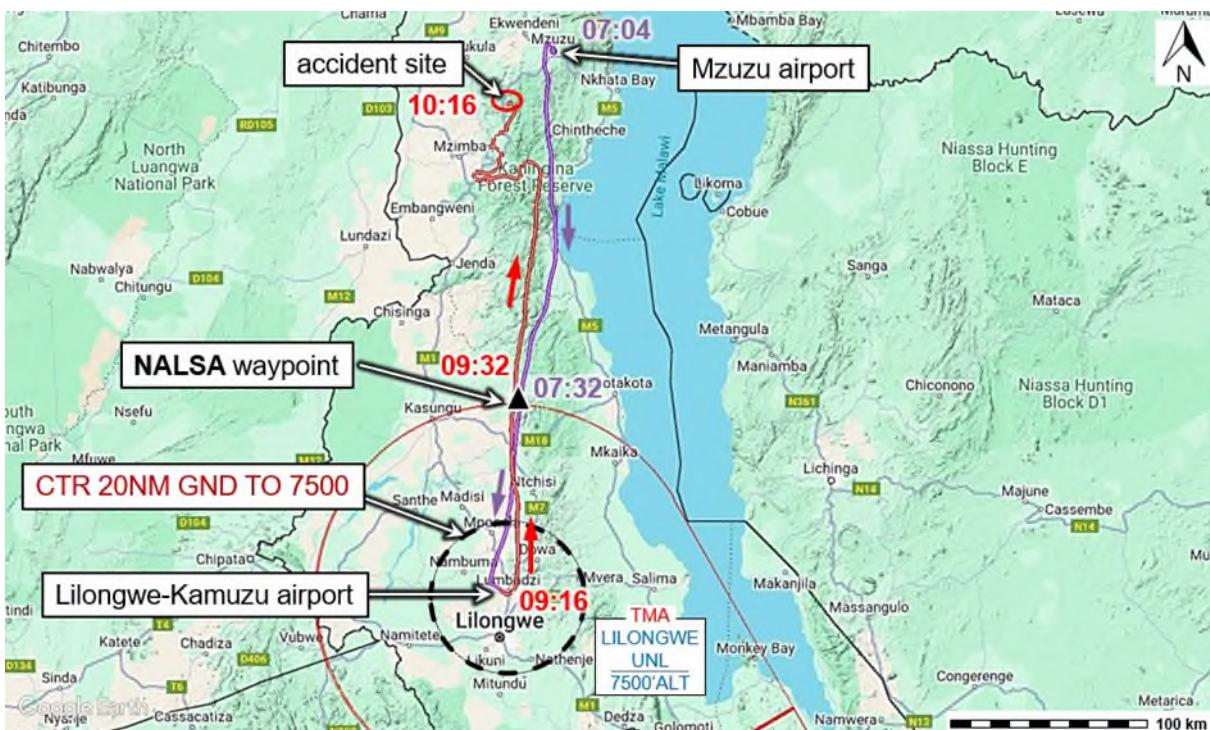
Fig. 1: Flight path of both flights on the day of the accident, according to the GPS recording

The GPS data showed that at 0704 hrs, the airplane took off from runway 35 and one minute later during climb, it turned towards the south (Fig. 1, flight path in purple).

According to the controller, at 0912 hrs, he had given the crew a clearance for a direct flight to Mzuzu in FL90 as well as the departure clearance and the transponder code 2772. The plane took off at 0916 hrs with 3 crew members and 6 passengers on board on runway 14 (Fig. 1 flight path in red). The controller stated that the aircraft's radar target appeared on the monitor when it reached an altitude of about 4,800 ft AMSL. At 0917 hrs, in climb, the aircraft began a left turn, two minutes later the turn was ended in a northerly direction.

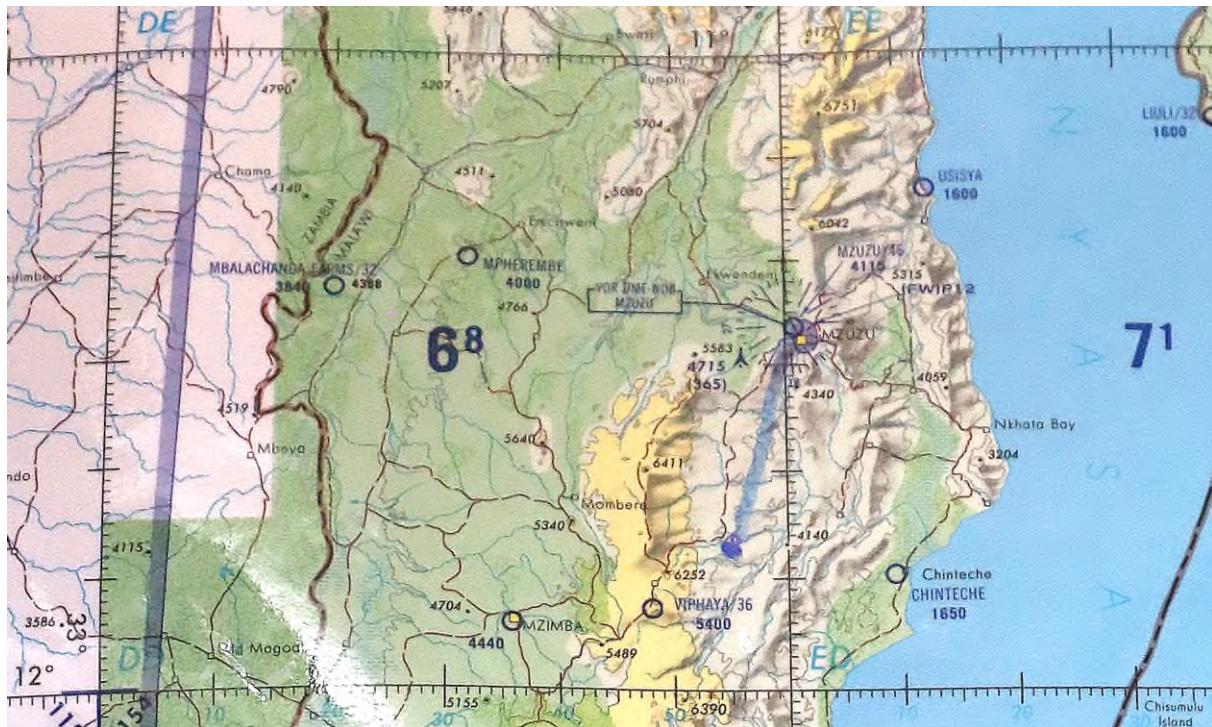
Fig. 6: Excerpt from the VFR flight map with the maximum elevation figure

In a VFR flight map available to the Malawi Air Force, the highest terrain elevation/obstacle (Maximum Elevation Figure) in the area around the accident site (11°-12° S, 33°-34° E) was displayed with a value of 6,800 ft AMSL and in the area of Mzuzu airport with 7,100 ft AMSL (Fig. 6).

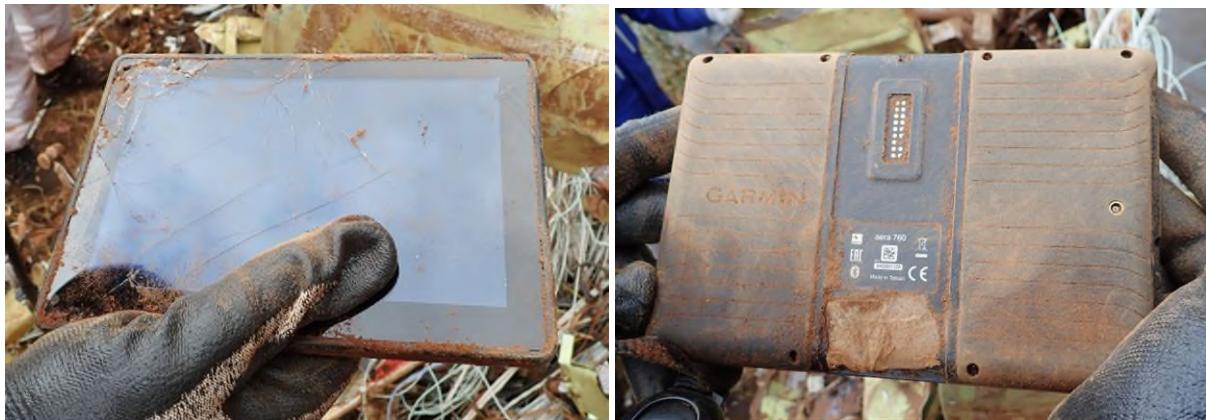
Fig. 12: Recovery of the navigation system at the accident site

The navigation system Garmin Aera 760 was secured at the accident site by the BFU and later read out in the BFU laboratory (Fig. 12).
