# Investigation Report

Type of Occurrence: Serious Incident

Date: 5 December 2022

Location: Dortmund Airport

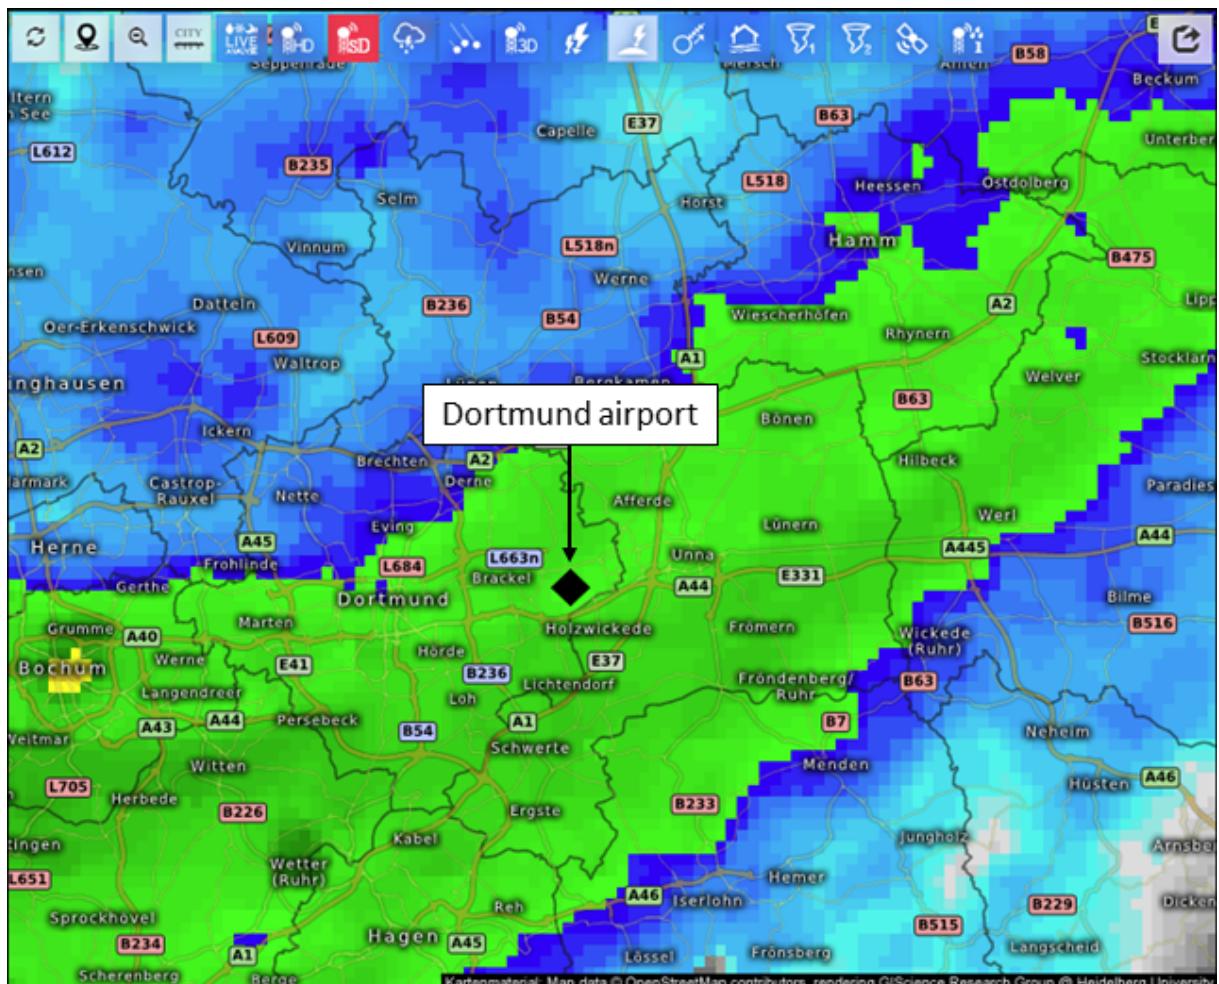
Fig. 4: Weather radar image with precipitation intensity

Figure 4 was taken from the archive of a private weather provider (Kachelmannwetter.com) and is a composite picture with a resolution of 1 x 1 km. It depicts the precipitation intensity in the region Dortmund on 5 December 2022.

The colour range Radar Standard (dBZ = decibel relative to Z) below the radar image depicts the reflectivity Z of the Hydrometeore. Higher dBZ values correspond with heavier precipitation and/or larger Hydrometeore, e. g. hail.

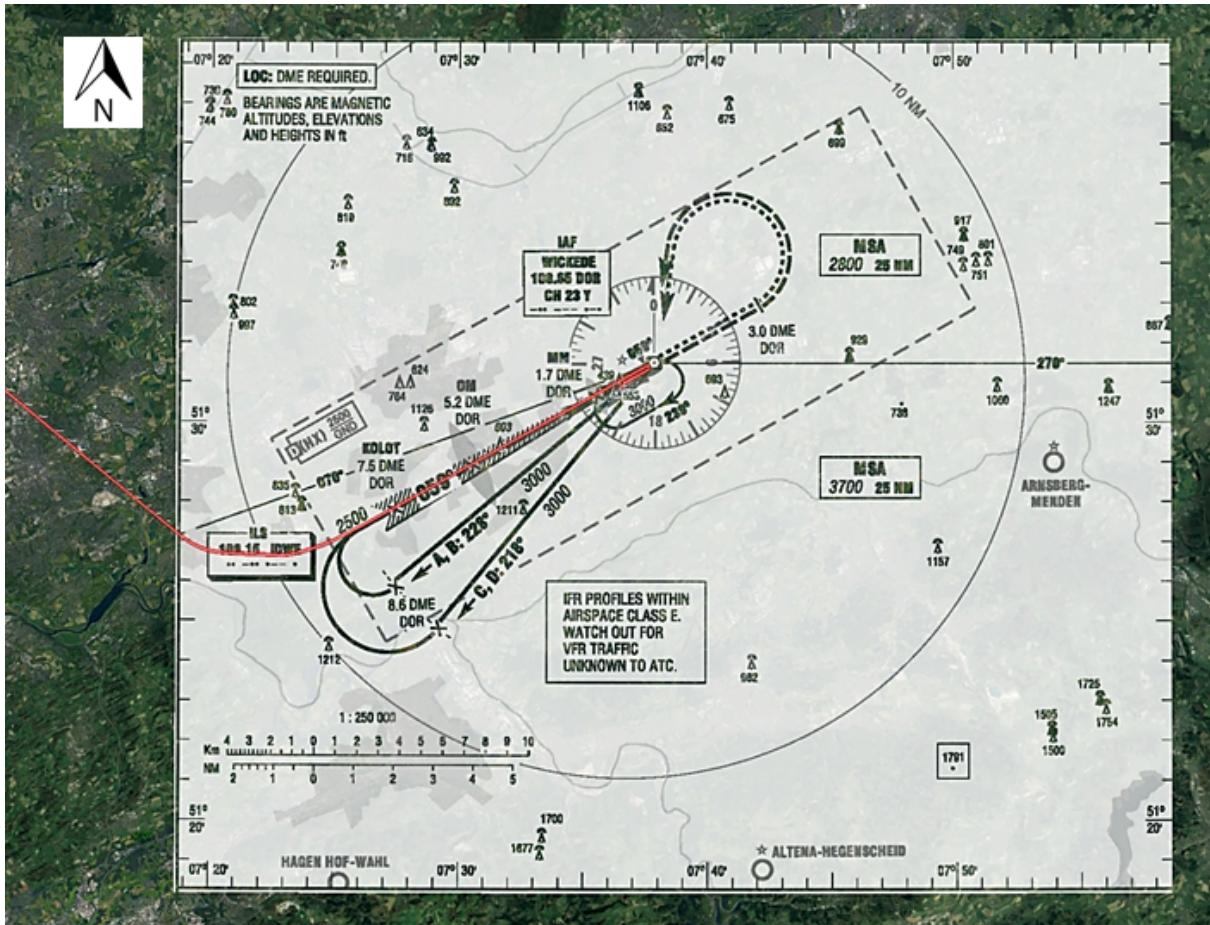
Fig. 5: Flight path in a GoogleEarth™ chart with an AIP overlay approach chart

The instrument approach was conducted as category II precision approach (ILS 06 CAT II) to runway 06. It began with the Final Approach Point KOLOT at 2,500 ft AMSL.

The BFU entered the flight path as red line into the AIP Germany approach chart (Fig. 5) (AD 2 EDLW 4-2-2; 20 June 2019; ILS CAT II or LOC RWY 06).
