## Maintenance Briefing Notes

### Uncommanded Ram Air Turbine (RAT) extensions

The purpose of this Maintenance Briefing Notes note is to summarize the RAT extension logic for the individual Airbus aircraft programs, and then provide a summary as to likely causes of uncommanded RAT extensions.

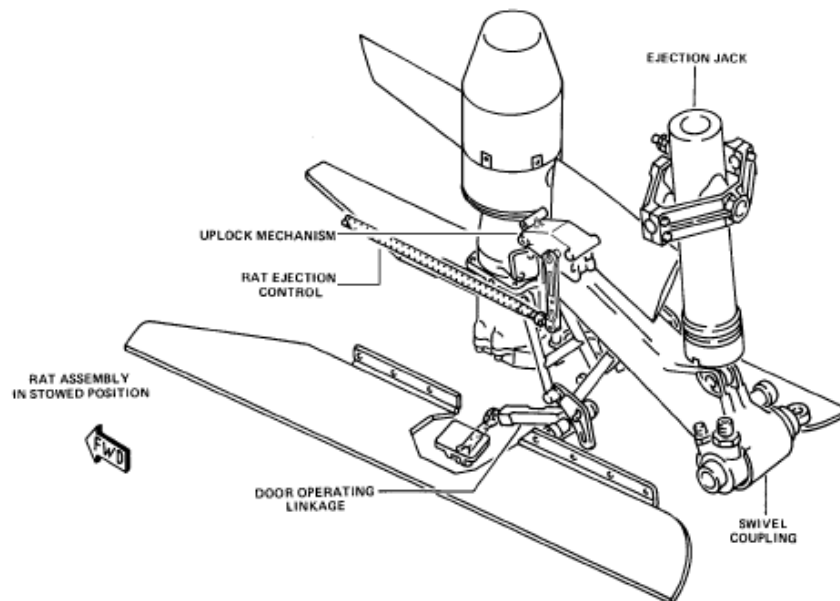
**Figure 2: A300 Family RAT in retracted Position**

An uplock mechanism holds the RAT in a stowed position. The RAT deployment is initiated from the flight compartment. The rotation of an uplock input shaft moves an internal locking cam in order to unlock the uplock hook. Release of this uplock hook allows the ejection jack to push the RAT into the airstream.

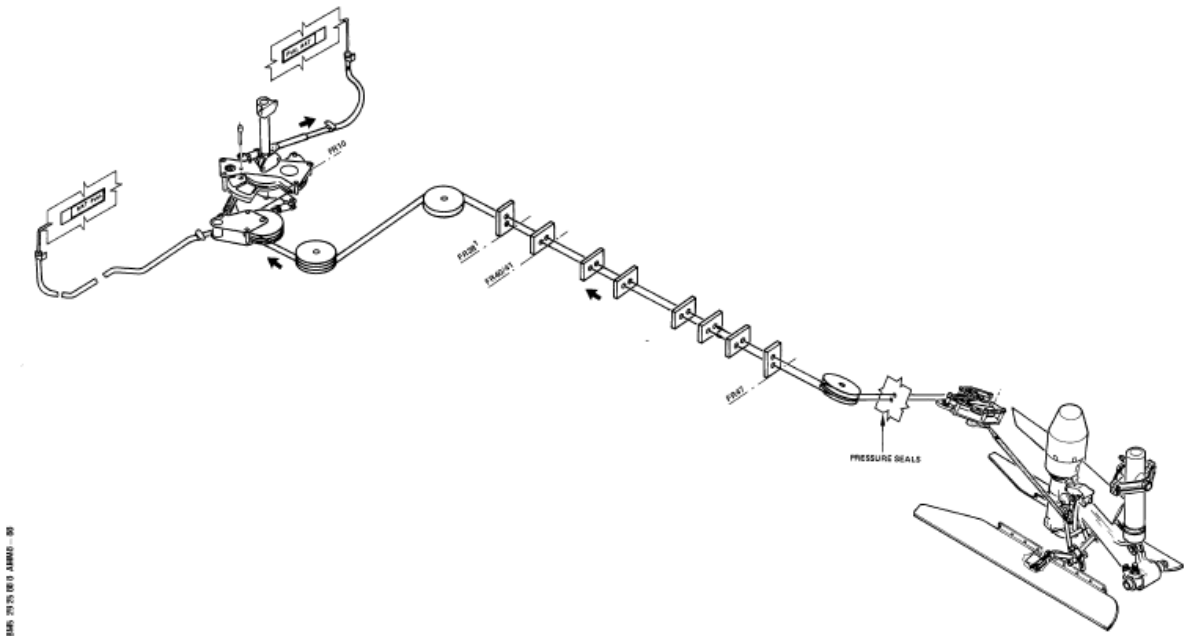
**Figure 3: A300 Family RAT Extension Mechanism**

The RAT ejection jack consists of an oil damped, spring powered actuator. Helical compression springs initiate the RAT deployment against the compartment doors. Once caught by the airstream, the RAT is forced to the fully deployed position. As the RAT approaches the fully deployed position, oil is forced through various sized internal orifices causing a dampening effect. The dampening effect prevents high shock loads from being transmitted into the RAT and into the aircraft structure.

*"Upon touchdown, the RAT extended without any cockpit selection. Trouble shooting confirmed that the UPLOCK P/N: 730822B, IPC 29-25-03-3A-90 was weak and could be released by manual effort, with no obvious damage in cables/ control linkages detected. A new uplock was ordered to replace the suspected one. Investigation of the uplock confirmed that the uplock (which was >20 years old) would not lock, and therefore could lead to the uncommanded RAT extension. "*
