A1. Factual information

A1.1 Background and course of the accident flight

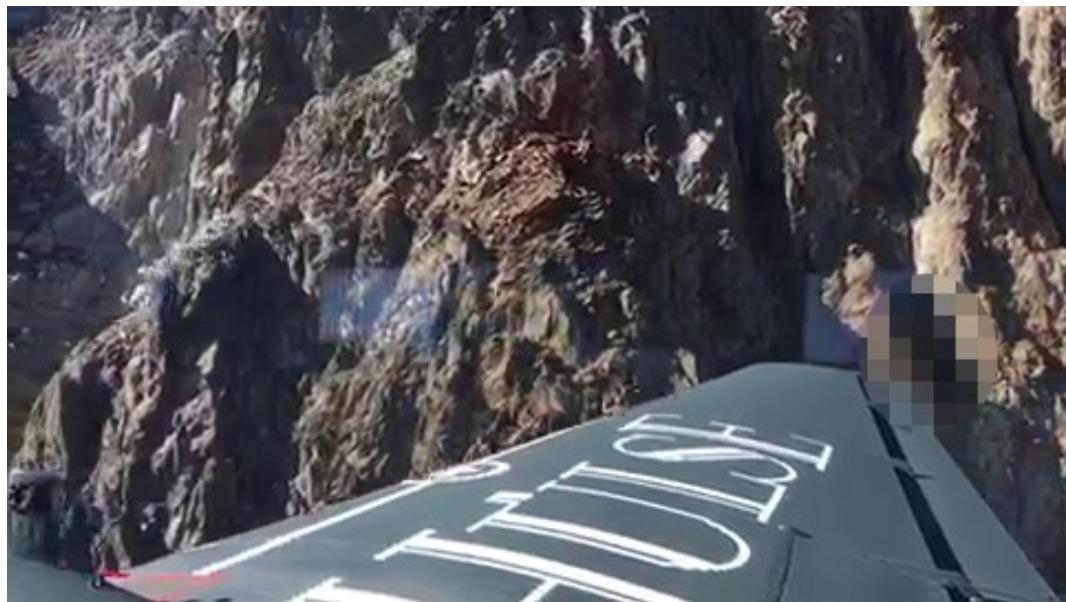
At 09:37, the Ritzlihorn mountain (3,277 m AMSL) was passed during a slight right turn and at a short distance from the rock face – estimated at 30 to 50 m between wing tip and rock face. The flight past the Ritzlihorn was filmed by several passengers (see figure 1).⁷

Figure 1: Still image from one of the videos recorded from inside the aircraft when passing the Ritzlihorn mountain (3,277 m AMSL). The still image shows the right wing of HB-HOT and part of the engine cowling (bottom left corner of the image) in front of the northern flank of the Ritzlihorn. Footage from a private individual.

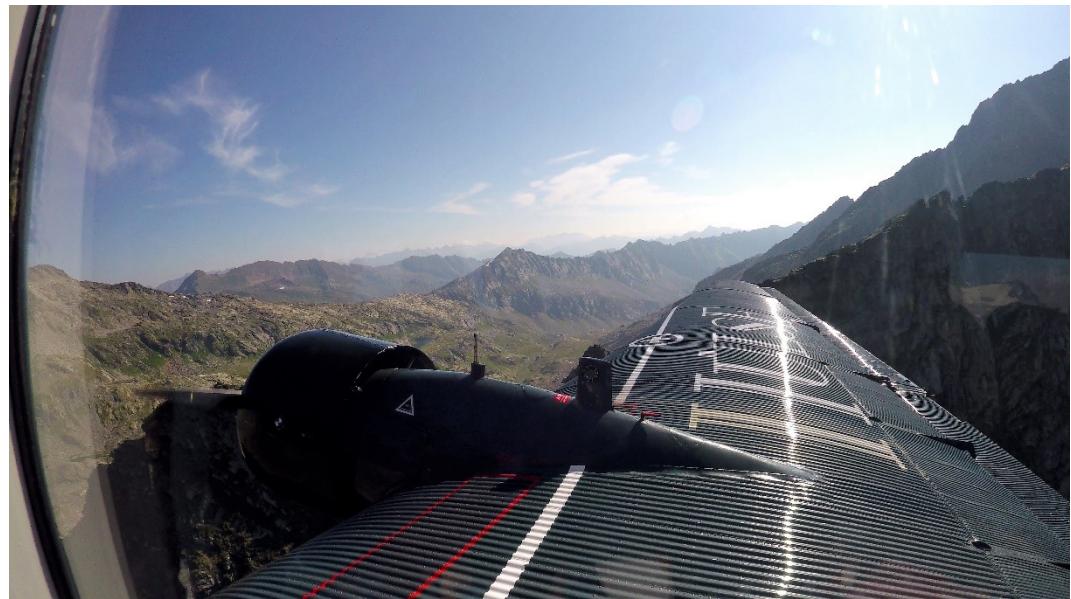
At 09:48, HB-HOT crossed the Val Bavona valley north of San Carlo in a left turn and took a generally north-easterly heading. During an S-turn in the region of the Cristallina mountain (2,912 m AMSL), HB-HOT flew over the Bocchetta del Lago Nero pass (2,563 m AMSL) at a flight altitude of between 2,650 and 2,700 m AMSL. According to video footage recorded from inside the aircraft, HB-HOT at times was flown in close proximity to the terrain during this phase of the flight (see figure 2). Shortly afterwards, the aeroplane passed the Pizzo del Lago Scuro peak (2,647 m AMSL), where a group of hikers saw and captured this on video (see figure 3).

Figure 2: Still image from one of the videos recorded from inside the aircraft when flying past the Cristallina mountain. This frame was captured just before the aeroplane crossed the Bocchetta del Lago Nero pass. The ridge (in the shade), which leads from the Bocchetta del Lago Nero pass towards the southeast can be seen behind the engine (left) and behind the wing's trailing edge (right). Behind the ridge, the basin southeast of the Cristallina mountain is visible. Footage from a private individual.

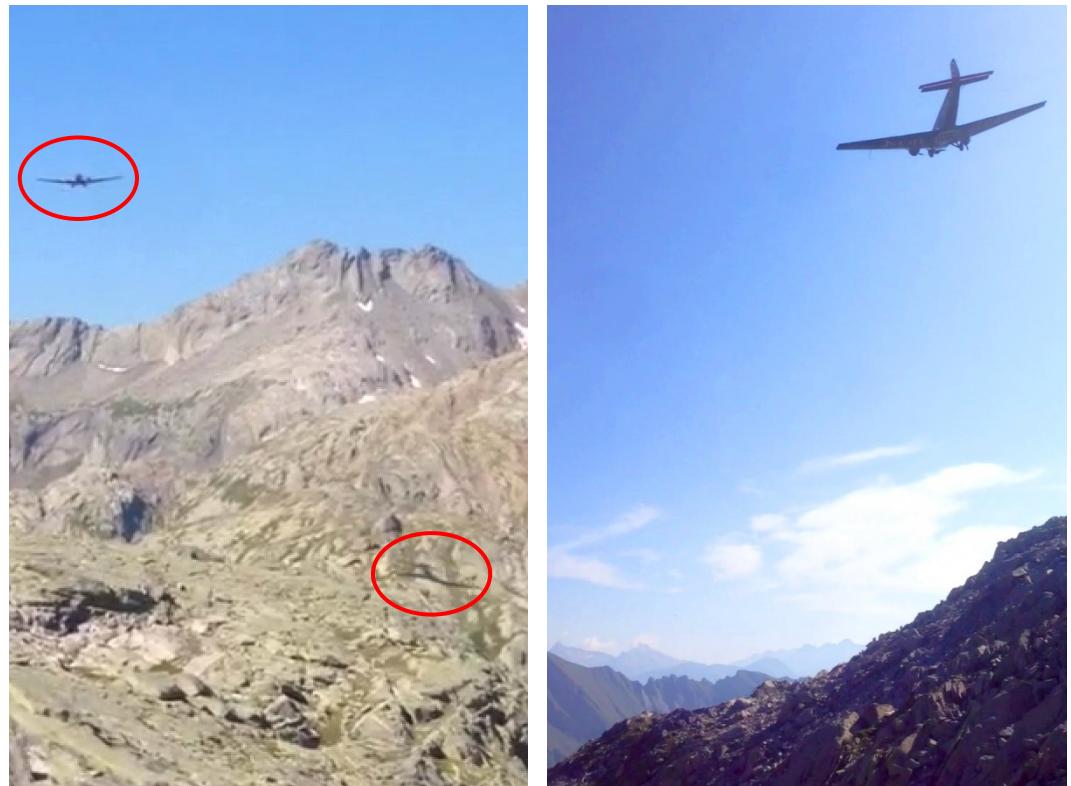
Figure 3: Still images (details) from two videos recorded by hikers from a position of approximately 330 m west of and 150 m below the summit when HB-HOT passed the Pizzo del Lago Scuro peak (2,647 m AMSL). In the image on the left, HB-HOT and its shadow on the surface of the terrain are marked in red. Footage from private individuals.

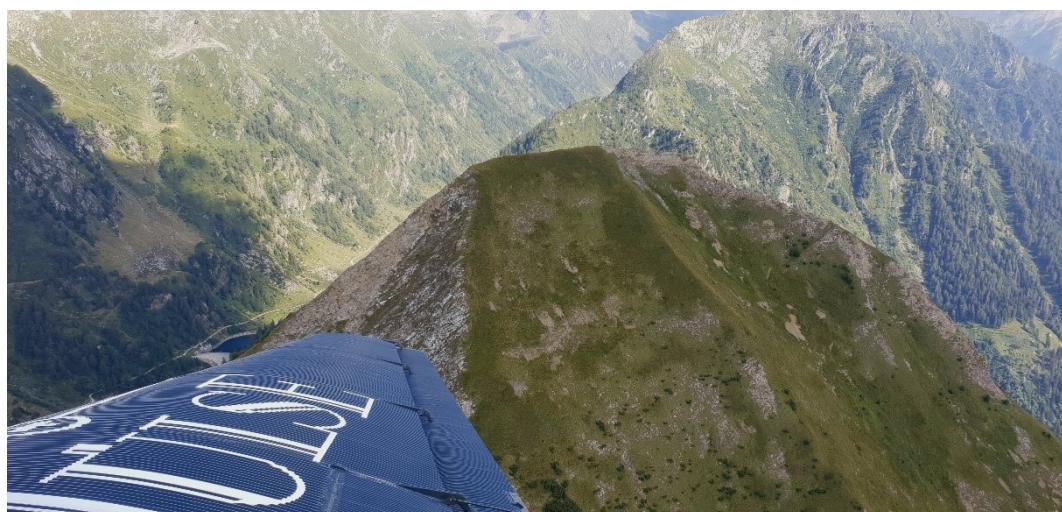
Figure 5: Still image from a video recorded from inside the aircraft when passing the Sosto mountain (2,221 m AMSL). The image shows the right wing of HB-HOT in front of the western and north-western side of the Sosto as well as the view into the Val Carassina valley including reservoir and dam. Footage from private individual.

When flying past the Sosto mountain, the corrected transponder altitude was 2,270 m AMSL. The south-western spur of the Torno mountain (2,556 m AMSL) was flown over at approximately 120 m above ground, and the western flank of this

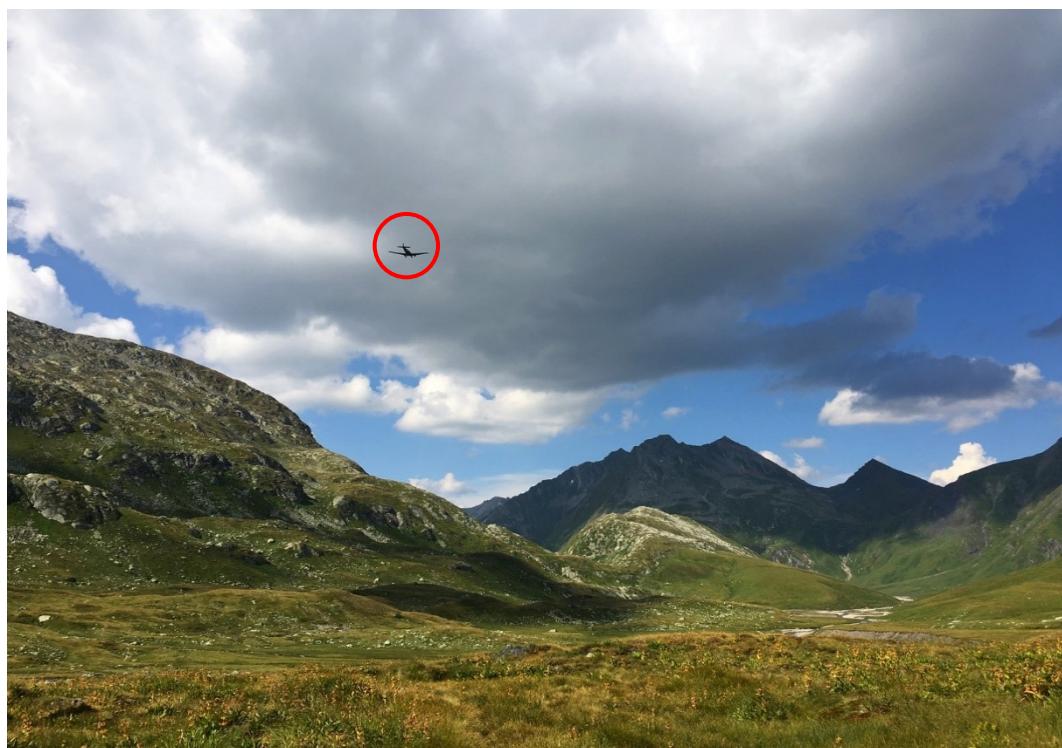
mountain was passed at approximately 150 m above ground. At the north-eastern end of the Lago di Luzzone reservoir, HB-HOT initiated a left turn before following a generally northern heading. The Lungadera ridge (2,419 m AMSL) was followed at a flight altitude of approximately 2,400 m AMSL. At 16:42, the Greina plateau was crossed at a height of 200 to 300 m above ground. The north-eastern section of the Greina plateau was covered by cumulus clouds at this time with a cloud base between 3,300 and 3,400 m AMSL (see figure 6).

Figure 6: HB-HOT (red circle) flying over the Greina plateau towards the Terrihütte hut. The cumulus cloud with its base between 3,300 and 3,400 m AMSL is clearly visible. Photograph from private individual.

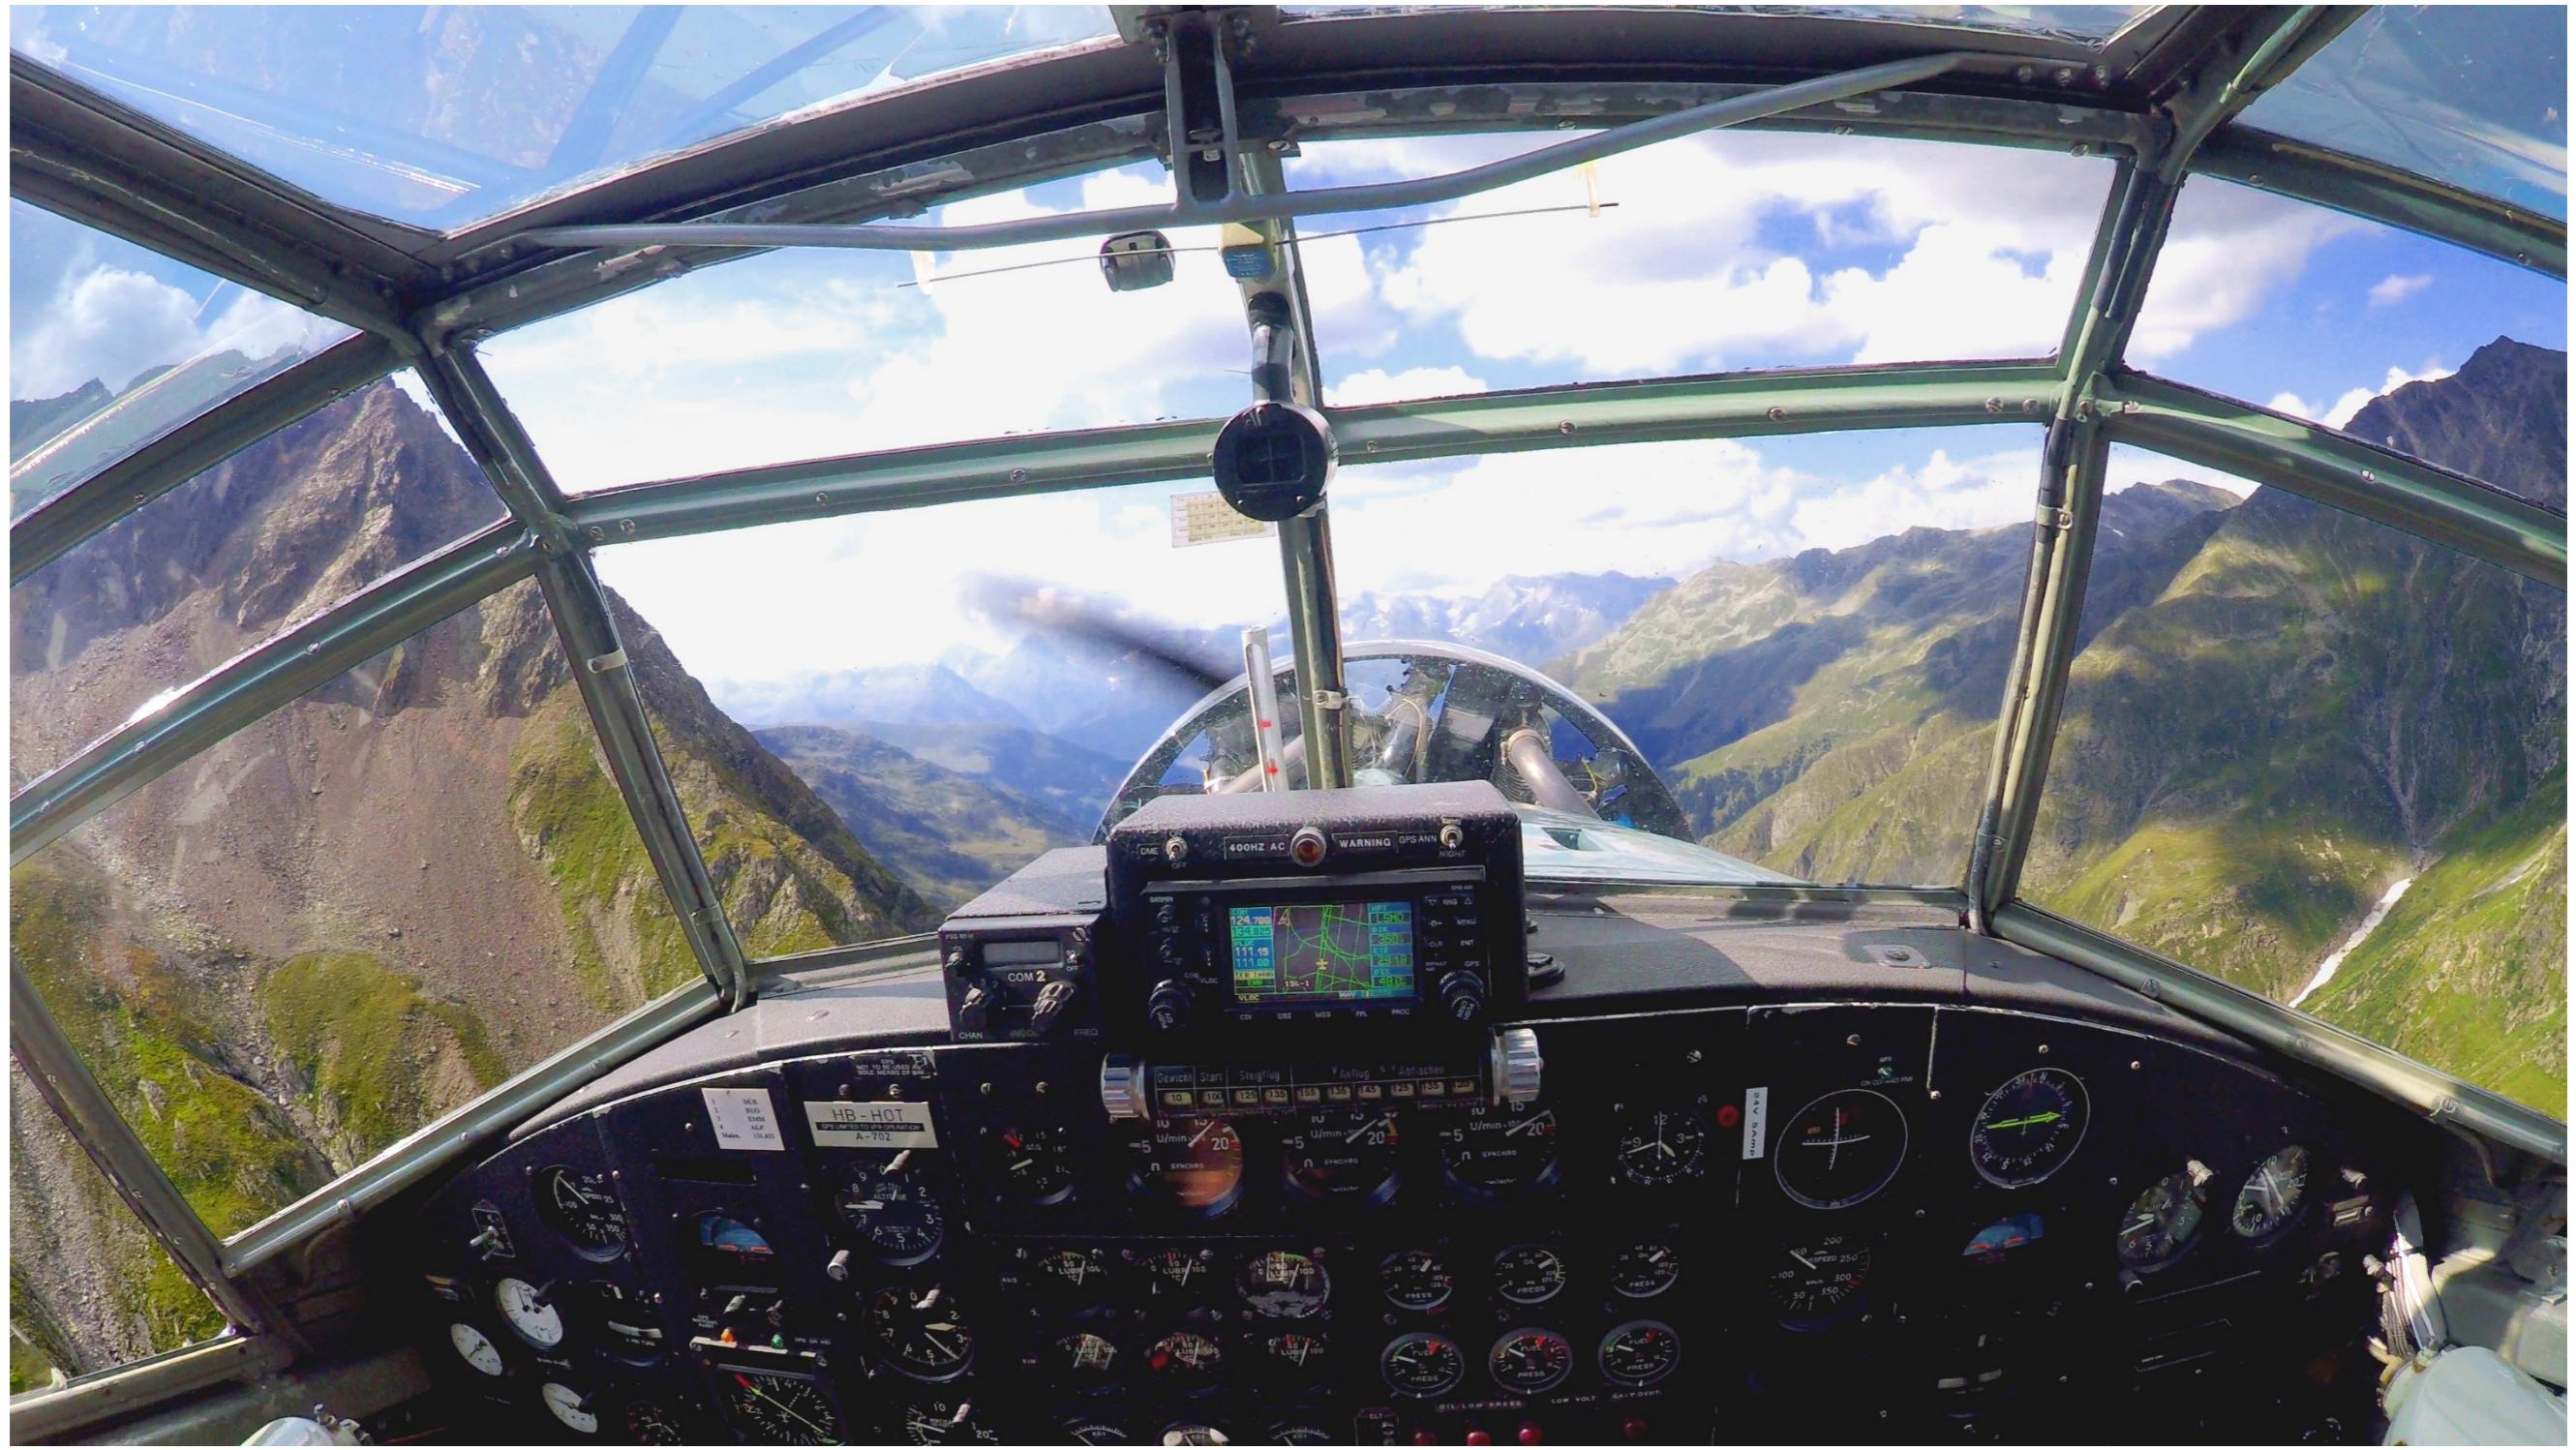
At 16:42:30, the Terrihütte hut was passed. At this time, the following altitudes were displayed in the cockpit (see figure 7):

A calibrated altimeter set to the QNH of Locarno would display a reading of 2,358 m AMSL or 7,745 ft AMSL under the local conditions prevailing at that time.

Figure 7: Still image from a video recorded by a passenger in the cockpit when crossing the Adula/Greina/Medels/Vals sanctuary for silence and nature. The image shows the instrument panel and the view from the cockpit when passing the Terrihütte hut. Footage from private individual.

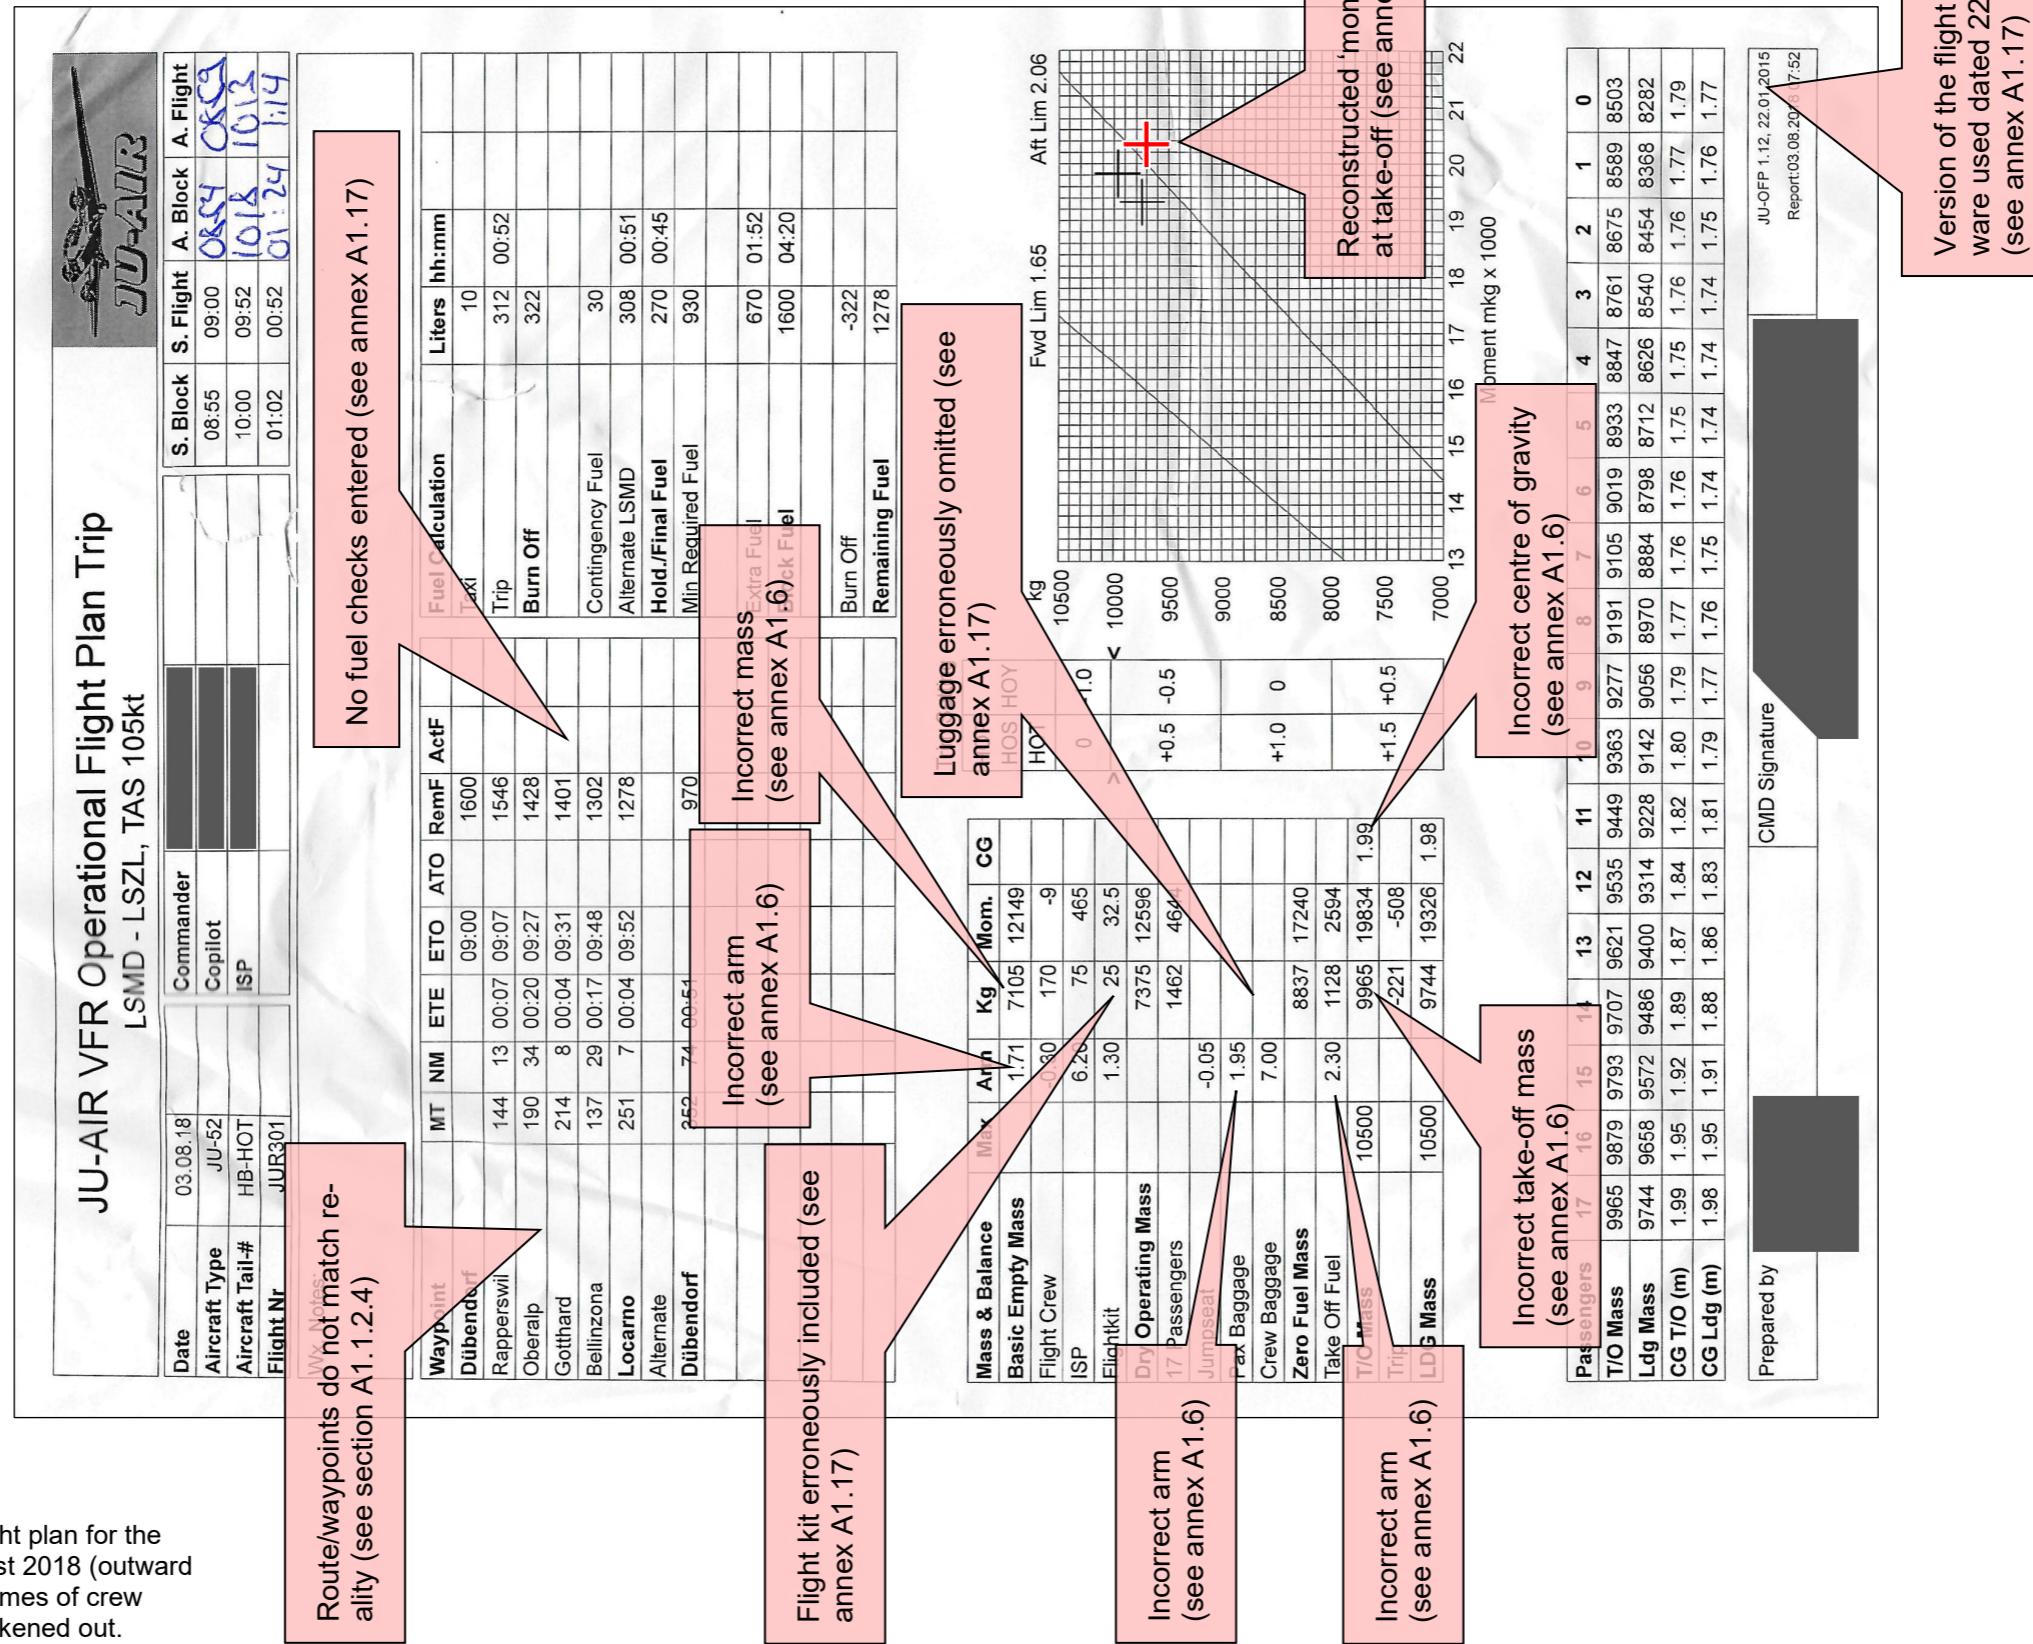
The following two pages contain the operational flight plans (OFPs) for the 2018 Locarno adventure tour. Comments including references to further explanations have been added to the most significant abnormalities and errors.

Figure 9: Operational flight plan for the HB-HOT flight on 3 August 2018 (outward flight) with comments. Names of crew members have been blackened out.

For the reconstruction of the actual situation for take-off from Dübendorf on 3 August 2018, the values for mass and centre of gravity corresponded to a 'moment' (mass \times arm) of 20,375 kg \times m (see annex [A1.1](#), figure 9, OFP1, red cross).

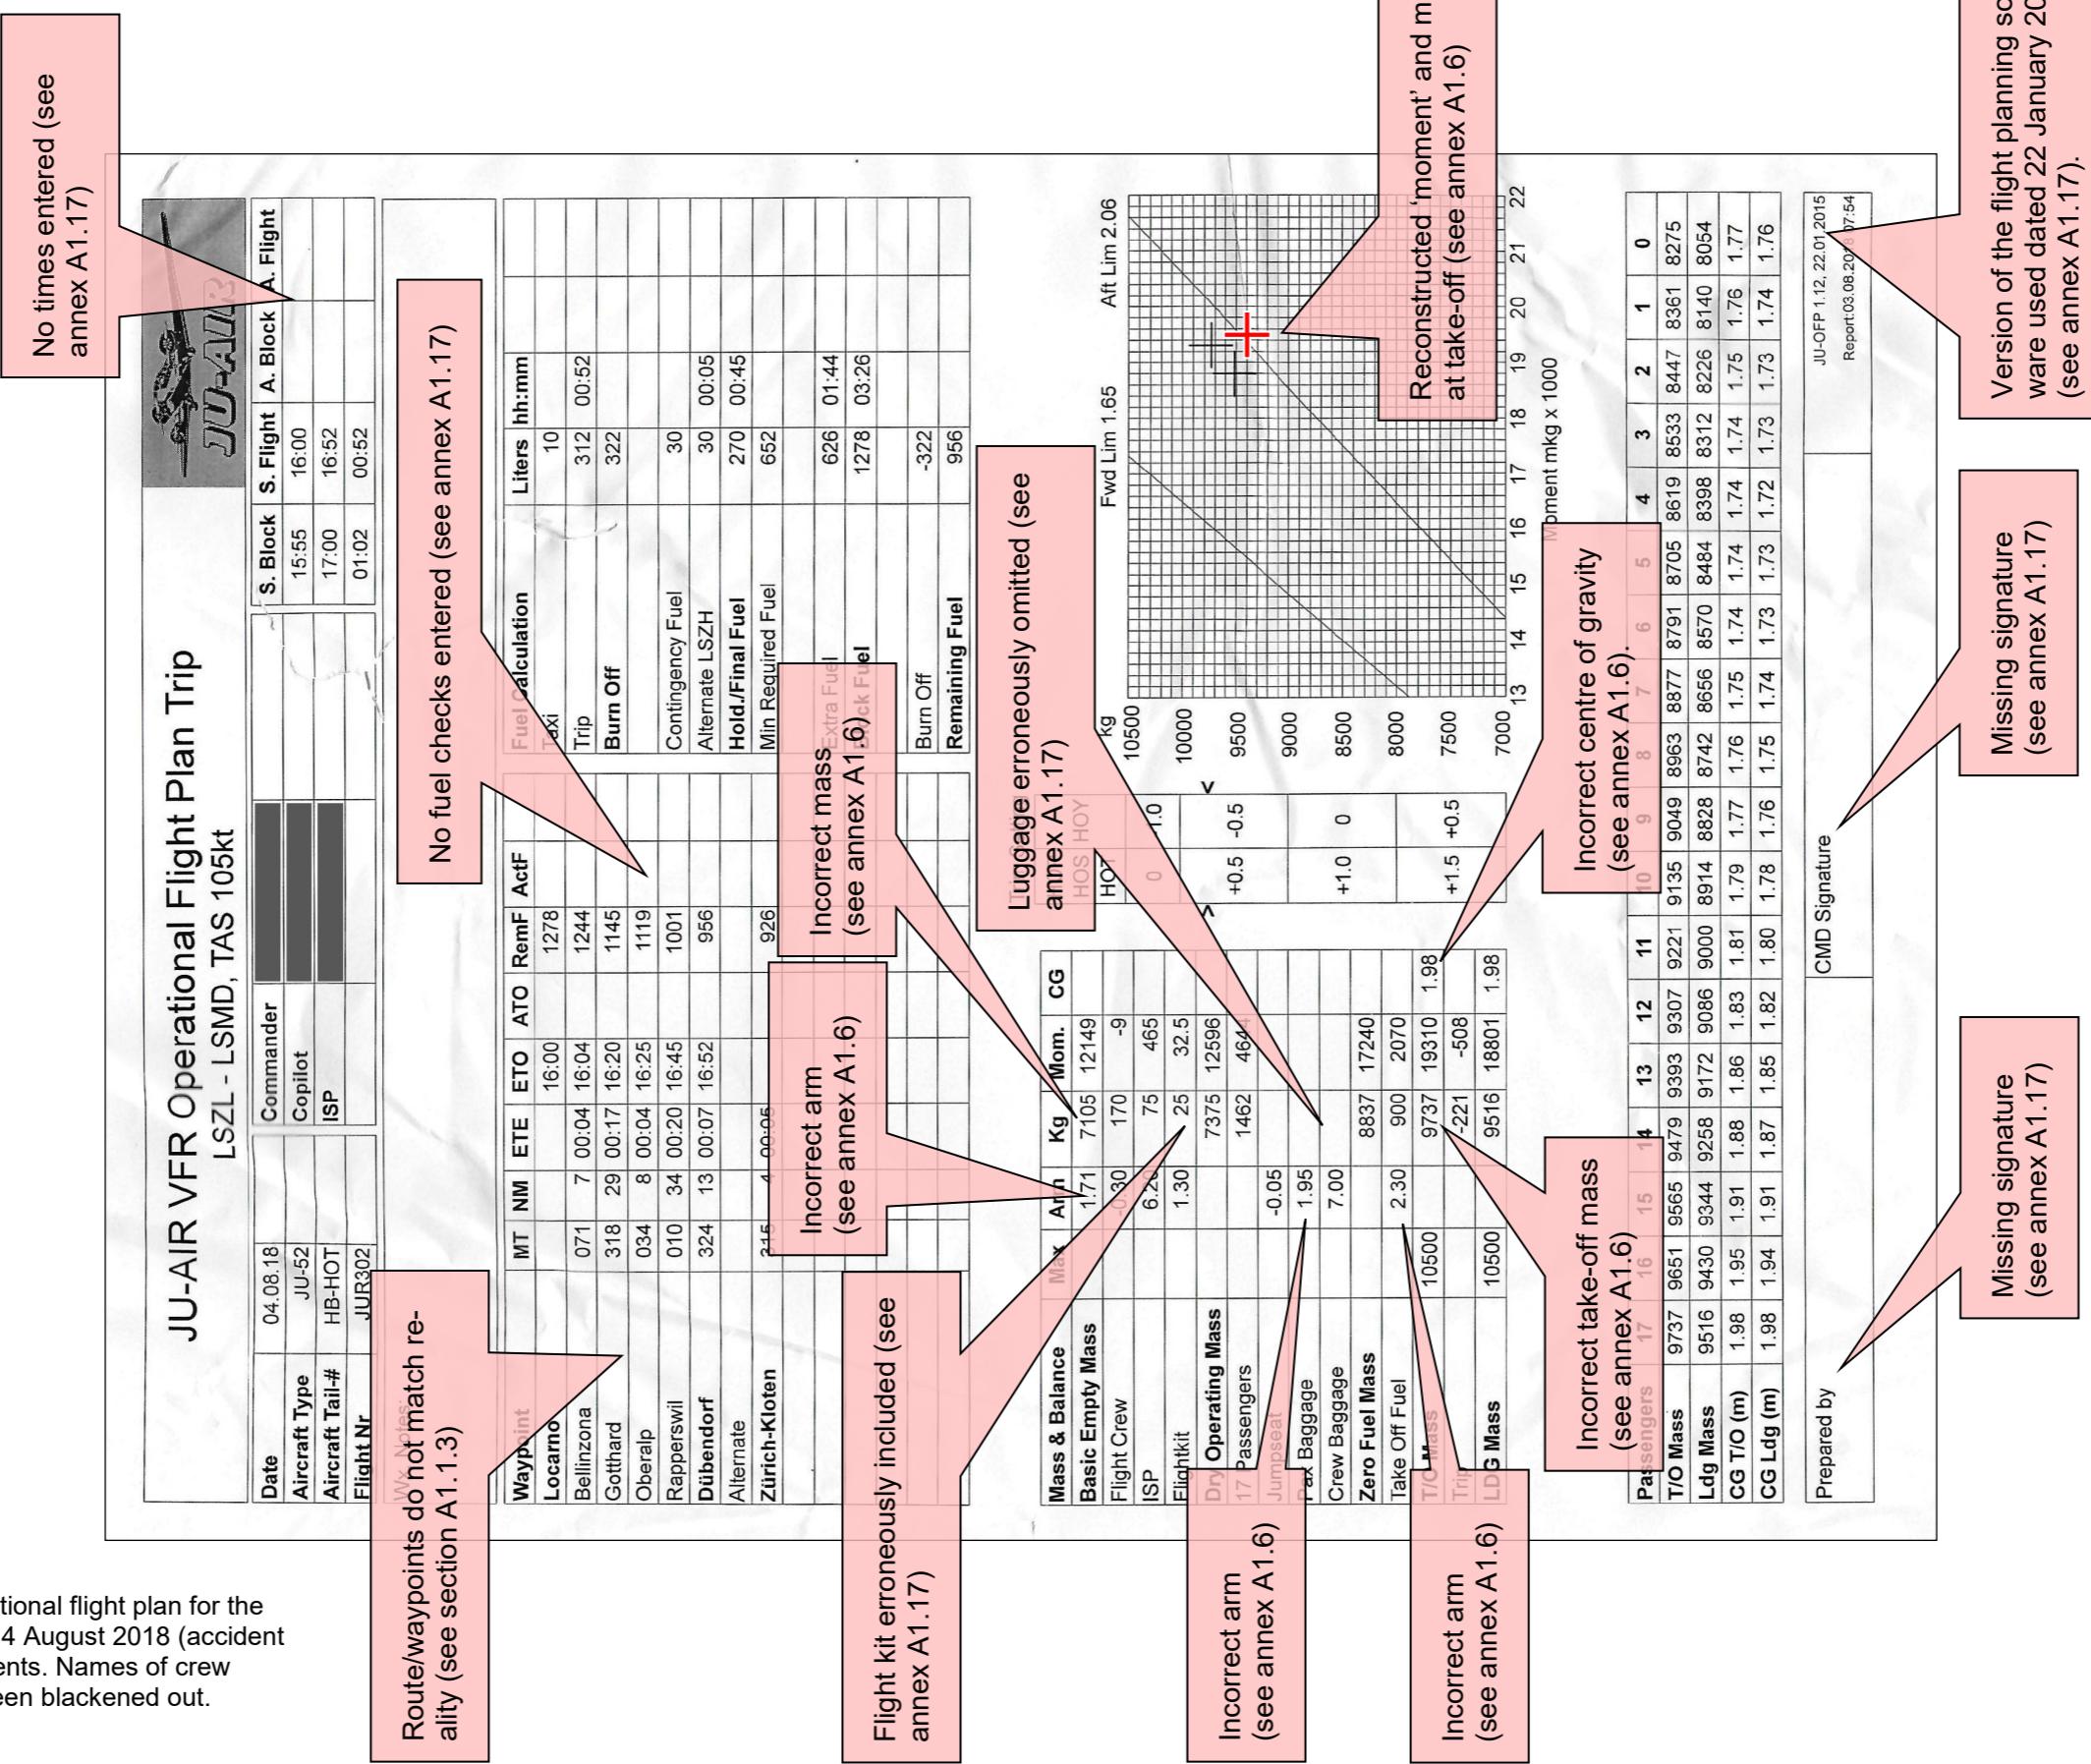
The OFP, which pilot A had already prepared for the return flight the day before, included a route via Bellinzona, the Gotthard pass, the Oberalp pass and Rapperswil. A mass of 9,737 kg and centre of gravity at 1.98 m were noted for take-off (see figure 10). The reconstructed value for the mass at take-off from Locarno was 9,387 kg and the centre of gravity at 2.077 m (see annex [A1.6](#)).

Figure 10: Operational flight plan for the HB-HOT flight on 4 August 2018 (accident flight) with comments. Names of crew members have been blackened out.

For the reconstruction of the actual situation for take-off from Locarno on 4 August 2018, the values for mass and centre of gravity corresponded to a 'moment' of 19,499 kg \times m (see annex [A1.1](#), figure 10, OFP2, red cross).

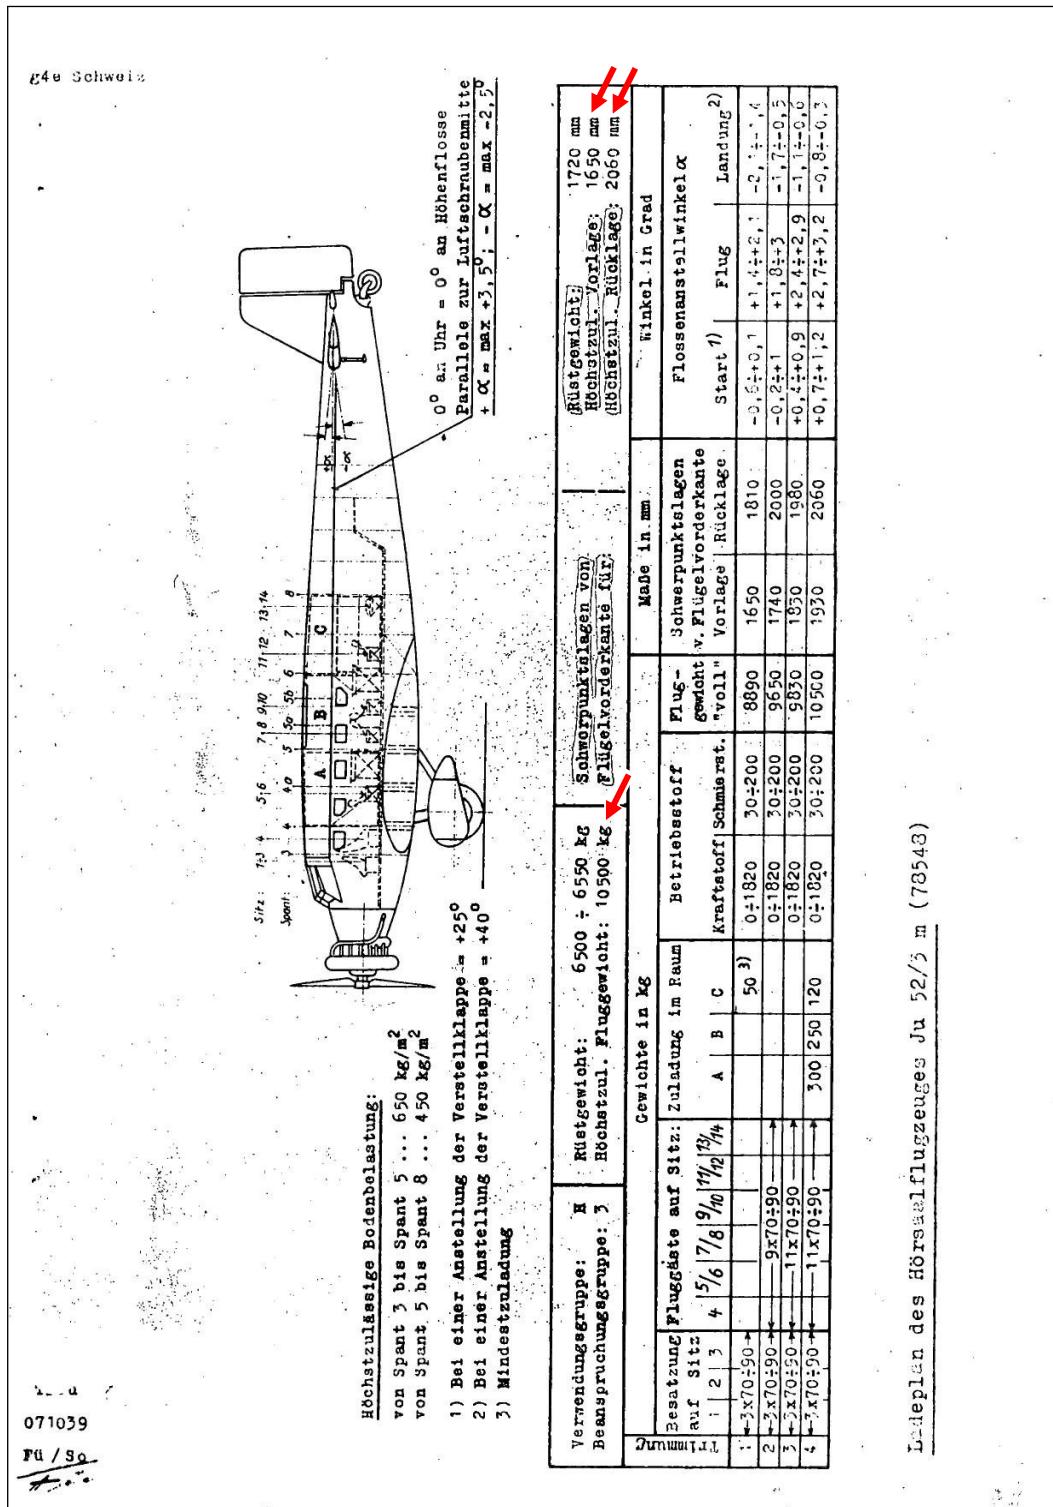
When the three Ju 52/3m g4e aircraft were handed over to the Swiss Confederation, a loading plan drawn up by Junkers Flugzeug- und Motorenwerke AG for the use of 'classroom aircraft' was supplied (see figure 1). This loading plan was part of the operating instructions²³ supplied by Junkers and specified the maximum permissible flight mass (10,500 kg) and permissible balance limits (maximum of 1,650 mm forward and 2,060 mm aft, measured from the leading edge of the wing). This loading plan was subsequently signed off by a department of the Swiss military administration and provided to the air defence corps as the 'TD 9560' loading plan (see figure 2). Although the air defence corps provided its Ju 52 pilots with the 'TD 9560' loading plan, investigation by the STSB revealed that it was evidently not used by the pilots. It could not be proven that loading plans were provided to Swiss air defence pilots for other purposes. There was also evidently no known alternative system for determining the mass and centre of gravity, as was the case with the loading instructions in Germany. Instead, the Swiss Ju 52 aircraft were loaded, refuelled and operated by the air defence corps based on experience passed on informally. Load sheets were not completed. As anecdotal examples show, the limits for flight mass and balance were regularly ignored by the Swiss air defence corps during operations.

Figure 1: Loading plan supplied to the Swiss Confederation in 1939. The red arrows point to information regarding the maximum permissible centres of gravity and maximum permissible flight mass. Source: "Betriebsanweisung Ju 52/3m g4e" (operating instructions).

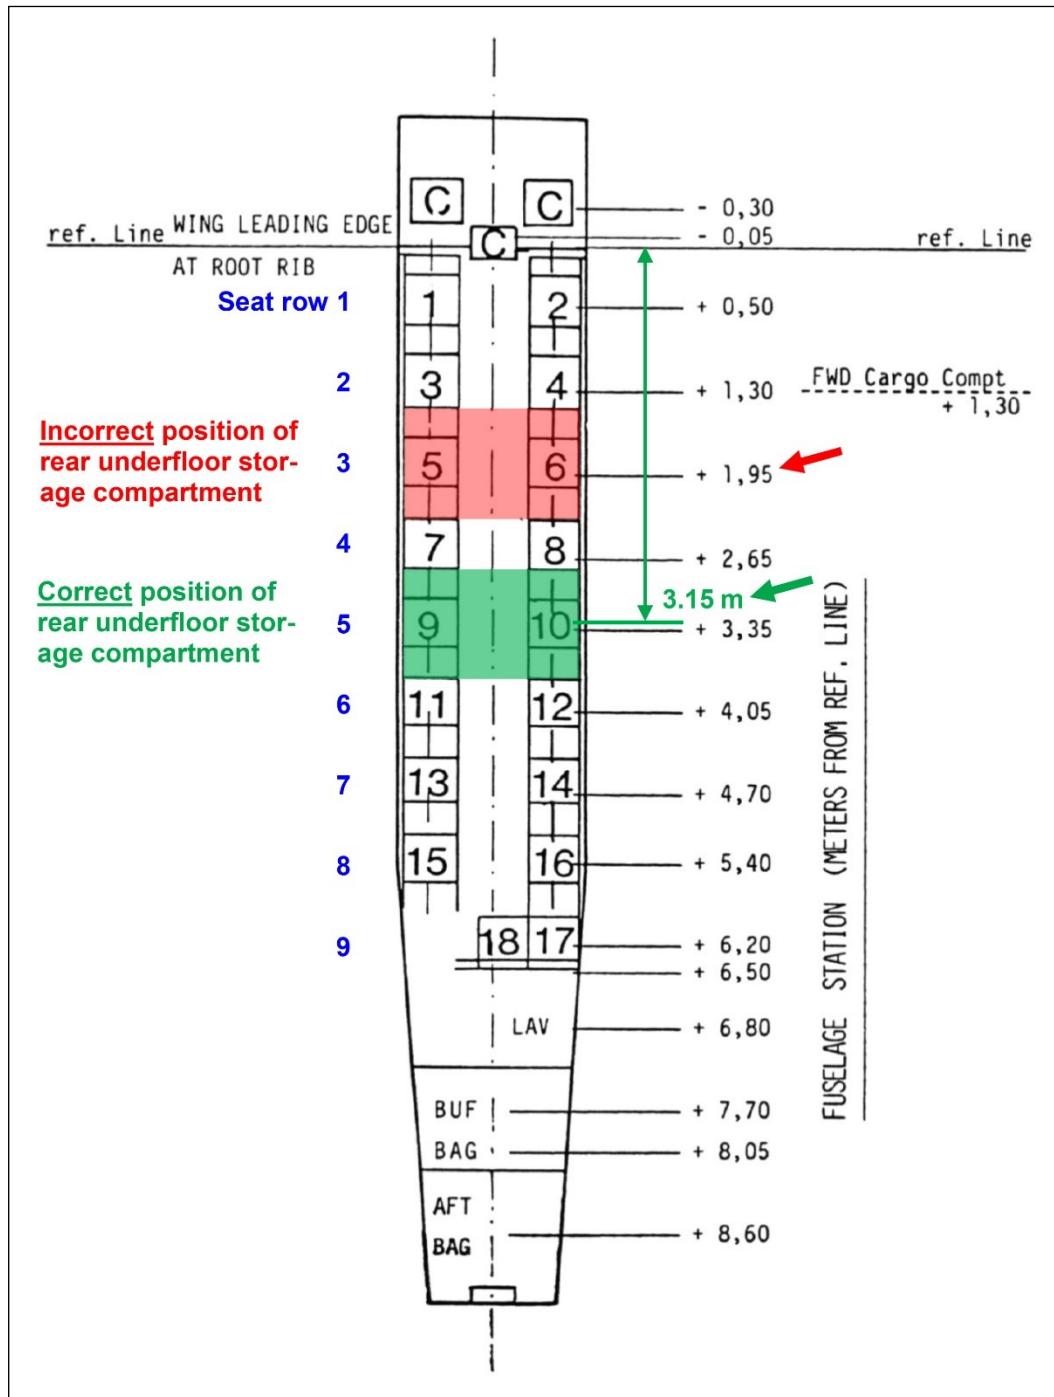
- As of no later than February 1986, the AFM included a "*Payload moment table*" which referred to the rear underfloor storage compartment²⁵ as "*cabin cargo*" with an arm value of 1.95 m. Next to this, the comment "*Same values as in PAX ROW 3*"²⁶ was added. "*PAX ROW 3*" was also listed with an arm value of 1.95 m in this table. It can be seen from the station plan in this edition of the AFM that, together, seats 5 and 6 form row 3 (see figure 3).

Re-measurements taken as part of the investigation on one of HB-HOT's sister aircraft revealed that the rear underfloor storage compartment begins 2.72 m behind the reference datum²⁷ and ends 3.58 m behind it. The centre of the rear underfloor storage compartment is therefore 3.15 m behind the reference datum. The rear underfloor storage compartment is situated approximately in line with row 5 consisting of seats 9 and 10 (see figure 3).

Figure 3: Station plan taken from the AFM from February 1986, with annotations by the STSB in blue, red and green.

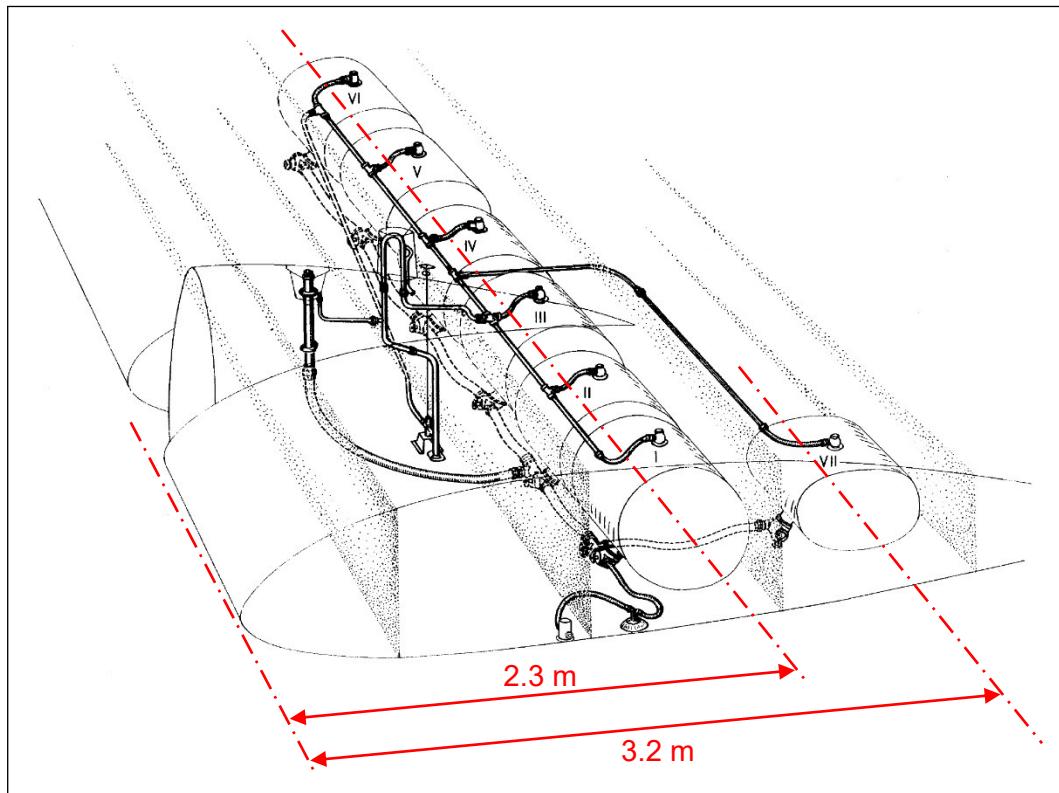
In addition, the arm values for the various fuel cells, as they have been included at various points in the AFM since 1983, were verified as part of the investigation on the sister aircraft. Both values – 2.30 m for cells 1 to 3 (I to VI) and 3.20 m for cells 4 (VII) – were correct (see figure 5).

Figure 5: Diagram showing fuel cells I to VII in the right-hand outer wing. View from the root of the wing outwards. Direction of flight to the left. Engine is not shown. The different arm values for cells I to VI (2.3 m) and VII (3.2 m) have been added in red. Source: Ju-Air AFM from 2017, dimensioning by the STSB.

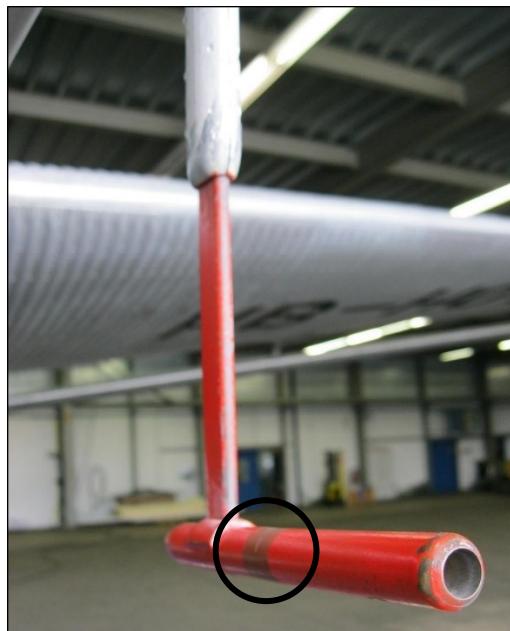
In the rearmost part of the pitot tube, the pressure line has a diameter of only 2 mm. This is where it is possible for foreign objects (dust, insects, etc.) to clog the pitot tube, which can lead to inaccurate readings on the air speed indicator.

Figure 26: Pitot tube of HB-HOT. The openings for the static pressure are circled in black.

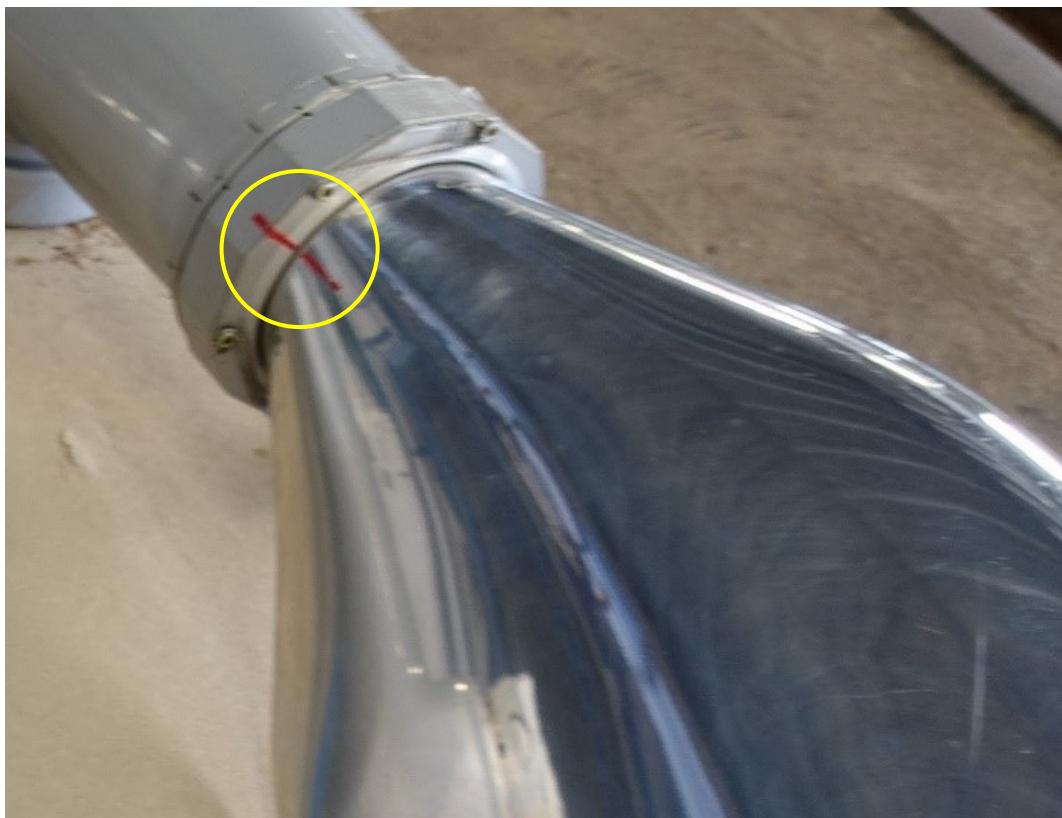
After a major overhaul, Ju-Air applied a mark (line) on each twelve-point nut and the corresponding propeller blade using red nail polish (see figure 37). This marking was intended to aid in the detection of a loose or twisted propeller blade.

Figure 37: Red marking on the twelve-point nut and propeller blade (yellow circle).

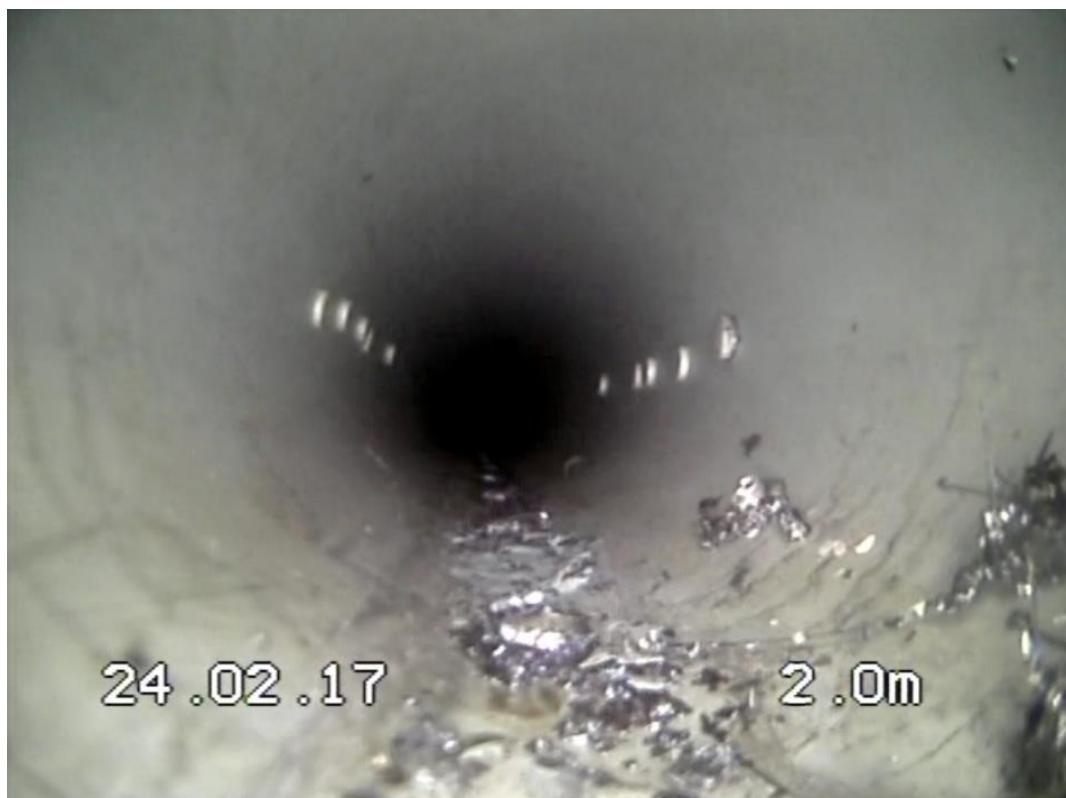
Figure 42: Right-hand outer wing, lower spar IV with swarf. Photograph provided by Ju-Air.
