A1. Factual information

A1.1 Background and course of the accident flight

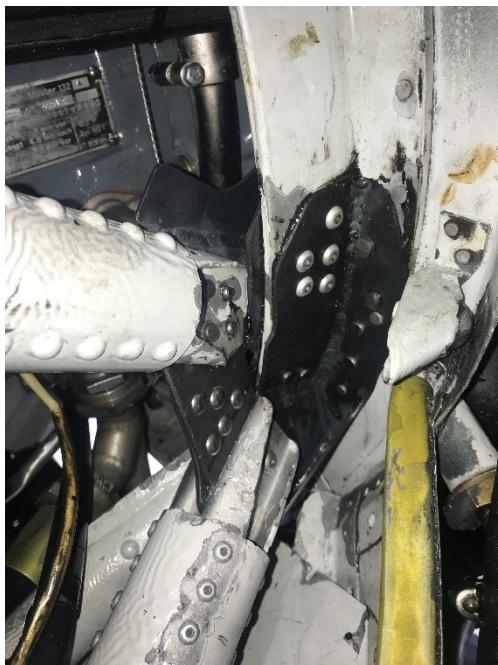
During a progressive inspection of HB-HOT's centre engine at the end of May 2018, approximately two months before the accident, a crack was detected on the engine frame in the lower-right mounting frame attachment (gusset plates) (see figure 45). To allow the repair to be carried out with the engine frame in place, the corner tube between the engine mount and the firewall was cut through (see figure 46). The cracked gusset plate was replaced by a remanufactured part, welded aluminium sheets with subsequent heat treatment (see figure 47). The severed corner tube was reattached using a doubler consisting of two manufactured U-shaped wraps. Corrosion protection was not applied (see figure 48). The repair was carried out by Kaelin Aero Technologies GmbH. According to the work report, the repair was carried out based on the "*Reparaturanweisung Ju 52/3m*" (Ju 52/3m repair instructions').

Figure 47: Remanufactured and assembled plate. Photograph provided by Ju-Air.

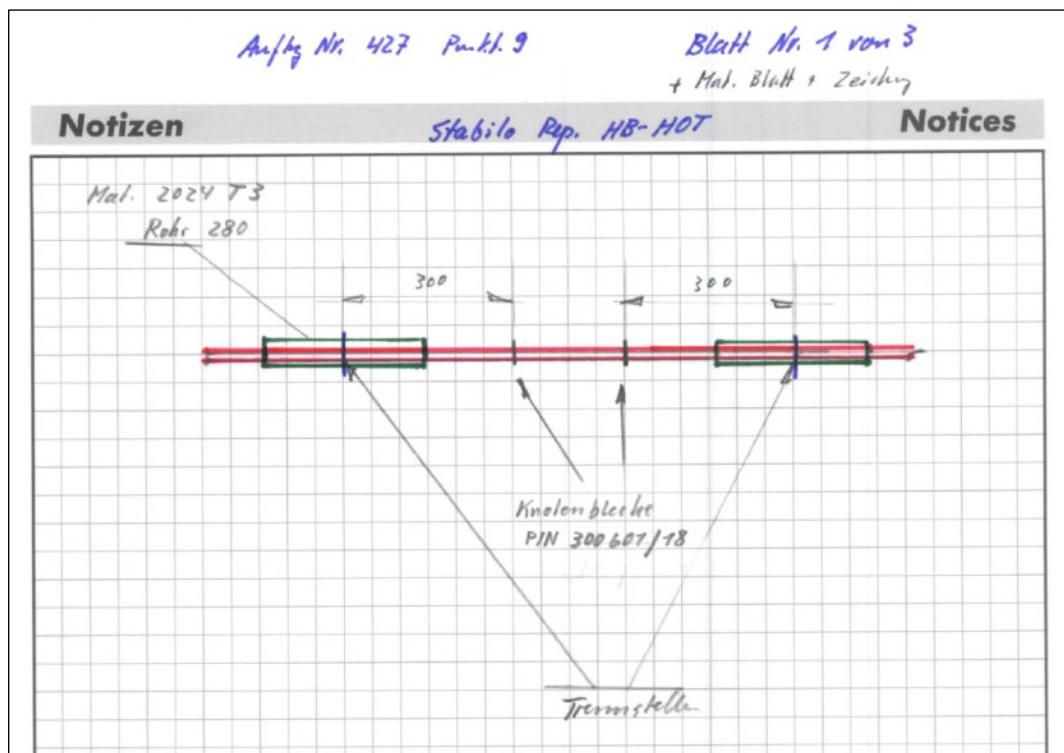
This repair was carried out using a hand-drawn sketch only (see figure 55) and no work report could be found in the technical files, only a complaint sheet with minimal description of the work carried out (see figure 56).

Figure 55: Repair work based on this hand-drawn sketch. Source: Technical records HB-HOT.

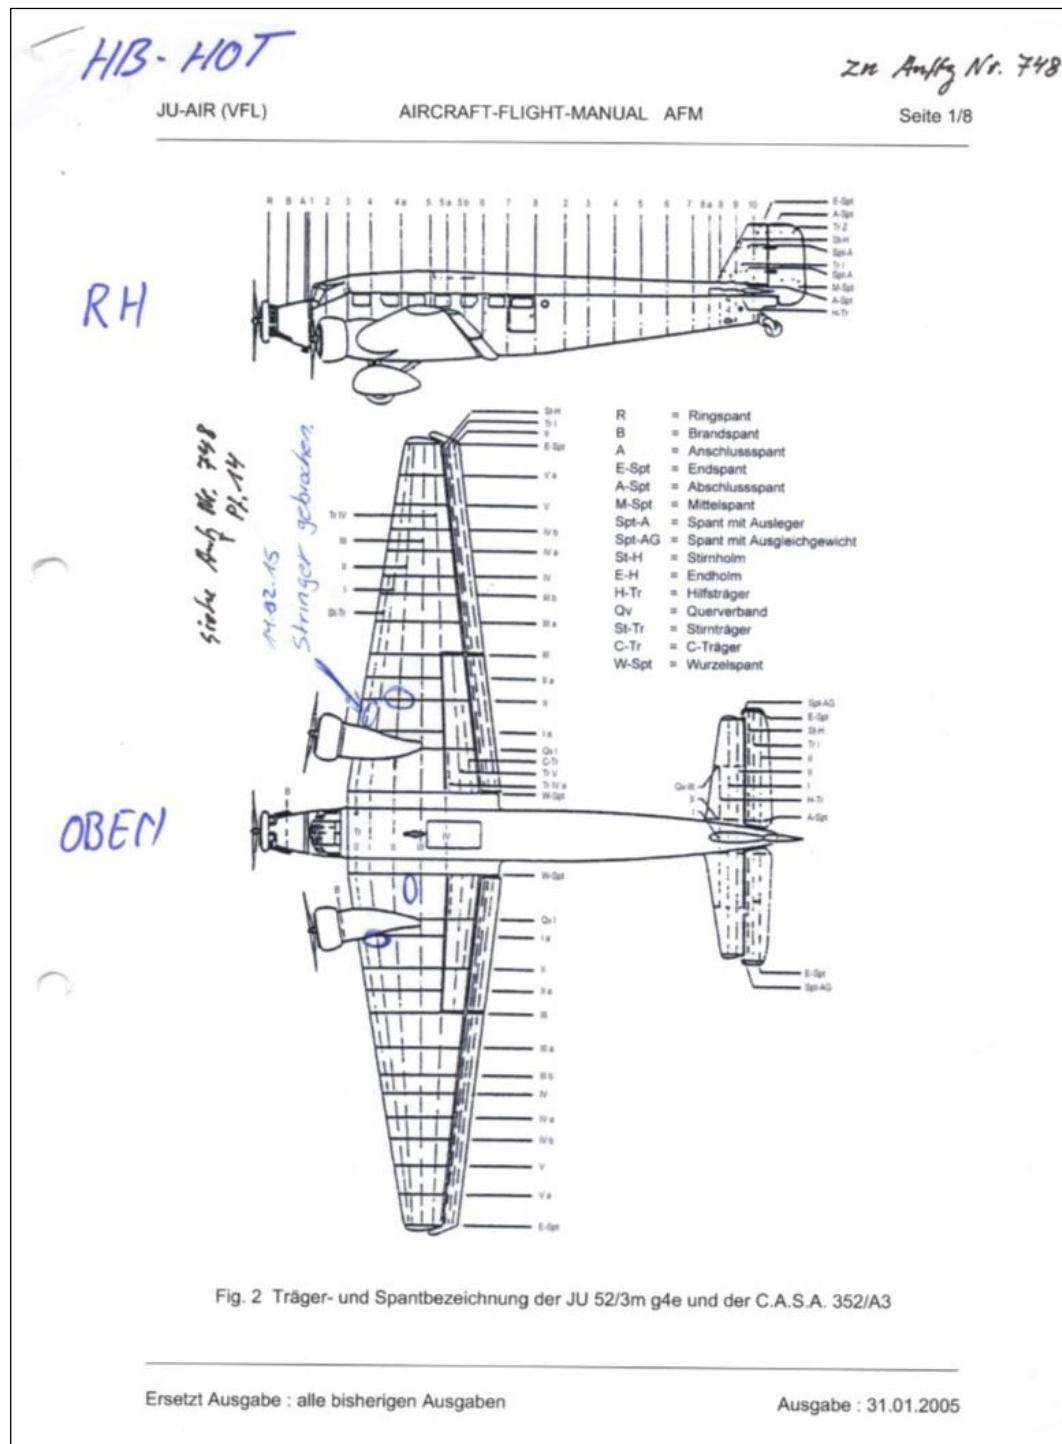
In December 2015, a broken stringer was found on the right-hand outer wing during maintenance work (see figure 57). The findings were recorded, but no repair was ever carried out.

Figure 57: Ju-Air document where the broken stringer is noted. Names of persons and signatures removed by the STSB. Source: Technical records HB-HOT.

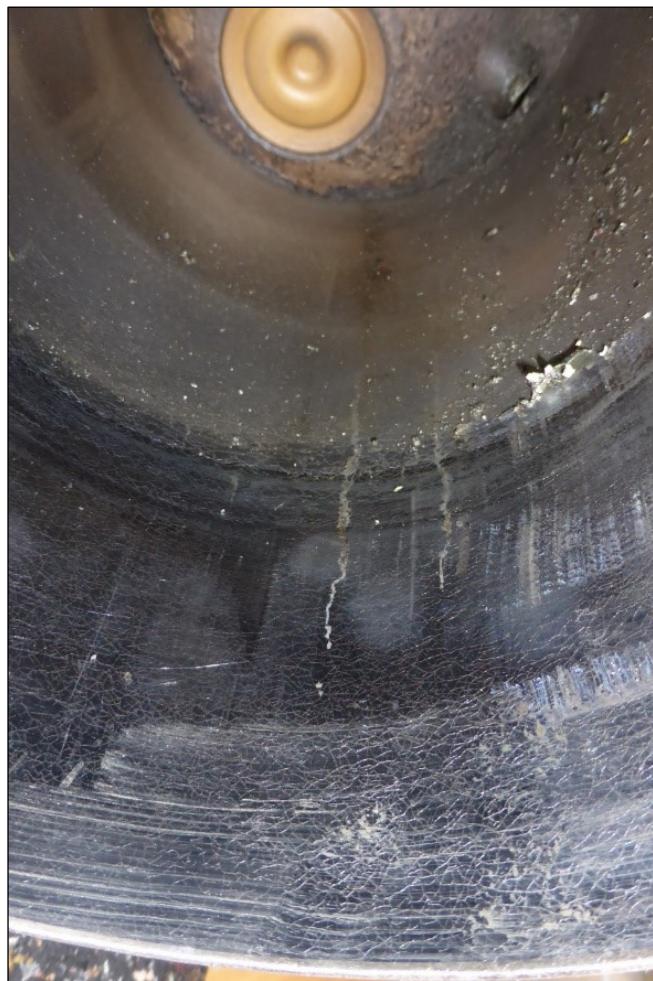
In 2015 and 2017, a company in Switzerland plated a further 20 cylinders for Ju-Air. This company's method of plating cylinders is a process in which the powder is injected into a hot plasma, where it melts and is accelerated before then being applied to the surface to be coated. There was neither a SB for this procedure nor was it approved by FOCA. Naef Flugmotoren AG issued a release certificate for each of the cylinders reconditioned using this method. Cylinders with chrome-plated and plasma-coated bores were installed in HB-HOT's engines.

Figure 59: Example of a chrome-plated cylinder bore. The crack network typical for this method is clearly visible.

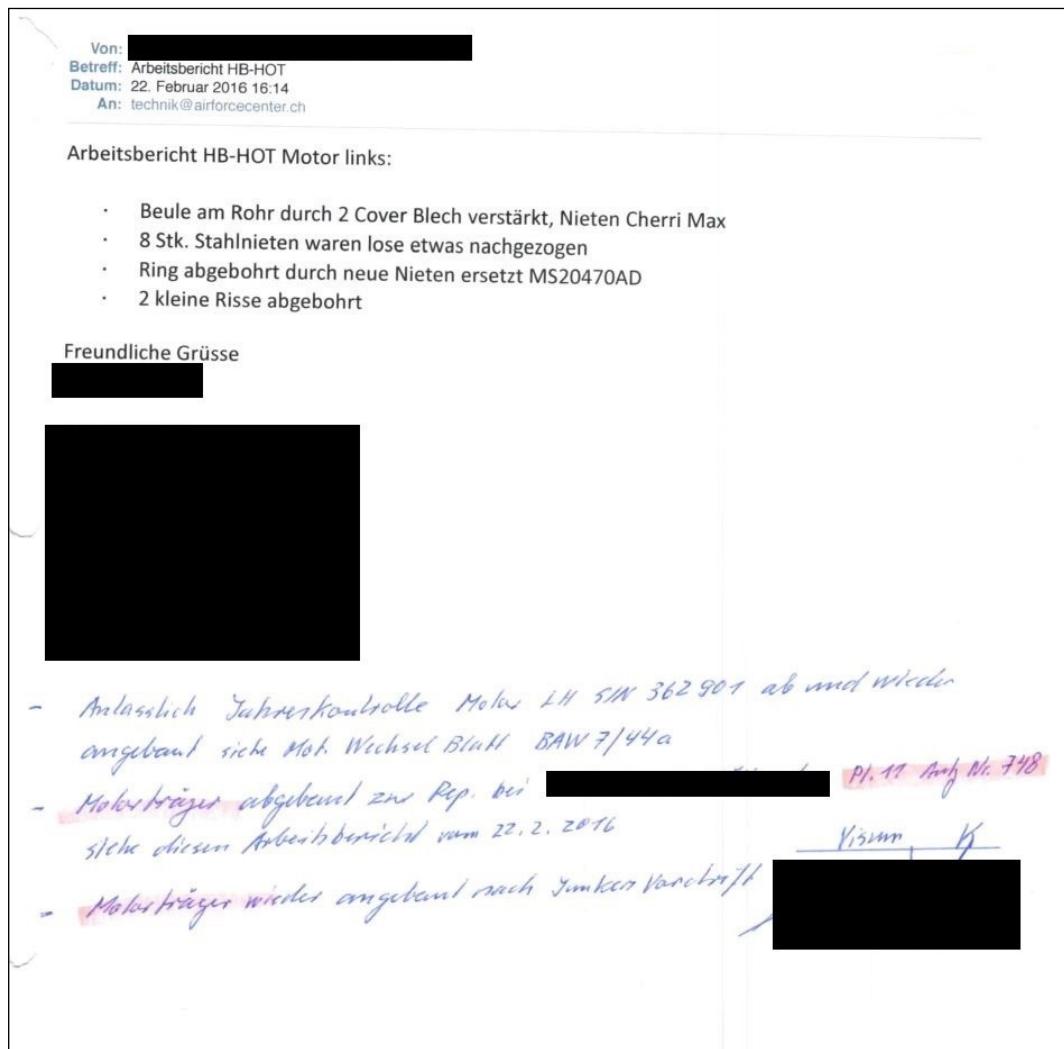
Figure 61: Work report by the Ju-Air subcontractor for item 11, complaint sheet no. 3 dated 20 October 2015. Names, signatures and subcontractors have been redacted by the STSB.

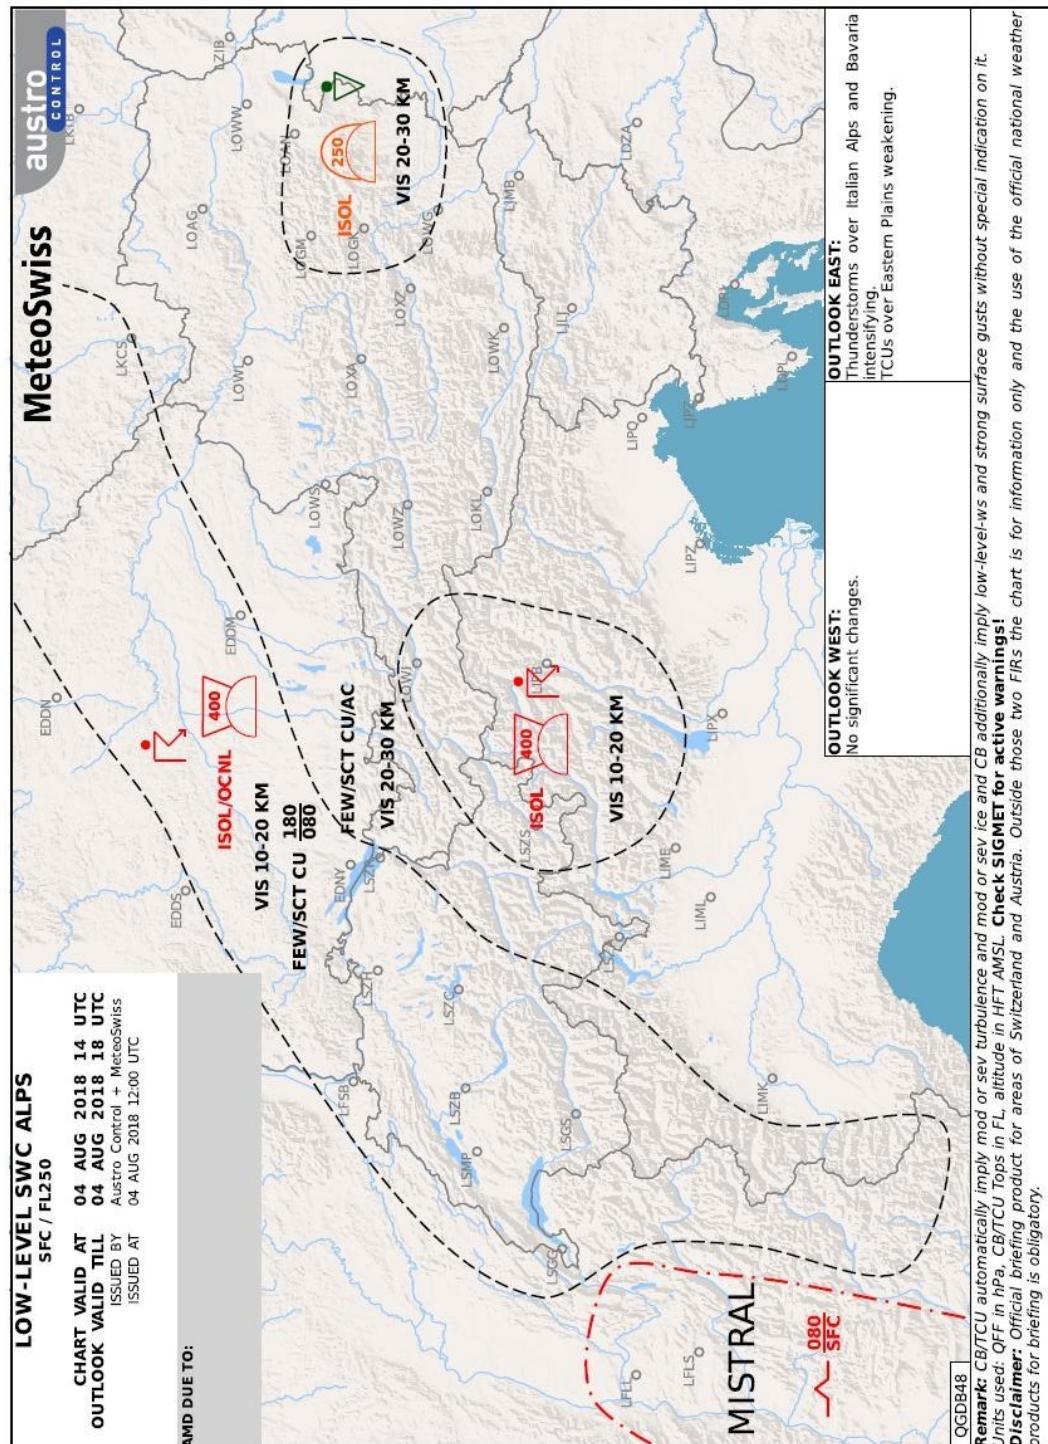
Figure 1: This LOW-LEVEL SWC ALPS was issued at 14:00 LT and was valid for 16:00 to 20:00 LT. The symbols are explained in the document from MeteoSwiss¹². For south-western Switzerland, isolated showers and thunderstorms are shown with good visibility. Similarly, but only occasionally, this was indicated for the western region which included the destination airfield Dübendorf (south of LSZH).

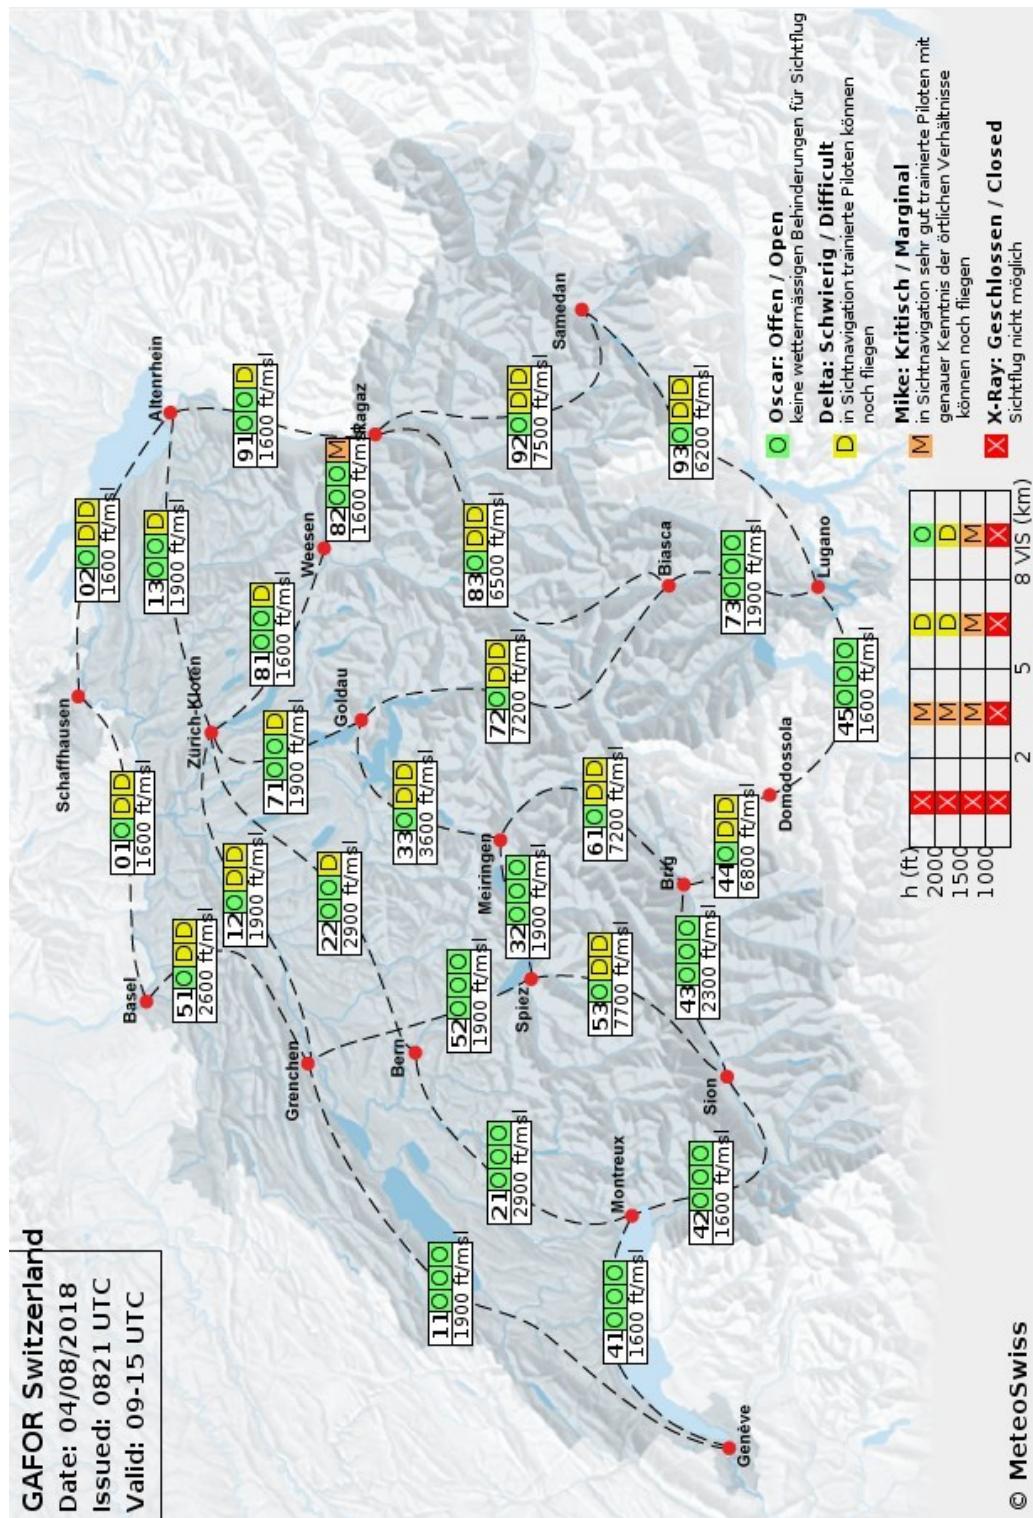
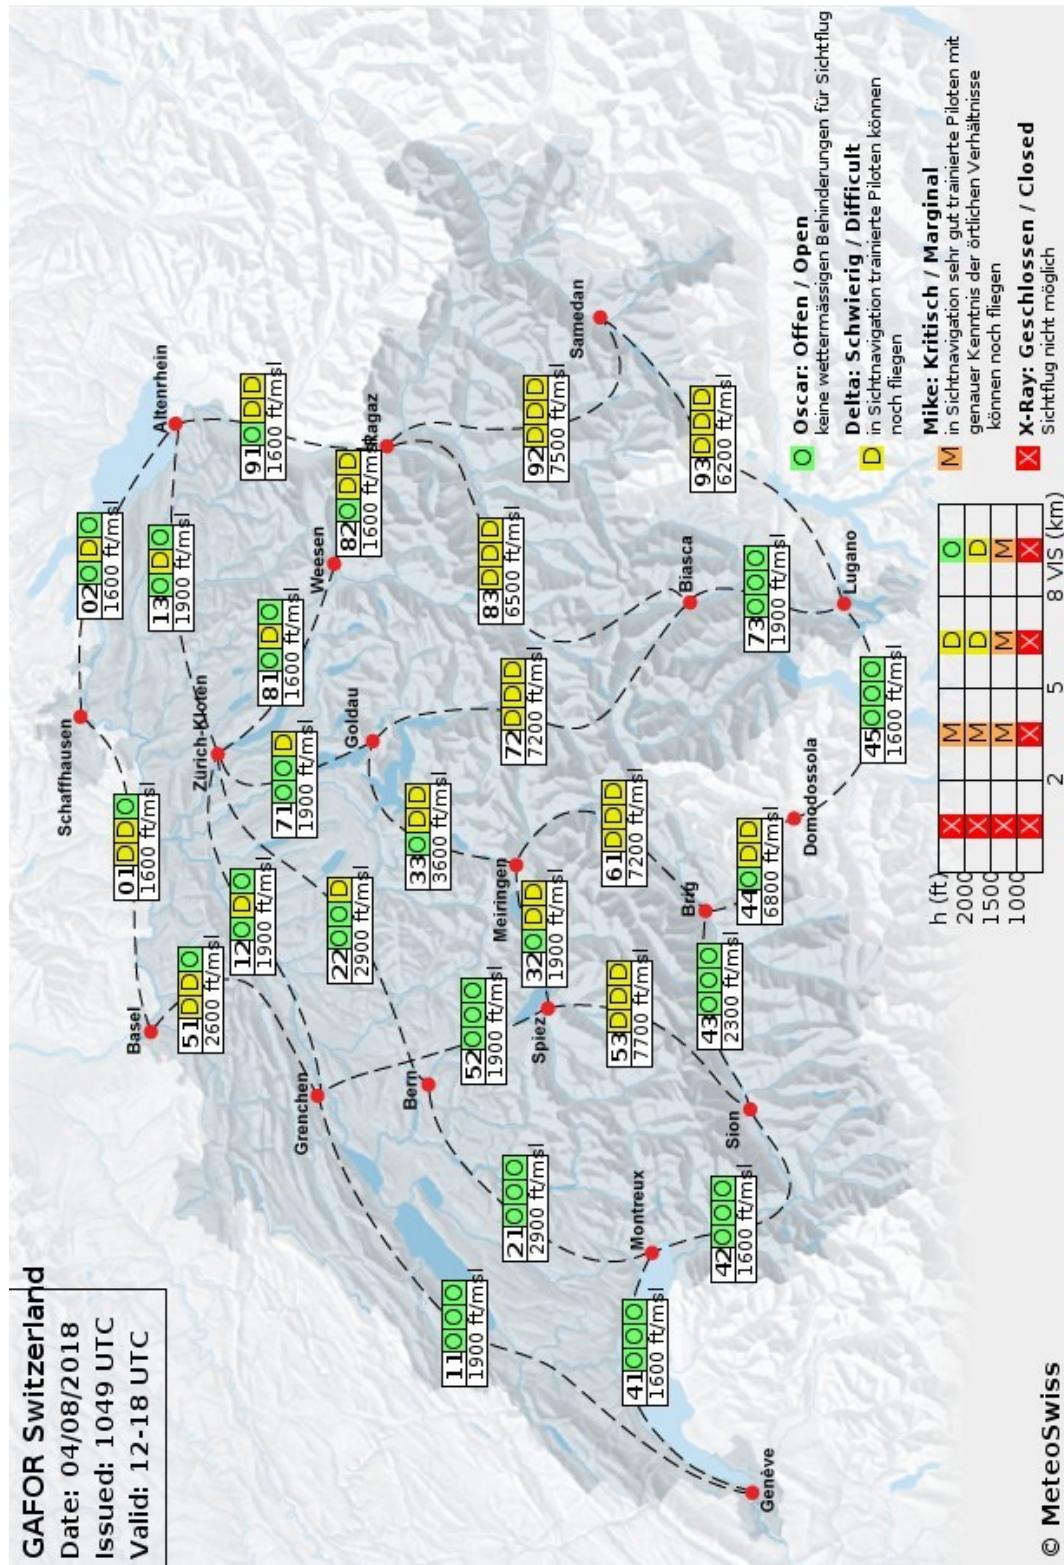
Figure 2a: The GAFOR charts for 11:00 to 17:00 LT (this page) and for 14:00 to 20:00 LT (next page) are not showing any closed routes. With the second GAFOR of the day (next page), there were also no marginal routes left. The route crossing the Segnes pass is between the routes no. 72 and 83. Each character in the boxes denotes two hours within the six-hour periods of the two GAFOR charts. The elevations indicated as 'ft/msl' are reference altitudes in ft AMSL for those routes (e.g. elevations of passes). The classifications O/D/M/X are explained on the bottom right of the chart. Continued in figure 2b.

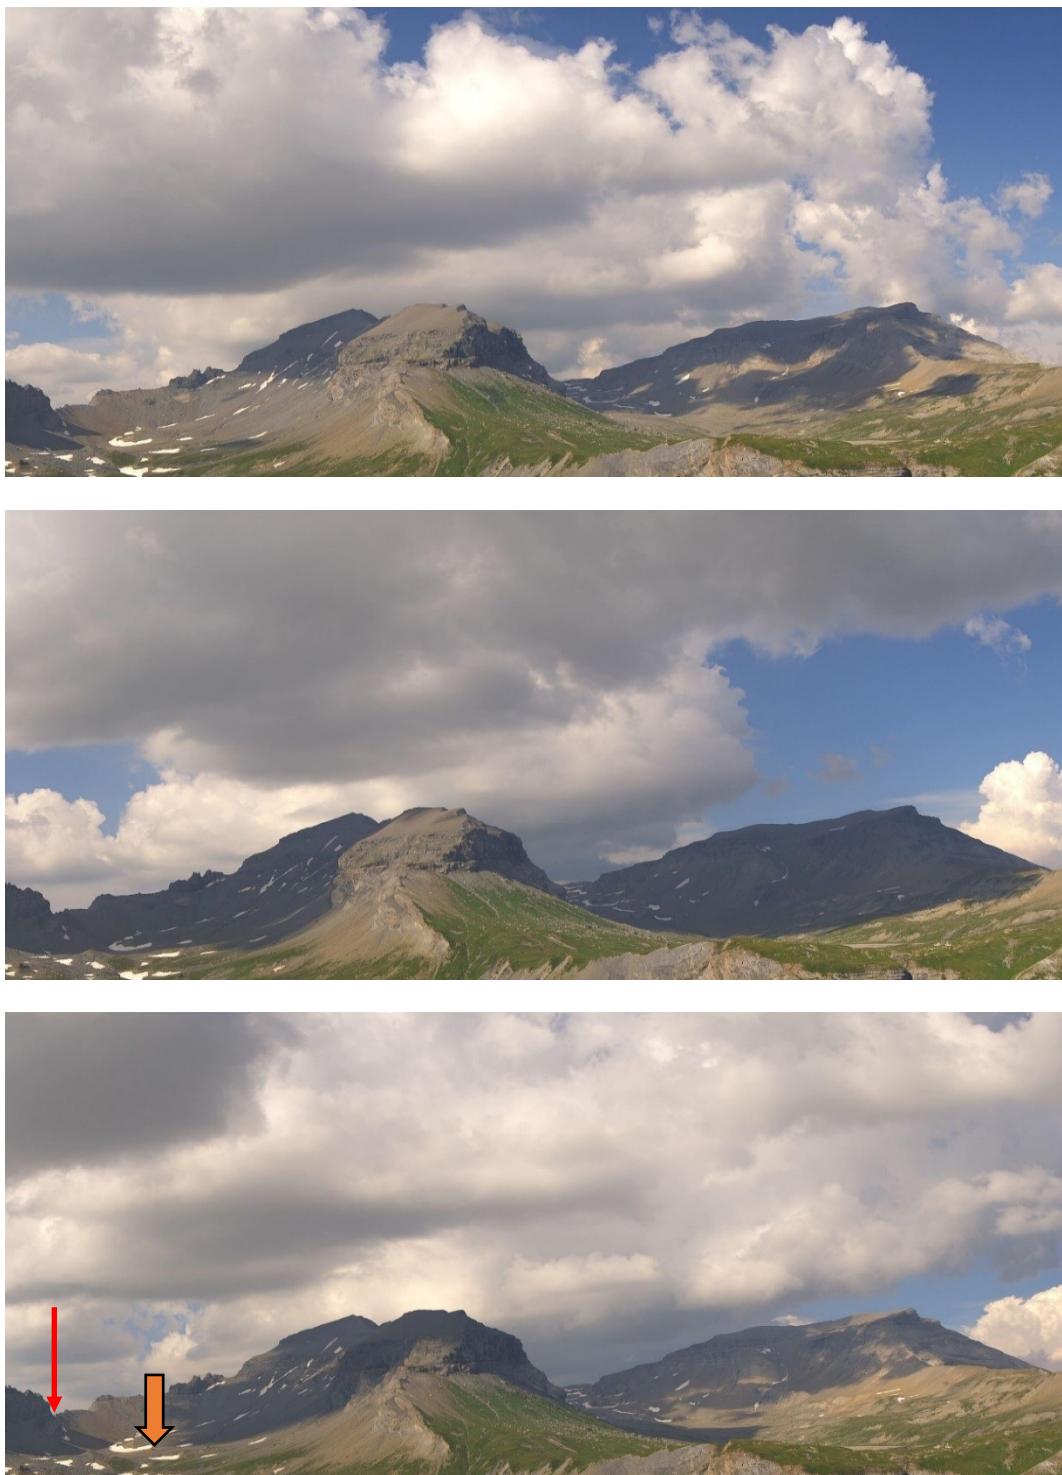
Figure 3: Three frames of the webcam on Mutta Rodunda¹³ (see map in figure 4) viewing towards the north 17 minutes before the accident (16:40 LT, top frame) until three minutes after (17:00 LT, bottom frame). The orange pointer is marking the site of the accident, where the wreckage is faintly visible on the original image. The Segnes pass is marked by the red pointer. Left of the centre of the image is Piz Segnas with Atlas in front. On the right is the Trinserhorn (Piz Dolf) mountain (see map below).

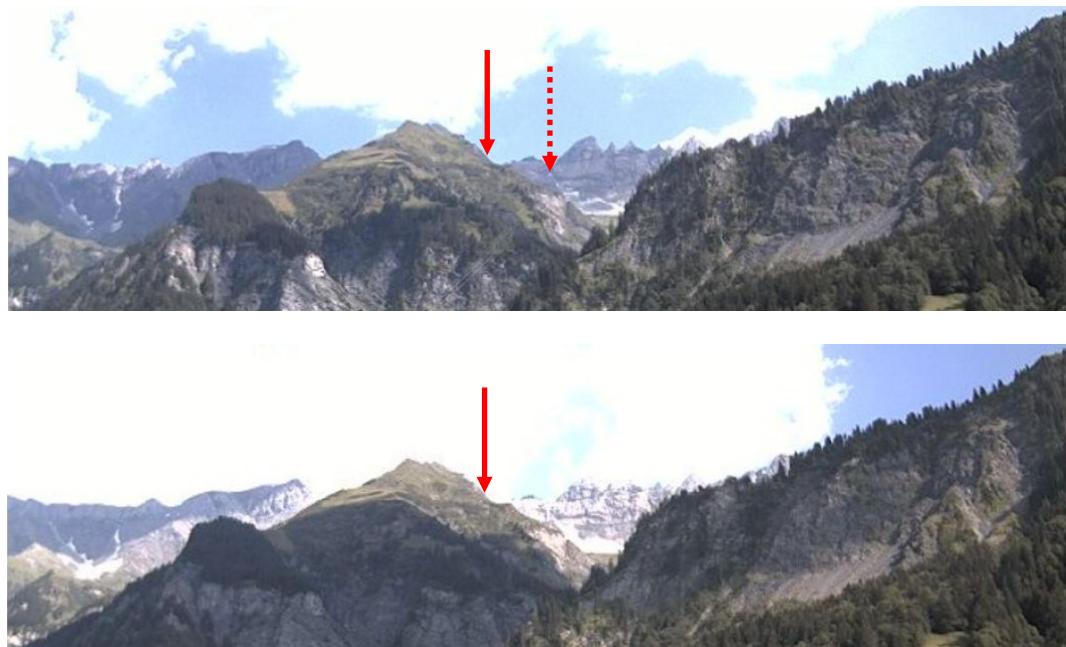
Figure 5: Two frames from the webcam in Elm around 16:00 LT (top frame) and at about 17:00 LT (bottom). The Segnes pass is within the ridge in the background, almost hidden by the mountain in front of it (solid red pointer). The prominent mountain peak just right of the centre of the images is the Grosses Tschingelhorn. The Martinsloch (dotted pointer) is visible on the webcam when the light is favourable. The site of the accident is behind the ridge between the Martinsloch and the Segnes pass. Based on the hourly imagery of this webcam, it can be concluded that the route from the Segnes pass to Elm was free of clouds during the afternoon, at least at the times of the images.

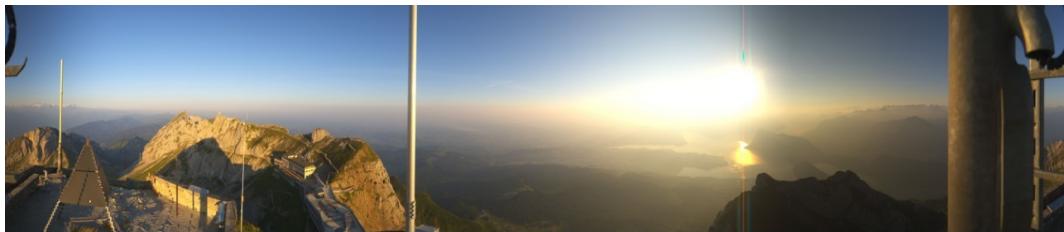
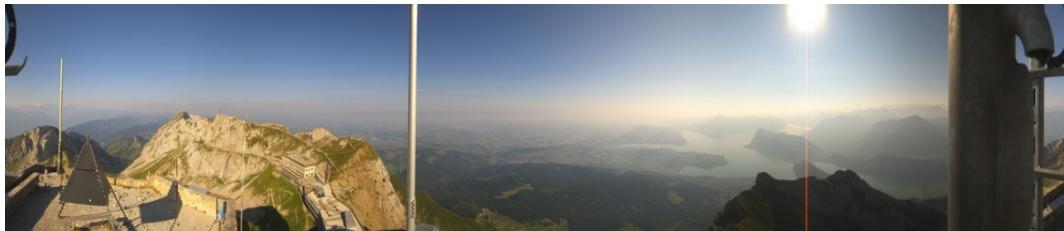
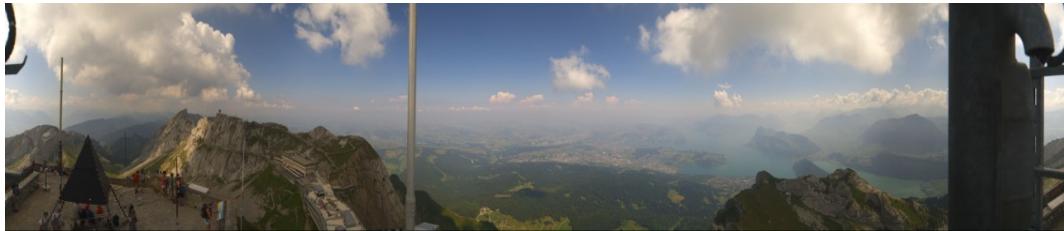
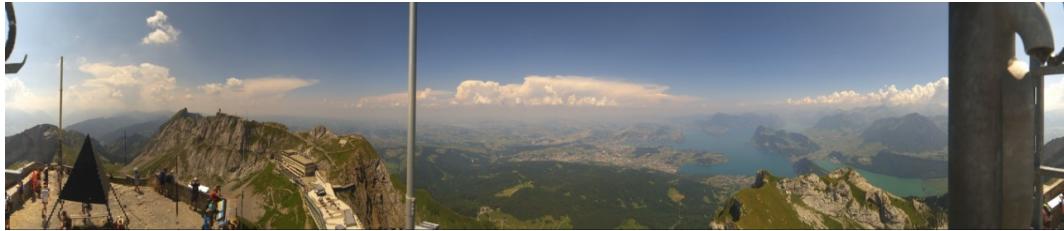
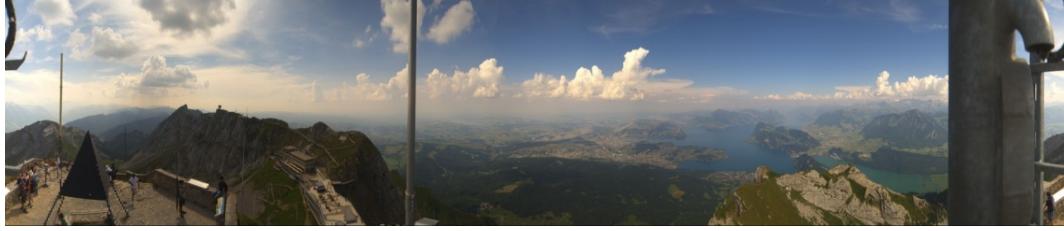
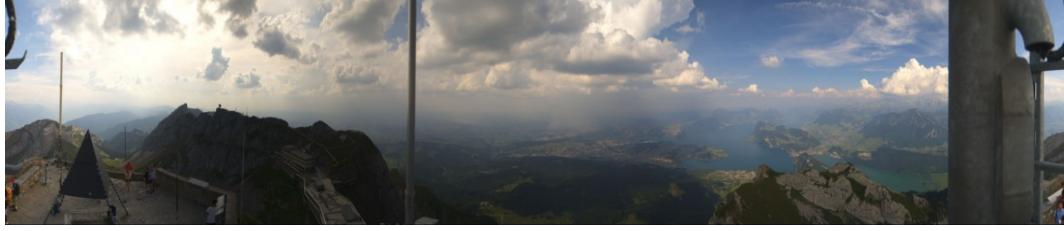
Figure 6: Roundshot webcam on Mount Pilatus¹⁴ on 4 August 2018 between 07:00 and 17:00 LT. The images show the cloud development during the day in the wider Alpine area. The thin pole left of the centre roughly marks the north, whereas the south is behind the thick pole, i.e. the southern sector is split between the two edges of the images.

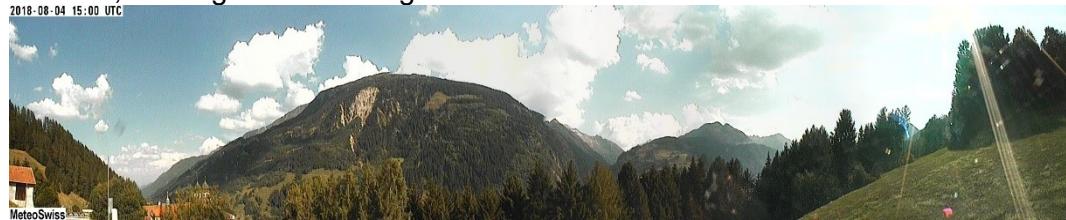
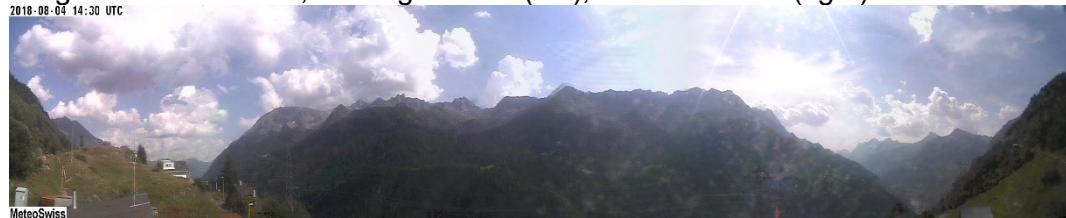
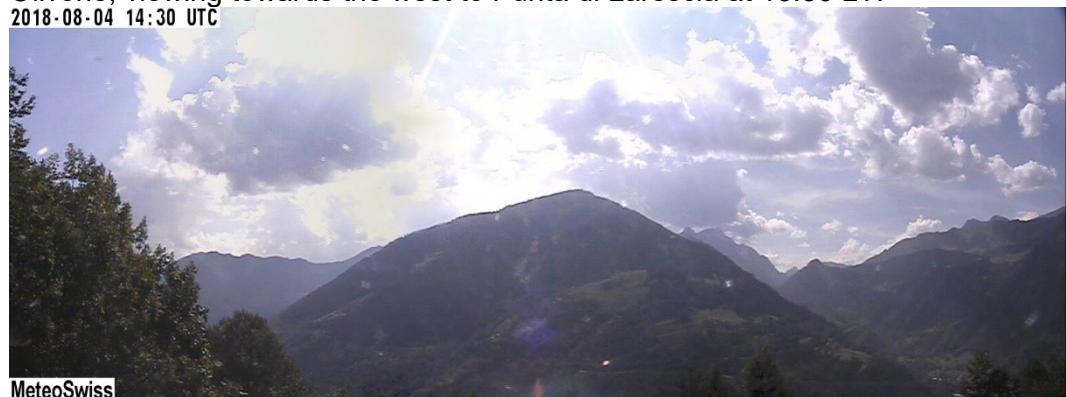
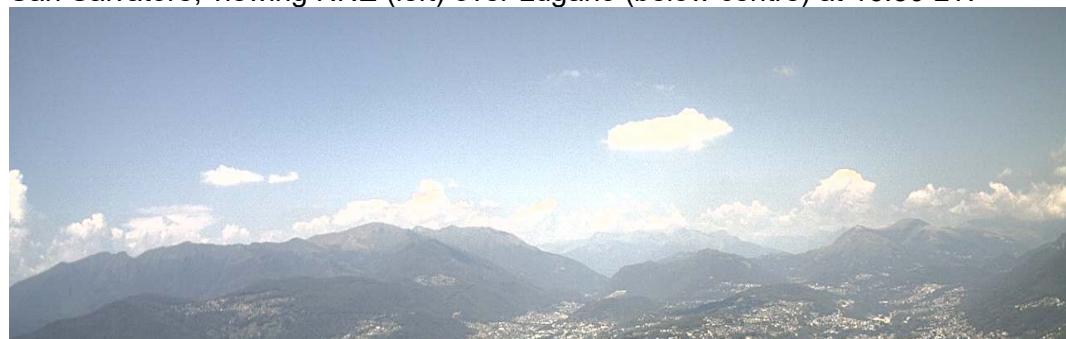
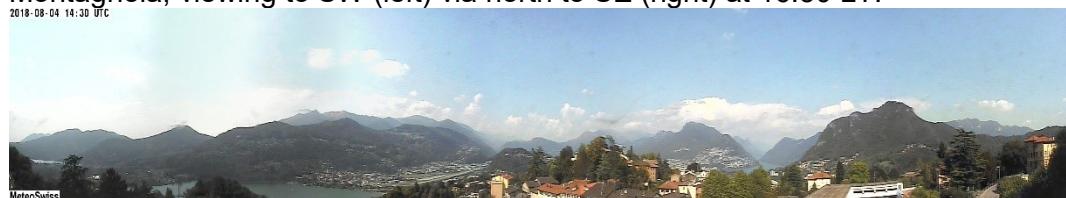
Figure 7: Webcams on the south side of the Alps at 16:30 LT, and from Disentis in the Rhine Valley at 17:00 LT. This large collection of images is archived every 10 minutes by the Federal Office of Meteorology and Climatology.

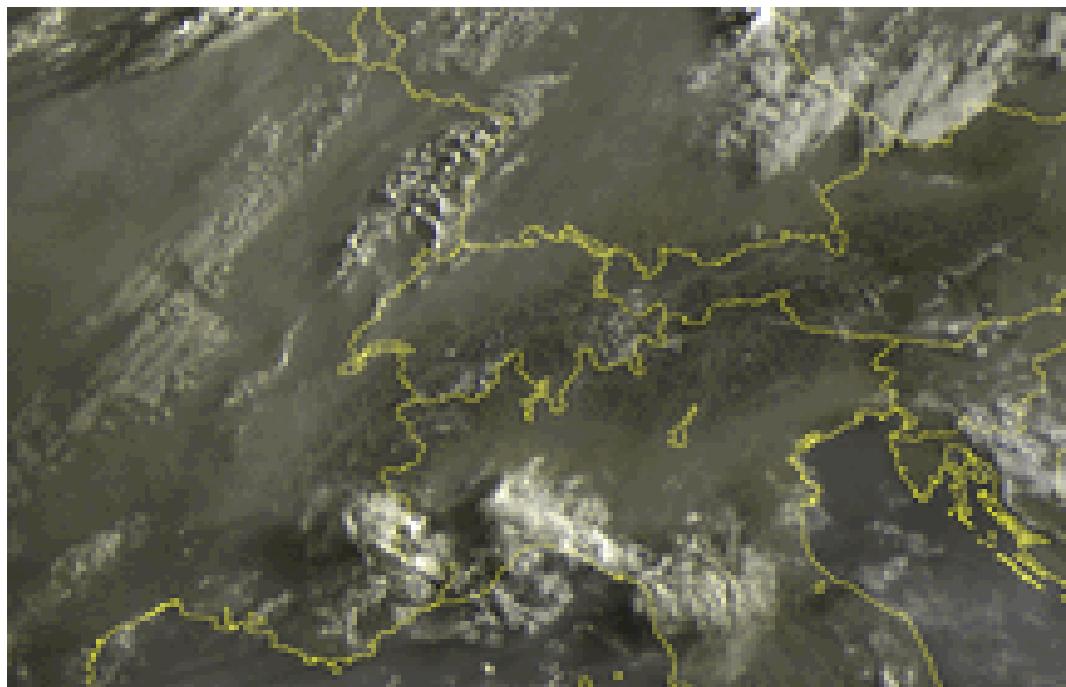
Figure 8: The (visible) satellite image from the geostationary satellite operated by EUMETSAT¹⁵ shows haze over the Swiss Plateau (between Lake Geneva and Lake Constance). No clouds are visible over the Alps.

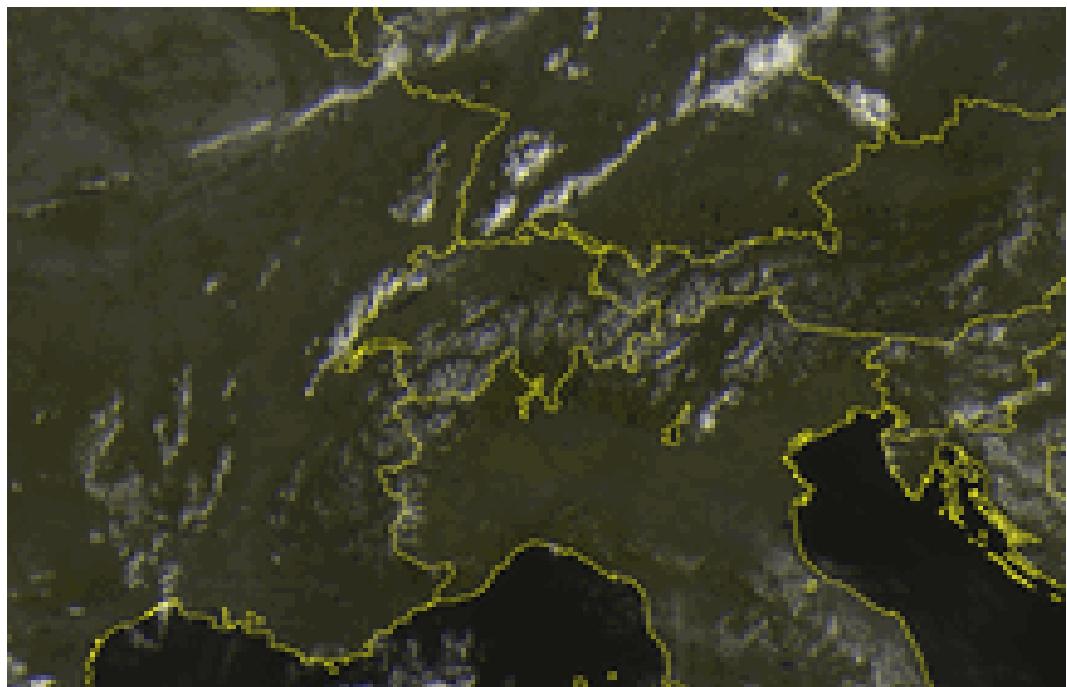
Figure 9: A first convective activity with cumulus clouds over the Jura mountains and north of Switzerland over the Vosges mountains, the Black Forest and the Swabian Alps is visible at 12:00 LT. The small cumulus clouds over the Alps (see figure 6) are not yet discernible due to this coarse resolution.

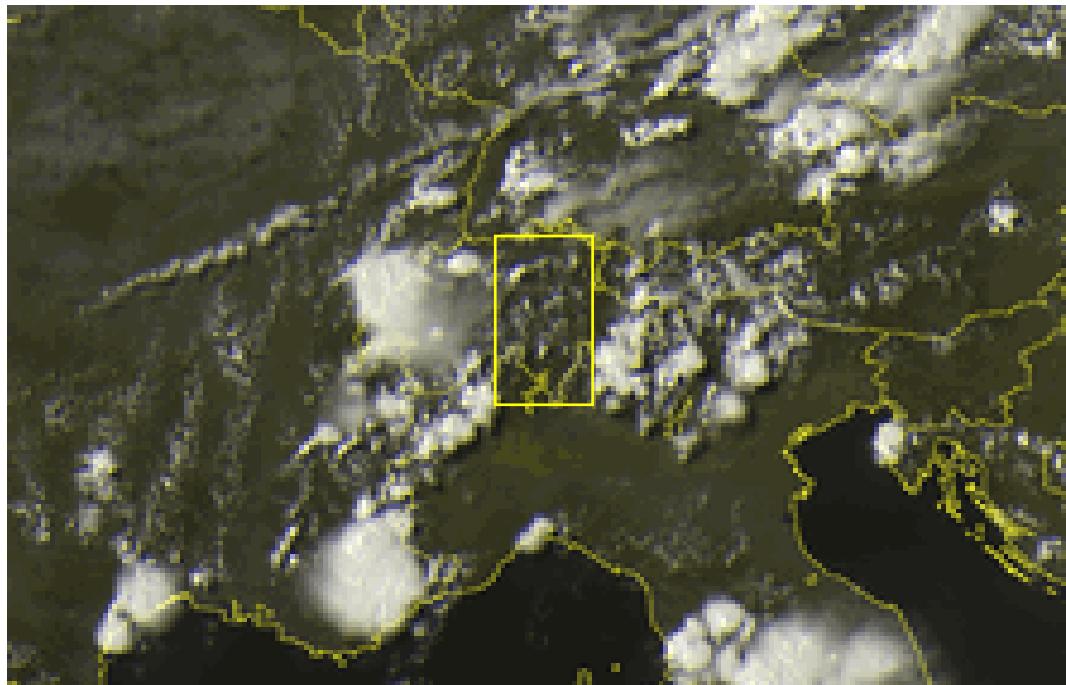
Figure 10: At 17:00 LT, convective areas with CBs had developed west and south-east of the region of interest (yellow rectangle between Ticino and northern Switzerland). Within this zone, around the planned flight, only a few CUs and possible TCUs, but no CBs are visible at the time of the accident.

The corresponding satellite images were screened for the day before, when HB-HOT was flown from Dübendorf in the north to Ticino in the south. This comparison shows a similar beginning to the day, with less convection in the afternoon. For both days, the infrared images showing cloud top altitudes were inspected. They confirm the finding from above in figure 10: there were no CBs in the vicinity of the planned flight.

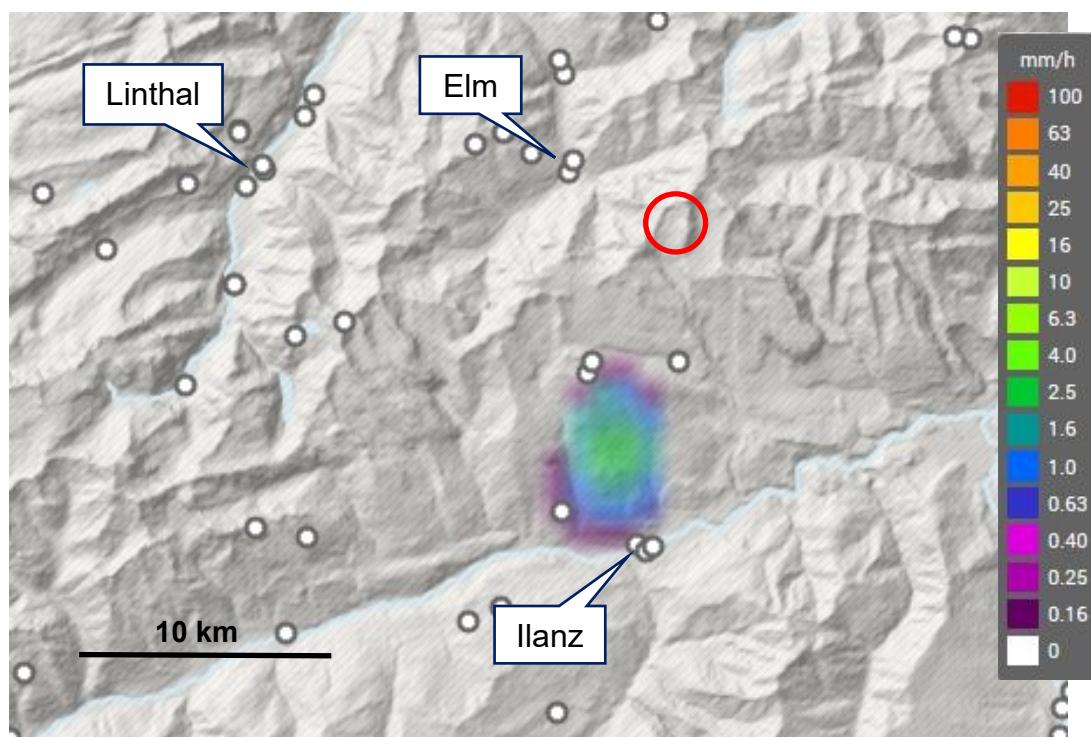
The radar images were generated and archived every two to three minutes, i.e. the temporal resolution is quite high. First echoes on the day and in the region of the accident were visible between 12:40 LT and 13:00 LT near Ilanz. Figure 11 shows the peak activity of this weak shower with only 2 mm/h.

Figure 11: Precipitation radar image at 12:50 LT. The accident happened within the red circle. The small white circles mark the location of surface weather stations. See text below for more information. Source: Federal Office of Meteorology and Climatology, MeteoSwiss, via GIN archive¹⁸.

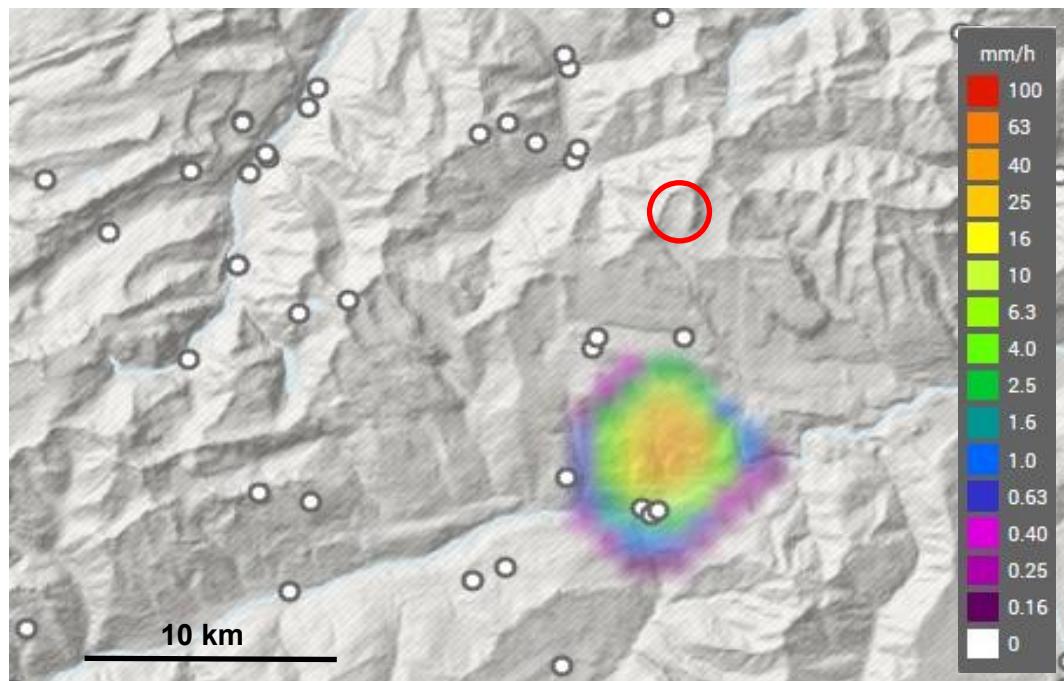
Figure 12: Precipitation radar image at 14:30 LT. The accident happened within the red circle. The small white circles mark the location of surface weather stations. See text below for more information. Source: Federal Office of Meteorology and Climatology, via GIN archive.

Between 13:50 LT and 15:00 LT, stronger precipitation with up to 25 mm/h was detected near Ilanz, in the vicinity of the later flight. The radar image in figure 12 shows the maximum intensity (orange) during that period at 14:30 LT. This shower is also clearly visible on the webcam between 14:20 LT and 14:40 LT. Figure 13

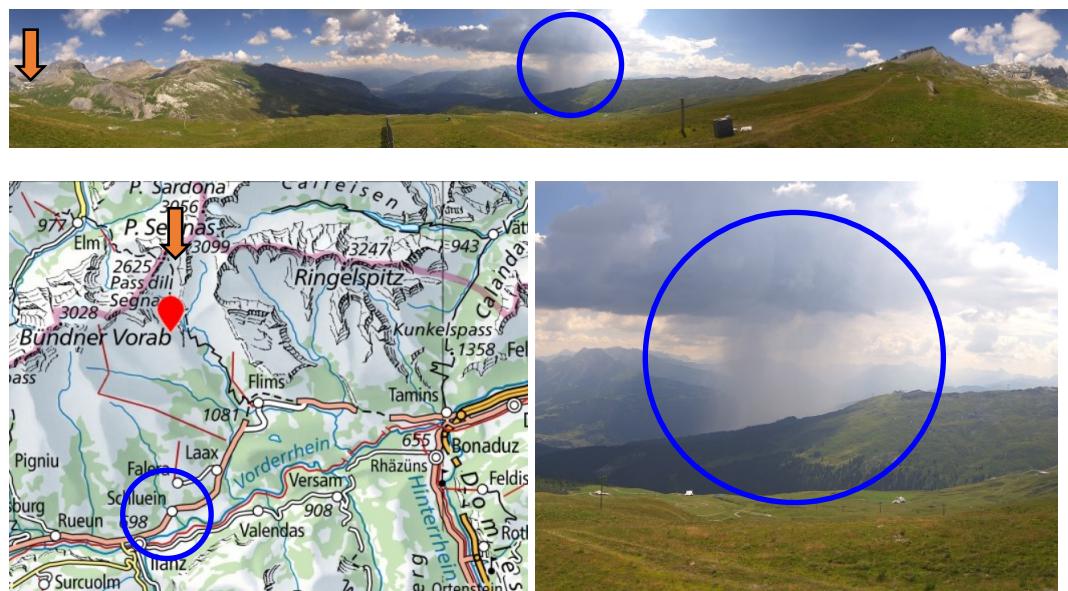
Figure 13: The shower at 14:30 near Ilanz as seen by the webcam at Mutta Rodunda¹⁹ (red placemark on the map). The site of the accident is marked by the orange pointer on the image and on the map. The core of the shower (see figure 12) is marked by the blue circle. Source of the map: Federal Office of Topography.

shows the shower at the same time that the radar image in figure 12 was generated. This demonstrates the isolated nature of the shower that was generating the prominent radar echo. The visibility outside of the shower remained excellent.

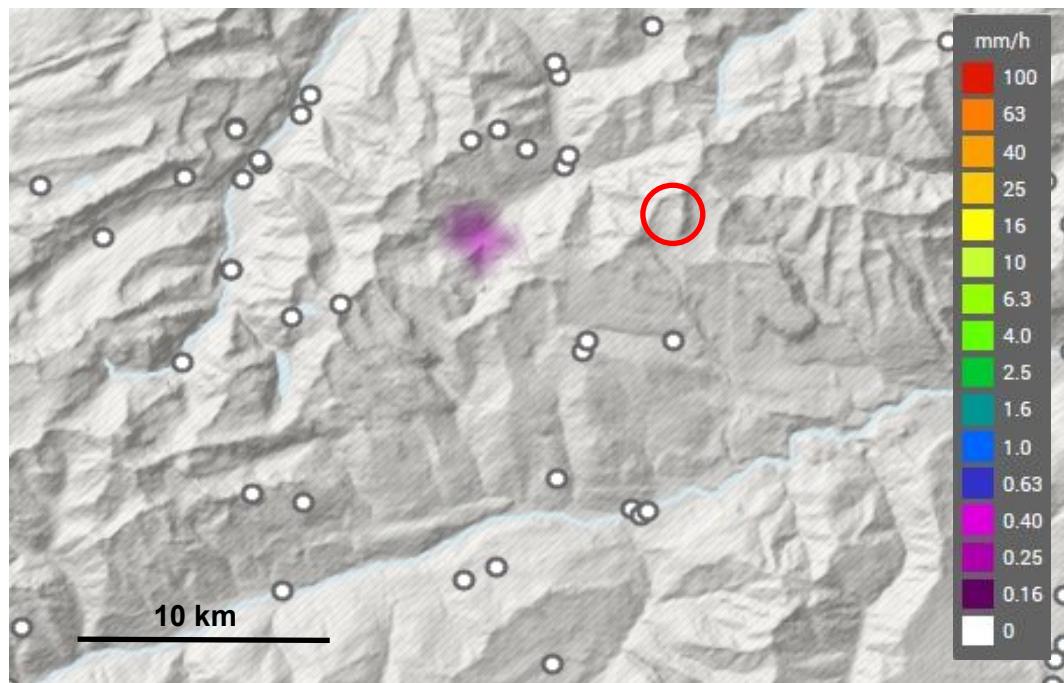
Figure 14: Precipitation radar image at 16:35 LT. The accident happened within the red circle. The small white circles mark the location of surface weather stations. See text below for more information. Source: Federal Office of Meteorology and Climatology, MeteoSwiss, via GIN archive.

Shortly before and at the time of the accident, two weak showers of rain were detected 7 km west, and 15 to 20 km west of the Segnes pass (figures 14 and 15). Both showers were not visible by the webcam because they were behind the crest. However, only TCUs but no CBs are visible above.

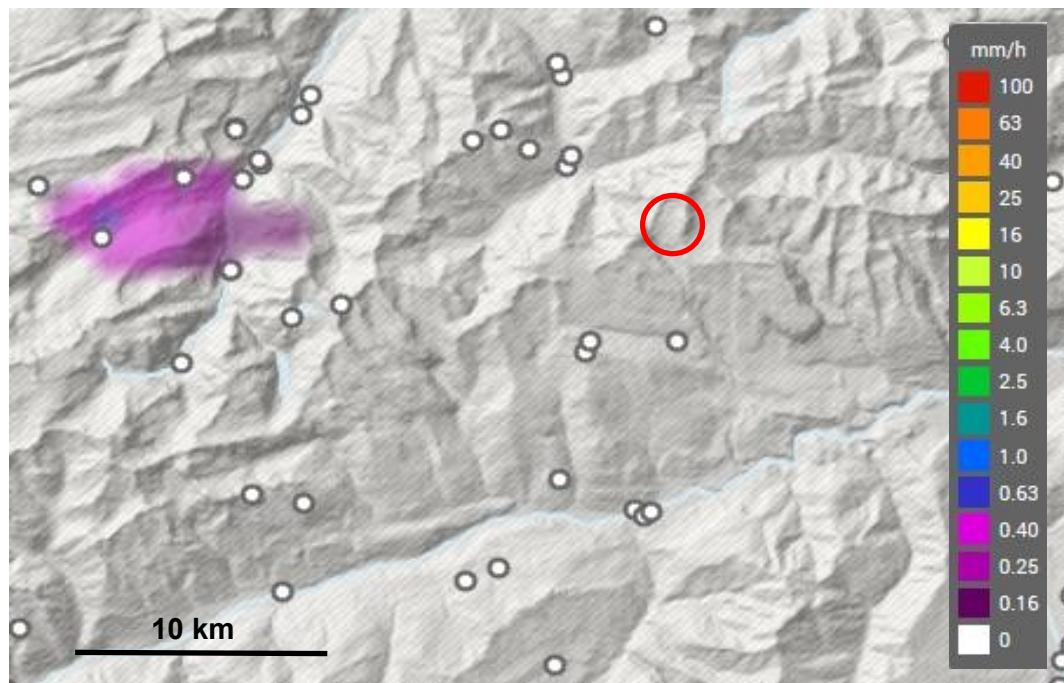
Figure 15: Precipitation radar image at 16:55 LT. The accident happened within the red circle. The small white circles mark the location of surface weather stations. See text below for more information. Source: Federal Office of Meteorology and Climatology, via GIN archive.
