A1. Factual information

A1.1 Background and course of the accident flight

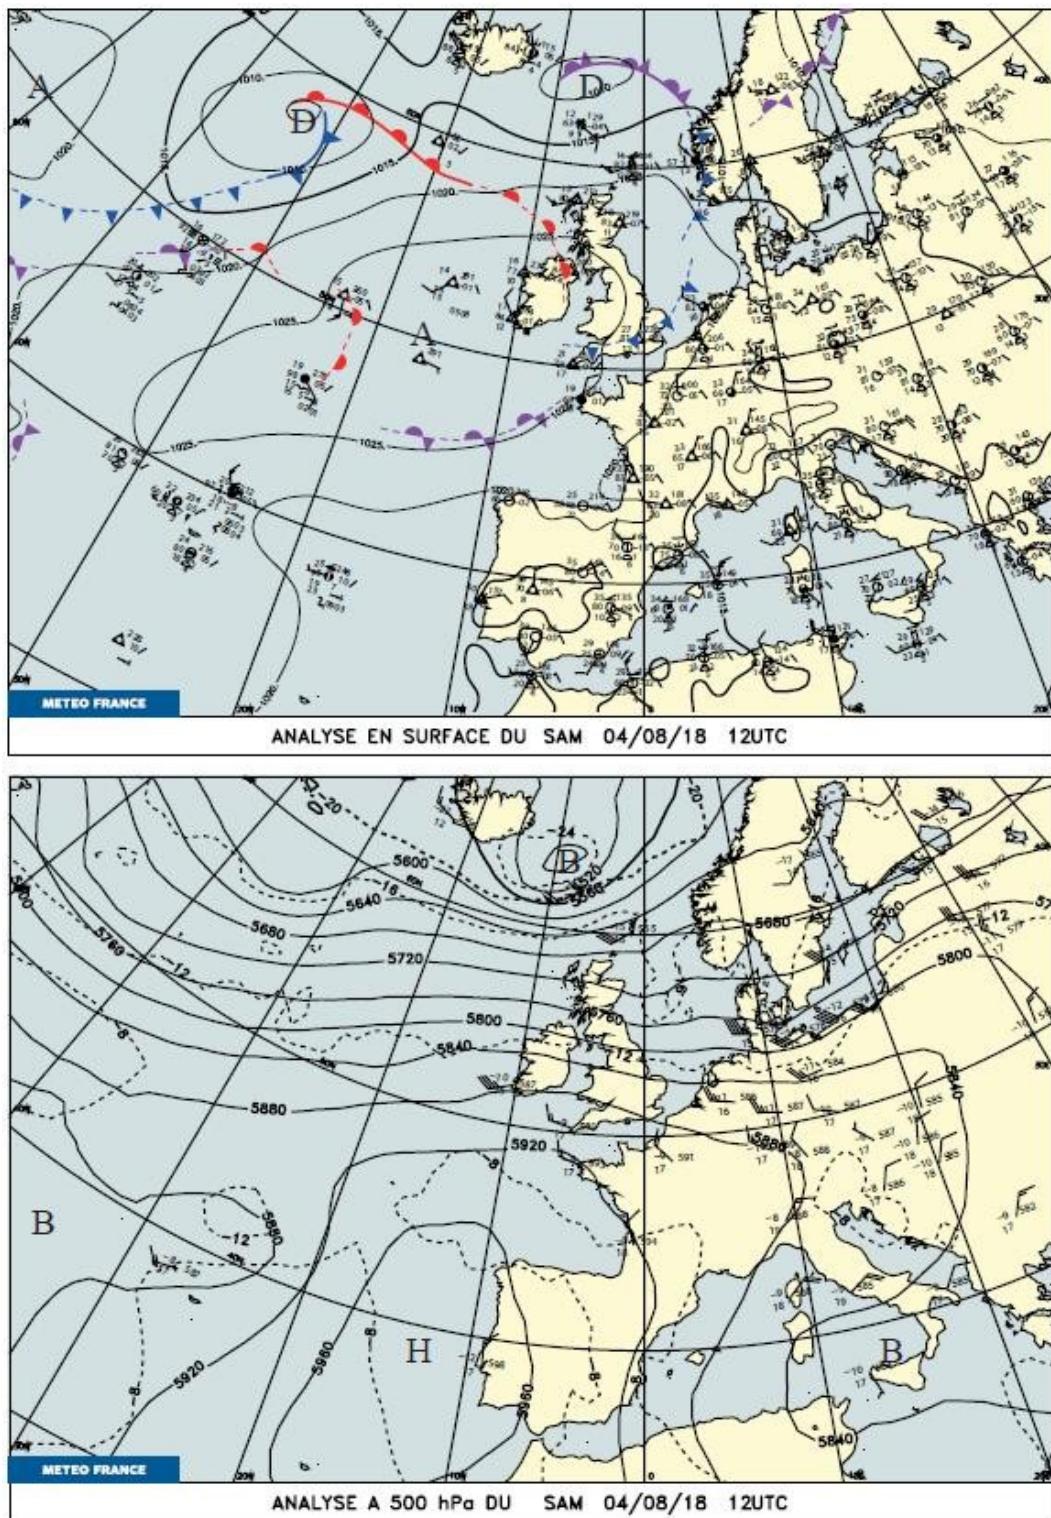
The upper air chart for 500 hPa (lower chart in figure 16) shows the centre of a high-pressure system west of Portugal (Azores anticyclone), which extends over Central and Eastern Europe. This pressure field generated northerly winds at about 5,880 m AMSL above the Alps.

The surface chart shows a flat pressure distribution over Central Europe, i.e. the pressure gradients and hence the winds on this scale are weak. However, on a smaller scale, not resolved by this type of chart, regional pressure differences define the wind field at lower altitudes (see section A1.7.13).

Figure 16: The European surface weather chart (top) and the upper air chart for 500 hPa (bottom). Source: Météo-France.

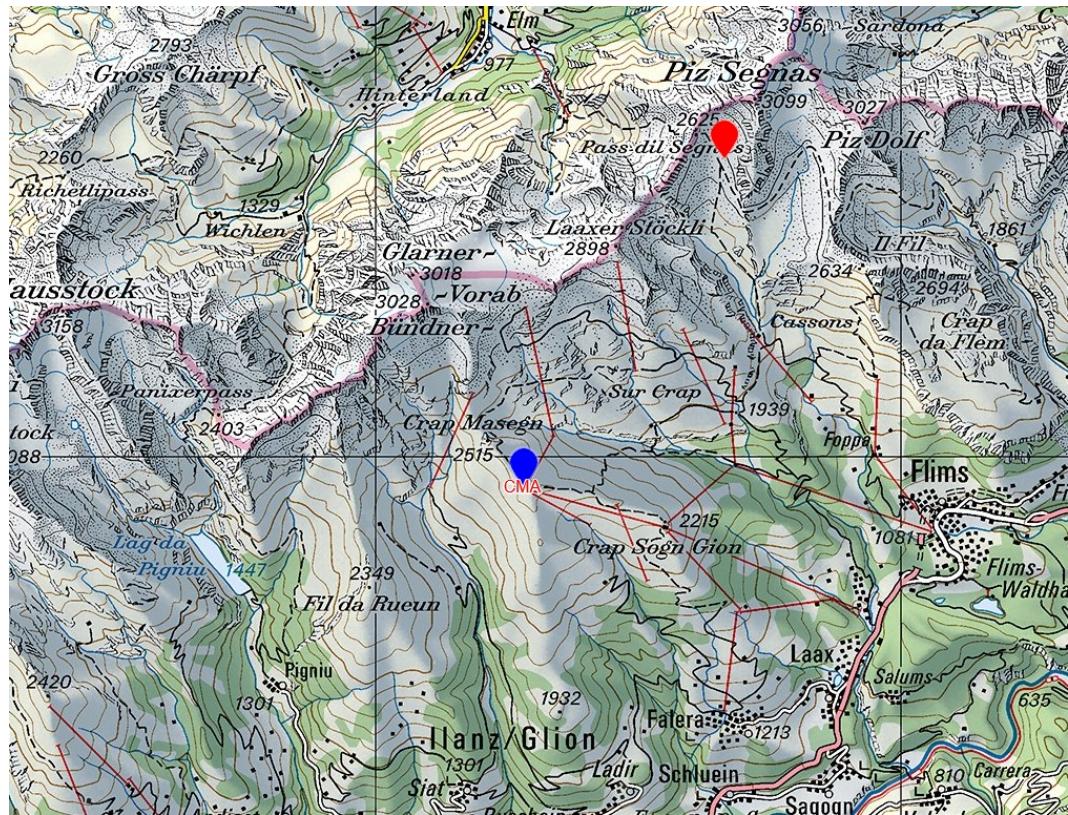
Table 1: Selected parameters measured in 10-minute intervals between 14:00 and 18:00 LT at the Crap Masegn station. The temperature, dew point and pressure readings QFE²² and QNH²³ are at the times listed in the first column. All the other parameters are averaged or summed up within the intervals before the given times. The two types of gusts (for 3 or 1 seconds) characterise the maximum wind speed persisting for 3 or 1 seconds, respectively. The intervals around the time of the accident are marked blue. More explanations about the parameters and a discussion can be found in the text below.

The temperature readings show the warm summer conditions at this altitude (16 °C higher than ISA), which is also reflected in the QNH for this reference altitude (see sections A1.7.2 and A1.7.13.2). This high QNH should not be confused with the QNH of the airfields at much lower reference altitudes. The dew point was well below the temperature, i.e. the air was relatively dry. Air pockets rising from this station would condensate at an altitude of about 3,500 m AMSL (cumulus cloud base). However, lower clouds in this region are possible because, in most cases, the cloud base is defined by the temperature and dew point lower in the valley. Based on other information (see section A1.7.12), the cloud base in the region was between 2,800 and 3,400 m AMSL.

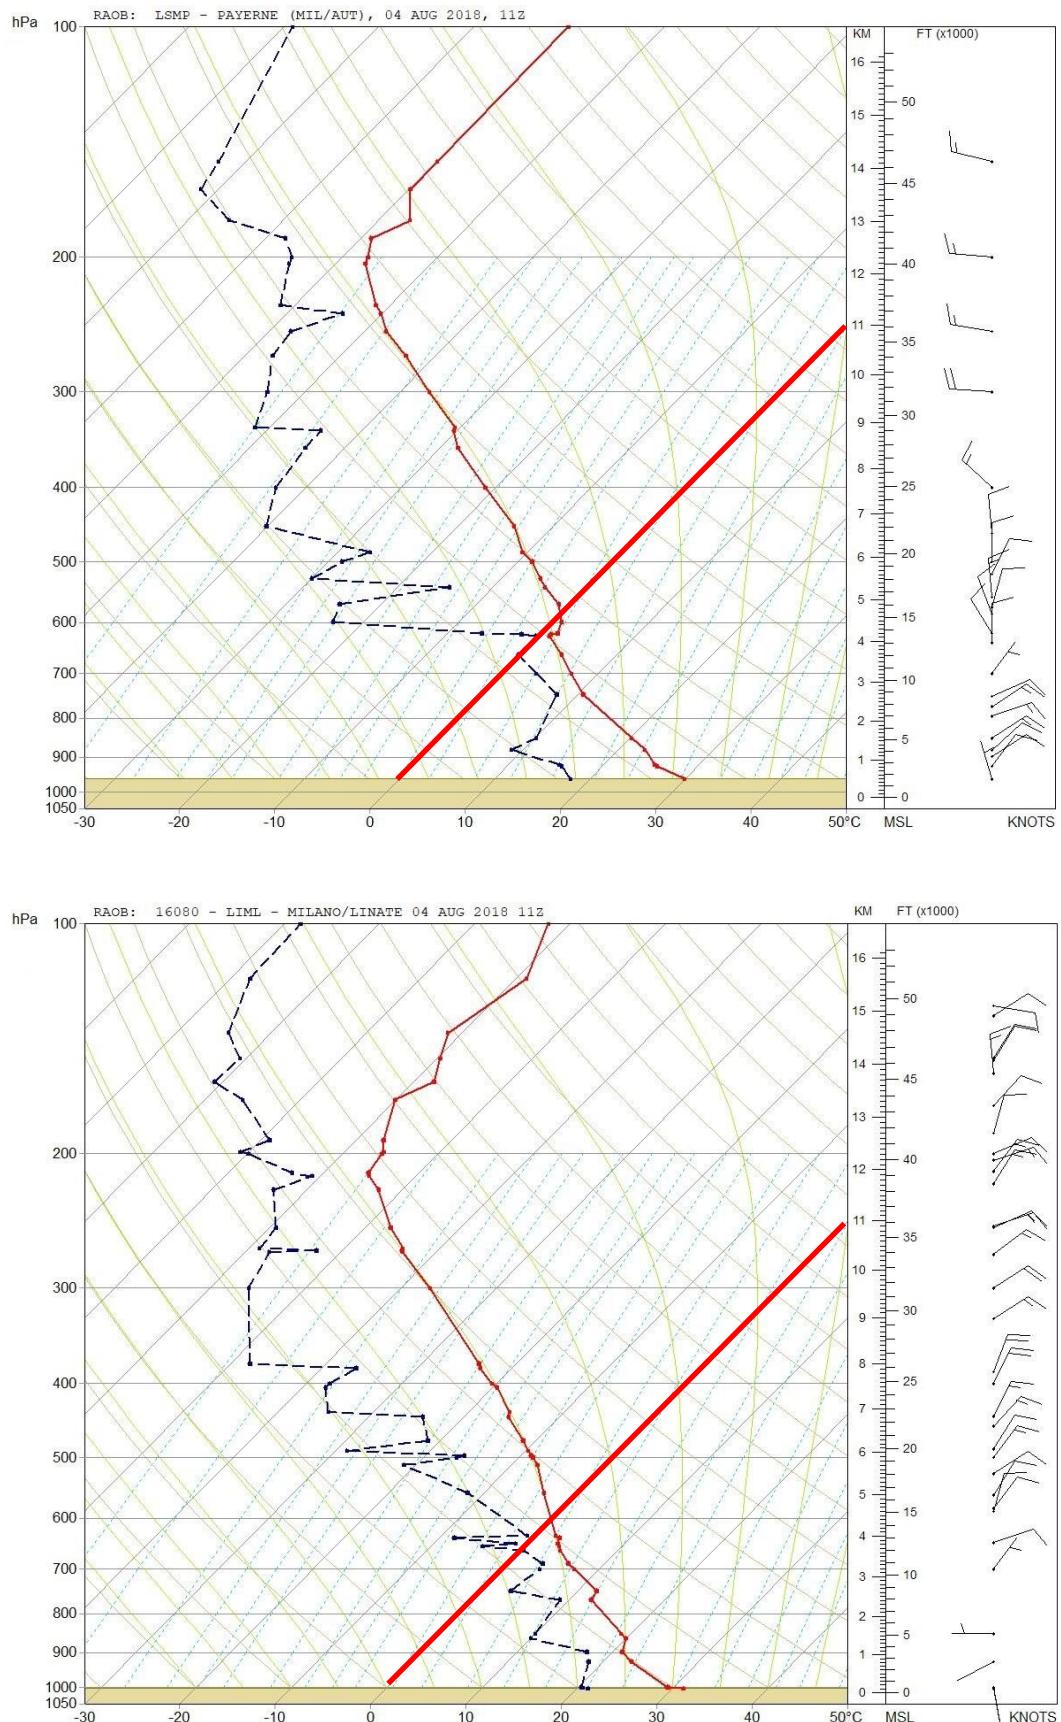
The changes forecast by the numerical weather prediction are expressed in the texts and tables in section A1.7.5.1. The vertical profiles of temperature and humidity are conditionally unstable, which means that the stratification was about neutral below the cumulus cloud base, but unstable as soon as condensation occurred. The consequence of such a stratification is that cumulus clouds – once triggered – will rapidly form into towering cumuli (TCUs) and thunderstorms (CBs) when no other meteorological processes stop them. Such processes exist and are the reason why the development of thunderstorms is different in different regions (see figure 10). On the north side of the Alps, a stable layer around 600 hPa (about 4,500 m AMSL) had to be overpowered.

Figure 18 on the next page: Thermodynamic diagrams show the vertical profiles of temperature, dew point and wind from the Payerne²⁷ and Milano²⁸ balloon soundings. The primary vertical coordinate (left-hand axis) is pressure. The altitudes indicated on the right-hand scale in km and 1,000 ft are calculated based on the present state of the atmosphere, i.e. they express true altitudes (not flight levels, FL). The isothermal lines on this skew-T-log-p-diagram (scale on the x-axis) are inclined, parallel to the red 0° isothermals. On both sides of the Alps – and most likely over the Alps as well – the stratification was conditionally unstable (see text). The wind in the north below 3,200 m AMSL was 10 to 15 kt from north-east, turning to north-west and west above. Over Milano, wind speeds of 10 to 15 kt were only observed above about 3,500 m AMSL.

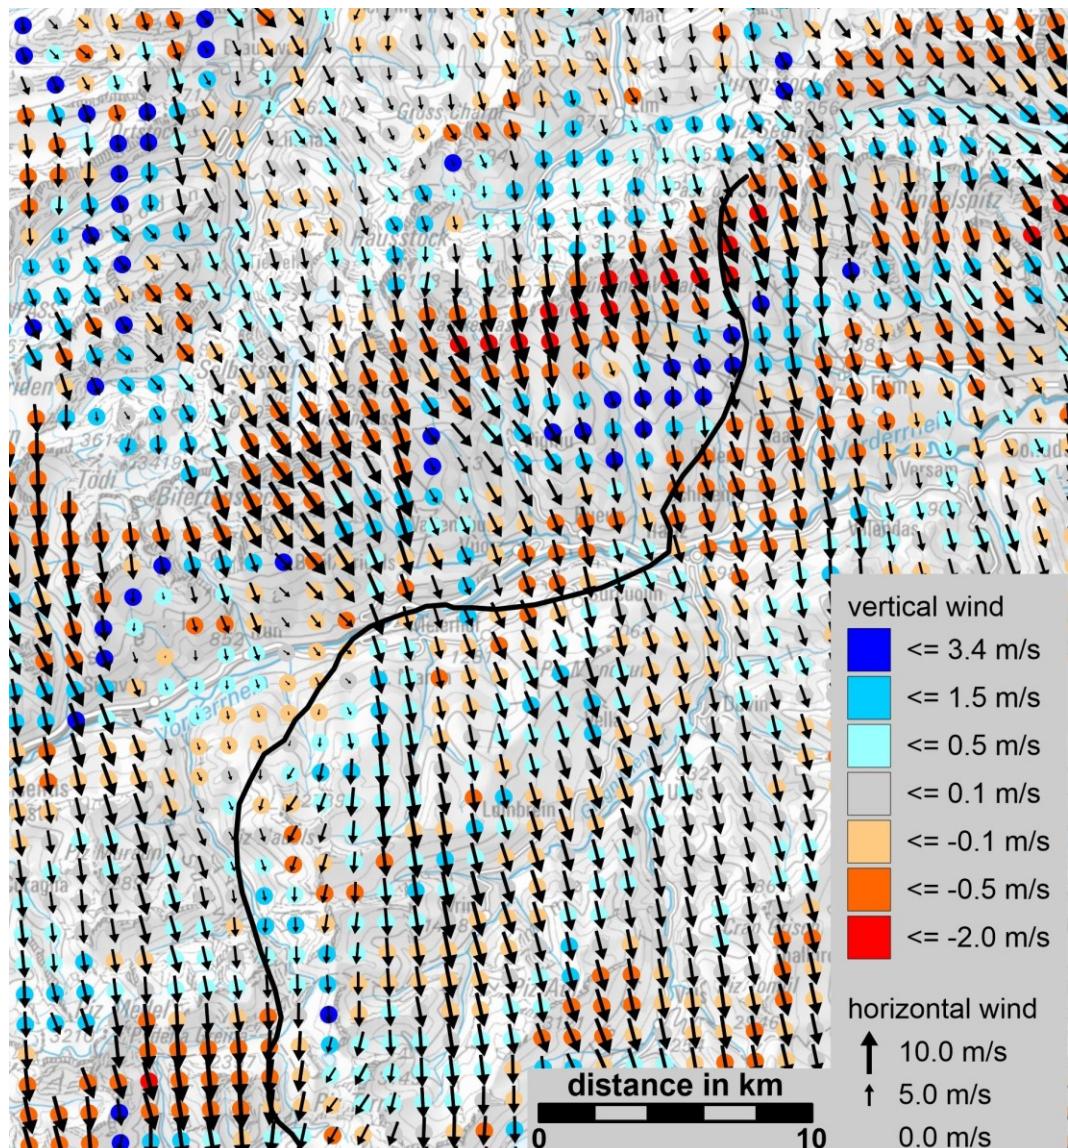
Figure 19: Three-dimensional wind around 17:00 LT at 2,800 m AMSL as interpolated from the terrain-following grid of the COSMO-1 analysis. The coloured points denote the average vertical movement of the air (not individual up- or downdraughts), whereas the arrows show the wind speed and direction (the maximum wind speed on this chart is 10.5 m/s or about 20 kt). The reconstructed flight track is drawn as a black line (see the main report for the official track). Source for the gridded COSMO-1 analysis: Federal Office of Meteorology and Climatology, MeteoSwiss; Source for the background map: Federal Office of Topography.

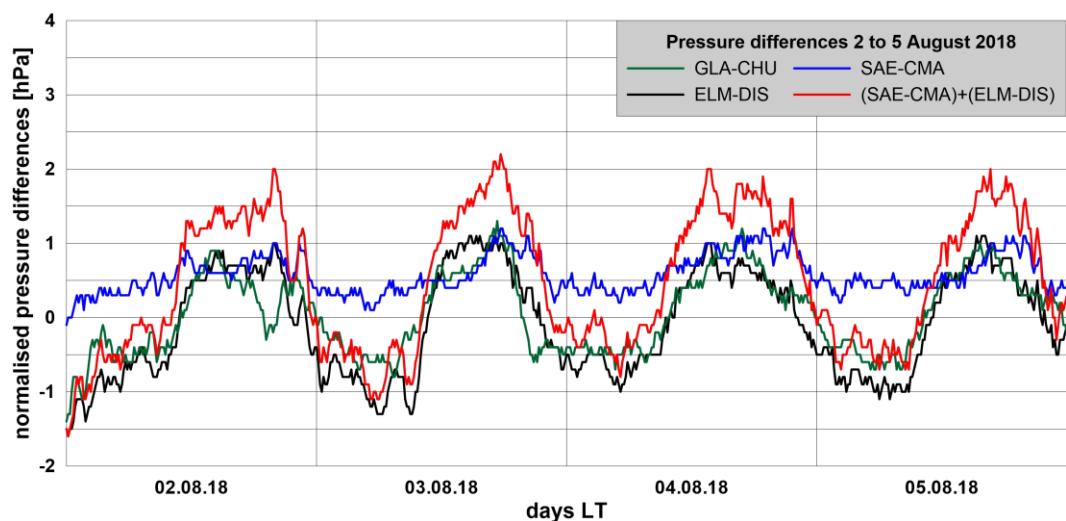
Figure 21: Diurnal pressure differences between selected stations in valleys and on mountains during four days around the day of the accident. See the map in figure 20 for the locations of the stations. Positive values show higher pressure in the north, i.e. from the Swiss Plateau towards the Alps. The pressure at Säntis (SAE) was reduced to the elevation of Crap Masegn (CMA); those at Elm (ELM), Glarus (GLA) and Chur (CHU) to the elevation of Disentis (DIS). The pressure difference SAE-CMA shows pressure differences at the altitude of higher mountains, where ELM-DIS and GLA-CHU show pressure differences between valley floors. The red curve shows the sum of the pressure differences at altitude and the ones between Elm and Disentis. For more information, see the text below.

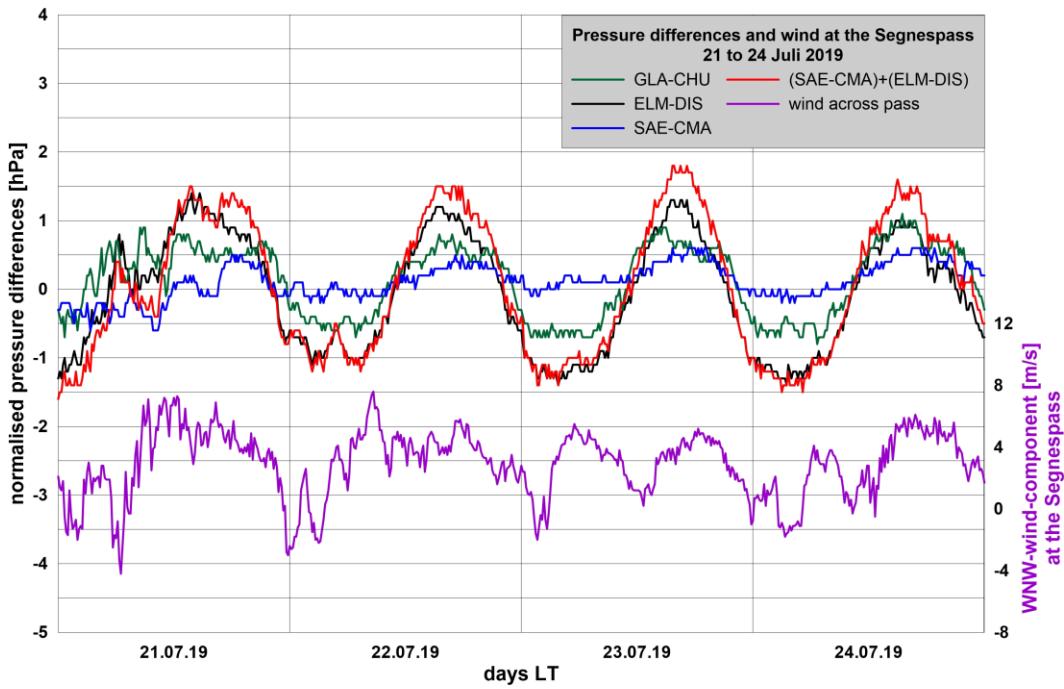
Figure 22: The pressure differences between the same stations as in figure 21, but for four comparable days in July 2019. Since the wind at Segnes pass was measured during that time in 2019, it can be shown in parallel. For more information, see the text below.

The time series in the figures 22 and 23 for nine summer days in 2019 show a similar pattern as during the four days in August 2018. Since the wind across the Segnes pass was measured in 2019 (see section A1.7.14), it can be compared with the diurnal pressure differences.

A typical diurnal pattern can be observed for these days. The pressure differences between Elm in the north and Disentis south of the Segnes pass increase during

the afternoon. The differences are less pronounced at the altitude of the mountain peaks, but still clearly detectable. Additional stations were also inspected, but those selected here seem to be the best choice for documenting the effect of differential heating in neighbouring valleys and aloft. The sum of the pressure difference at lower and higher level is a combined indicator for the enhanced pressure in the north (red curves in figures 21 to 23).

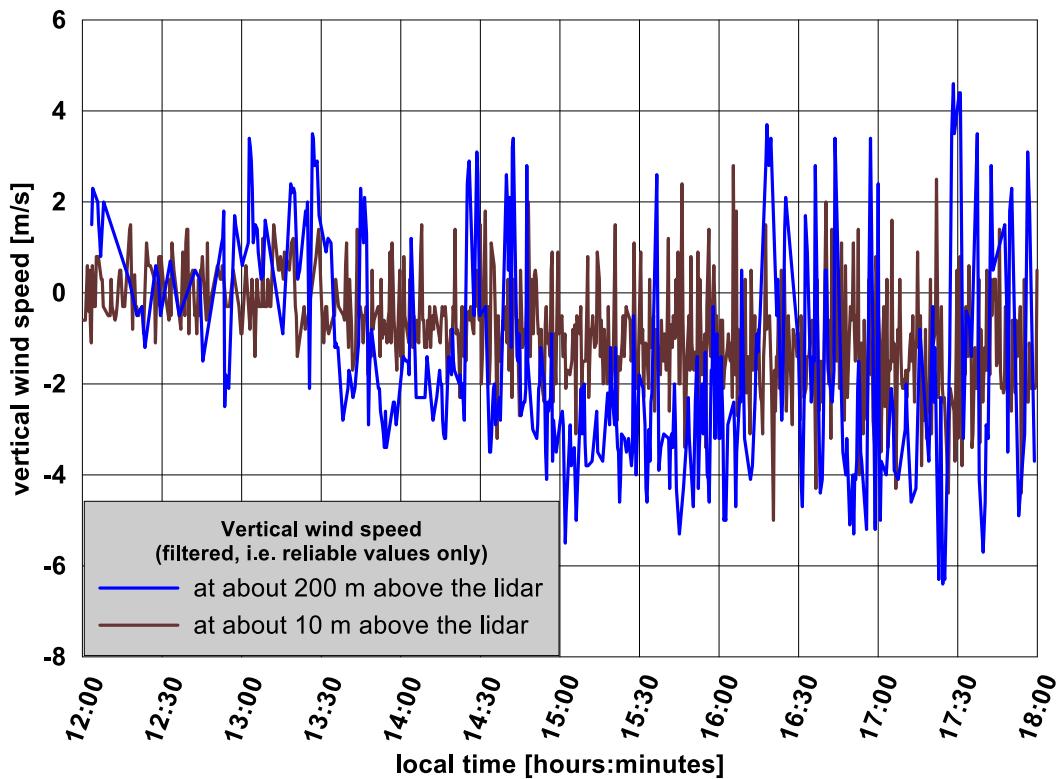
Figure 28 shows the time series of the vertical wind for the afternoon of 25 August 2019. The blue curve shows the vertical wind at an altitude of about 2,660 m AMSL, i.e. 50 to 100 m below the flight track of HB-HOT one year previously. Another 12 suitable days were identified for a statistical characterisation of the turbulence in this sector of the valley.

The vertical wind reflects the same diurnal evolution as discussed above for the wind near the surface. Shortly after noon, following a period with some turbulence caused by rising thermals (slope convection with positive vertical gusts between 1 and 3 m/s), stronger negative values were dominant. Based on the station readings from above, this was within the downslope flow from about 60° (see figure 27 for 25 August 2019). Between about 15:00 and 18:00 LT, the vertical wind varied between -6 m/s and +4 m/s.

Figure 28: Time series of the vertical wind speeds (positive values are updraughts) at the lowest and highest altitudes measured during the afternoon of 25 August 2019. The 10 and 200 m above the lidar are at about 2,470 and 2,660 m AMSL respectively (8,100 and 8,700 ft AMSL, i.e. about 50 to 100 m below the flight track one year ago). In between these heights, five others were measured and processed. For further information, see the text below.

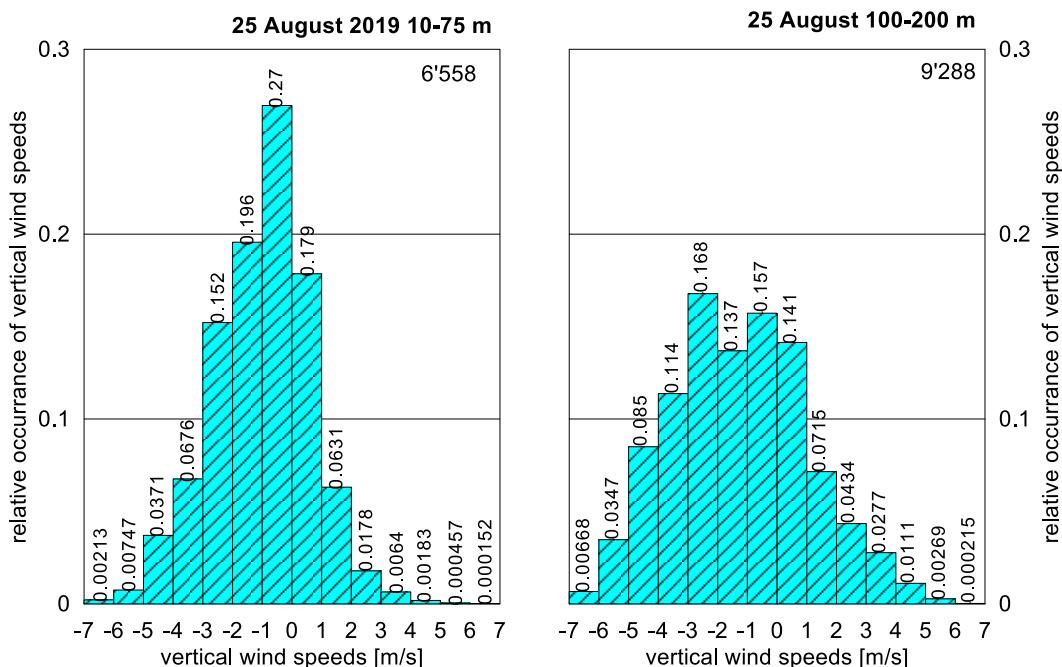
Figure 29: Histograms of the distribution of vertical wind speeds during the afternoon of 25 August 2019 (12:00–18:00 LT) in two height ranges above the lidar: 10 to 75 m (left) and 100 to 200 m (right). The numbers in the top-right corners are the numbers of individual measurements. The vertical axis and the values on top of the bars indicate the relative occurrence, i.e. downdraughts between -2 and -3 m/s dominated with 16.8 % occurrence in the range between 100 and 200 m above the lidar.

Such a statistical evaluation was made with all the 13 days that were selected. An example is presented in figure 29. The bars in the histograms indicate the relative occurrence of the different ranges of up- and downdraughts. At heights below 100 m above the lidar, weak downdraughts dominated with 27 %. Stronger up- and downdraughts exceeding ± 3 m/s were encountered more frequently higher up. This is plausible and supports the assumption that these values will not be much different another 50 to 100 m higher up (where HB-HOT flew through a year ago). Even 8.5 % of downdraughts ranging between - 4 and - 5 m/s were detected, and - 5 to - 6 m/s occurred during 3.5 % of the observation time. Updraughts exceeding 3 m/s were found in 3.7 % of the time (sum of all ranges > 3 m/s).

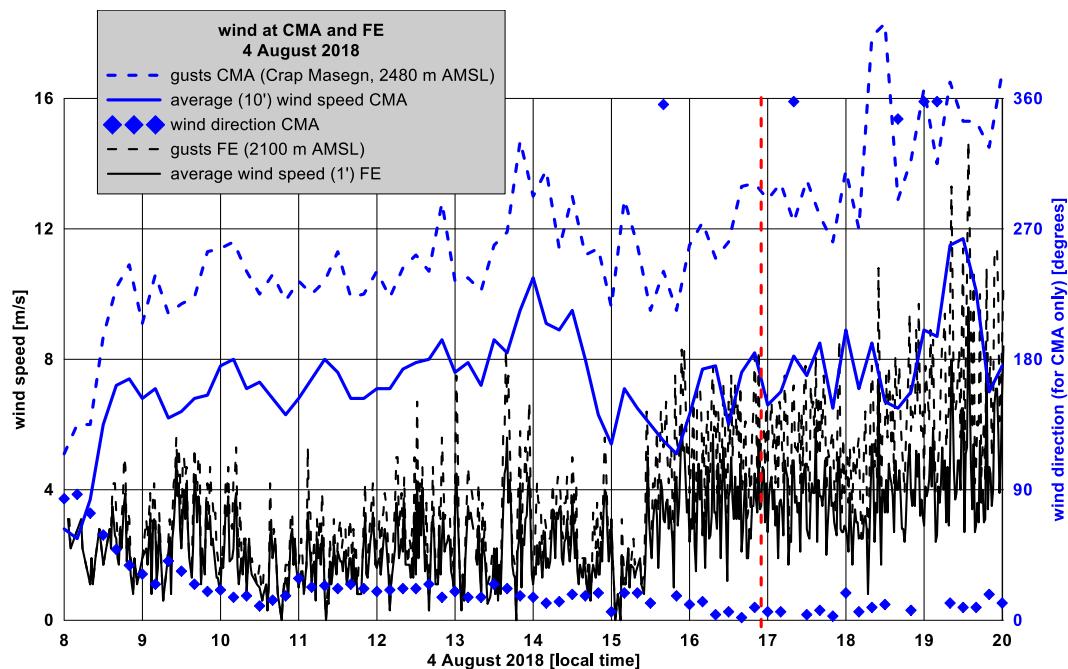
Figure 32: Wind at the two stations Crap Masegn (CMA) and Flims Electric (FE) on the day of the accident. The blue curves and points are for CMA (solid line: 10-minute averages of wind speed; dashed line: 1-second gusts; diamonds: wind direction on the right-hand scale). The one-minute averages and maxima are shown as solid and dashed lines in black. 8 m/s correspond to about 16 kt. Both the average wind speed and the gusts at CMA are about twice as high as at the FE station below the high plateau.

The wind at the time of the accident was stronger than a few hours earlier when the crew flew through the same region during their ferry flight from Dübendorf to Locarno in a single-engine aircraft. As recorded by the measuring station at Crap Masegn (see figure 32), the northerly wind had an increasing tendency. This increased wind at crest height most likely intensified the turbulence in the south-west of Piz Segnas.

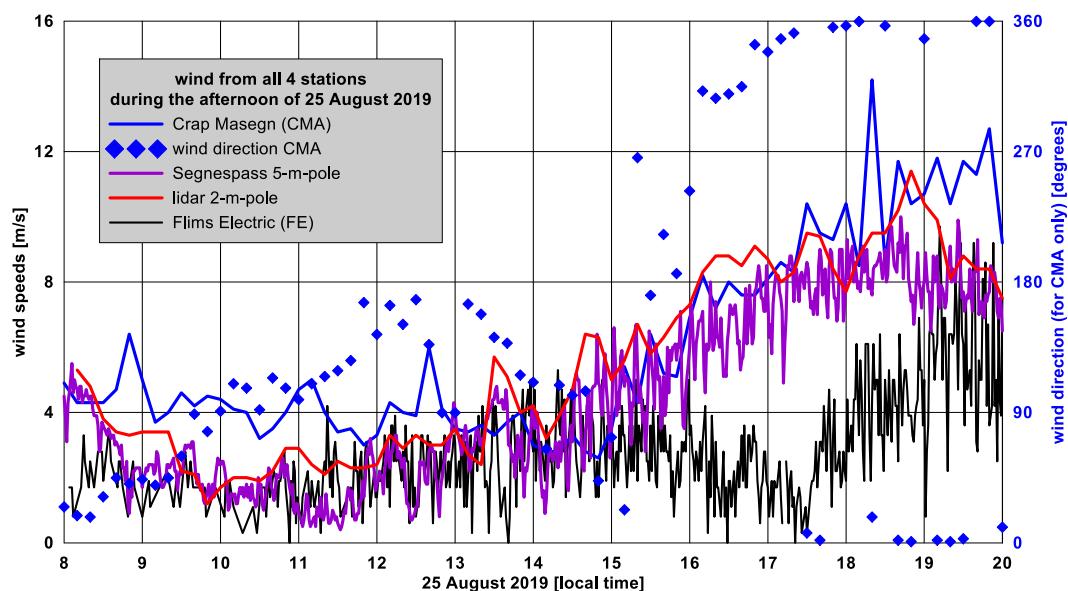
Figure 33: The average wind speeds of all the four stations discussed in this section (see figure 30). The 25 August 2019 was the day with the closest similarity to 4 August 2018. The gusts are not shown here in order to keep the graphics simple. They reached about 50 % above the 10-minute averages on both days (4 August 2018 and 25 August 2019).

Within the observations in summer 2019, 25 August 2019 was selected to have the closest similarity to 4 August 2018. This day allowed a direct comparison between the two operational stations and the two stations closer to the site of the accident operated in 2019 only. Figure 33 demonstrates that the wind at the Segnes pass closely followed the wind at Crap Masegn (CMA). This is a strong indication that the wind at Crap Masegn is representative of the wind across the Segnes pass for the day of the accident.

The FE station at the southern edge of the high plateau recorded about half of the wind speed observed at Crap Masegn during both days. This shows that the lower station is not fully exposed to the stronger downslope wind higher up in the valley. It decreases even more after 17:00 LT. The FE station would have been more important had the winds at the Segnes pass and at Crap Masegn not correlated so well. Then the wind at the Segnes pass could be estimated by doubling the speed measured at the FE station.

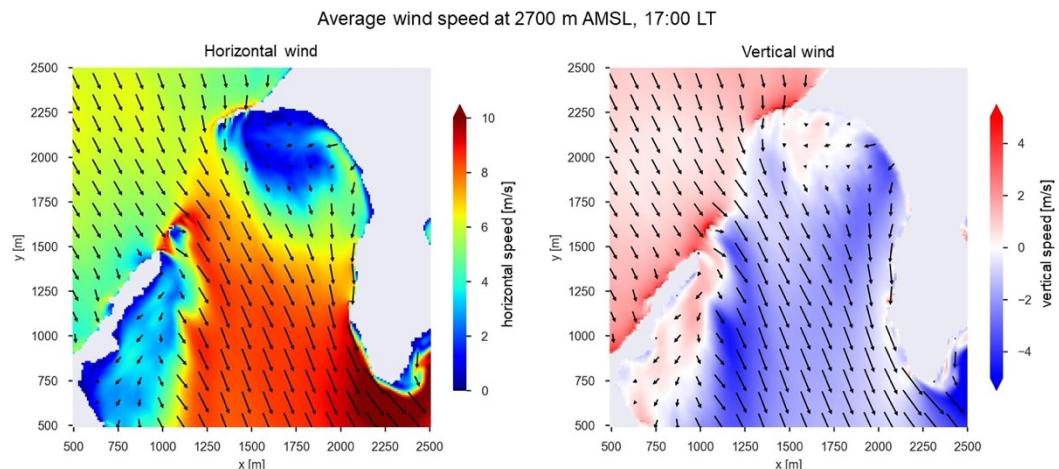
Figure 35: The horizontal wind field (left) and the vertical wind component (right) at 2,700 m AMSL as simulated by PALM (averages between 16:30 and 17:00 LT). The arrows depict the horizontal wind on both frames, but the colour coding is for horizontal wind speed on the left and vertical wind speed on the right. See further information below.

The illustrations demonstrate that a rotor flow with considerable downdraught most likely developed on the downwind side (lee) of the western crest, whereas at the northern slope of the basin, updraughts dominated. The horizontal wind along the centre of the valley was enhanced (8 m/s or 16 kt), with maxima over the Segnes pass and at the southern edge of Atlas. A zone with much less wind is associated with the zone in the north, where thermal lift was active. Therefore – even when not projecting any details onto the reconstructed flight track – the following scenario is plausible. Initially, when entering the basin from the south, nose-wind and sinking were dominant. When approaching the Segnes pass, the zone with less wind and some thermal lift was encountered.

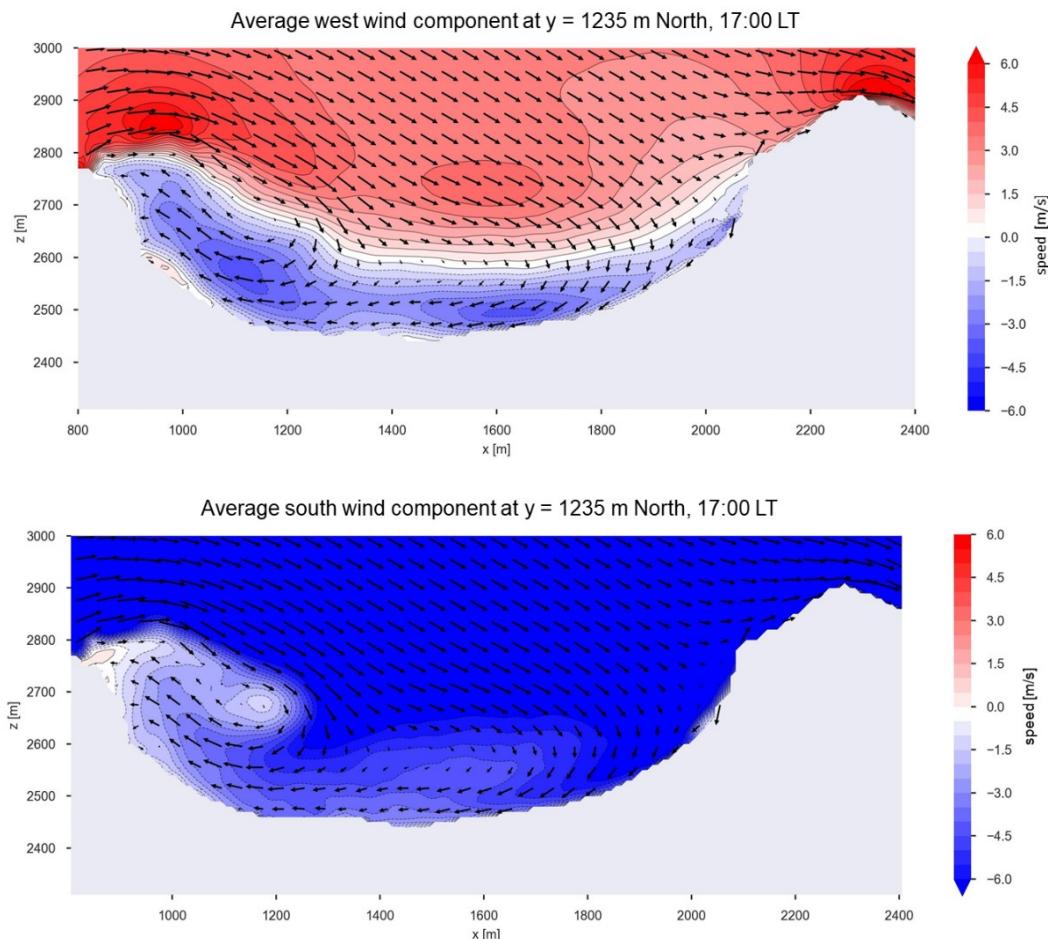
Figure 36: Vertical cross-section from west to east along the blue dashed line in figure 34. The arrows depict the flow on this plane in both frames, clearly showing the rotor behind the western crest (the Tschingelhörner range of mountain peaks on the map). The colours according to the scales on the right-hand side show the wind from the west (negative values from the east) in the upper frame, and the wind component from the north by the negative values in the lower frame. The wind components above the crest were about 7 m/s from the west and 8 m/s (outside of the colour scale) from the north, i.e. a north-westerly wind of about 21 kt above the basin. Near the western slope of Atlas in the east, the wind near the surface was from the north-east.

The two wind components near the surface in figure 36 are both about 5 m/s, resulting in roughly 15 kt from the north-east. This correlates with the wind observed³⁹ after the impact (17 kt from 060 to 070°), and is also in accordance with the descriptions of the eyewitnesses 15 minutes after the accident in section A1.7.7. The estimate of 60 km/h for the very local flow across the Segnes pass is plausible as well and is in the same order of magnitude as the maxima measured in 2019. The wind field shown in figure 35 is 75 m above the pass. For such comparisons, it is important to note that the results shown here are average wind speeds, whereas the observations are representative for shorter periods.

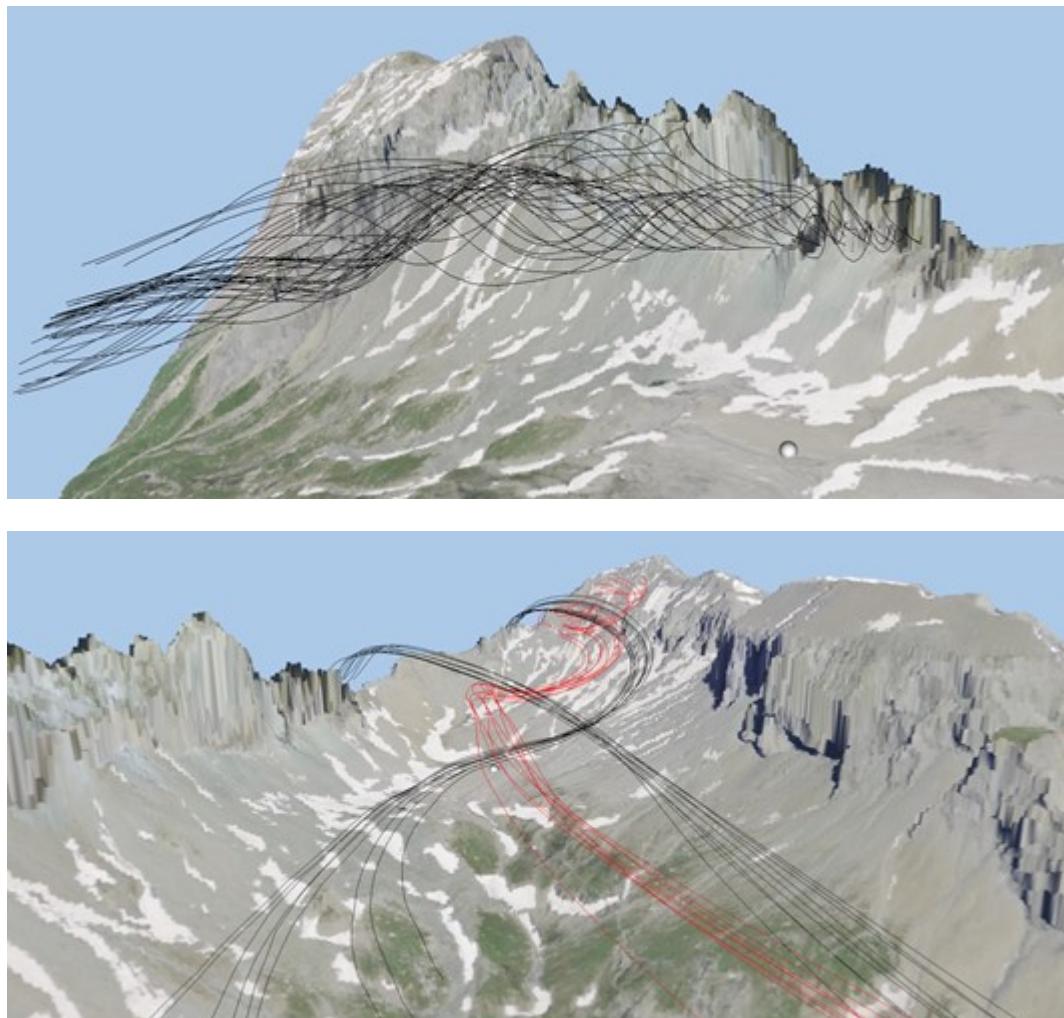
Figure 37: Three-dimensional display of selected streamlines in the region of the last minute of the flight. The site of the accident is marked by the white spheres. Top frame: Turbulent flow in the core of a rotor behind the western crest (the Tschingelhörner peaks on the map) seen from the east. Bottom frame: More laminar stratified flow near the surface. The lowest streamlines pass the site of the accident at a height of 10 m; the red ones at 100 m, and the higher black ones at 200 m. The north-easterly flow along the slope of Atlas and the north-westerly flow aloft are clearly visible. As emphasised above, this is a plausible flow pattern that can vary in time and space and must not be projected in detail to the reconstructed flight track.

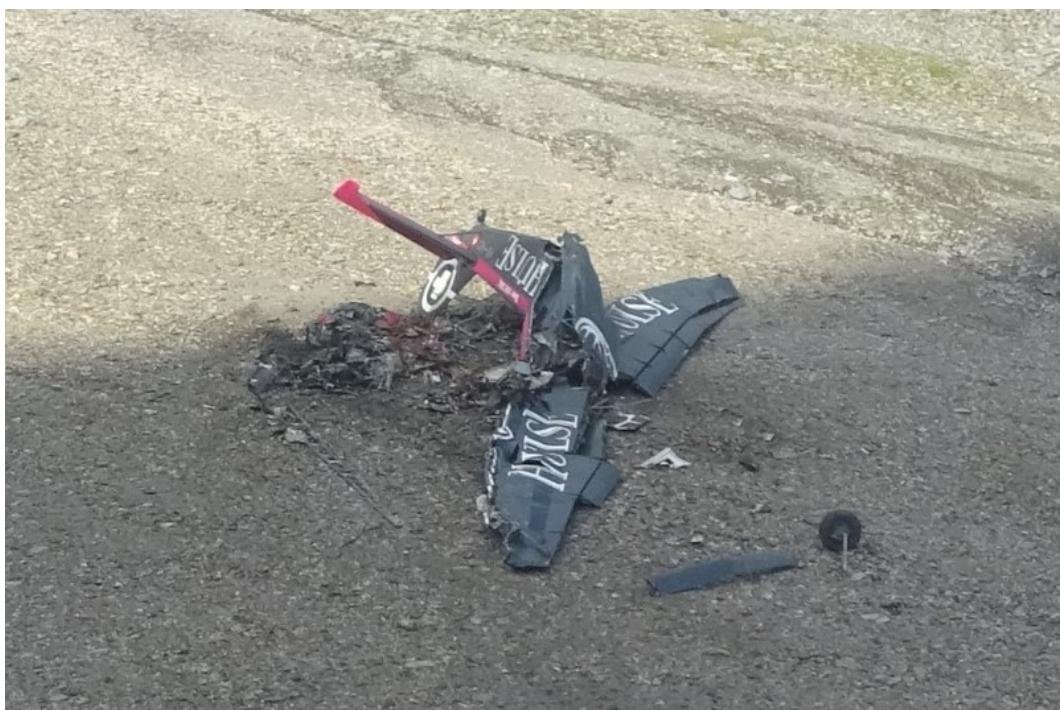
The accident site was located in the basin south-west of Piz Segnas, approximately 1.2 km from its summit and at an altitude of 2,480 m AMSL. The Martinsloch, a natural rock window in the Tschingelhörner range of mountain peaks, is located approximately 500 m west of the accident site. At this point, the Tschingelhörner peaks form the border between the cantons of Glarus in the north-west and Grisons in the south-east. The accident site falls within the municipality of Flims in the canton of Grisons (see annex [A1.1](#)).

Figure 1: Final position of the wreckage. Looking east towards the scene of the accident.

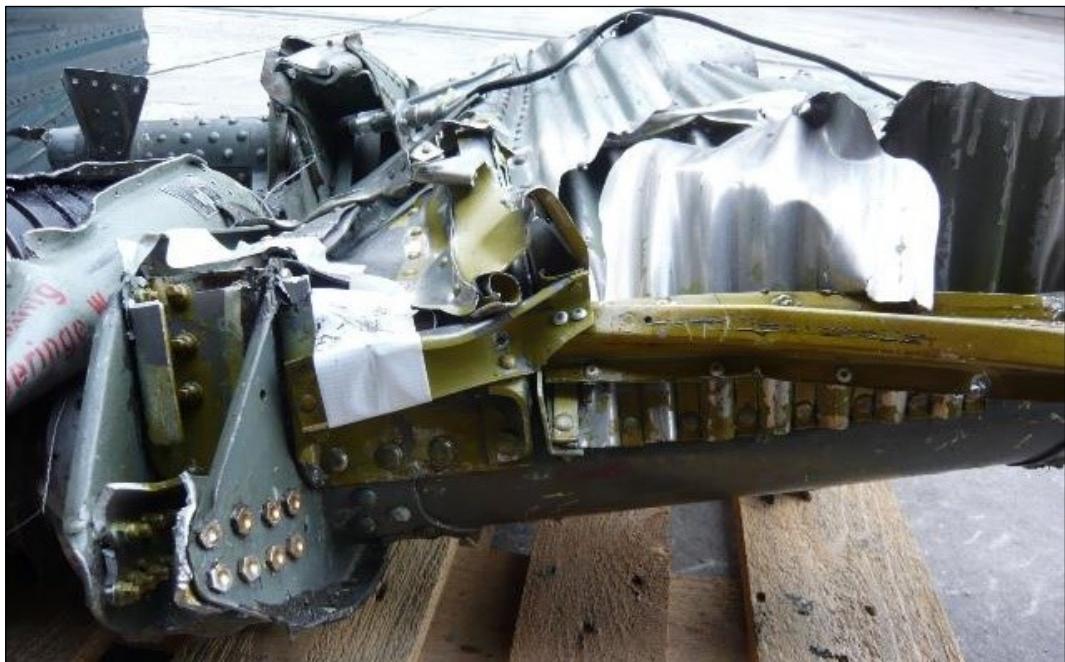
Components subjected to high loads and stress were found to have been repaired (see figure 11). This included sheet aluminium parts that had been attached using blind rivets and sheet-metal screws.

Figure 11: Repairs carried out in the centre wing, apparent by the greenish-yellow structural parts and the golden yellow connecting elements.

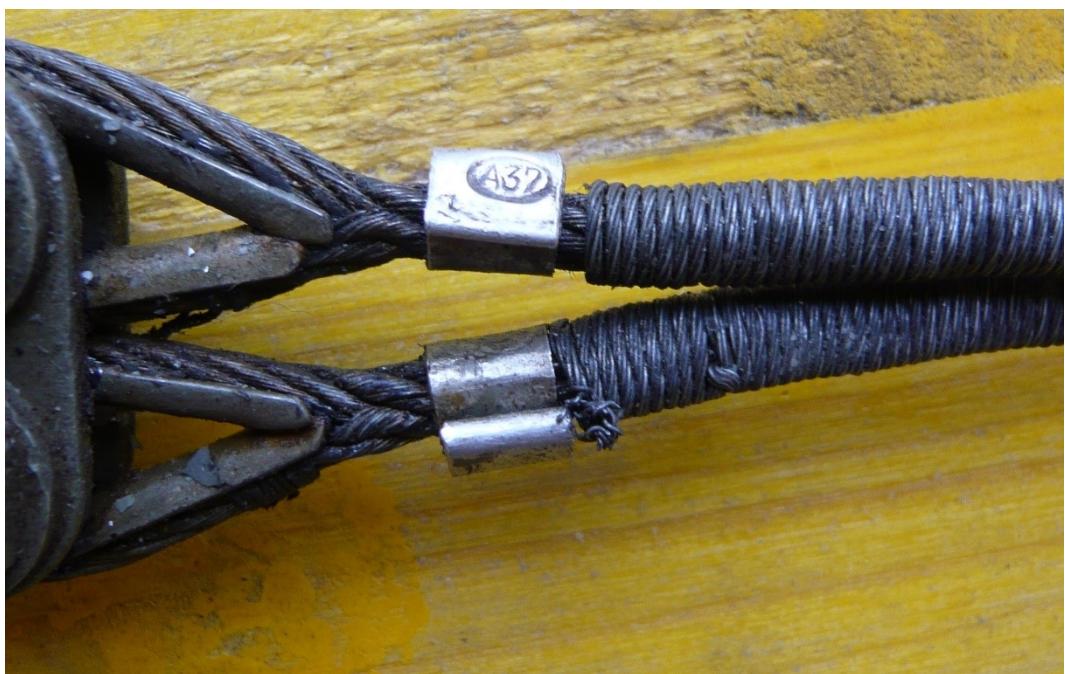
All examined connecting linkages used in controlling the aircraft were in working order but in poor condition. Many elements exhibited corrosion, and rivets were loose or missing. The protective coat of paint had flaked off almost all parts, and the corrosion protection was therefore insufficient (see figure 19). The control cables were old: their production method is consistent with the time when the aircraft was manufactured (see figure 20).

Figure 20: Old control cables, whose production method was consistent with the time when the aircraft was manufactured.

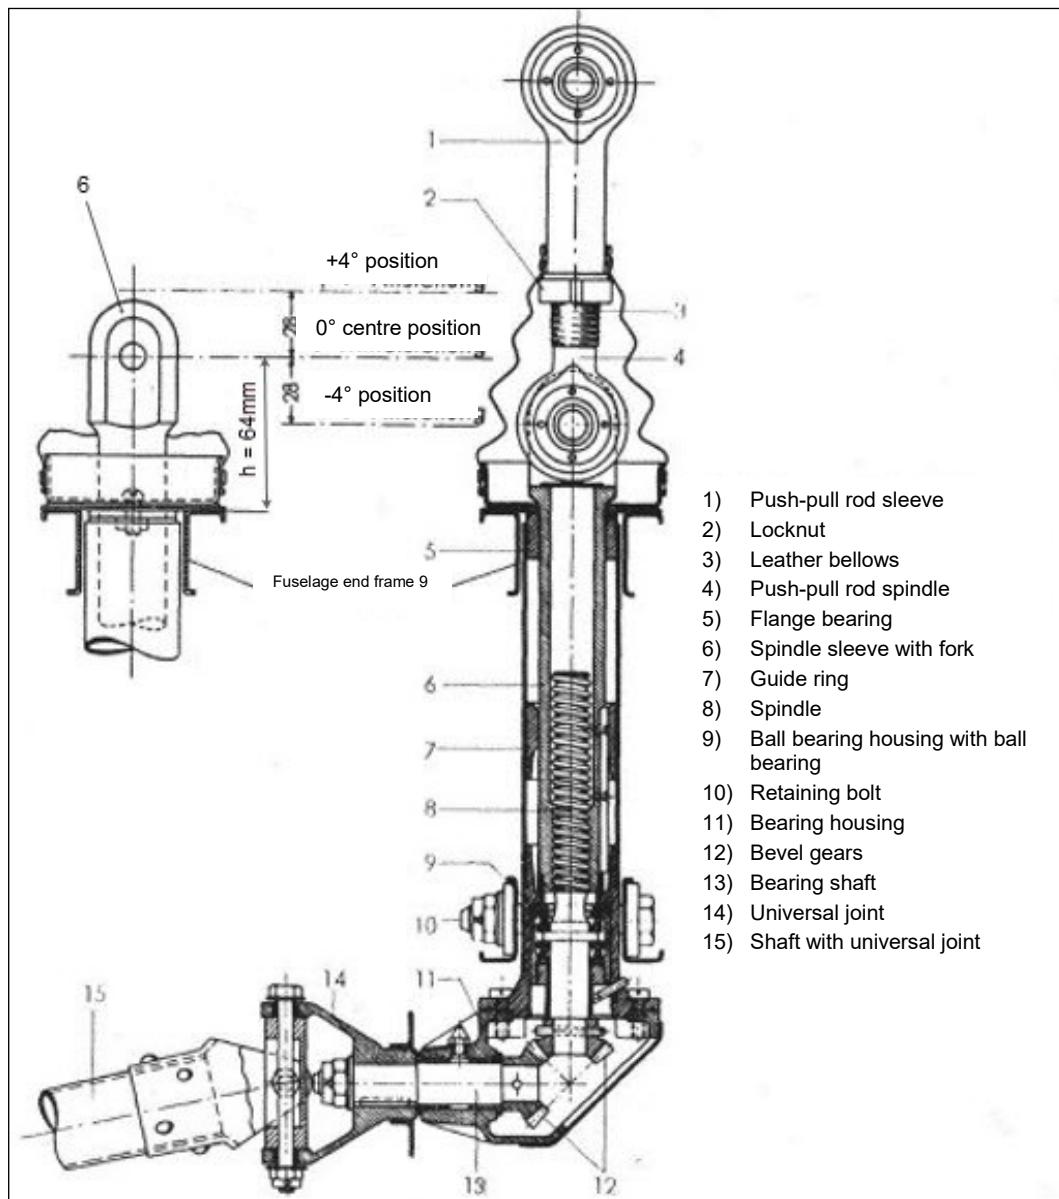
Figure 22: Dimensioned drawing for determining the horizontal stabiliser's angle. Source: "Betriebsanweisung Ju 52/3m g4e" (operating instructions).

The adjustment spindle and the bevel gear were not damaged in the accident. In order to determine the condition and position of the horizontal stabiliser at the time of the accident, the adjustment spindle – including bevel gear – was first removed from the tail of the wreckage, measured and dismantled. A functional check was also carried out.

- The assembly was in working order.
- No damage could be identified.
- No abnormal wear and tear was found.
- The axial play of the spindle was 0.2 mm.

During repairs to the elevators and ailerons on 11 March 2003, various work was also carried out on the horizontal-stabiliser adjustment spindle, which was removed and reinstalled in the process. The question of whether any misadjustments were made during this work remains open. No misadjustments were found during the last progressive inspection.

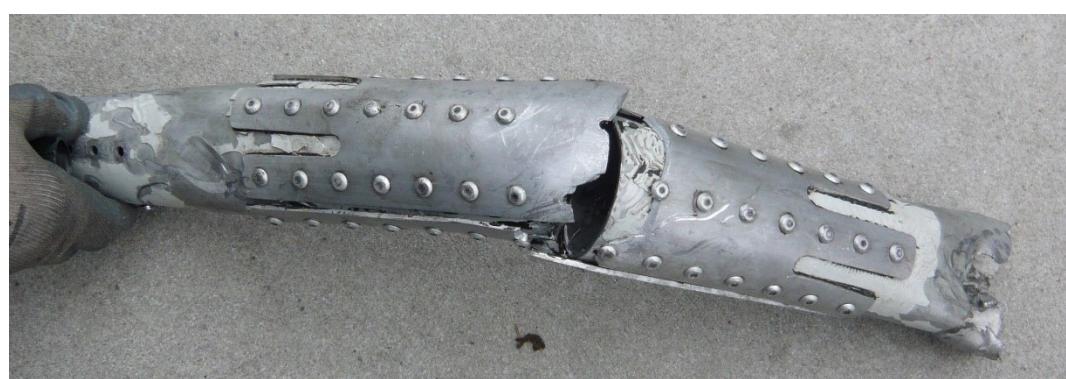
- The fractures as well as the type of plastic deformations were not consistent in all three of the engine mounts.
- The material thickness of the engine mount for the right engine was different to that of the other engine mounts.
- The surface structure of the three engine mounts was different.
- All three engine frames exhibited several areas that had been repaired (see figure 23).
- Parts of the engine frames were painted differently.

Figure 23: Tubular strut from the centre engine frame repaired with a doubler (see annex [A1.6](#)).

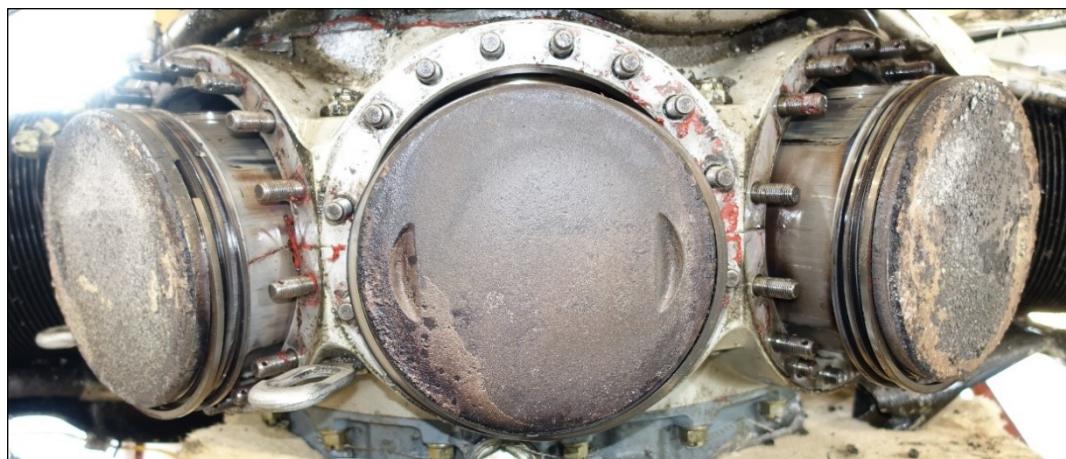
All three engines were dismantled and generally revealed a similar picture. Burn residue was prominent on the pistons and in the cylinders' combustion chambers (see figure 26).

Figure 26: Pistons in cylinder positions 1, 2 and 3 in the right engine.

The condition of the cylinder bores was first assessed visually. In a large number of the cylinders, fine surface cracks distributed in a net-like pattern were visible in the bores. On some cylinders, the bores had a red discolouration. Subsequently, three cylinders were subjected to metallurgical investigations (see annex [A1.16](#)).

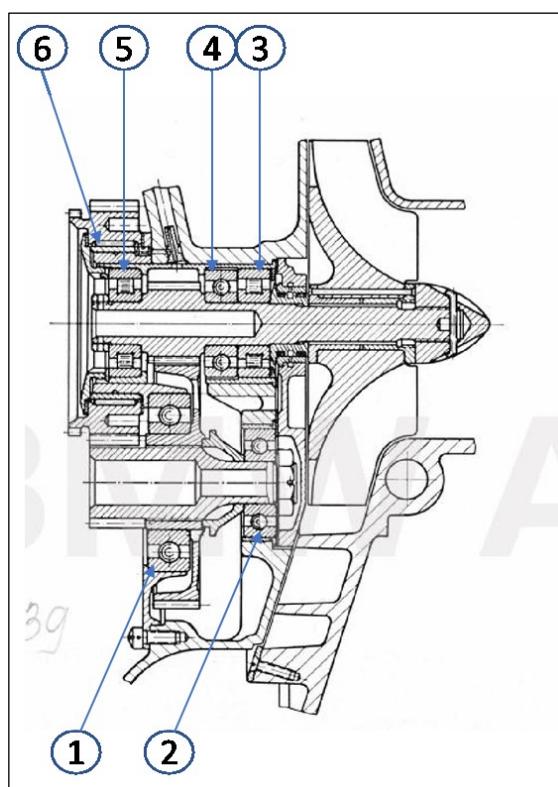
The bearings installed in the superchargers were of different origins and were also marked differently. None of the supercharger bearings were broken. Bearings number 3, 4 and 5 (see figure 29) of the high-speed supercharger shaft from the left engine were subjected to metallurgical investigations (see annex [A1.16](#)).

Figure 29: Cross-sectional diagram of the supercharger with bearing nos 3, 4 and 5 on the supercharger shaft. Source: BMW 132-A3 engine operating instructions.

The bearings used in the supercharger had different speed ratings, but none of the three supercharger-shaft bearings met the necessary specifications for speeds of up to 20,500 rpm, which the shaft can be subjected to when running.
