A1. Factual information

A1.1 Background and course of the accident flight

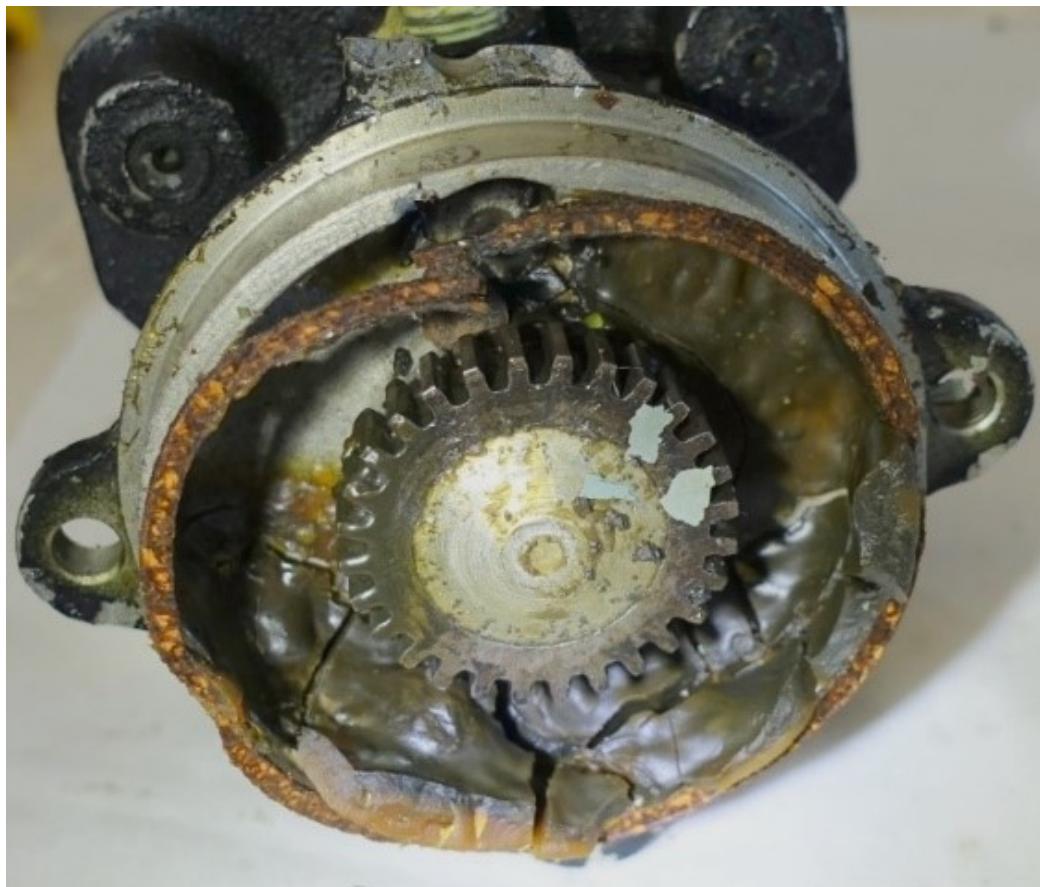
The electric fuel pumps had not been in operation for several years. The fuel therefore did not flow through the pump body but through the bypass. Both pumps were found to have solidified grease in them after dismantling and defective seals due to their age (see figure 32).

Figure 32: Electric fuel pump gear.

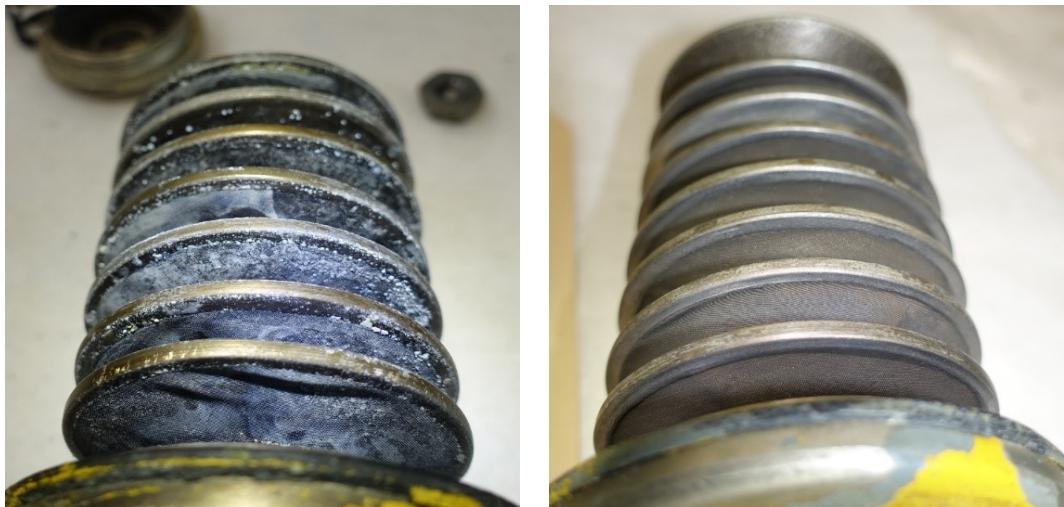
Each outer wing was fitted with a fuel filter. However, following the accident, it was not possible to determine which one they had come from. While one set of filter elements was clean, the other set was found to be heavily contaminated (see figure 33). According to the technical files, these filters were last checked and cleaned on 19 June 2018, some 42 flight hours before the accident. The manufacturer's operating instructions stipulate that the filters must be checked every ten flight hours.

Figure 33: Fuel filter elements.

From the different condition of the two fuel filters and the fact that all tanks were filled with the same fuel, it can be concluded that the contamination did not originate from the fuel. The nature of the contamination in the one fuel filter indicates that deposits from one of the tank systems had led to the contamination.

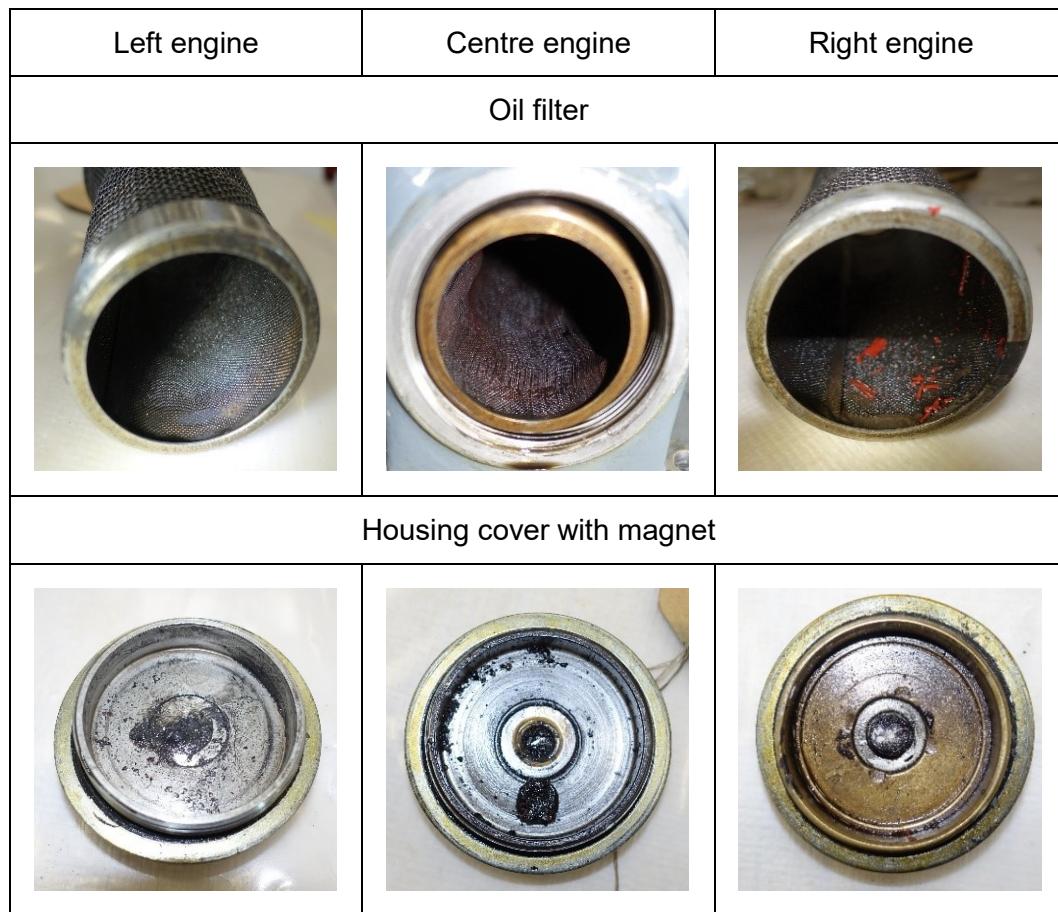
Each engine had an oil filter, which was fitted with a magnet in the housing cover (see figure 34). Loose pieces of red sealing compound were found in the oil filter element of the right engine. Metallic debris was found in all of the oil filters.

Figure 34: Oil filter and housing cover with magnet from all three engines.

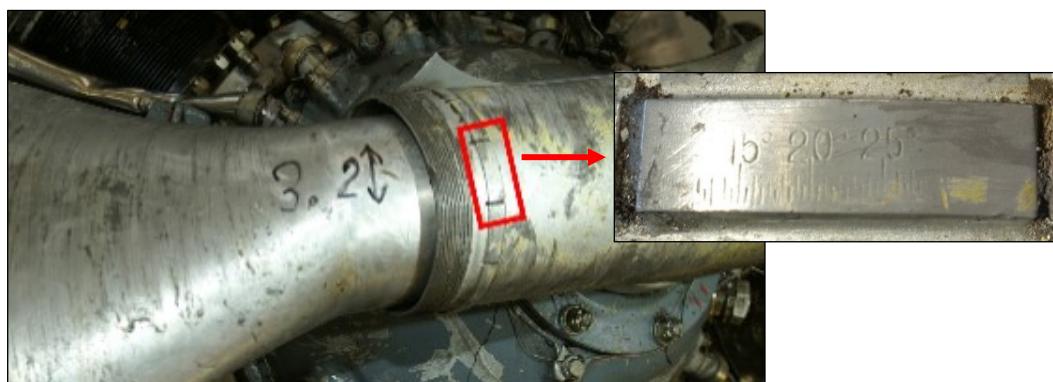
Upon removing the anti-corrosion paint, an adjustment scale became visible on the propeller hubs (see figure 35), which is intended to be used to adjust the pitch of the blades once they are installed on the aircraft. The maintenance team had no knowledge of this scale.

Figure 35: Adjustment scale on a propeller hub.

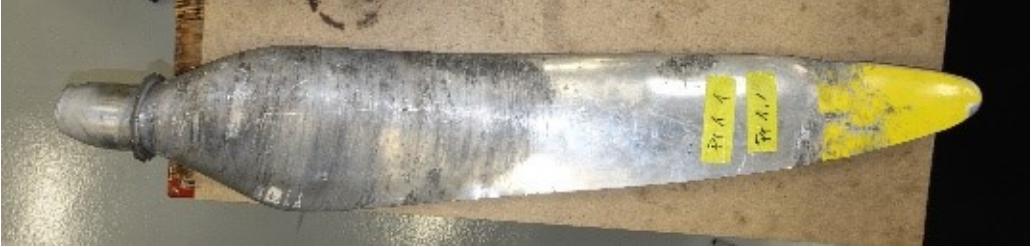
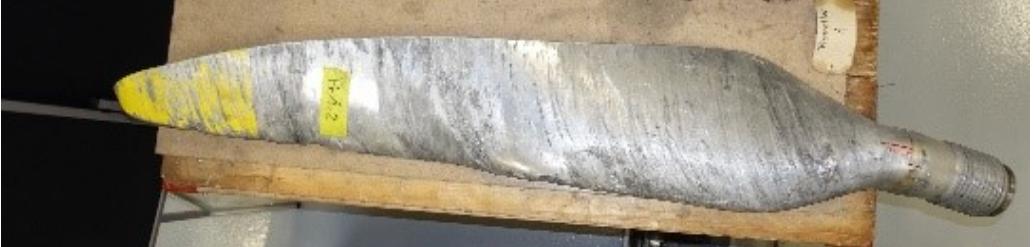
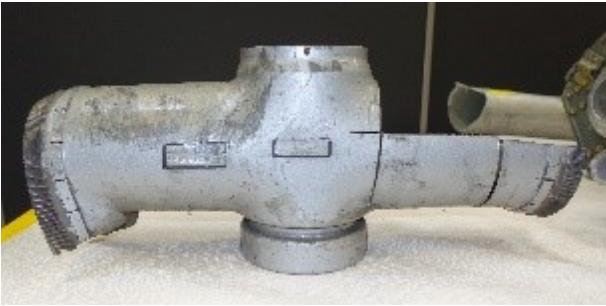
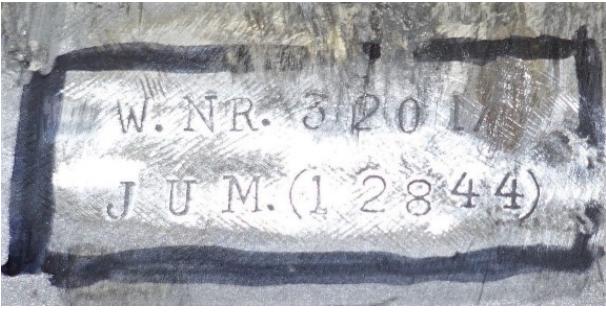
Figure 36: Propeller 1 – blades and hub.

Blade 2 of the left propeller was still attached to the hub. All the other propeller blades had broken off at the root. The propeller blades all exhibit a similar degree of damage. The marks indicate that the three propellers were rotating on impact (see figures 36 to 38).

Newly stamped different serial number on the hub (see annex A1.6)

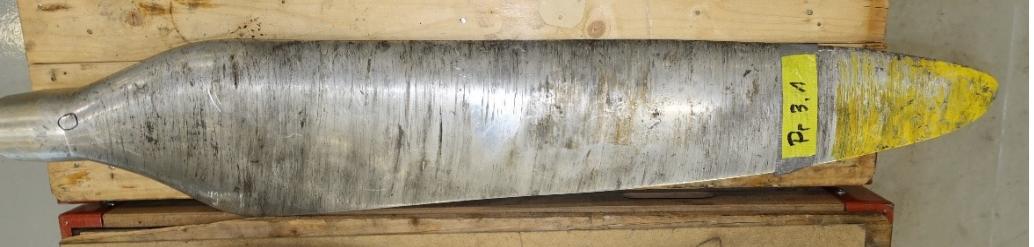
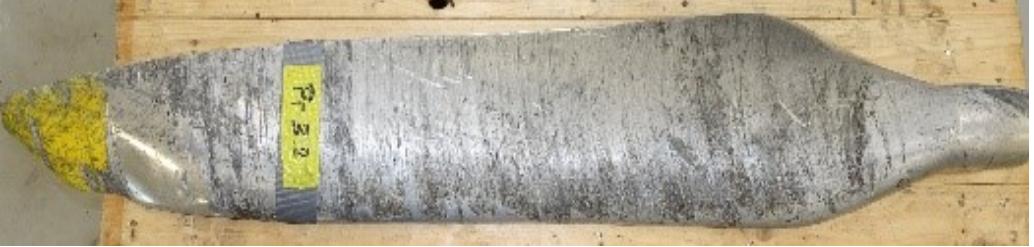
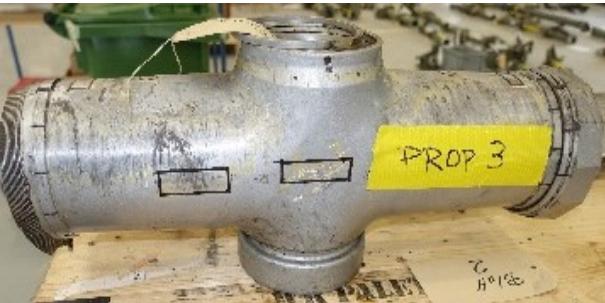
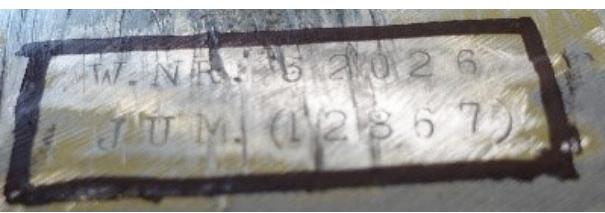
Figure 38: Propeller 3 – blades and hub.

Newly stamped different serial number on the hub (see annex A1.6)
