## A1. Factual information

### A1.16 Tests and research results

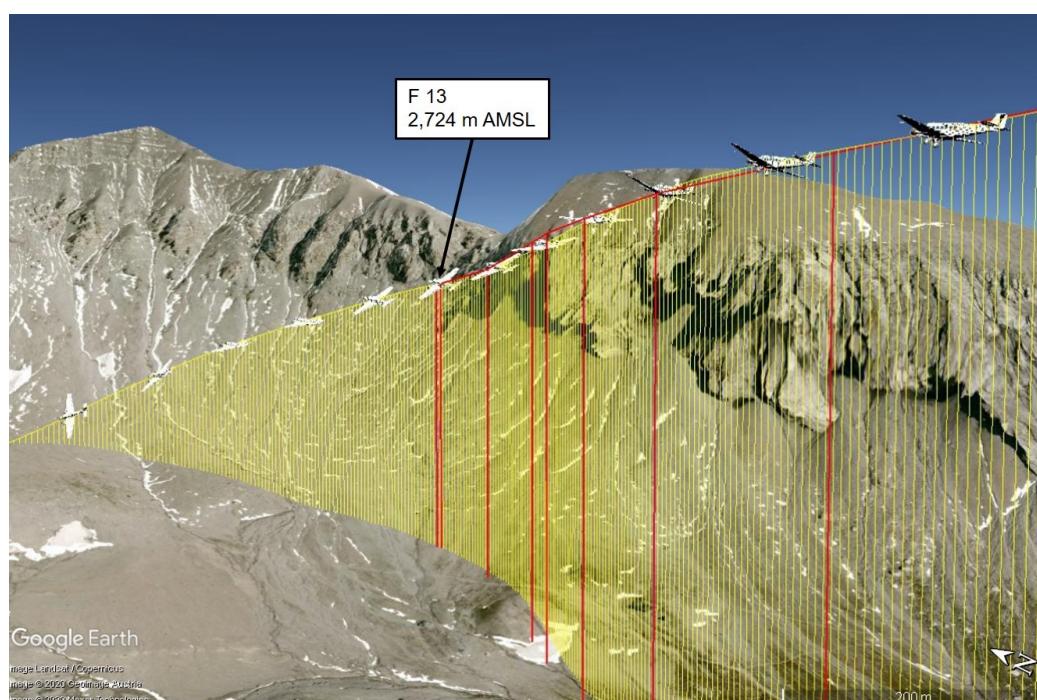
**Figure 1:** Simulated flight path (yellow) and reconstructed flight path of HB-HOT (red) from 4 August 2018 leading up to the photogrammetrically determined position F13; shown on Google Earth. The enlarged (2:1) three-dimensional models are shown on the basis of simulation results at position F13 and at two-second intervals before and after that point.

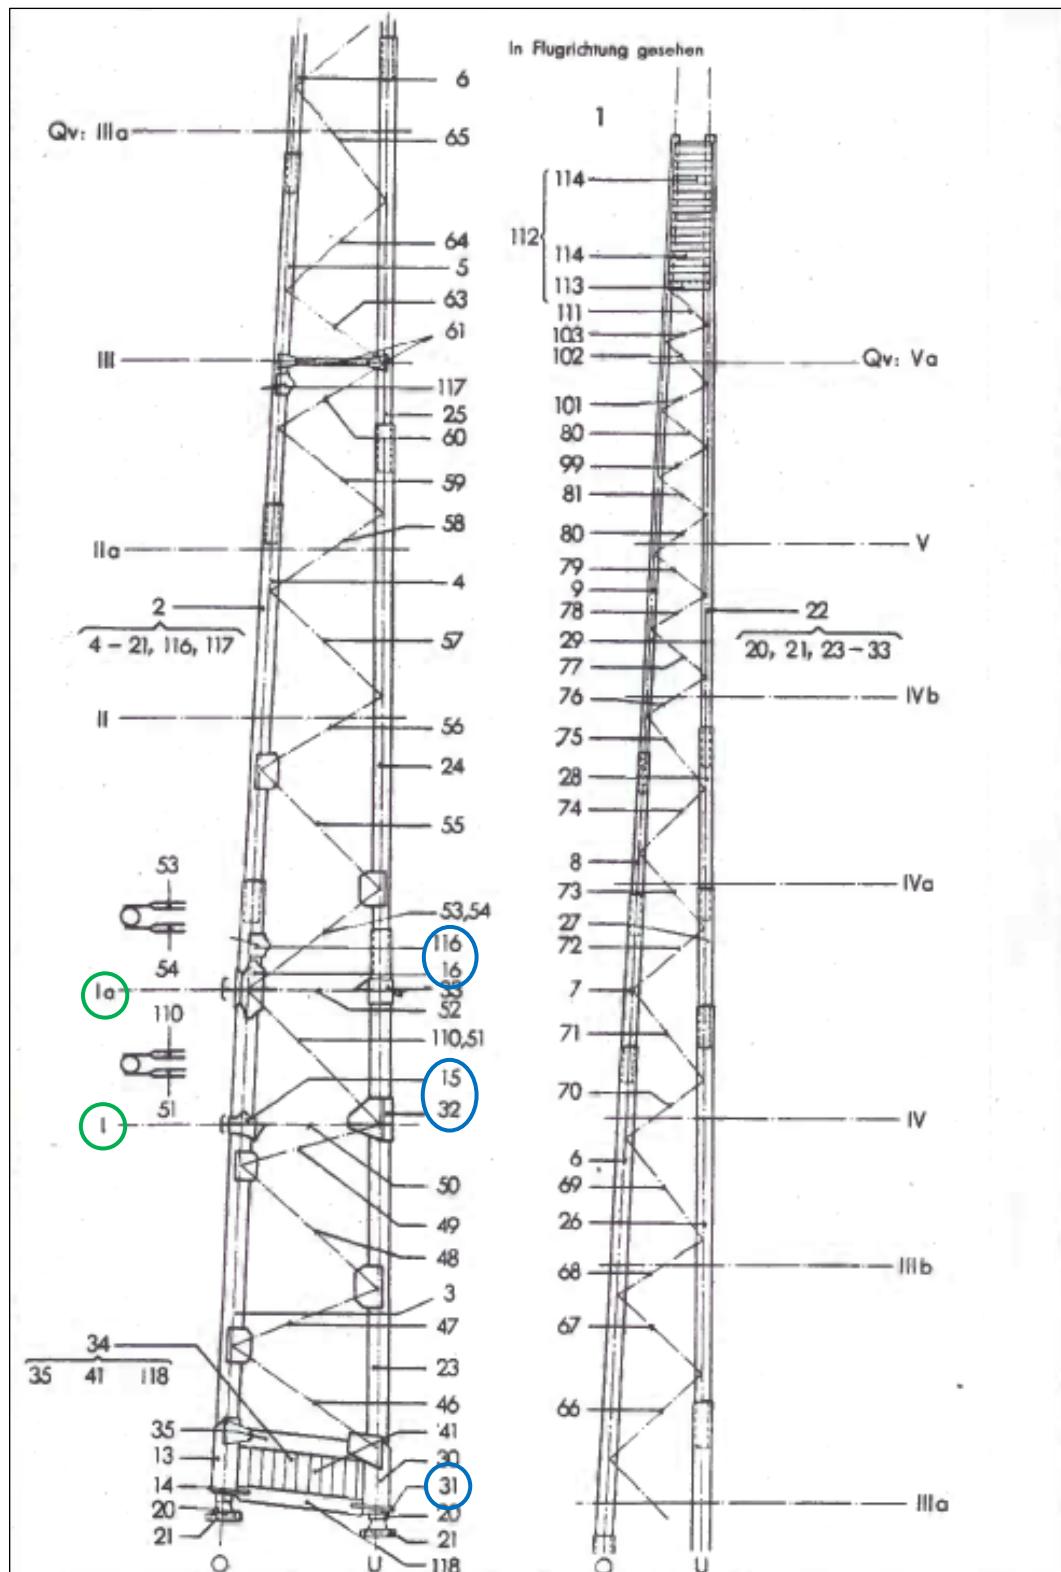
**Figure 3:** Spar I of the right-hand outer wing – the blue encircled position numbers indicate the examined parts, the green encircled positions I and Ia indicate the ribs. Source: Junkers Ju 52/3m aircraft parts list H.

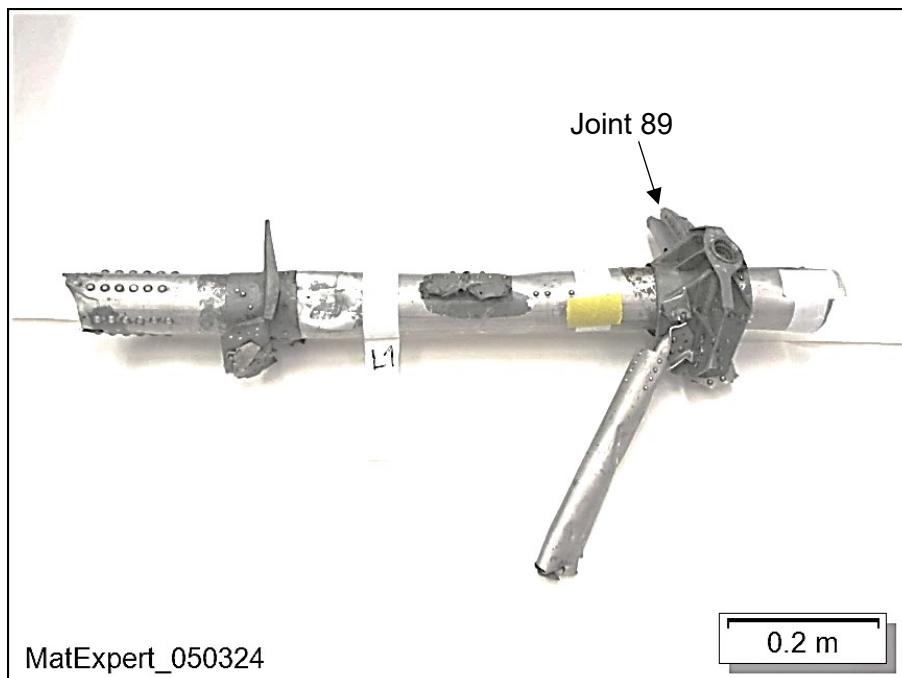
After removing joint 89 (see figure 4), severe corrosion and cracks were found in the contact area between the joint and the spar tube. This would not have been visible without dismantling the joint or the panelling. After cutting open the spar tube, no damage was visible on the inside (see figure 5). This shows that a borescope inspection cannot detect such damage and is therefore unsuitable (see annex [A1.6](#)).

**Figure 4:** Lower spar section L1 of the left outer wing.

Spar section L1 (see figure 4) exhibited grain boundary precipitations (see figure 6). These precipitates were formed either by artificial ageing after solution heat treatment or by a secondary, longer exposure to a temperature of more than 120 °C. This makes the material in question susceptible to intergranular corrosion. Intergranular corrosion can develop along the detected grain boundary precipitates.

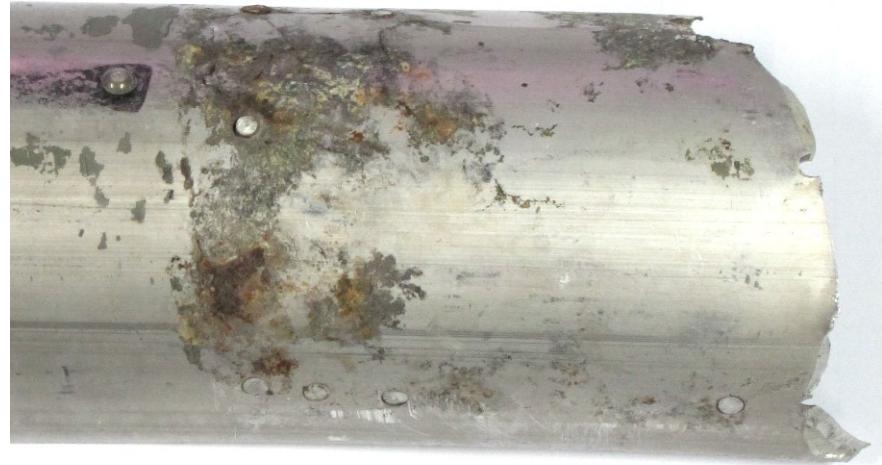
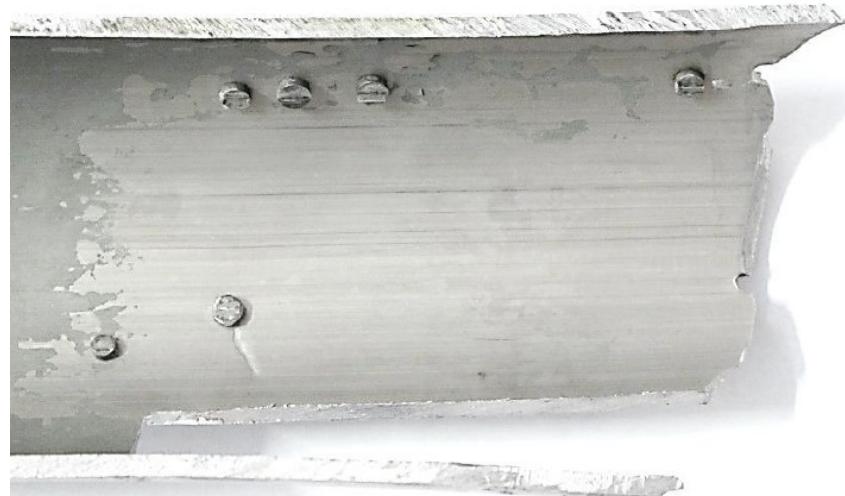
**Figure 5:** Cut open lower spar section L1 – the outer surface with corrosion and cracks, the inner surface with no signs of corrosion.

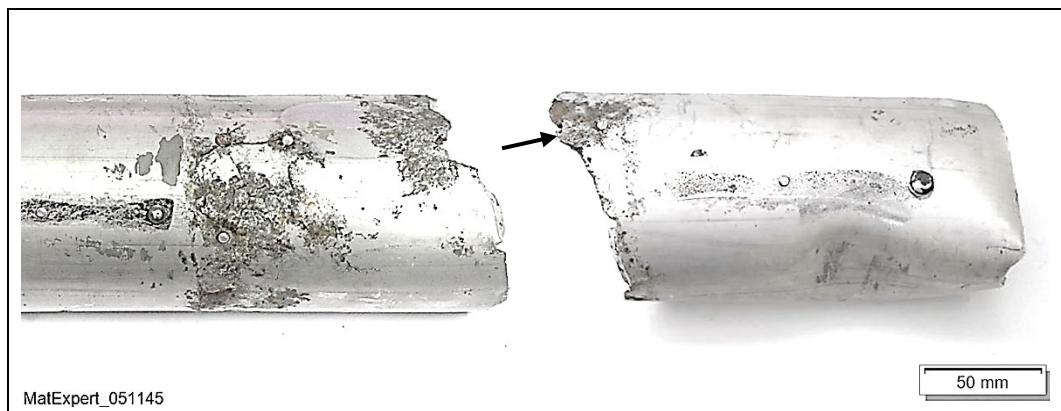
The spar tube below joint 89 was broken (see figure 7). The analysis of this fracture surface using SEM showed a ductile spontaneous fracture and a fatigue fracture with typical striations (see figure 8). The fatigue fracture accounted for approximately 10 % of the total fracture surface. Extensive corrosion damage and further cracks were uncovered in the contact area between joint 89 and the spar tube. This corrosion was intergranular corrosion resulting in a loss of wall thickness (see figures 9 and 10). One of the cracks was exposed and fractographically analysed (see figure 11). This crack was an intergranular fracture with striations, i.e. a fatigue crack (see figures 12 and 13).

**Figure 7:** Overview of the broken spar section; approximately 10 % of the fracture surface (arrow) is accounted for by fatigue fracture.

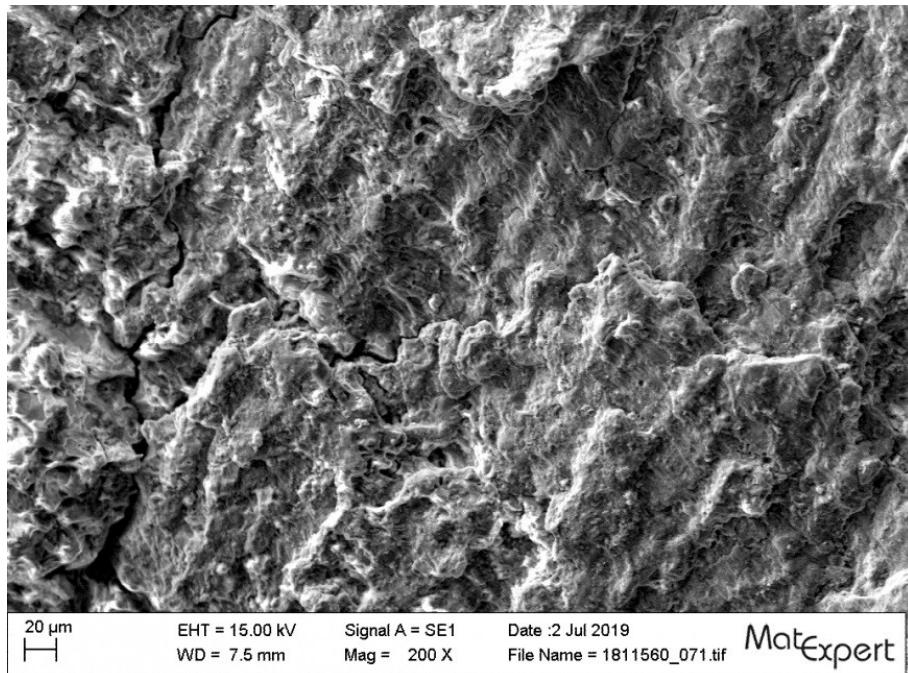
**Figure 12:** Close-up – crack surface in the exposed crack with fatigue fracture and intergranular cracks.

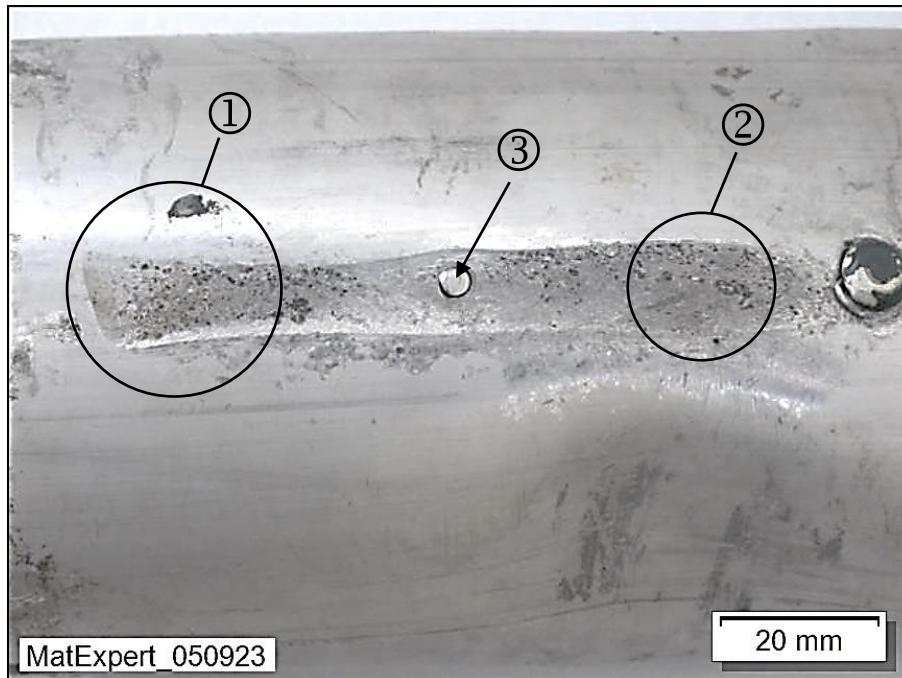
In the area where the panelling was riveted to the spars, damage similar to chafing can be seen (see figure 14). This type of wear attests that the panelling was no longer firmly attached to the spar and that the surface was severely damaged by the panelling's movement and by penetrating liquid (see figure 15). Besides general loss of material, intergranular cracks were also discovered (see figure 16). These cracks were mainly found near the rivet holes, and they can initiate fatigue cracks (see figure 17).

**Figure 14:** Wear on the lower spar L1 – number (1) see figure 15, number (2) see figure 16, number (3) see figure 17.

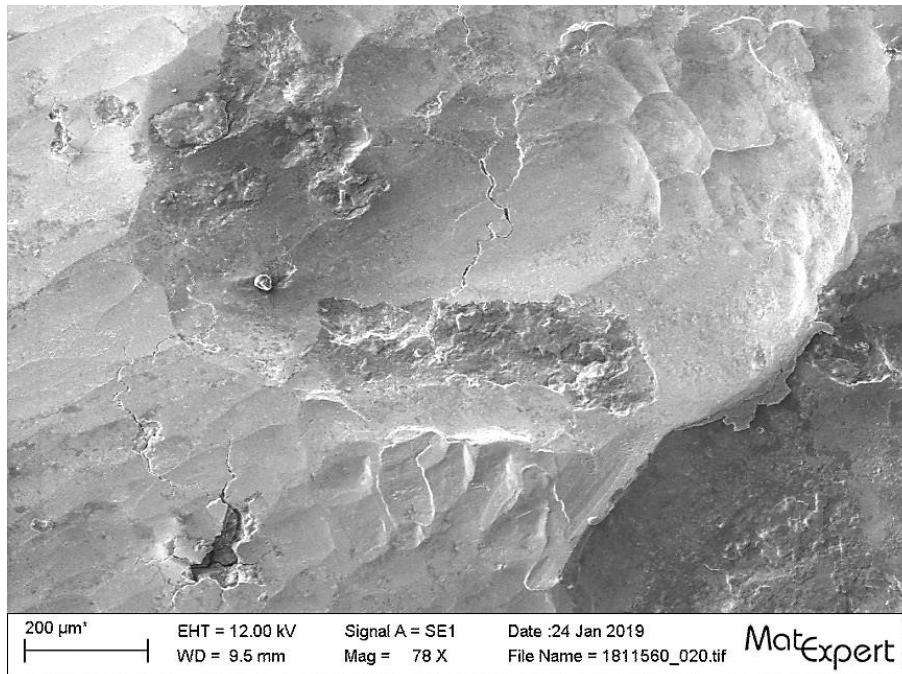
**Figure 15:** Impact wear on lower spar L1 (close-up of number (1) in figure 14).

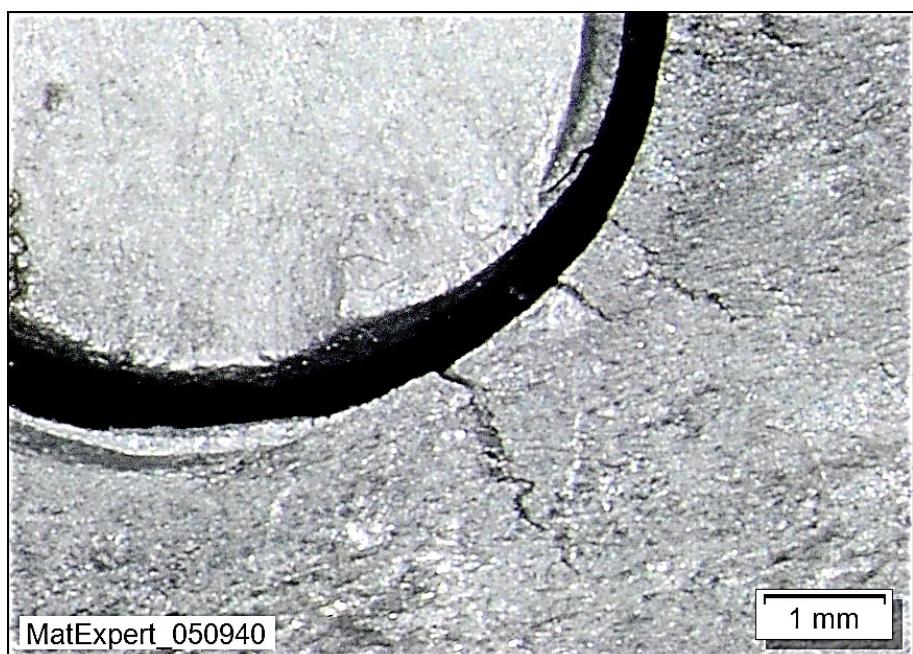
**Figure 17:** Intergranular incipient cracks at the rivet hole, crack lengths of up to 5 mm (close-up of number (3) in figure 14).

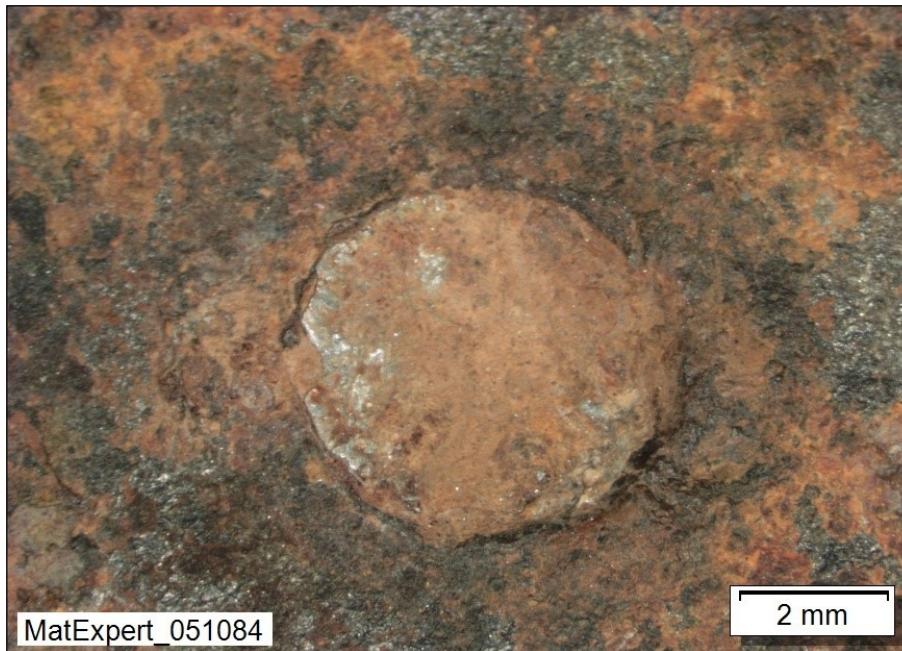
Rivet fractures were discovered which clearly occurred before the accident (see figure 21). They can be easily distinguished from the shear fractures caused by the accident.

**Figure 21:** Close-up – broken rivet N4 with severe corrosion.

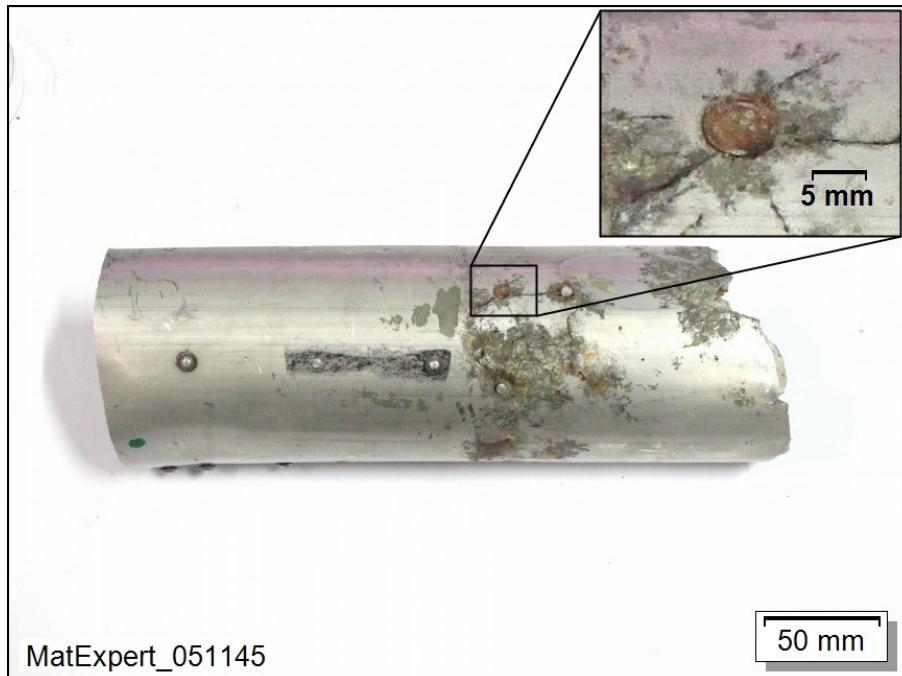
Fractures were found in the rivets which clearly occurred before the accident (see figures 23 to 25). Furthermore, intergranular corrosion was discovered (see figure 26). Fatigue and intergranular fractures were also discovered in some rivets. They can be easily distinguished from the shear fractures caused by the collision.

**Figure 23:** Spar section L1, after removing joint 89, with rivet N5.

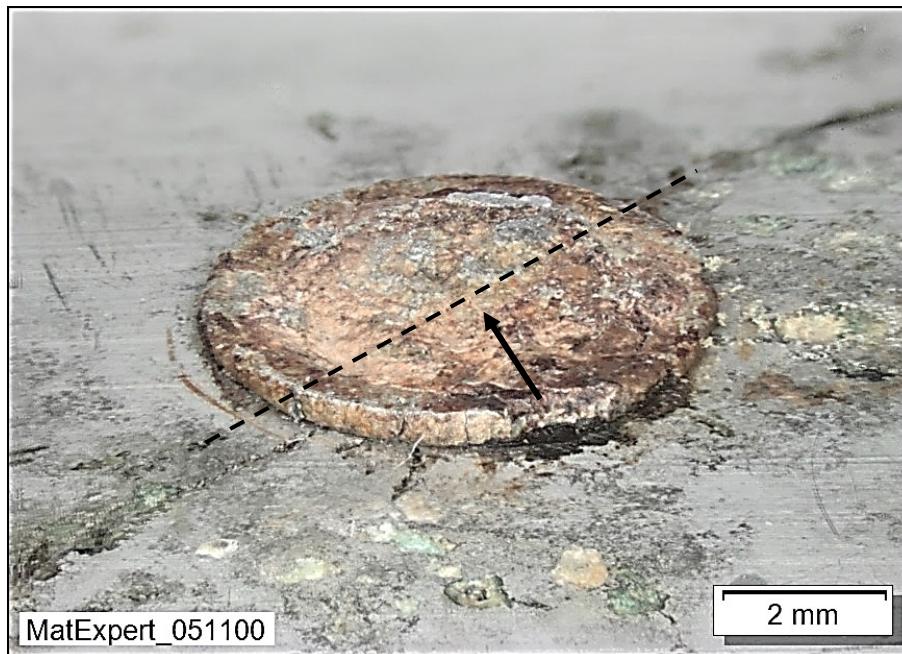
**Figure 24:** Severely corroded rivet N5. The black dashed line indicates the position of the microsection and the arrow indicates the direction the microsection surface was viewed from.

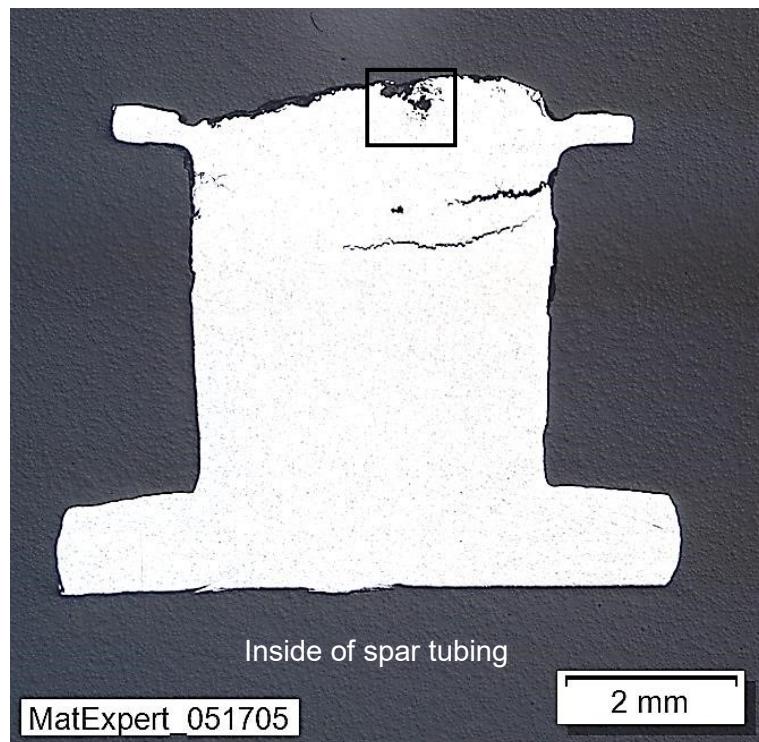
**Figure 25:** Cross section of broken rivet N5 with intergranular corrosion.

Intergranular corrosion causes cracks to form that give rise to the notch effect and can lead to the total failure of the component. Likewise, intergranular cracks form the ideal conditions for fatigue cracks to develop. This also applies to the connections between the steel joints and the aluminium spar tubes, which have been secured using rivets made of identical material (see figures 25 and 26).

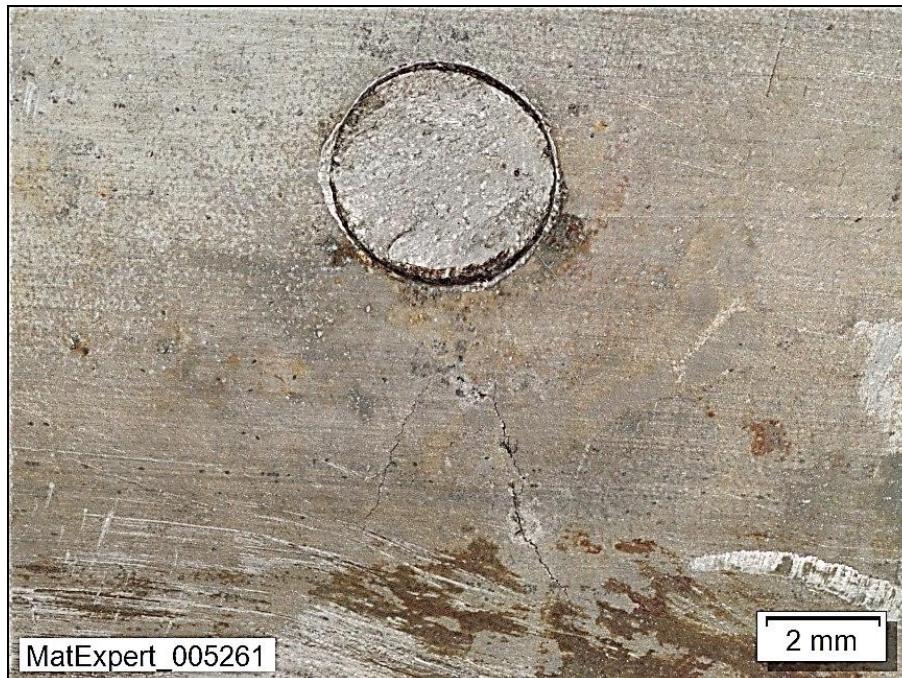
**Figure 29:** Area around joint 15 – brittle cracking, partially intergranular.

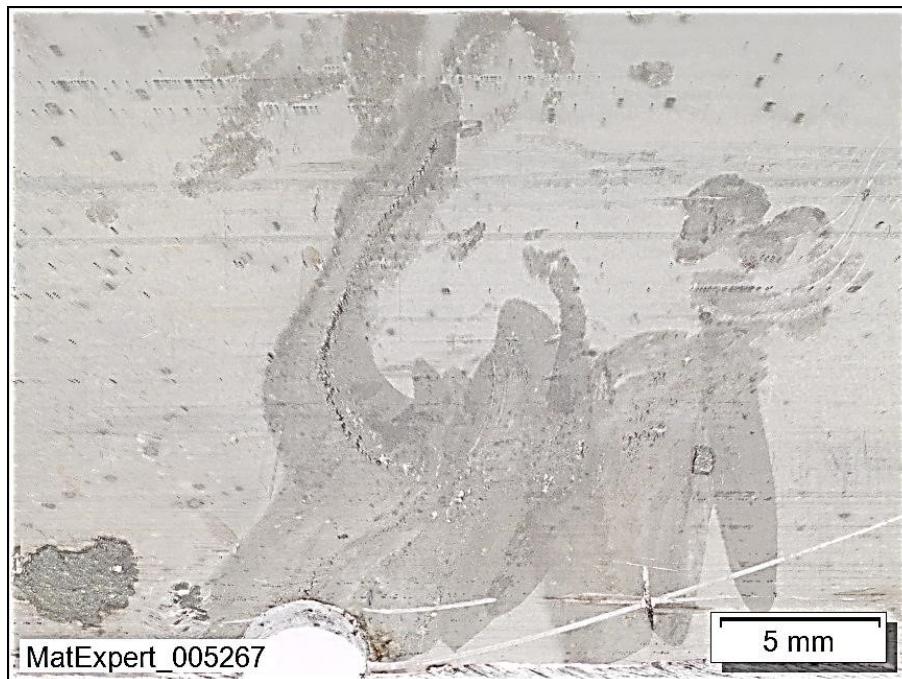
**Figure 30:** Area around joint 15 – crack-like surface condition.

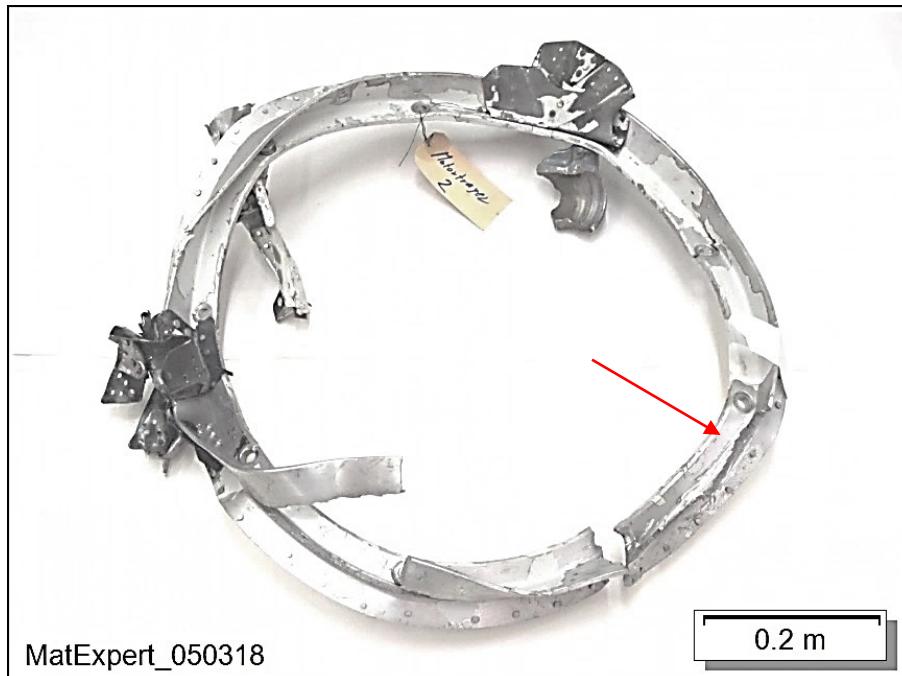
A fracture surface from the centre engine mount (see figure 33) was microfractographically analysed using SEM (see figure 34). The fracture was identified as a brittle, spontaneous fracture exhibiting a mixed fracture pattern of honeycomb, quasi-cleavage and intergranular fractures across a wide area (see figure 35). The intermetallic phases are clearly visible in the fracture pattern and are partially surrounded by roundish cavities. The localised 'terracing', which is a defect, is striking (see figure 36). On the fracture surface, a localised fatigue fracture-like formation can be seen (see figure 37).

**Figure 33:** Severely deformed and broken centre engine mount. A part of the fracture surface on the engine mount (red arrow) was analysed.

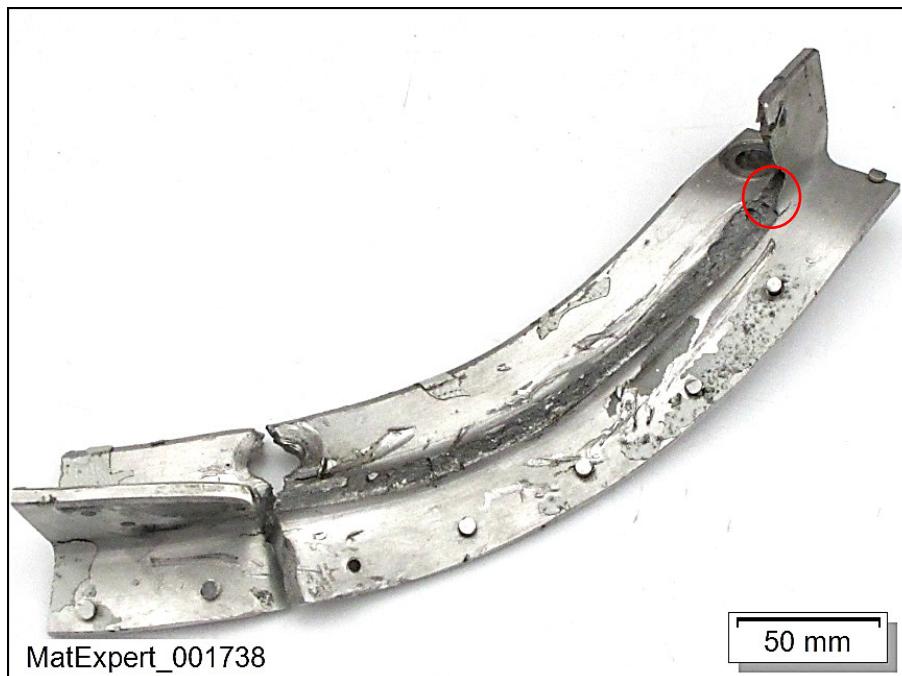
**Figure 34:** Location of the analysed fracture surface (red circle).

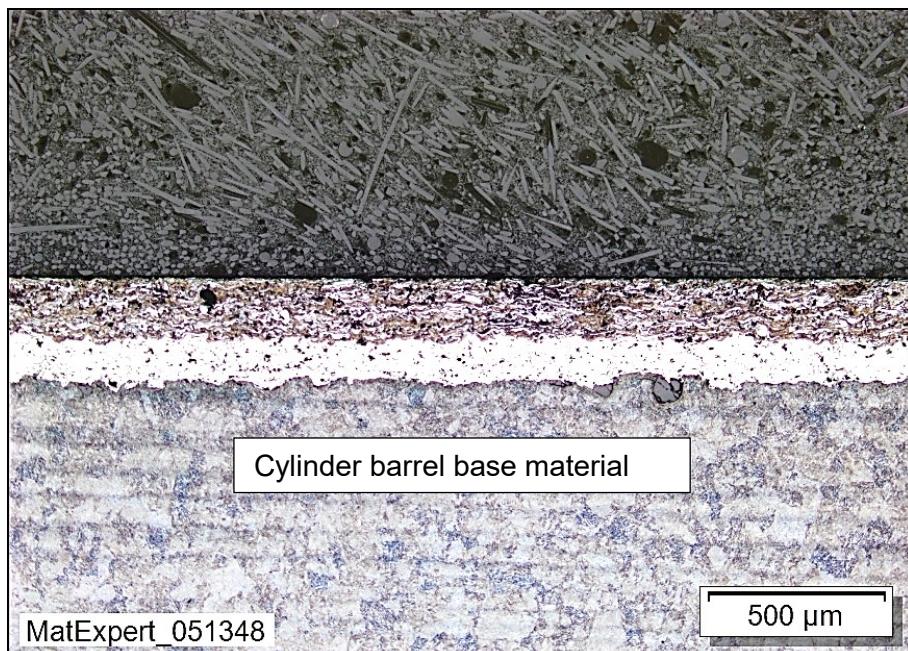
The cylinder from the right engine was plated with a thermal sprayed coating consisting of two different materials (see figure 45). The surface of this plating was porous, cracked and partially discoloured red (see figures 46 and 71).

What is known as a bond coat was found on the substrate, which had been covered by a top coat that featured approximately the same level of thickness as the bond coat. The measured thickness of the bond coat was 0.135 mm and that of the top coat 0.165 mm. The hardness measurement HV0.3 of the bond coat was 160 and that of the top coat 340.

**Figure 45:** Microsection with two-layer spray coating (right engine, cylinder 1).

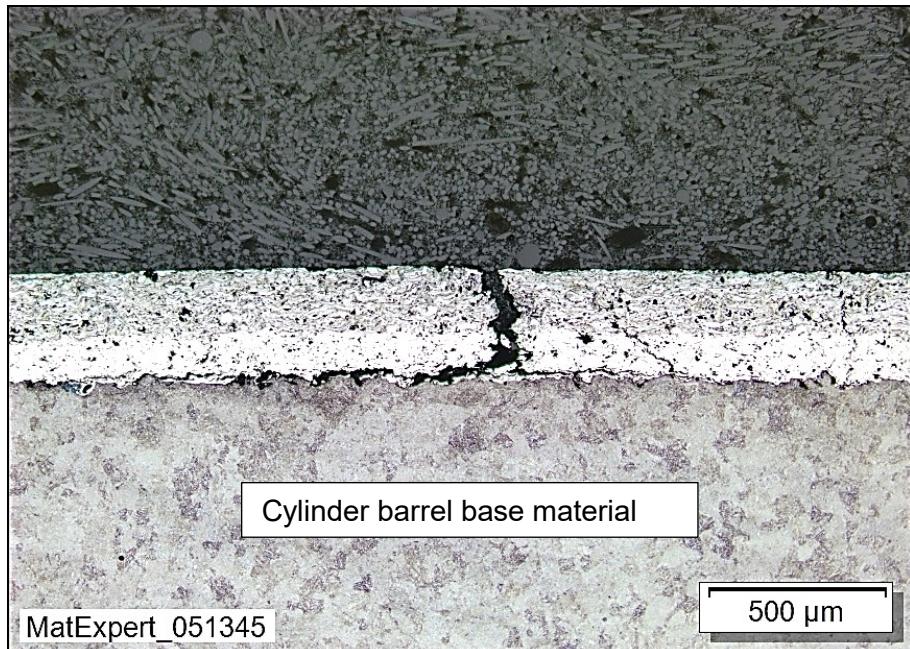
**Figure 46:** Crack in bond and top coat.

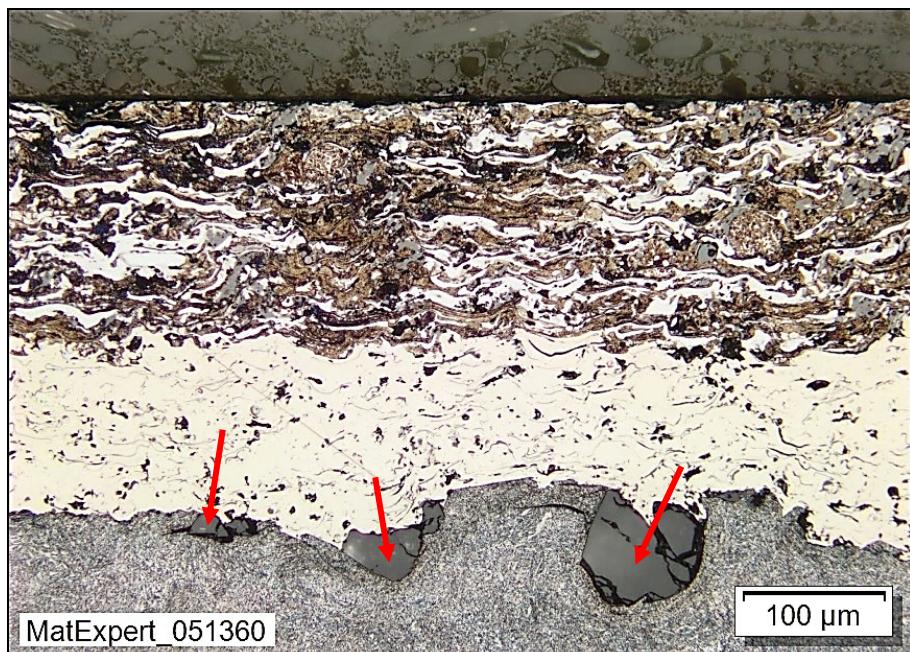
Prior to coating, the cylinder was honed to a diameter of 156.44 mm and the surface was abraded (see figure 47). Honing the cylinder to this diameter is not permitted according to the 1939 operating instructions supplied by the manufacturer of the BMW 132 A3 aircraft engine.

**Figure 47:** Microsection of the spray coatings with typical abrasive residues on the surface of the base material (red arrows).

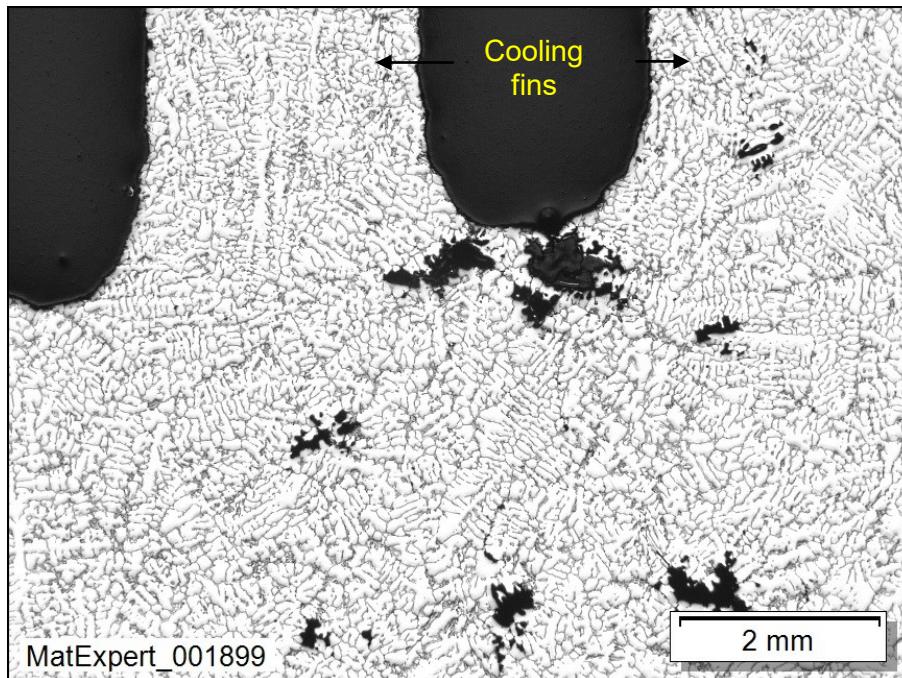
The material used for the cylinder head complies with the specifications of the engine manufacturer. Casting defects in the form of shrinkage cavities are evident (see figure 48). The microstructure can be judged as typical for the alloy in question, but is more consistent with a brittle state.

**Figure 48:** Microsection of the cylinder head's structure with solidification holes (left engine, cylinder 5).

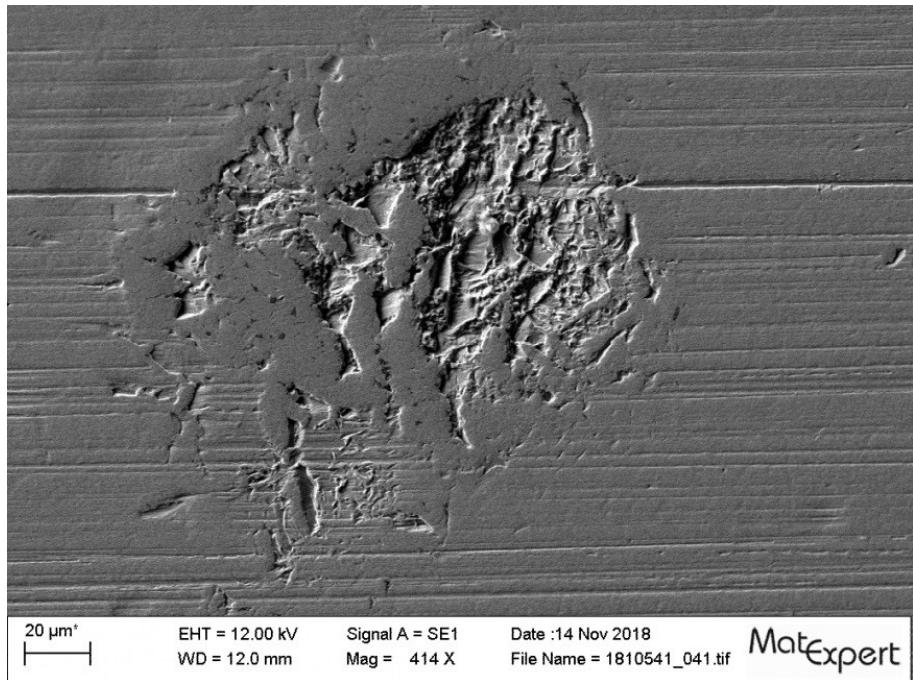
**Figure 52:** Ball bearing from the centre engine, outer-race bearing track – pitting, possibly due to foreign-body indentations.

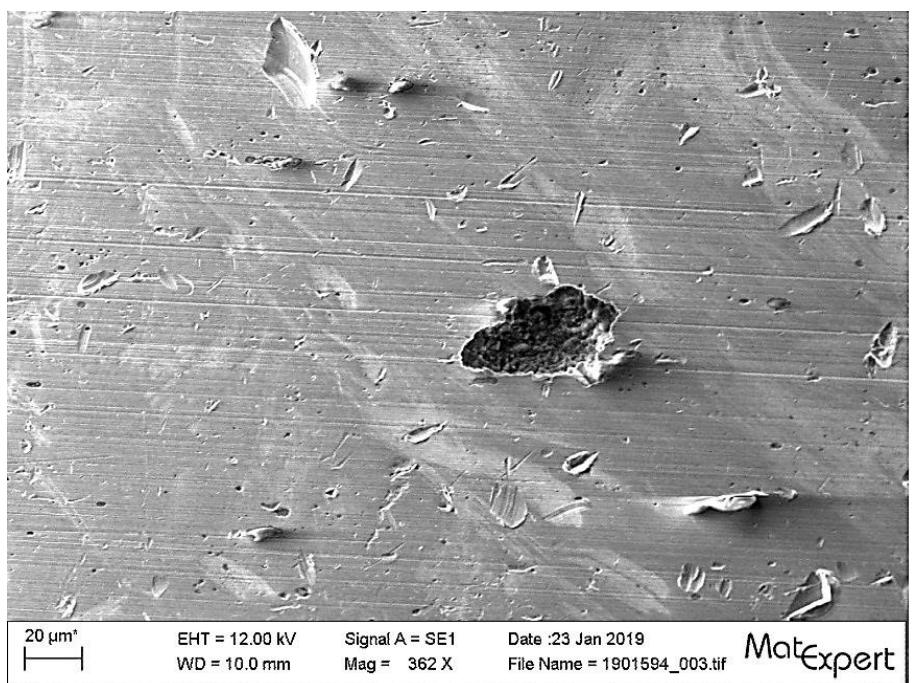
**Figure 53:** Ball bearing from the centre engine, inner-race bearing track – mechanical indentations, material chipping and pitting.

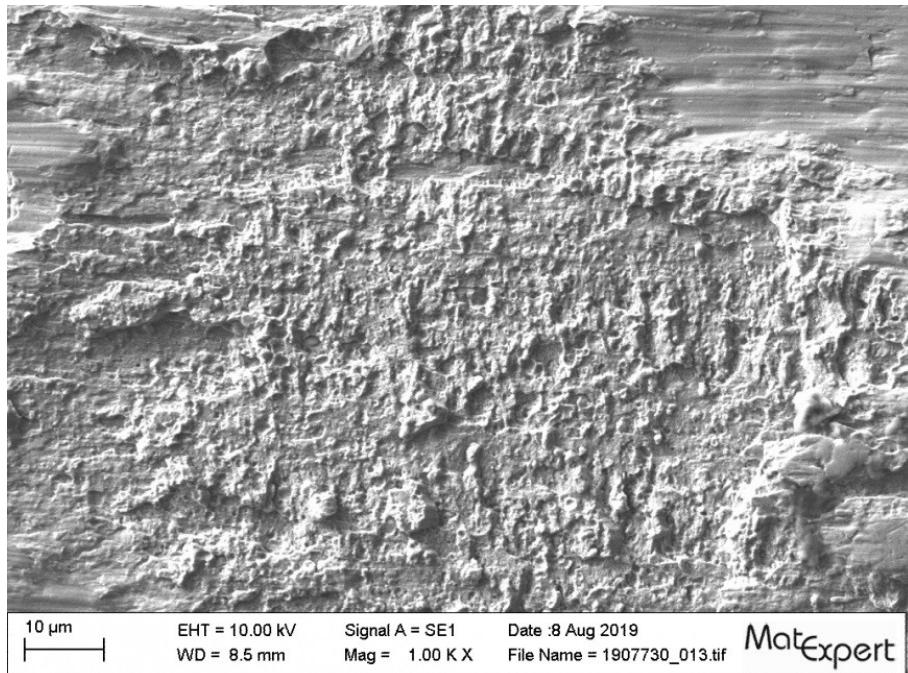
**Figure 55:** Close-up of the worn area – material chipping and cavitation.

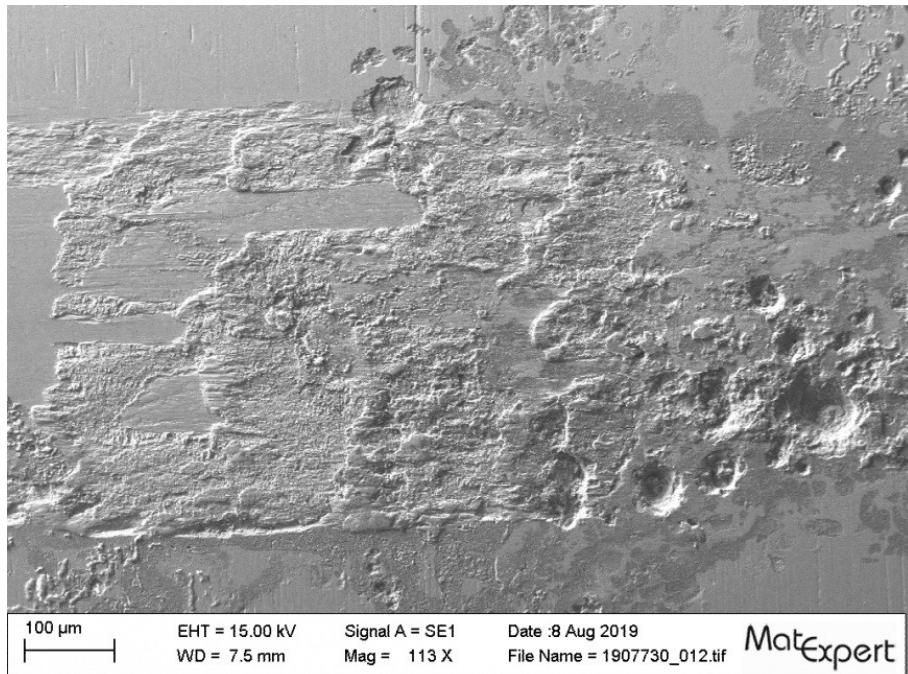
**Figure 56:** Close-up of the worn area – pitting.

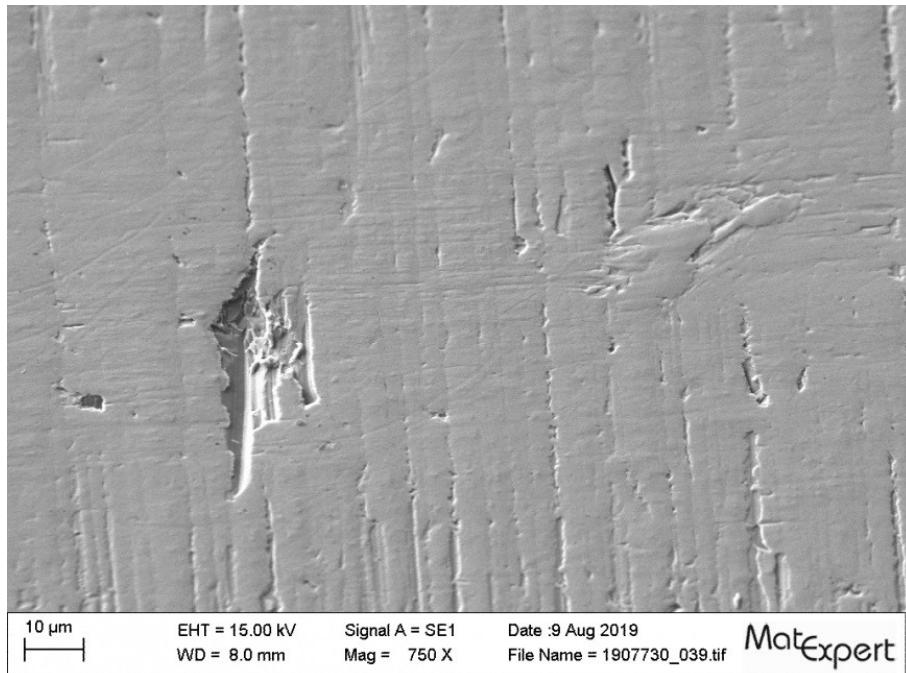
**Figure 57:** Bearing no. 3, outer-race bearing track – smoothed stop point and material build-up.

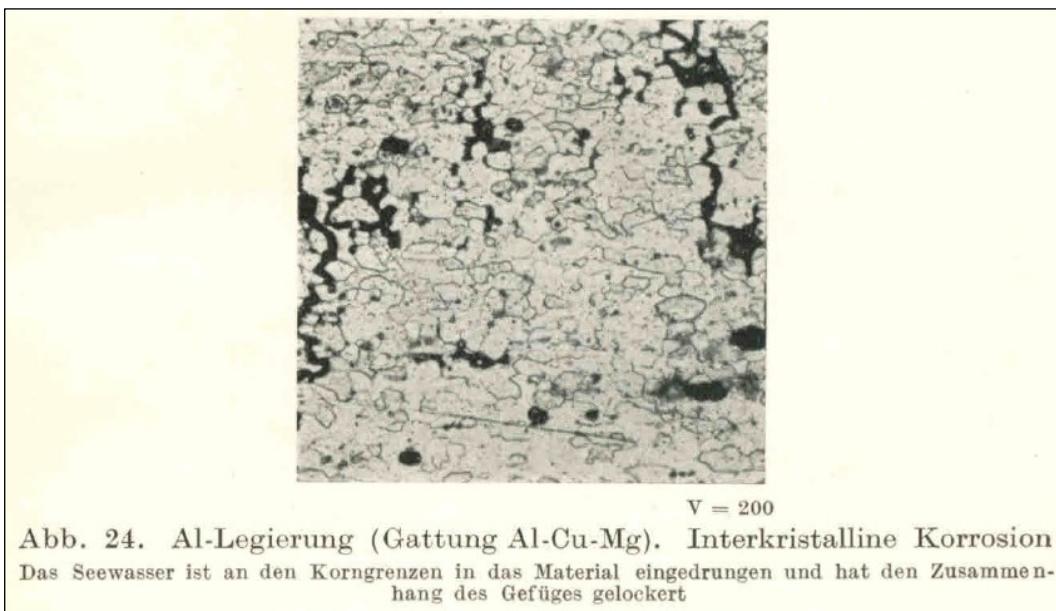
**Figure 61:** Illustration of an AlCuMg alloy with intergranular corrosion from book 28 of "Werkstoffkunde für den Flugzeug- und Motorenbau" by Ing. Cl. Böhne.

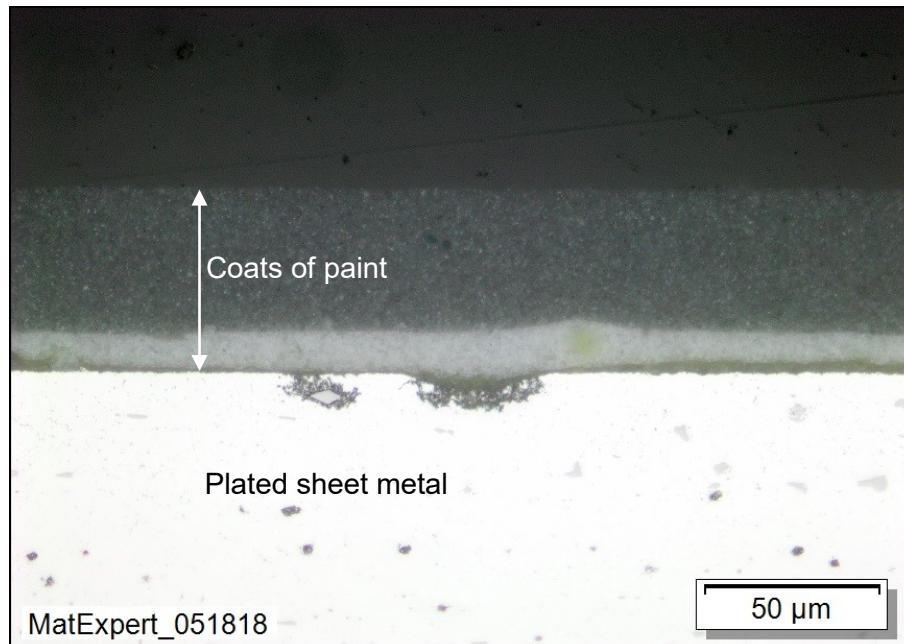
The panelling was also examined in the laboratory for corrosion. Analyses using scanning electron microscopy show that the surface was partially covered with corrosion and exhibited corrosive damage (see figure 69). Metallographically, corrosion spots can be detected in some areas on the surface of the plating, underneath the coat of paint (see figure 70).

**Figure 70:** Microsection of corroded plated sheet metal under the layers of paint.

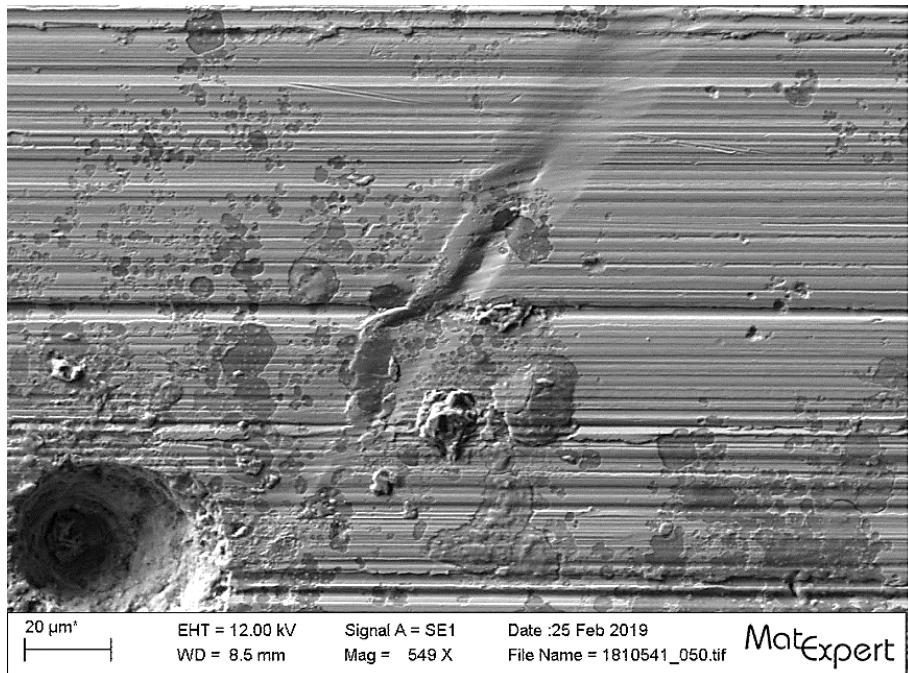
The three propeller bearings were subjected to corrosion tests in the laboratory. For this purpose, the bearings were cut in half and the individual bearing components were analysed. All three bearings exhibited tribological and corrosive damage (see figures 73 to 75). As the corrosive damage to the bearing tracks and surfaces on the inner race fitting the shaft as well as on the outer race fitting the housing was found to have already existed for a long time prior to the accident, it has to be assumed that the corrosive damage caused the tribological damage to the bearings.

**Figure 74:** Ball bearing from the left engine, inner-race bearing track – pitting and indentation.

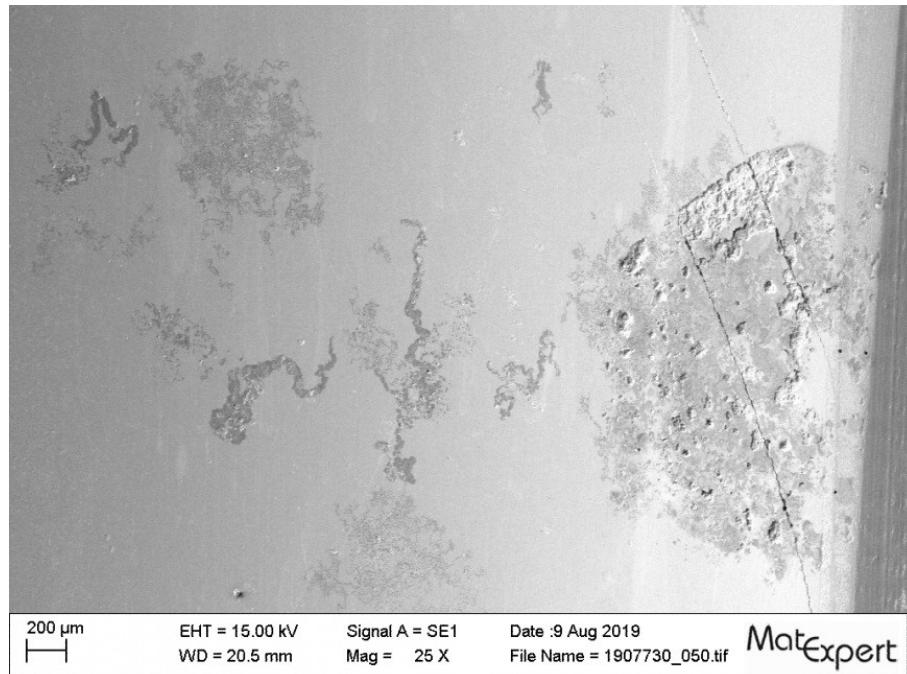
**Figure 77:** Bearing no. 4, outer-race bearing track – filiform corrosion and pitting with cracks.

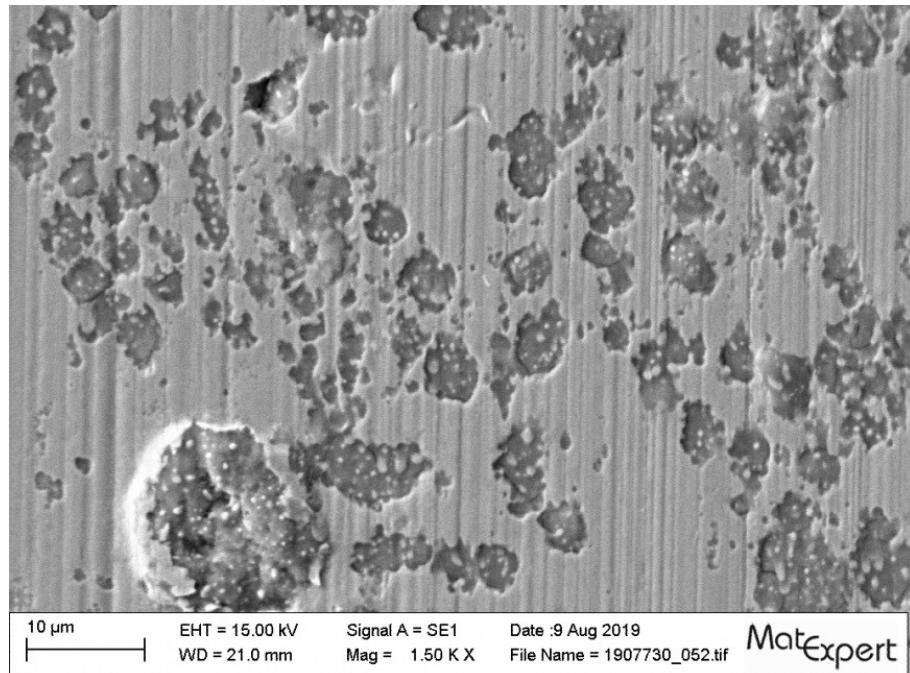
**Figure 78:** Close-up of figure 77.
