## A1. Factual information

### A1.16 Tests and research results

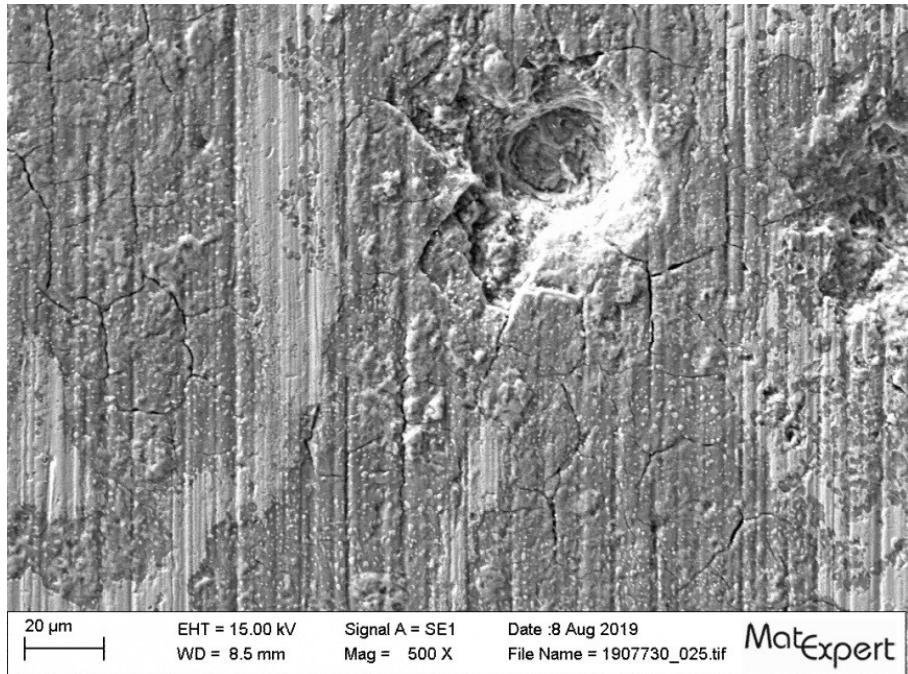
**Figure 81:** Close-up of figure 80 – stress cracks in the corrosion.

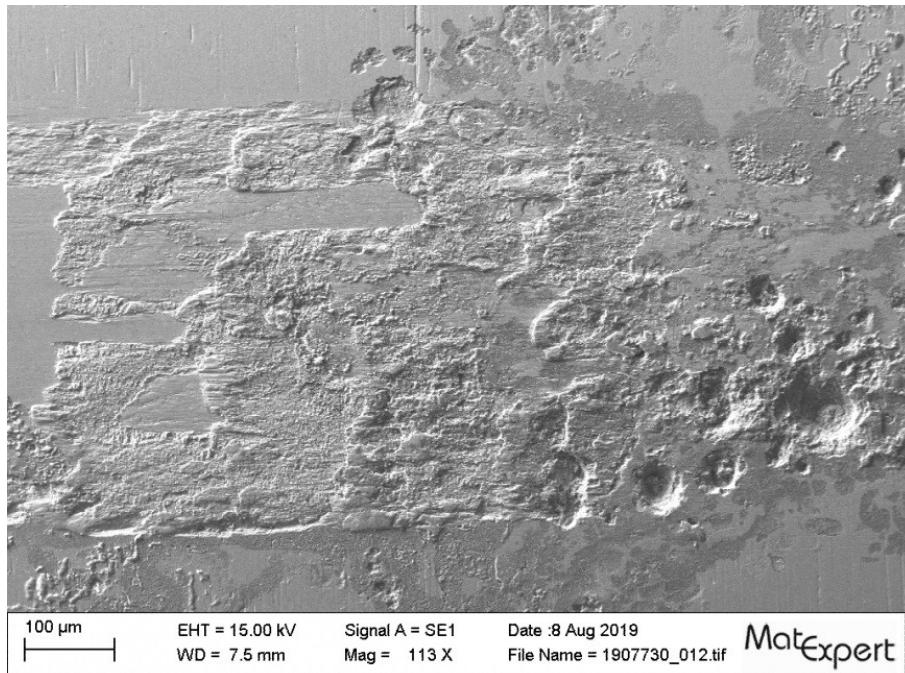
**Figure 82:** Bearing no. 3, cylindrical roller – pitting and corrosion.

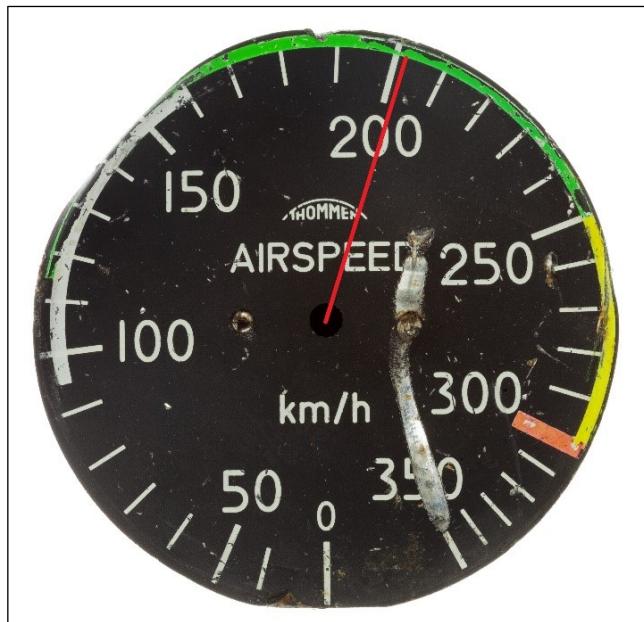
**Figure 85:** Speed indicator dial.

The needle left scratch marks in the range of 200 km/h (see figure 85). The needle's counterweight left a notch above the letter 'k' of the km/h notation. The positioning of a comparable needle in line with the detected marks showed that the instrument needle should have indicated a value of approximately 202 km/h at the point of impact.

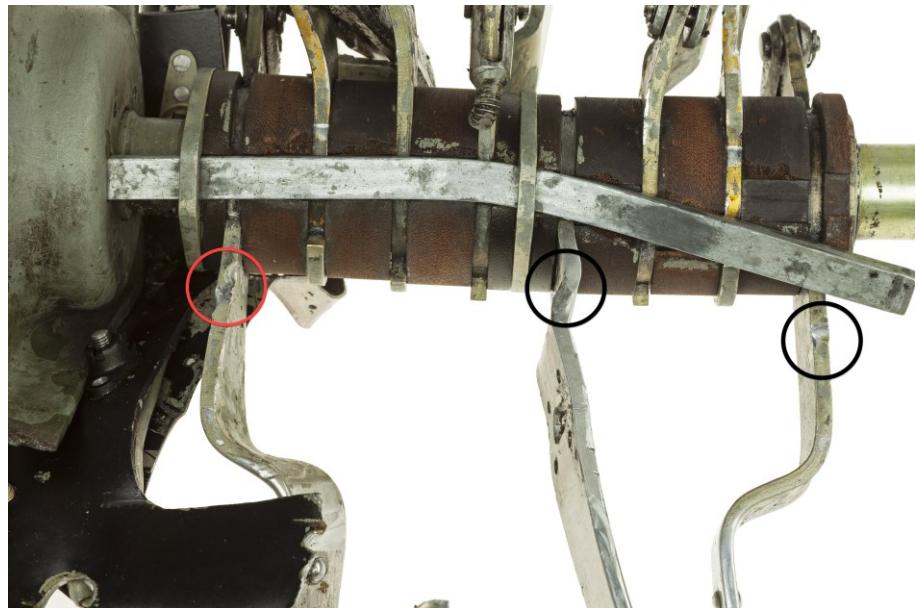
The three circled marks are located in the area where the limit stop bolts touch the front of the main throttle levers when in the 'on' position (see figure 87). Circled in red is the mark on the main throttle lever for the left engine, which was generated by the corresponding limit stop bolt (see figure 88). The direction of movement for the applied force is clearly visible in the image of the curved indentation, or notch.

Figure 87: Front of the three main throttle levers with circled marks.

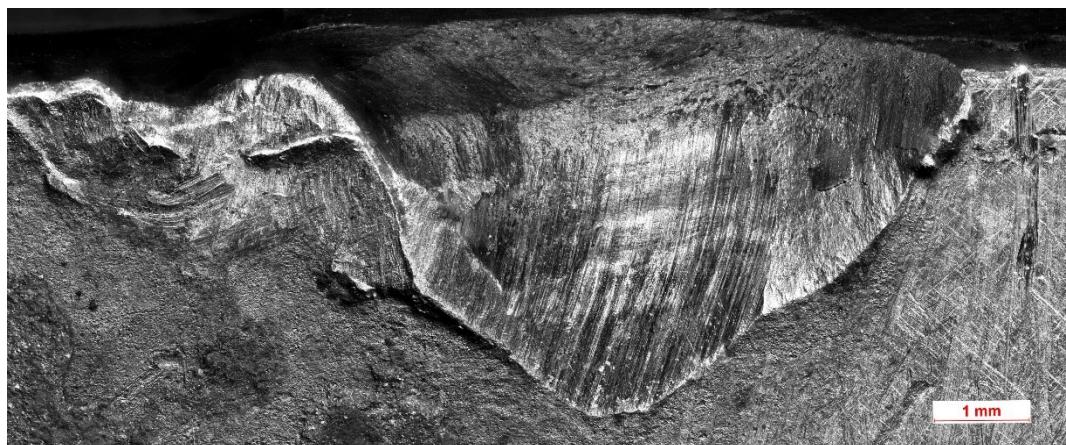
Figure 88: Notch mark on the main throttle lever for the left engine.

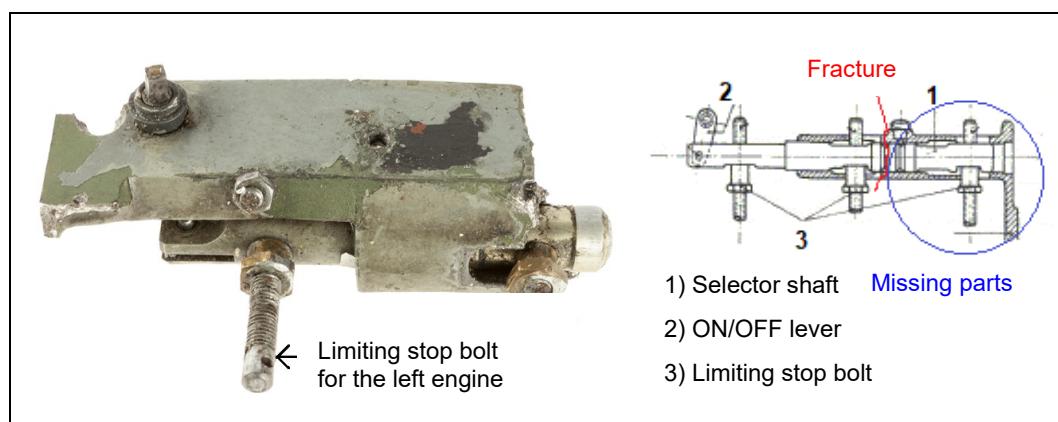
A fragment of the full-throttle limiting mechanism was found in the wreckage (see figure 89). On the limit stop bolt for the left engine, damage was found on 13 turns of the thread (see figure 90).

Figure 89: Fragment of the full-throttle limiting mechanism with limiting stop bolt for the left engine.

These marks on the front of the main throttle levers and the damage on the thread of the limit stop bolt for the left engine could only have happened if the full-throttle limit had been set to 'on' at the time of the impact.

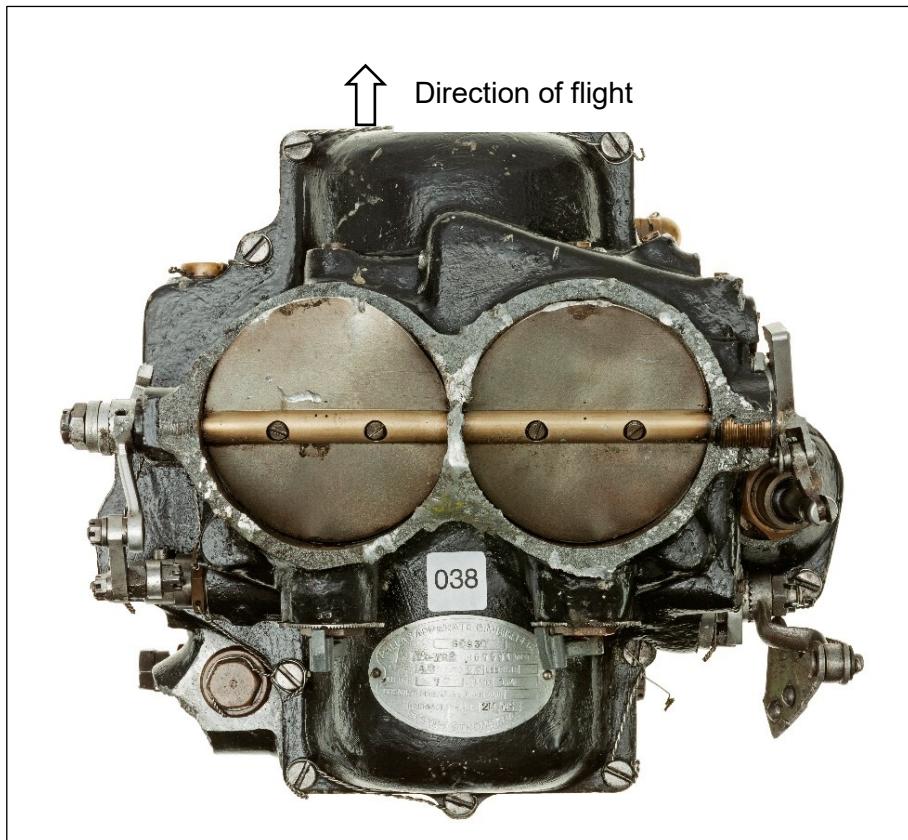
The carburettors exhibited varying degrees of damage. With the carburettors for the left and the centre engines, the flange above the two butterfly valves was broken off (see figure 91).

**Figure 91:** As an example, the carburettor for the centre engine is shown.

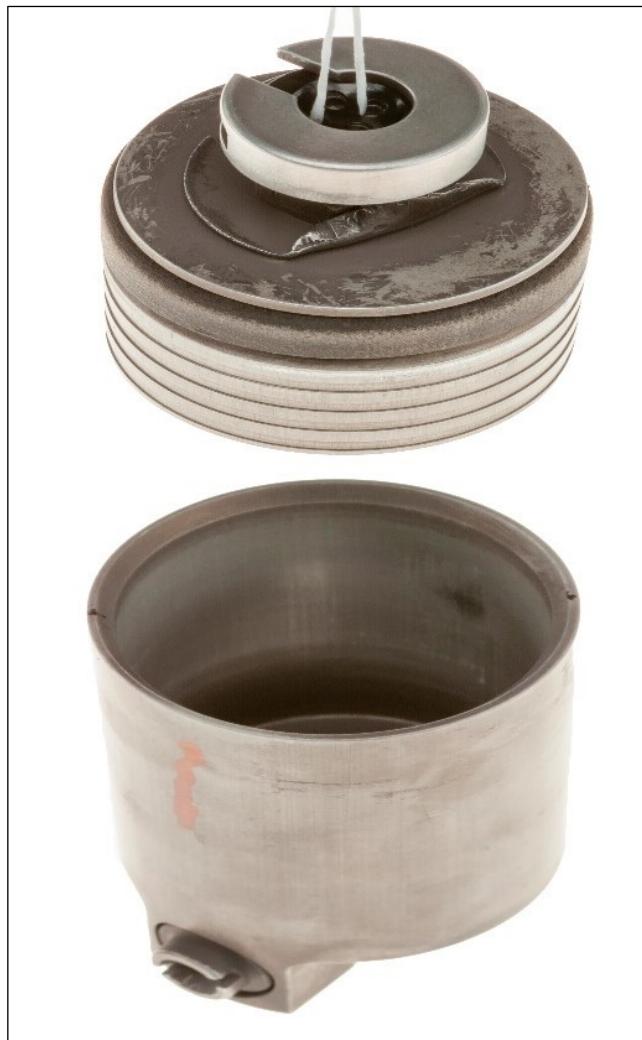
The accelerator-pump piston (see figure 92) is located at the top of the pump cylinder when the engine is idling. As the butterfly valve opens, the piston is pushed down by a connecting rod linked to a bell crank until it is at the bottom of the pump cylinder when the butterfly valve is fully open. As a result, the butterfly valve and the accelerator-pump piston run synchronously.

The maximum stroke for the piston in the pump cylinder is about 24 mm.

**Figure 92:** Accelerator-pump piston and pump cylinder.

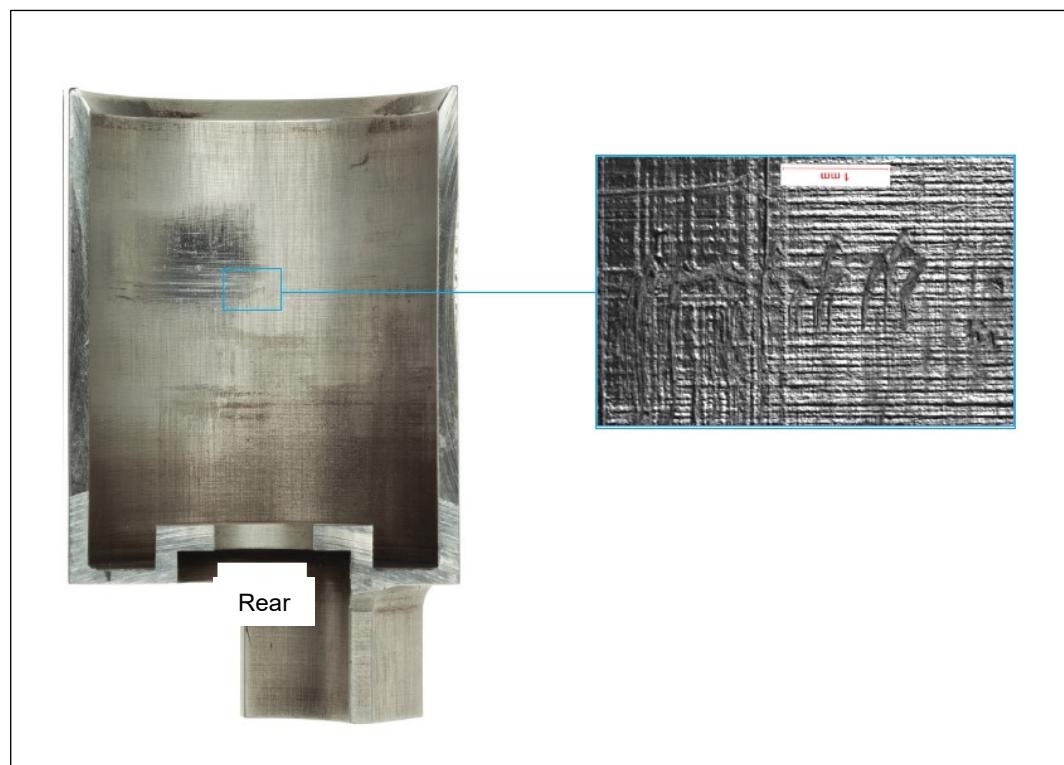
The cylinders in the accelerator pumps were sectioned to allow the bores to be examined under a stereomicroscope. Abrasions that cannot be attributed to conventional wear caused by the piston movements during normal operation were visible on all of the bores (see figures 93 to 95). These abrasions do not run axially in a straight line, but are slightly curved or jagged.

**Figure 94:** Abrasions in the pump cylinder from the carburettor for the centre engine.

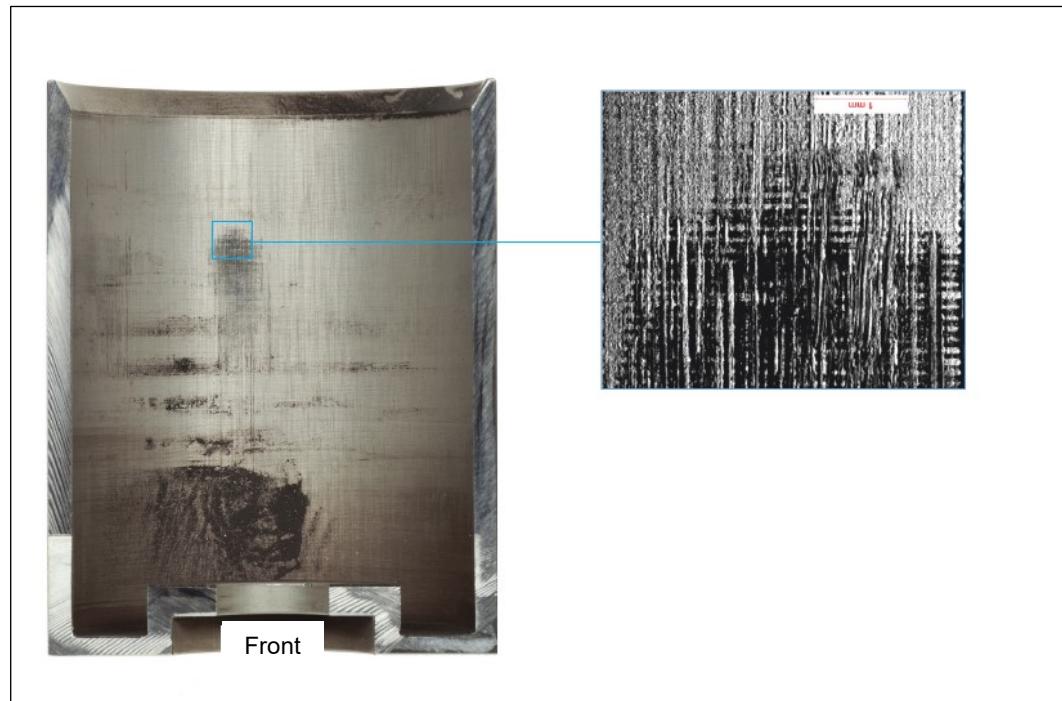
**Figure 95:** Abrasions in the pump cylinder from the carburettor for the right engine.

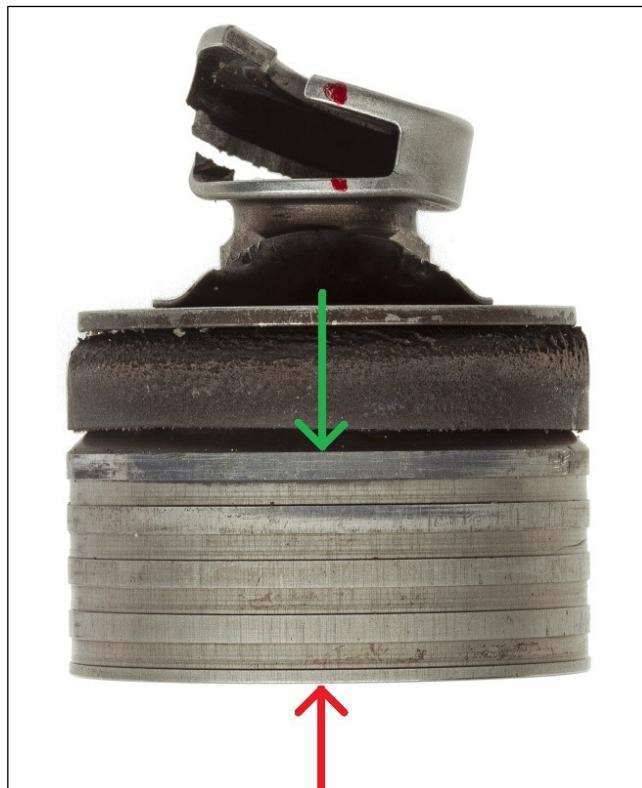
All three pistons were inspected for damage and other abnormalities under the stereomicroscope. This revealed that the chamfer at the lower end of the piston (see red arrow in figure 96) was not damaged on any of the pistons. However, all of the pistons exhibited signs of wear and abrasions on the chamfer where the upper end of the piston skirt (green arrow) transitions into the sealing ring. These abrasions can be plausibly attributed to the corresponding curved and jagged abrasions on the pump cylinder bores.

**Figure 96:** Accelerator-pump piston from the carburettor for the centre engine.

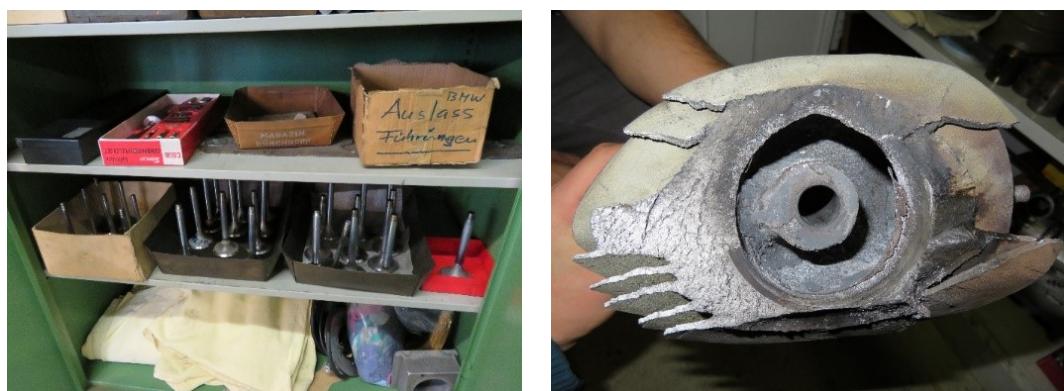
The STSB also discovered after the accident that, at Ju-Air, the components stored in the hangar were neither marked with a tag nor with a release certificate for identification. Furthermore, the spare parts warehouse did not have identification papers for all components. In Naef Flugmotoren AG's engine workshop, there were engine components which were also unidentifiable (see figure 2).

**Figure 2:** Unidentifiable engine components stored in a cabinet.

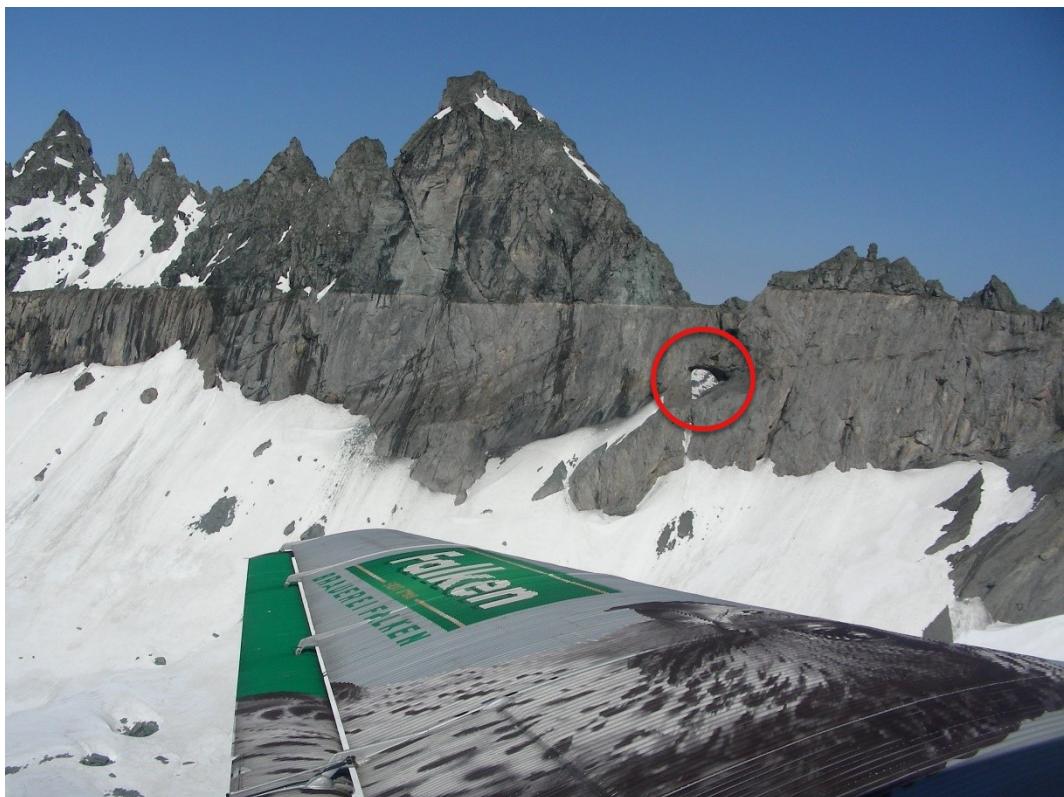
Three photographs taken from HB-HOP were available from a flight over the Segnespass on 6 July 2013. Figure 1 shows a flight past the Martinsloch. On board HB-HOP for this flight was the same crew as on the accident flight in HB-HOT on 4 August 2018.

**Figure 1:** The second of three photographs taken from HB-HOP on 6 July 2013 during a flight past the Martinsloch (red circle).

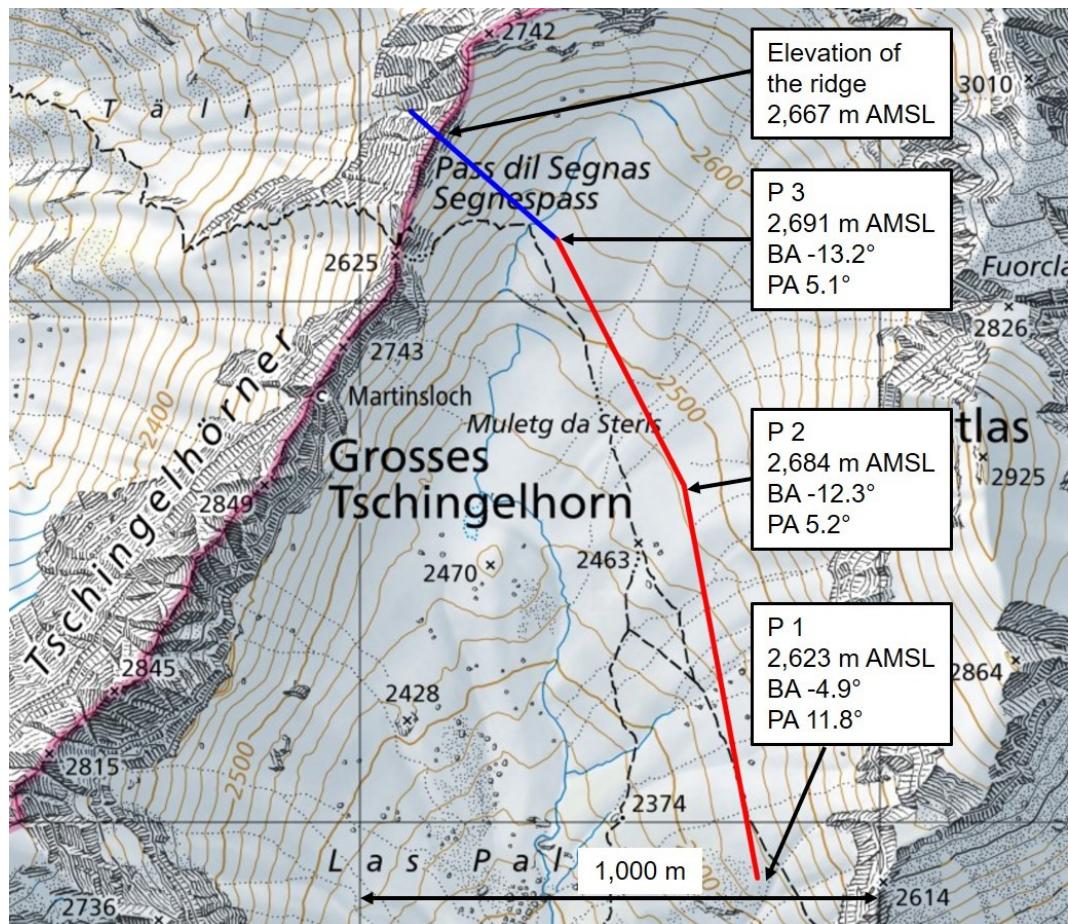
**Figure 2:** The flight path (red) and extension of the flight path (blue) reconstructed from data points P 1 to P 3 for the flight on 6 July 2013. Assuming the altitude of P 3 was to be maintained, the difference in height between the extension of the flight path (blue) and the elevation of the ridge is 24 m. Source of base map: Swiss Federal Office of Topography.

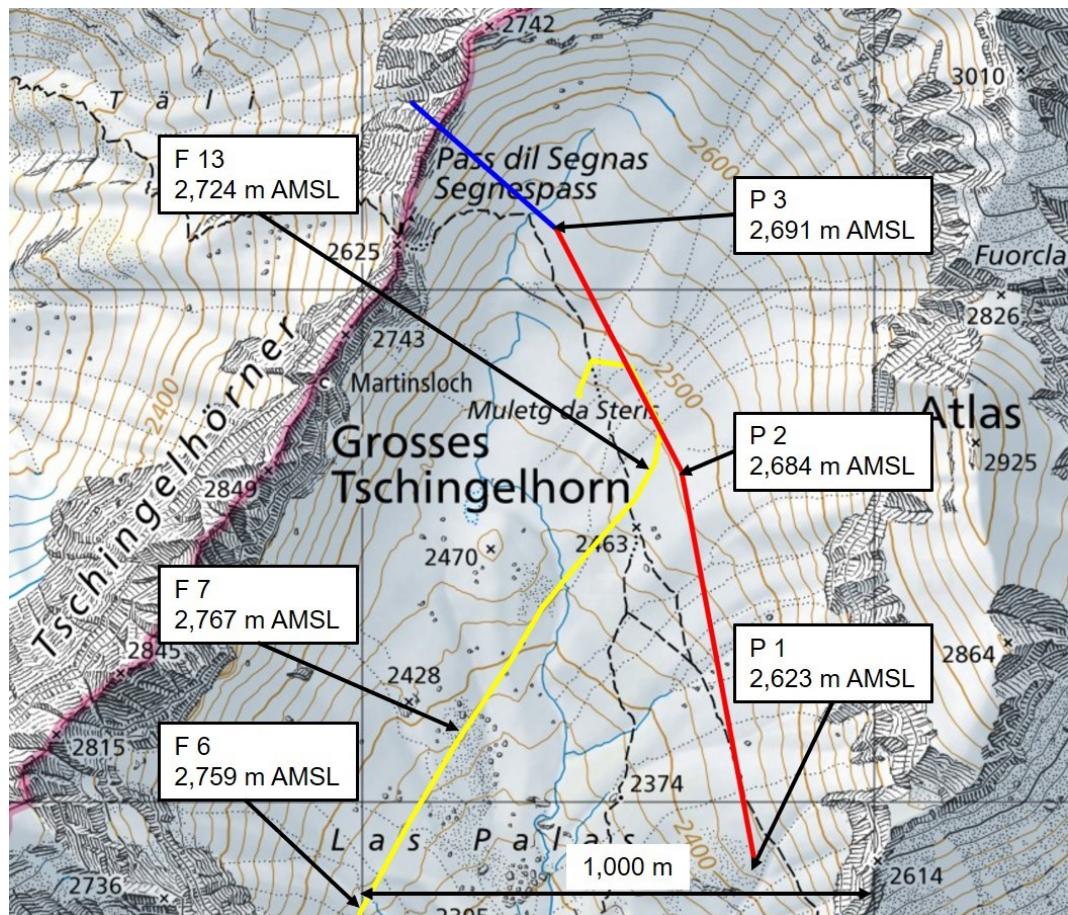
There are striking parallels between the flight past the Martinsloch on 6 July 2013 and the accident flight (see figure 4).

**Figure 4:** Comparison between the reconstructed flight paths of 6 July 2013 (red) and the accident flight of 4 August 2018 (yellow). On 6 July 2013, the section of terrain in front of the Segnespass was entered along the western flank of the mountain called Atlas, approximately 150 m lower than during the accident flight. Source of the base map: Swiss Federal Office of Topography.

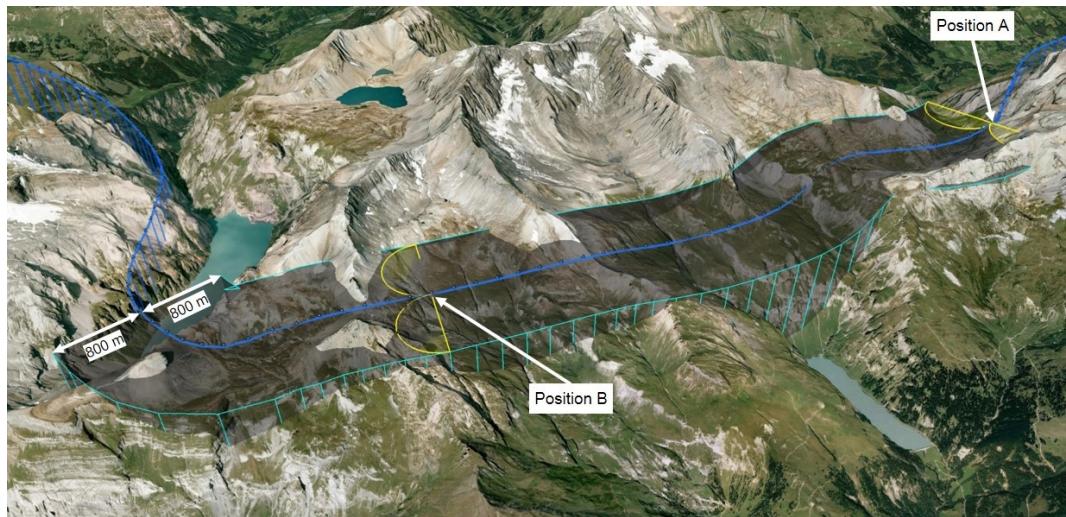
and a turn radius of 400 m, i.e. a 180-degree turn with a diameter of 800 m (see figure 7). It should be noted that this is a theoretical consideration assuming optimal conditions. In particular, the margin on the stall speed does not represent a large enough safety margin for flying in the mountains. Furthermore, no minimum distance from the terrain was taken into account, which would of course also have to be respected in reality.

**Figure 7:** Flight path of HB-HOP on 4 August 2018, ascertained from GPS data (blue) and 180-degree turns (yellow) at a constant flight altitude at positions A and B. Shown on Google Earth.

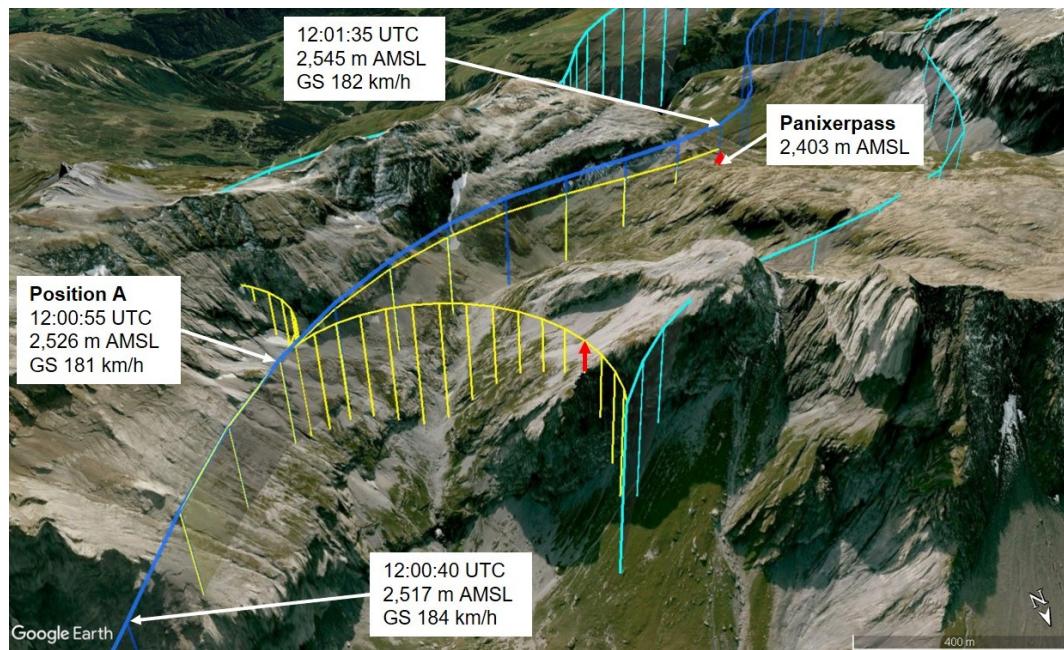
The approach over the V-shaped valley to the Panixerpass, which was flown over at approximately 140 m above ground, was made along a slightly climbing flight path. A 180-degree turn to the right would still have been possible at position A, assuming the parameters described above, i.e. if flown at a turn radius of 400 m and a rate of descent of 2 m/s. Just before the end of the semicircle (red arrow in figure 8) the hypothetical flight path runs approximately 100 m above the terrain. Had the flight hypothetically continued (marked in yellow in figure 8), also at a rate of descent of 2 m/s, the flight path would have run over the Panixerpass at a height above ground of approximately 43 m.

**Figure 8:** Flight path of HB-HOP on 4 August 2018, ascertained from GPS data (blue), including a zone 800 m either side and hypothetical flight paths at position A (yellow) assuming the sink rates described. Shown on Google Earth.

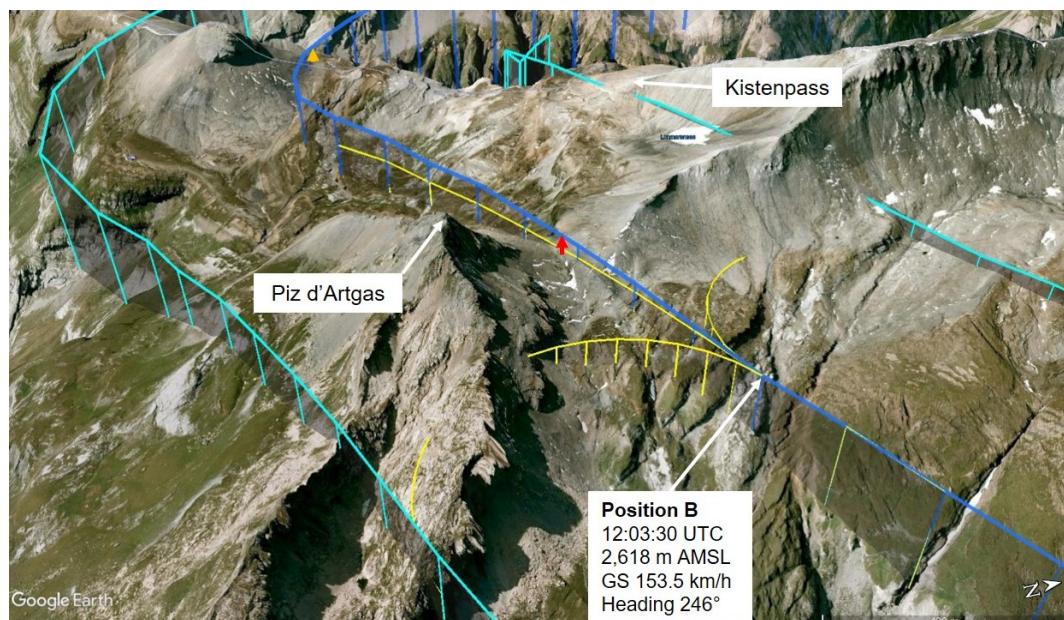
The saddle of the Piz d'Artgas mountain was flown over at 90 degrees to the saddle ridge at an altitude of less than 50 m above ground (red arrow in figure 9). A 180-degree turn was not possible from position B onwards, approximately 690 m or 17 seconds before the overflight. Had the flight hypothetically continued at a rate of descent of 2 m/s, it would have flown over the saddle of the mountain at a clearance of less than 10 m.

During the right turn south-west of the Kistenpass, the altitude when flying over the ridge at 90 degrees was approximately 60 m (orange arrow in figure 9).

**Figure 9:** Flight path of HB-HOP on 4 August 2018, ascertained from GPS data (blue), including a zone 800 m either side and hypothetical flight paths at position B (yellow) assuming the sink rates described. Shown on Google Earth.

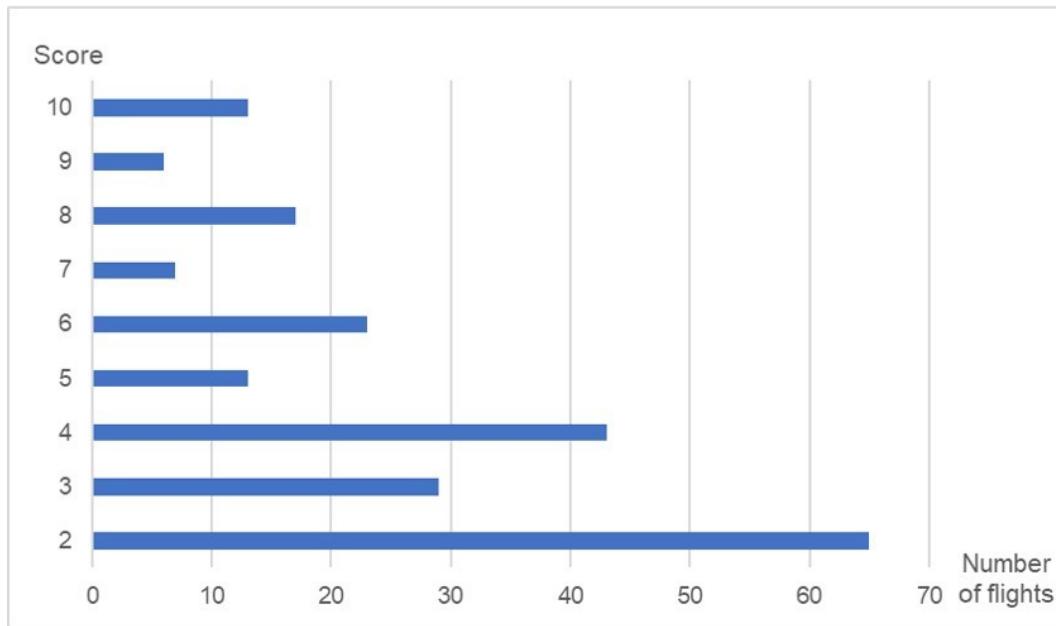
**Figure 10:** Evaluation of the 216 flights with a score ranging from 2 (unremarkable) to 10 (extremely notable and very high-risk).

It is striking that 79 flights (36.6 % of the 216 flights evaluated) were assessed as having medium and high scores, i.e. risk scores of 5 to 10. These deviations from the principles of safe flying in the mountains will henceforth be referred to as infractions. Flights with scores of 5 to 7 involve major infractions. Flights with a score of 8 to 10 involve massive infractions. This category comprises 36 (16.7 %) of the flights analysed.

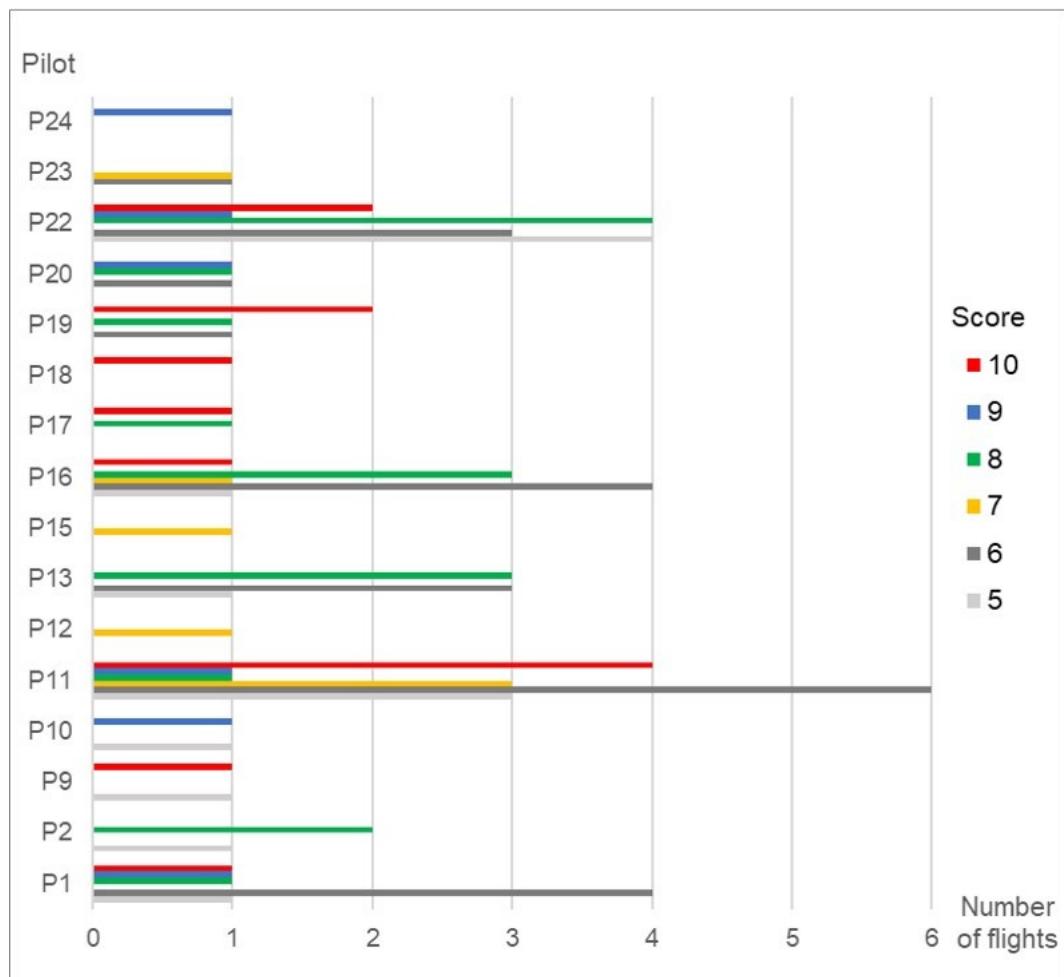
In figure 11, infractions with a score of 5 to 10 are shown individually for each pilot. 16 out of a total 27 pilots exhibit major or massive infractions (score 5 to 10). The purpose of such analyses is to ascertain whether the infractions occurred with individual pilots or whether undesired conduct extended across the entire cohort of pilots.

**Figure 11:** Analysis of the number of major and massive infractions with scores of 5 to 10 (x-axis) per pilot in command (y-axis).

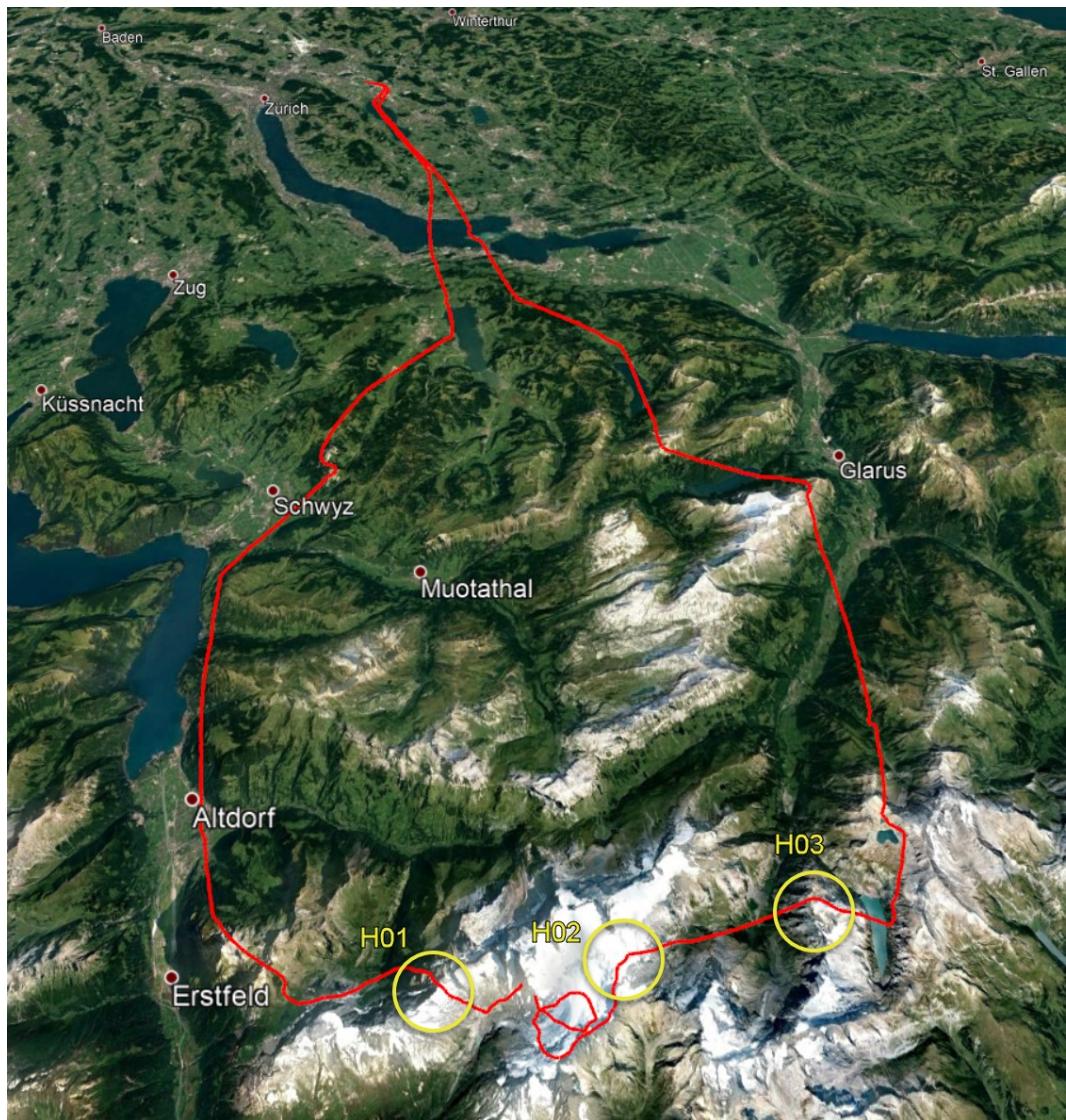
A1.18.6.2 Flight\_0525\_01\_HOT

**Figure 12:** Overview of the flight path including hotspots H01 to H03 (yellow circles). Shown on Google Earth.

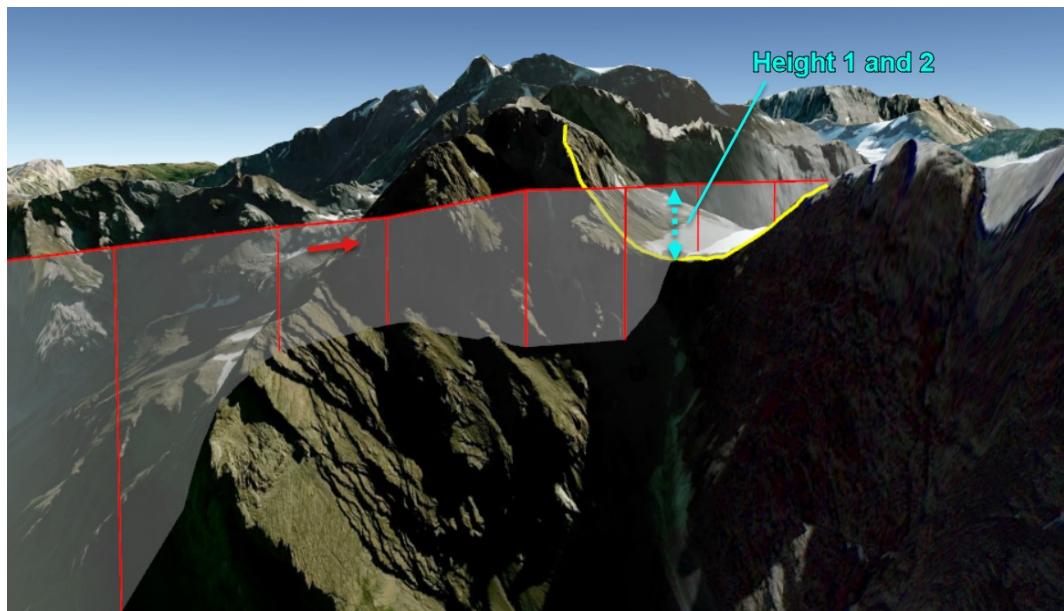
A1.18.6.2.2 Hotspot H01

**Figure 13:** Climbing overflight at 90 degrees to the saddle of the mountain ridge at an altitude of 2,732 m AMSL with a height of 122 m above ground directly below the radar flight path (height 1) and 122 m above ground with respect to the lowest point of the terrain profile (height 2). Shown on Google Earth.

Figure 13 shows a choice of flight path classified as 'very high-risk', which is characterised by the following safety-related features:

- Low-level flight over the terrain;
- Restricted view of the following section of terrain;
- Approaching an obstacle whilst climbing;
- No possibility of an alternative flight path for a prolonged period of time.

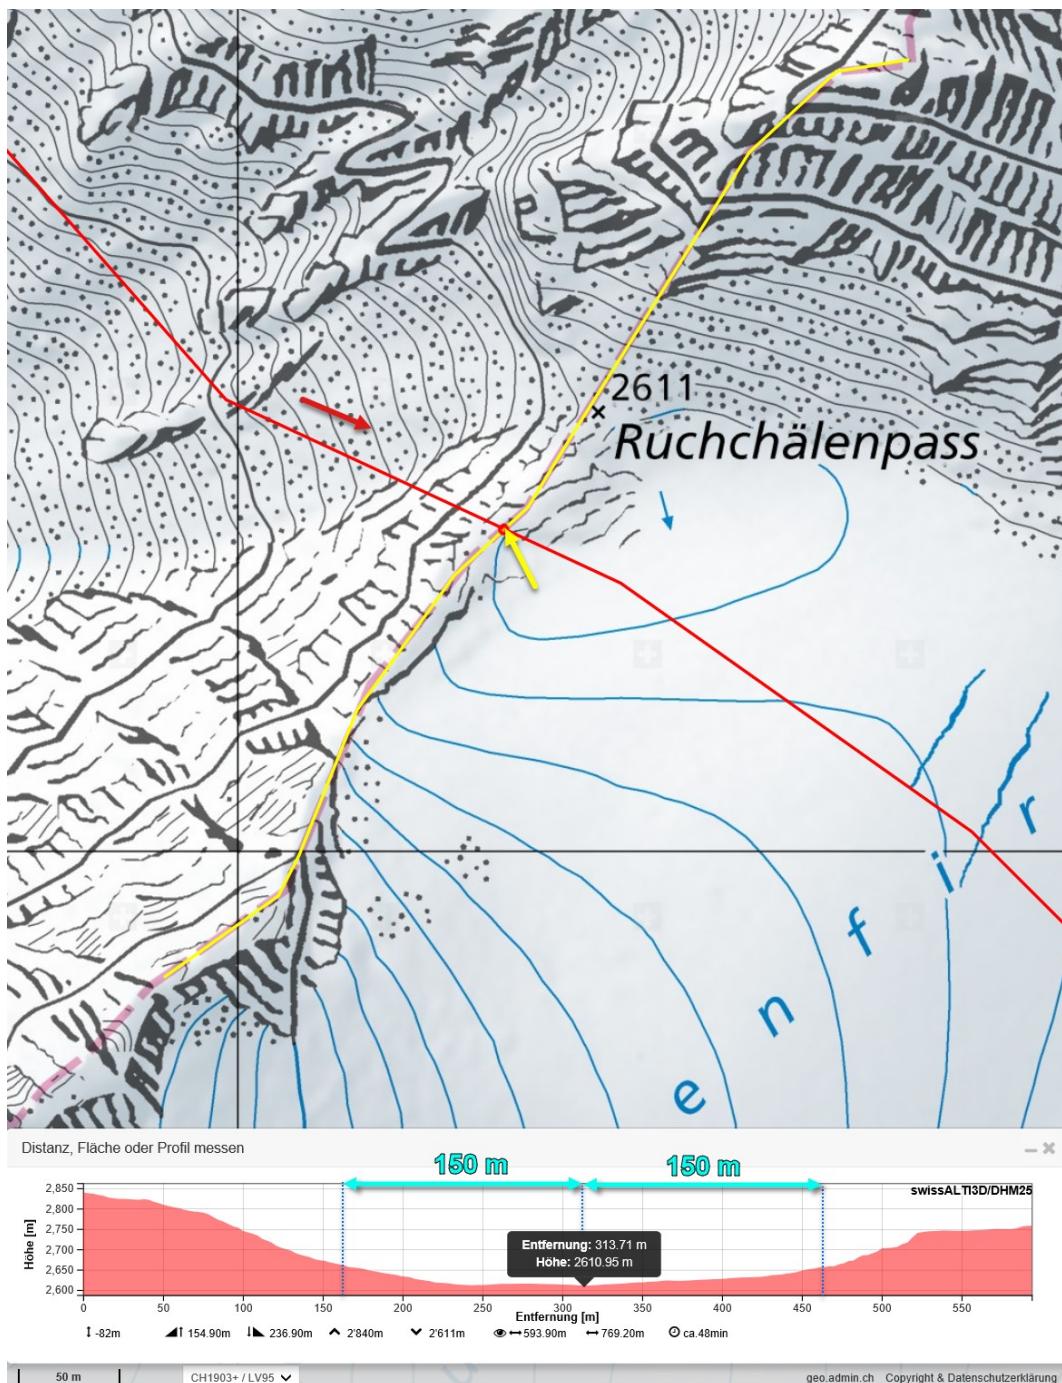
A1.18.6.2.2.1 Height 1

**Figure 14:** Depiction of the radar flight path (red line) in the direction of flight (red arrow) and the terrain profile (yellow line) with a height of 122 m above ground (2,610 m AMSL) directly below the radar flight path (yellow arrow) as well as a cross-section of the terrain 150 m to either side of the flight path (turquoise). Source of the base map: Swiss Federal Office of Topography.

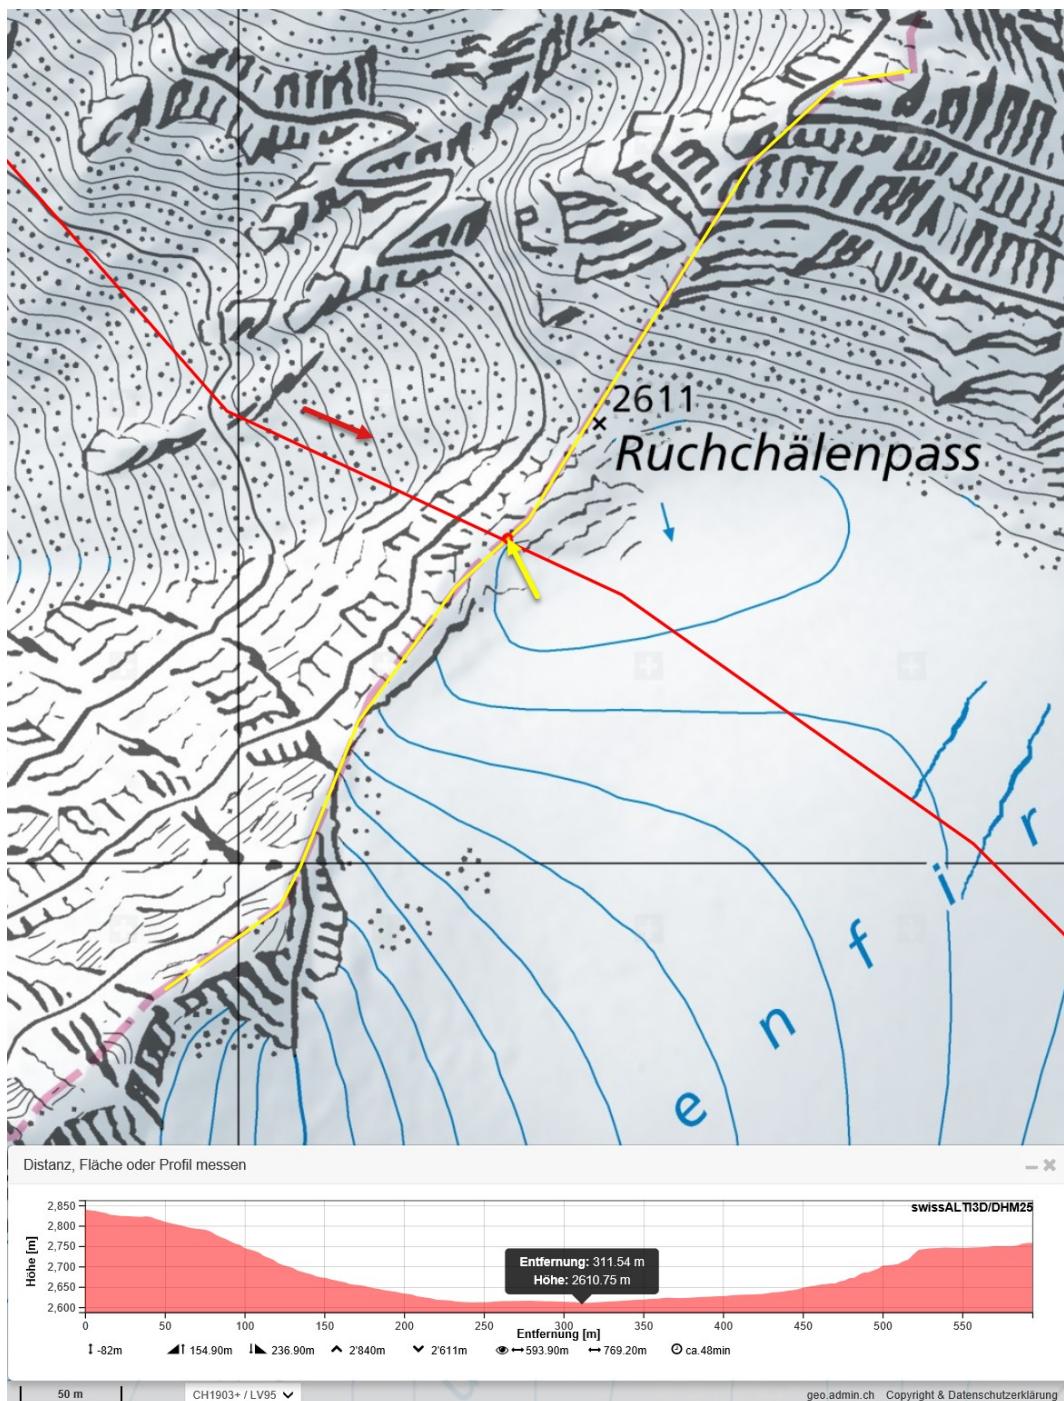
A1.18.6.2.2 Height 2

**Figure 15:** Depiction of the radar flight path (red line) in the direction of flight (red arrow) and the terrain profile (yellow line) with a height of 122 m above ground (2,610 m AMSL) at the lowest point of the terrain profile (yellow arrow). Source of the base map: Swiss Federal Office of Topography.

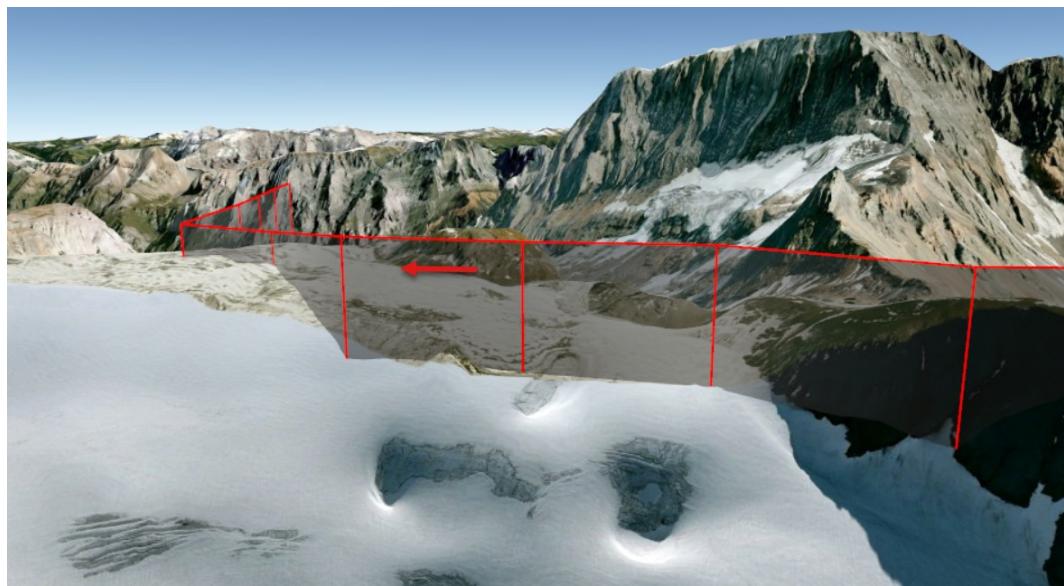
A1.18.6.2.3 Hotspot H02

**Figure 16:** Descending flight over the terrain at an altitude of 3,014 m AMSL with a height of 73 m above ground directly below the radar flight path and 78 m above ground with respect to the lowest point of the terrain profile. Shown on Google Earth.

Figure 16 shows a choice of flight path classified as 'very high-risk', which is characterised by the following safety-related features:

- Rising terrain in the direction of flight;
- Restricted view of the following section of terrain;
- Very low-level flight over the terrain;
- No possibility of an alternative flight path for a prolonged period of time.

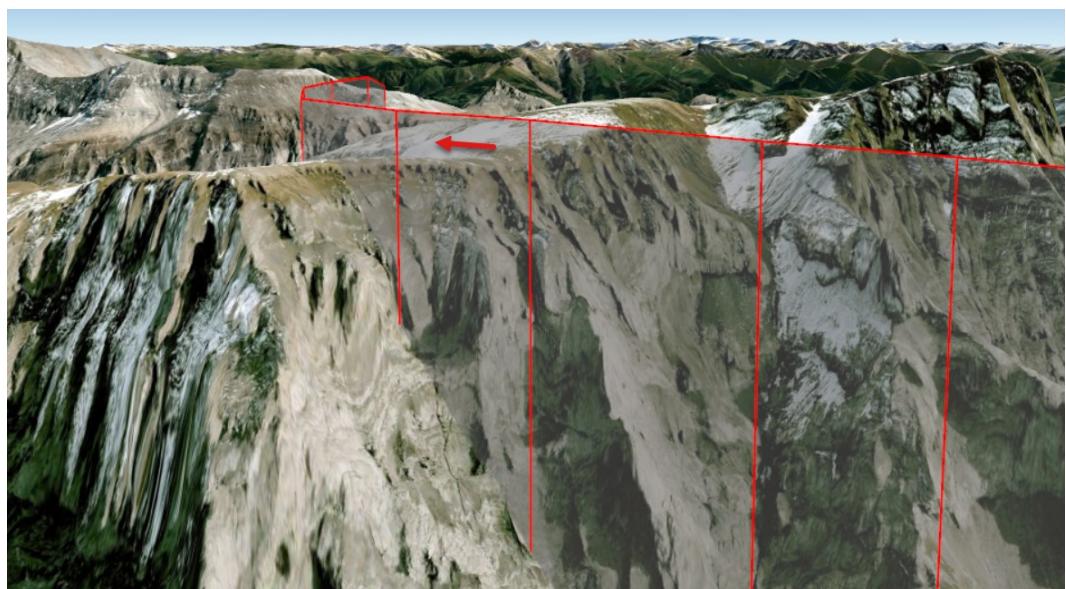
A1.18.6.2.4 Hotspot H03

**Figure 17:** Horizontal overflight at 90 degrees to the crest of the mountain ridge at an altitude of 2,982 m AMSL with a height of 88 m above ground directly below the radar flight path and 96 m above ground with respect to the lowest point of the terrain profile. Shown on Google Earth.

Figure 17 shows a choice of flight path classified as 'high-risk', which is characterised by the following safety-related features:
