## A1. Factual information

### A1.16 Tests and research results

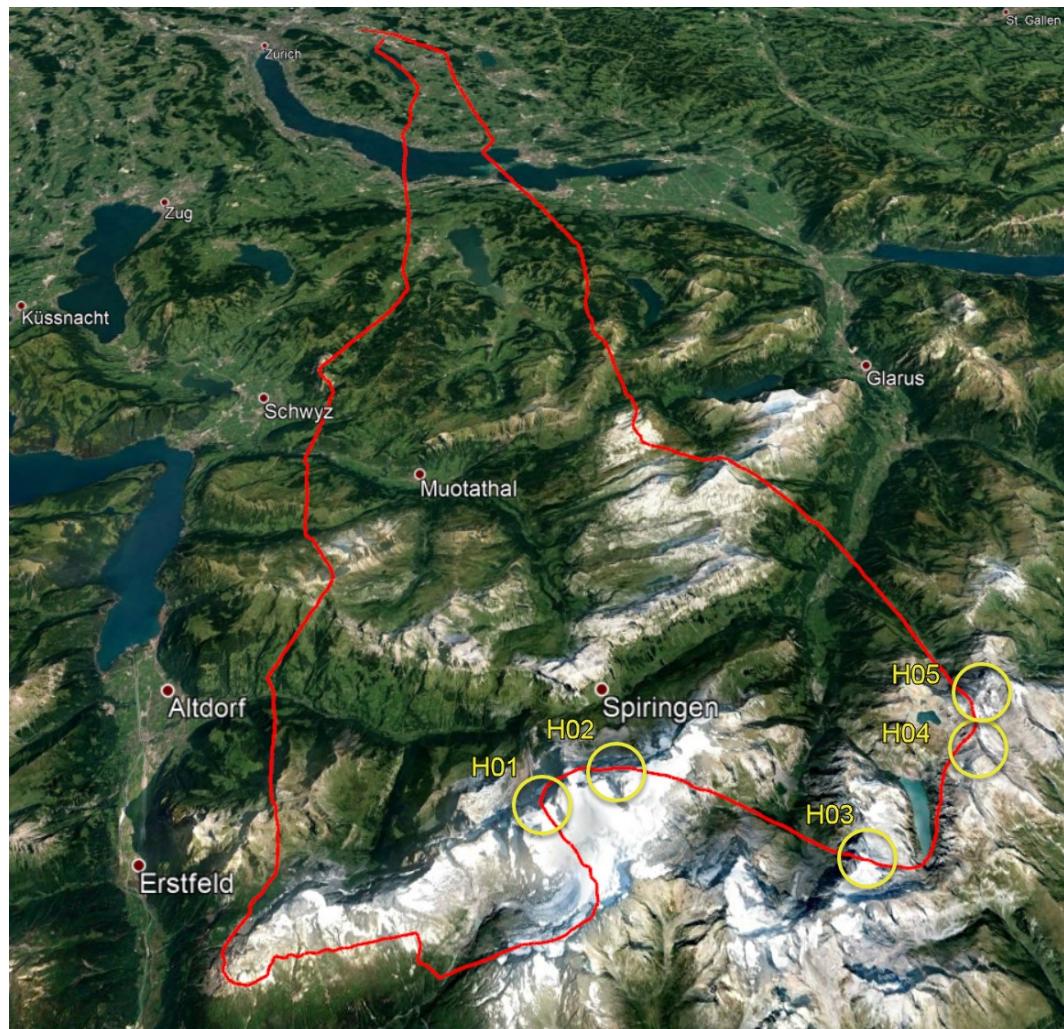
#### A1.18.6.3 Flight\_0526\_05\_HOT

**Figure 18:** Overview of the flight path including hotspots H01 to H05 (yellow circles). Shown on Google Earth.

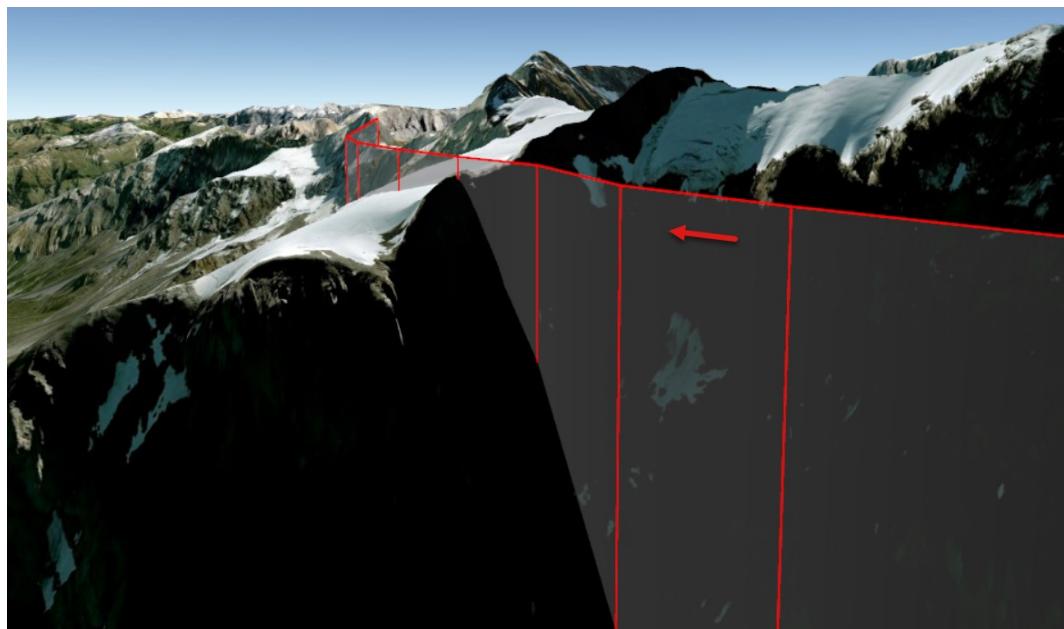
A1.18.6.3.2 Hotspot H01

**Figure 19:** Horizontal flight over the crest of the mountain ridge at an altitude of 3,053 m AMSL with a height of 40 m above ground directly below the radar flight path and 101 m above ground with respect to the lowest point of the terrain profile. Shown on Google Earth.

Figure 19 shows a choice of flight path classified as 'high-risk', which is characterised by the following safety-related features:

- Restricted view of the following section of terrain;
- Limited possibility of an alternative flight path;
- Very low-level flight over the terrain.

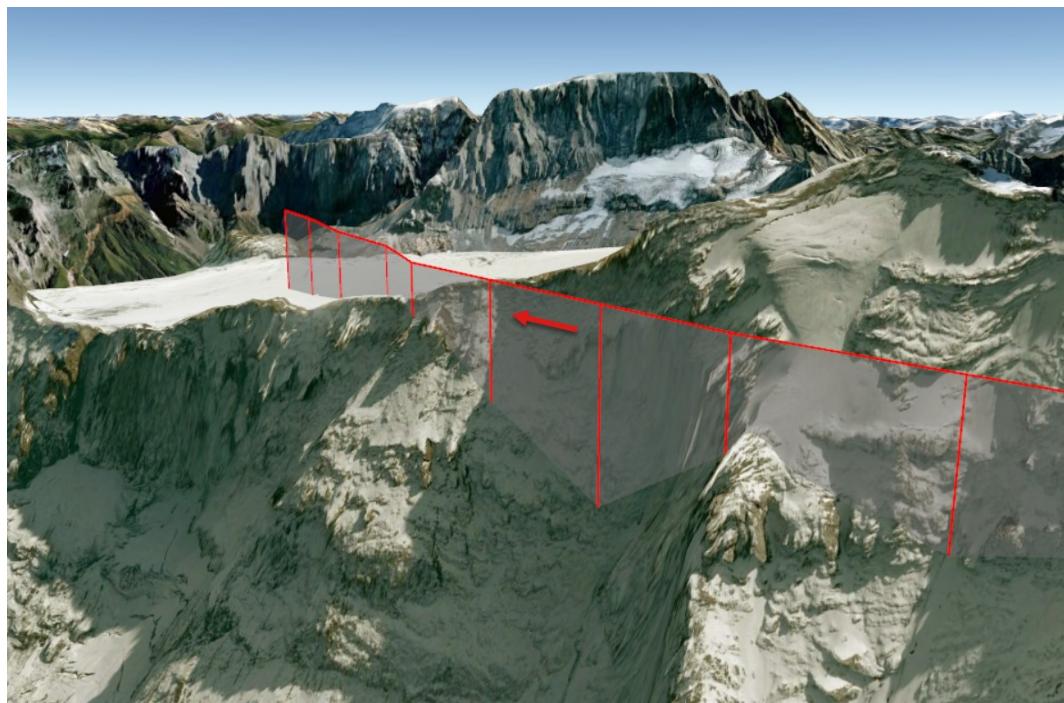
A1.18.6.3.3 Hotspot H02

**Figure 20:** Horizontal flight over the crest of the mountain ridge at an altitude of 3,084 m AMSL with a height of 69 m above ground directly below the radar flight path and 92 m above ground with respect to the lowest point of the terrain profile. Shown on Google Earth.

Figure 20 shows a choice of flight path classified as 'high-risk', which is characterised by the following safety-related features:

- Restricted view of the following section of terrain;
- Limited possibility of an alternative flight path;
- Very low-level flight over the terrain.

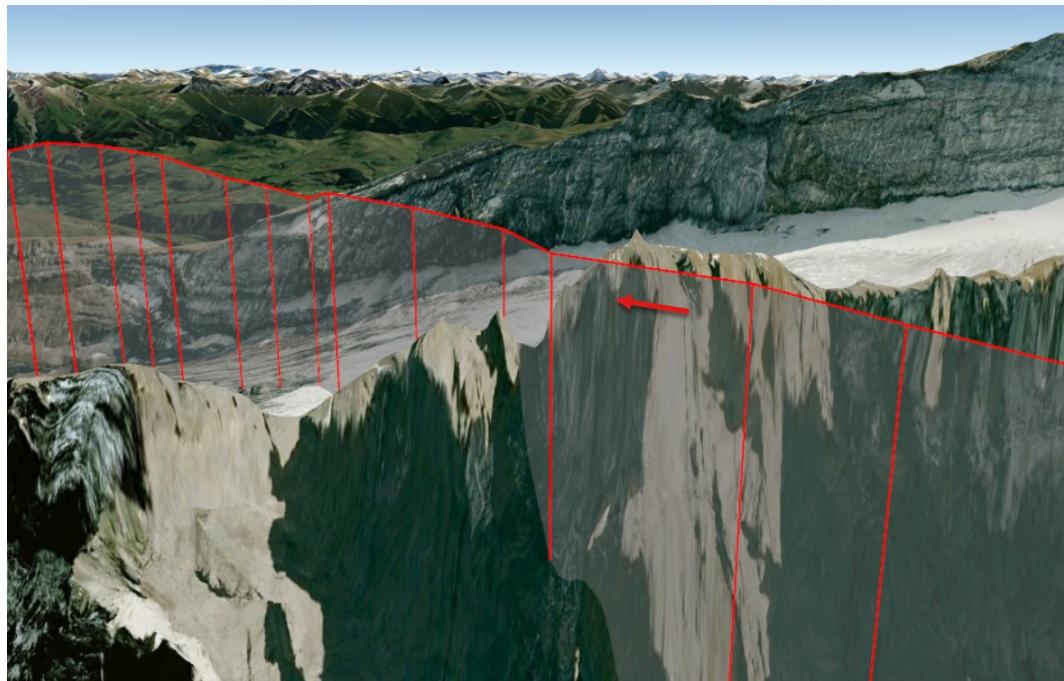
A1.18.6.3.4 Hotspot H03

**Figure 21:** Horizontal overflight at almost 90 degrees to the crest of the mountain ridge at an altitude of 3,084 m AMSL with a height of 116 m above ground directly below the radar flight path and 187 m above ground with respect to the lowest point of the terrain profile. Shown on Google Earth.

Figure 21 shows a choice of flight path classified as 'high-risk', which is characterised by the following safety-related features:

- Low-level flight over the terrain;
- Restricted view of the following section of terrain;
- Limited possibility of an alternative flight path.

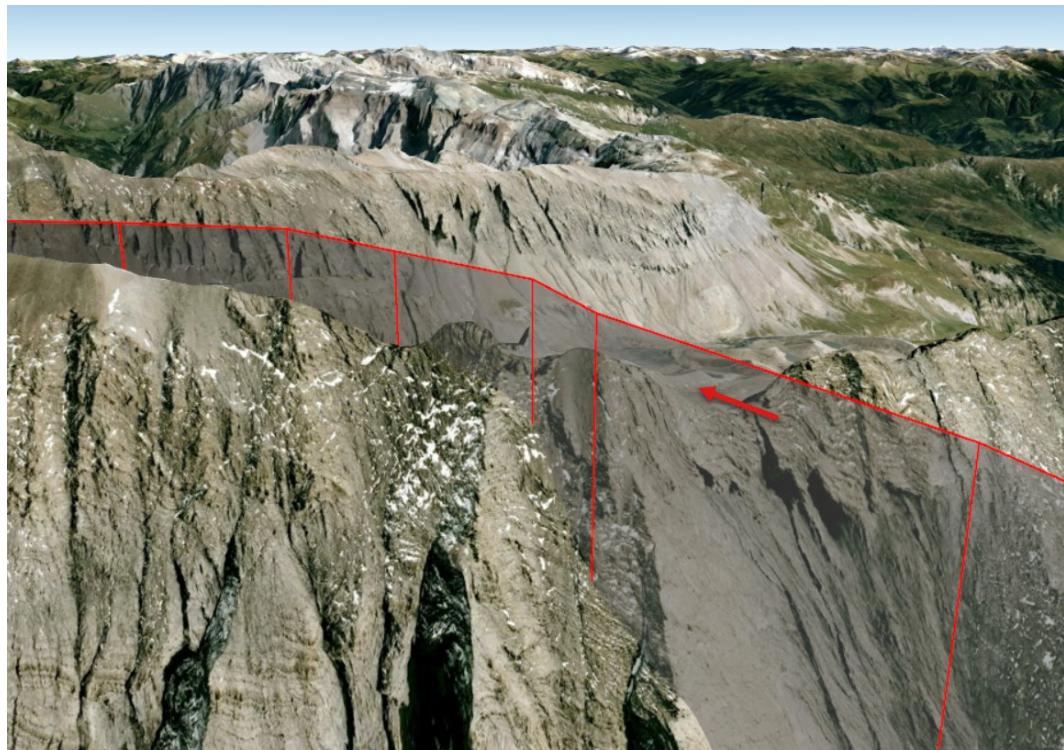
A1.18.6.3.5 Hotspot H04

**Figure 22:** Horizontal flight over the crest of the mountain ridge at an altitude of 3,112 m AMSL with a height of 85 m above ground directly below the radar flight path and 96 m above ground with respect to the lowest point of the terrain profile. Shown on Google Earth.

Figure 22 shows a choice of flight path classified as 'high-risk', which is characterised by the following safety-related features:

- Low-level flight over the terrain;
- Restricted view of the following section of terrain;
- Limited possibility of an alternative flight path.

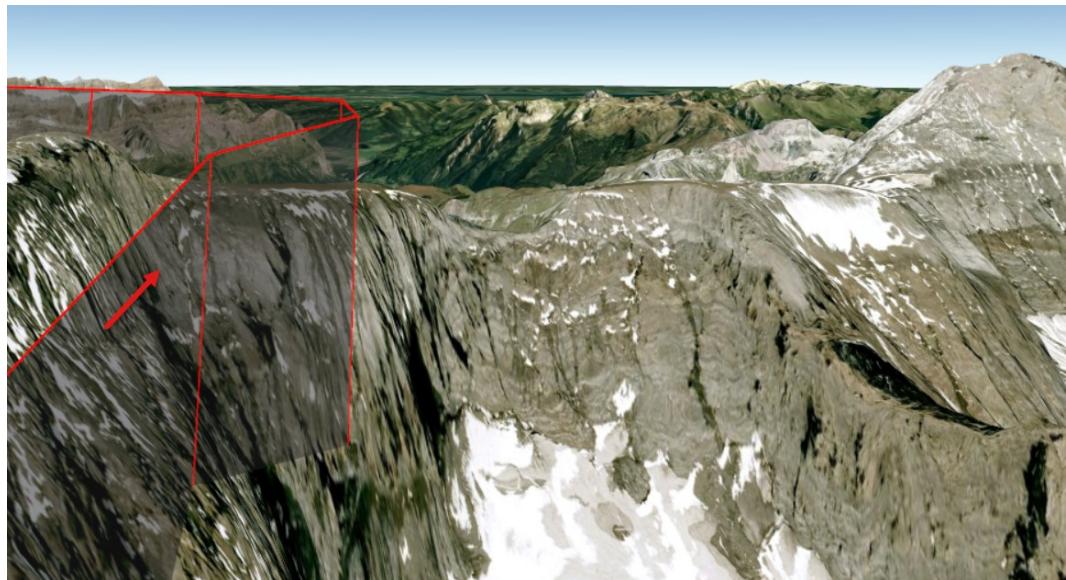
A1.18.6.3.6 Hotspot H05

**Figure 23:** Horizontal overflight at an altitude of 3,112 m AMSL with a height of 62 m above ground directly below the radar flight path and 106 m above ground with respect to the lowest point of the terrain profile. Shown on Google Earth.

Figure 23 shows a choice of flight path classified as 'high-risk', which is characterised by the following safety-related features:

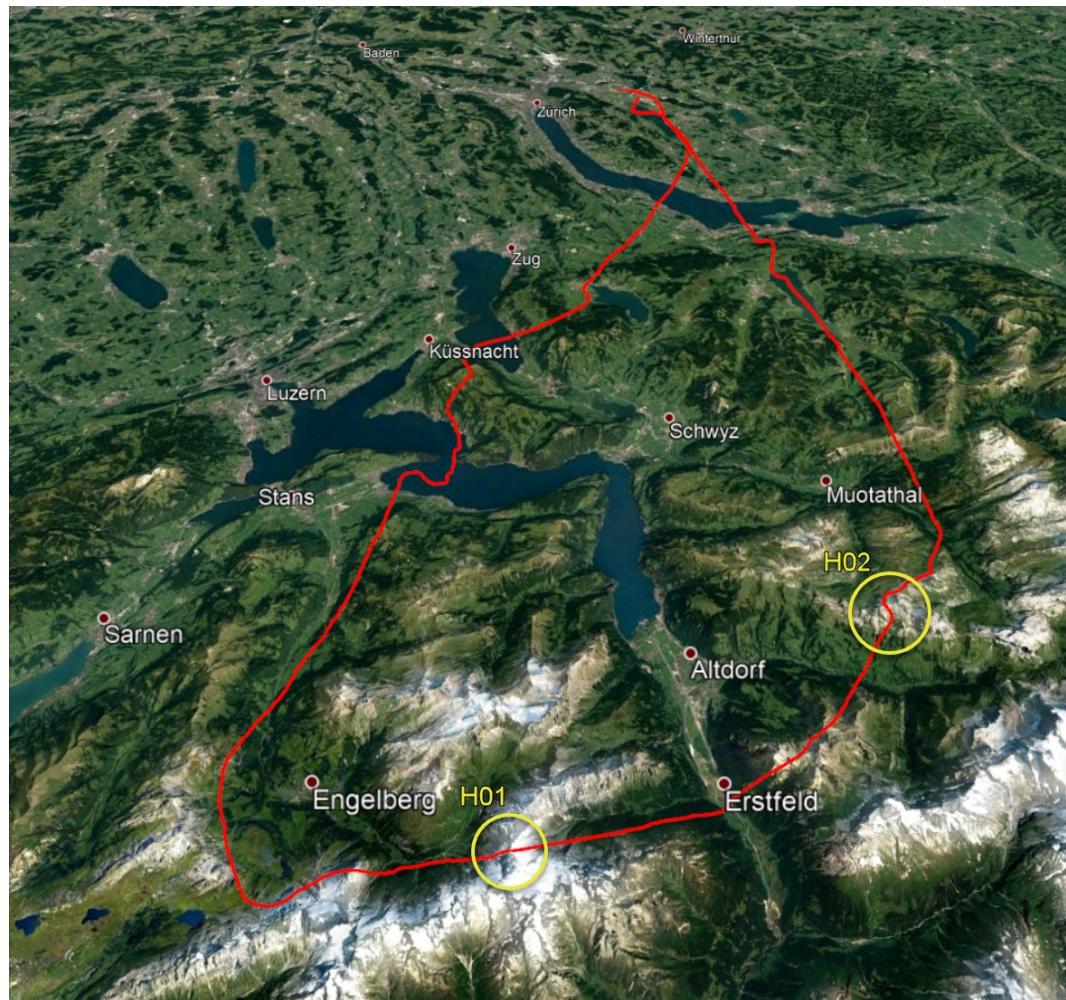
A1.18.6.4 Flight\_0602\_01\_HOS

**Figure 24:** Overview of the flight path including hotspots H01 and H02 (yellow circles). Shown on Google Earth.

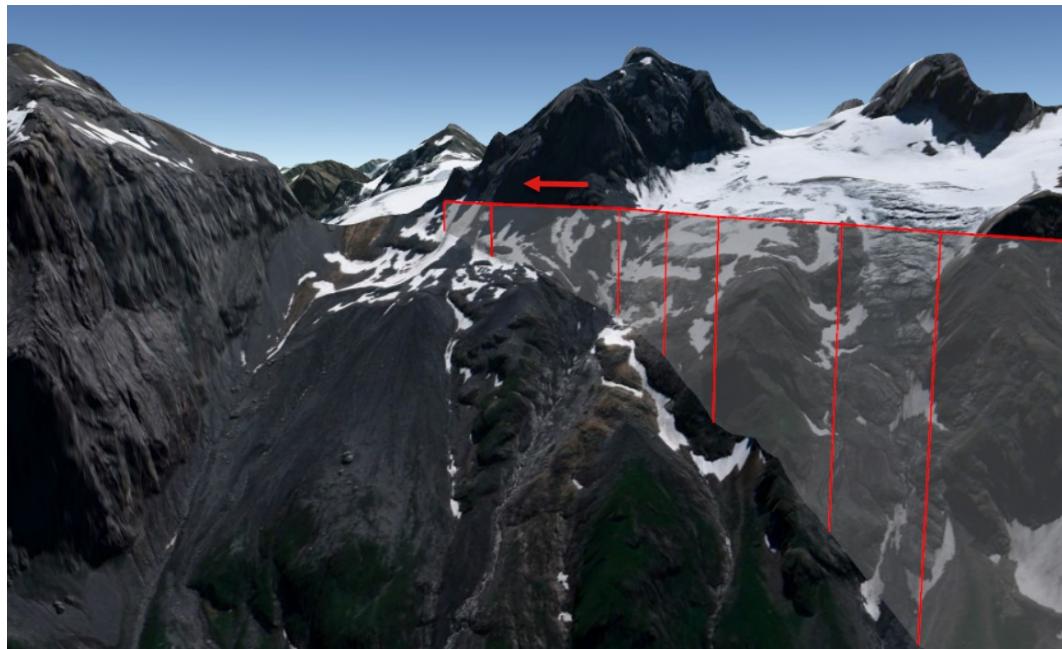
A1.18.6.4.2 Hotspot H01

**Figure 25:** Horizontal flight over the crest of the mountain ridge at an altitude of 2,704 m AMSL with a resulting height at a constant flying altitude of 46 m above ground directly below the radar flight path and 75 m above ground with respect to the lowest point of the terrain profile. Data extrapolated by the radar system were omitted. Shown on Google Earth.

Figure 25 shows a choice of flight path classified as 'very high-risk', which is characterised by the following safety-related features:

- Rising terrain in the direction of flight;
- Restricted view of the following section of terrain;
- Very low-level flight over the terrain;
- No possibility of an alternative flight path for a prolonged period of time.

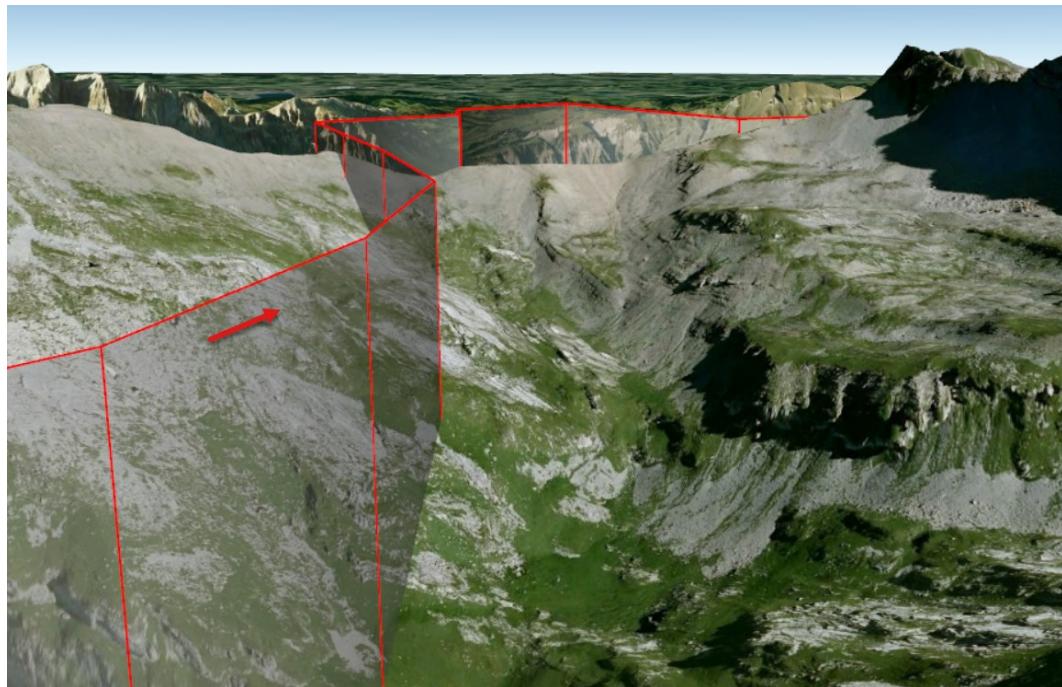
A1.18.6.4.3 Hotspot H02

**Figure 26:** Horizontal overflight at 90 degrees to the crest of the mountain ridge at an altitude of 2,418 m AMSL with a height of 26 m above ground directly below the radar flight path and 59 m above ground with respect to the lowest point of the terrain profile. Shown on Google Earth.

Figure 26 shows a choice of flight path classified as 'very high-risk', which is characterised by the following safety-related features:

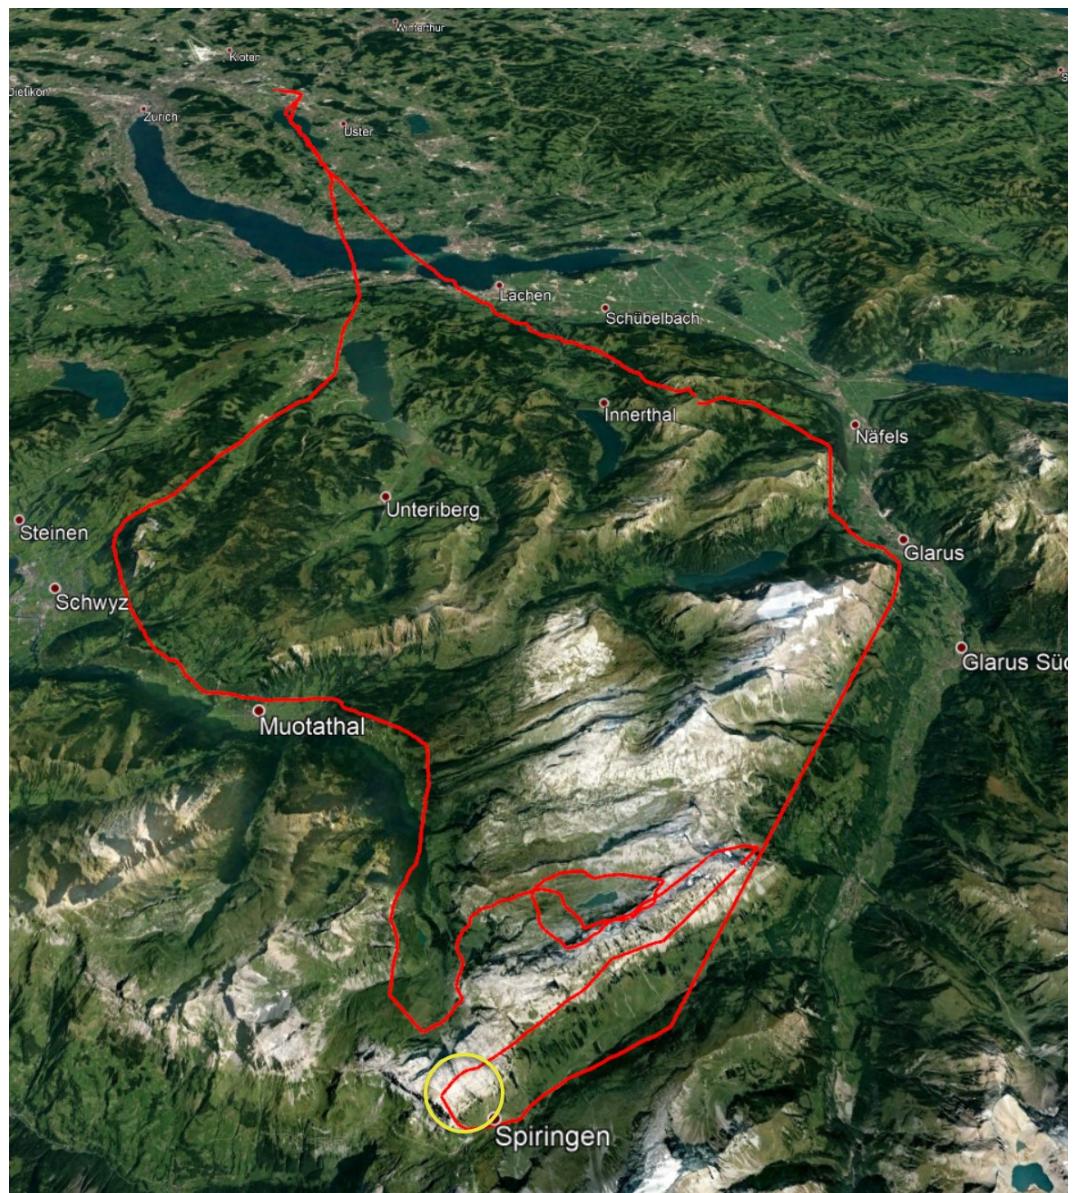
A1.18.6.5 Flight\_0606\_01\_HOP

**Figure 27:** Overview of the flight path including hotspot (yellow circle). Shown on Google Earth.

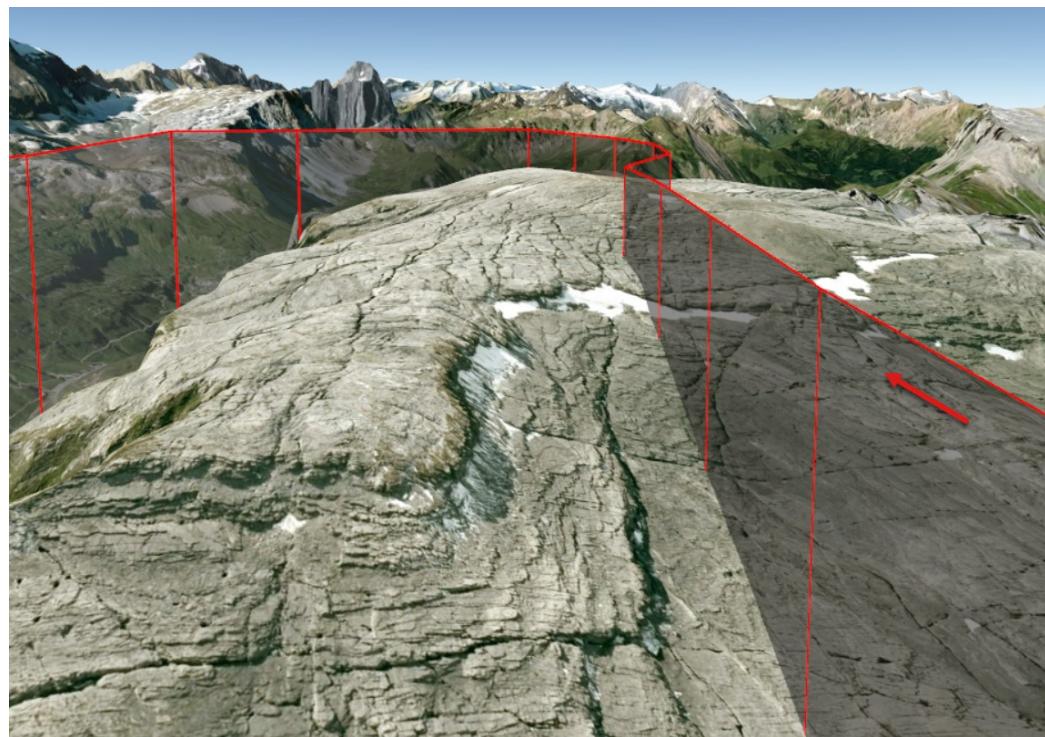
A1.18.6.5.2 Hotspot

**Figure 28:** Horizontal flight over the terrain at an altitude of 2,541 m AMSL with a height of 60 m above ground directly below the radar flight path and 76 m above ground with respect to the lowest point of the terrain profile. Shown on Google Earth.

Figure 28 shows a choice of flight path classified as 'very high-risk', which is characterised by the following safety-related features:

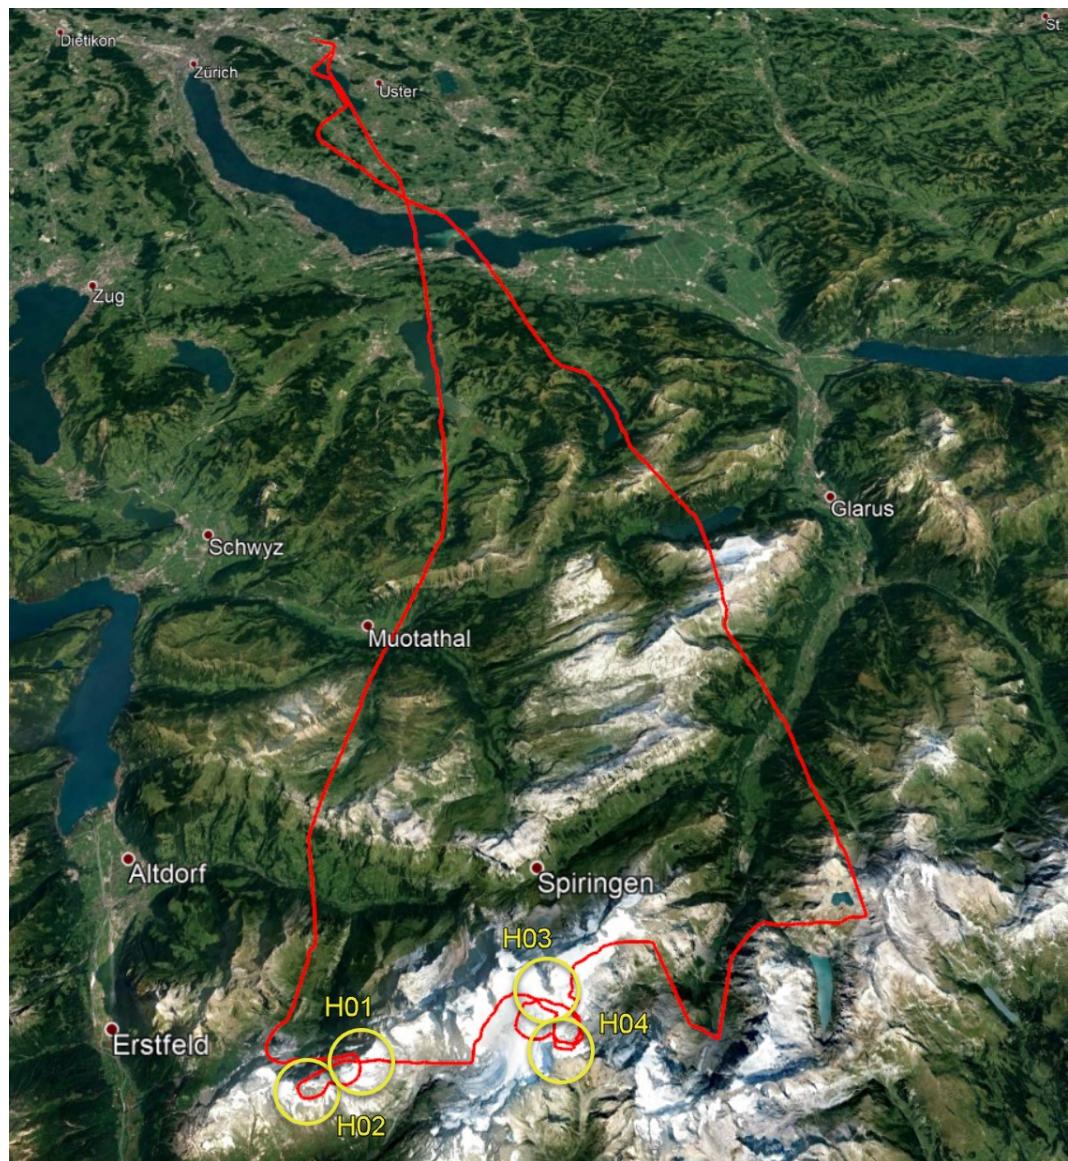
A1.18.6.6 Flight\_0623\_02\_HOT

**Figure 29:** Overview of the flight path including hotspots H01 to H04 (yellow circles). Shown on Google Earth.

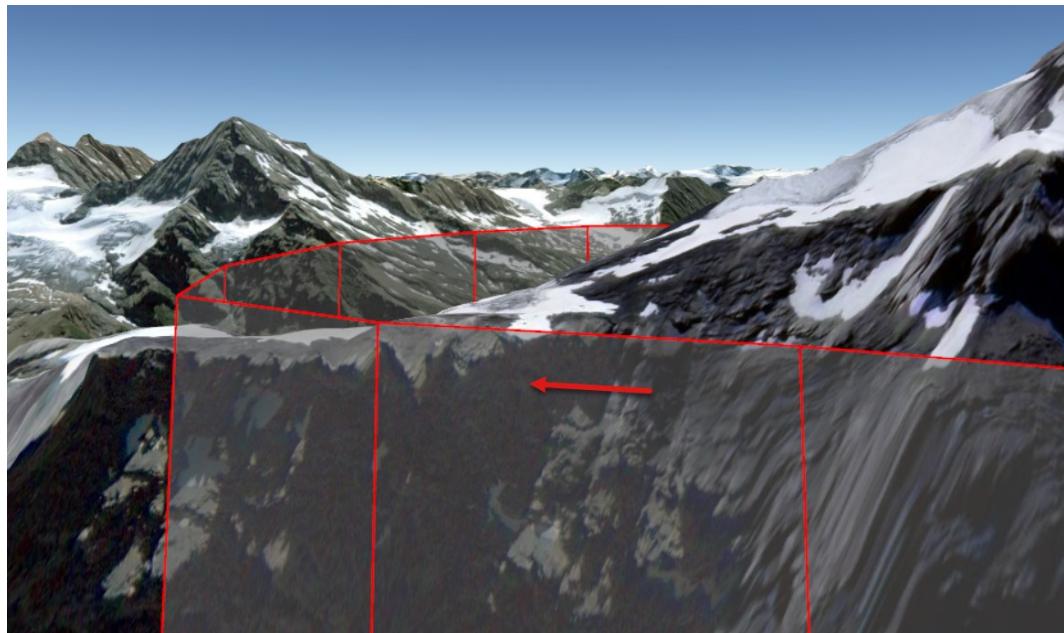
A1.18.6.6.2 Hotspot H01

**Figure 30:** Horizontal overflight at 90 degrees to the crest of the mountain ridge at an altitude of 2,887 m AMSL with a height of 65 m above ground directly below the radar flight path and 81 m above ground with respect to the lowest point of the terrain profile. Shown on Google Earth.

Figure 30 shows a choice of flight path classified as 'high-risk', which is characterised by the following safety-related features:

- Restricted view of the following section of terrain;
- Limited possibility of an alternative flight path;
- Very low-level flight over the terrain.

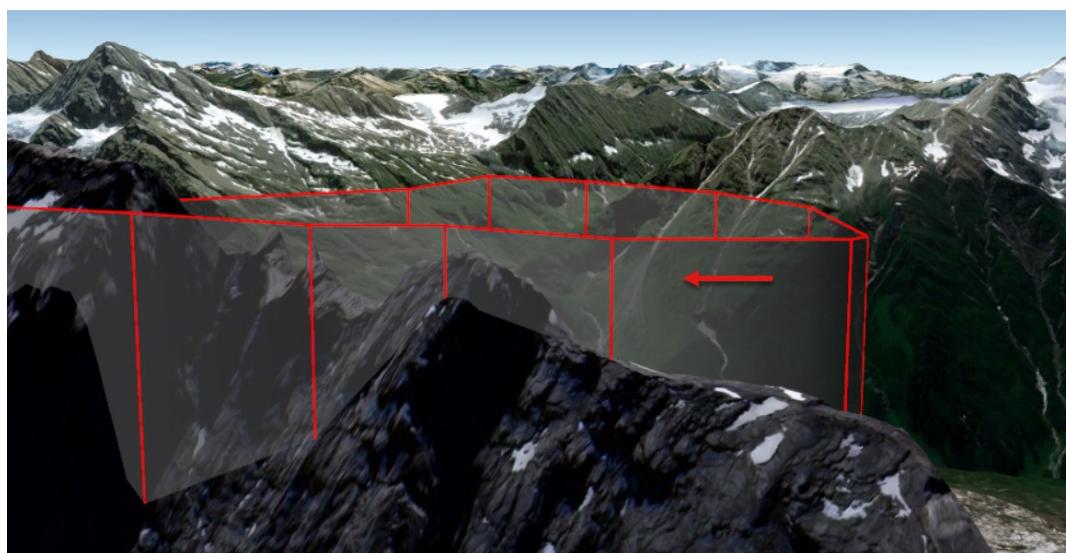
A1.18.6.6.3 Hotspot H02

**Figure 31:** Climbing flight over the crest of the mountain ridge at an altitude of 2,949 m AMSL with a height of 95 m above ground directly below the radar flight path and 121 m above ground with respect to the lowest point of the terrain profile. Shown on Google Earth.

Figure 31 shows a choice of flight path classified as 'very high-risk', which is characterised by the following safety-related features:

- Low-level flight over the terrain;
- Restricted view of the following section of terrain;
- Limited possibility of an alternative flight path;
- Approaching an obstacle whilst climbing.

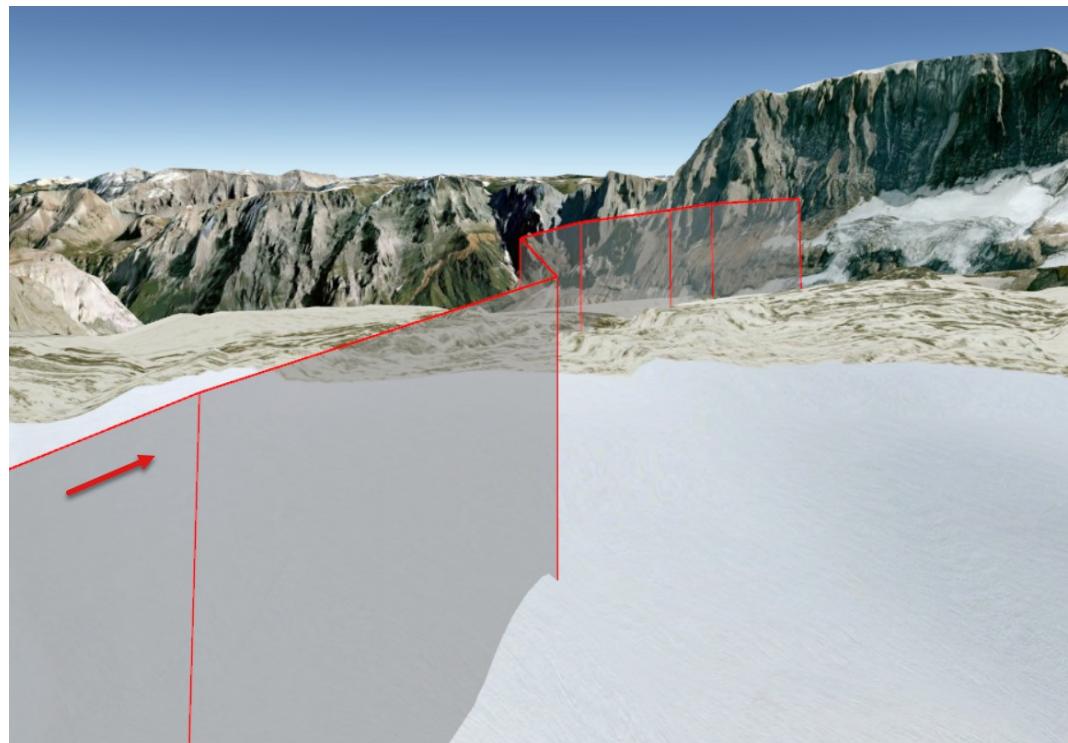
#### A1.18.6.6.4 Hotspot H03

**Figure 32:** Horizontal flight over the terrain at an altitude of 3,045 m AMSL with a height of 102 m above ground directly below the radar flight path and 102 m above ground with respect to the lowest point of the terrain profile. Shown on Google Earth.

Figure 32 shows a choice of flight path classified as 'high-risk', which is characterised by the following safety-related features:

- Rising terrain in the direction of flight;
- Low-level flight over the terrain;
- Restricted view of the following section of terrain;
- Limited possibility of an alternative flight path.

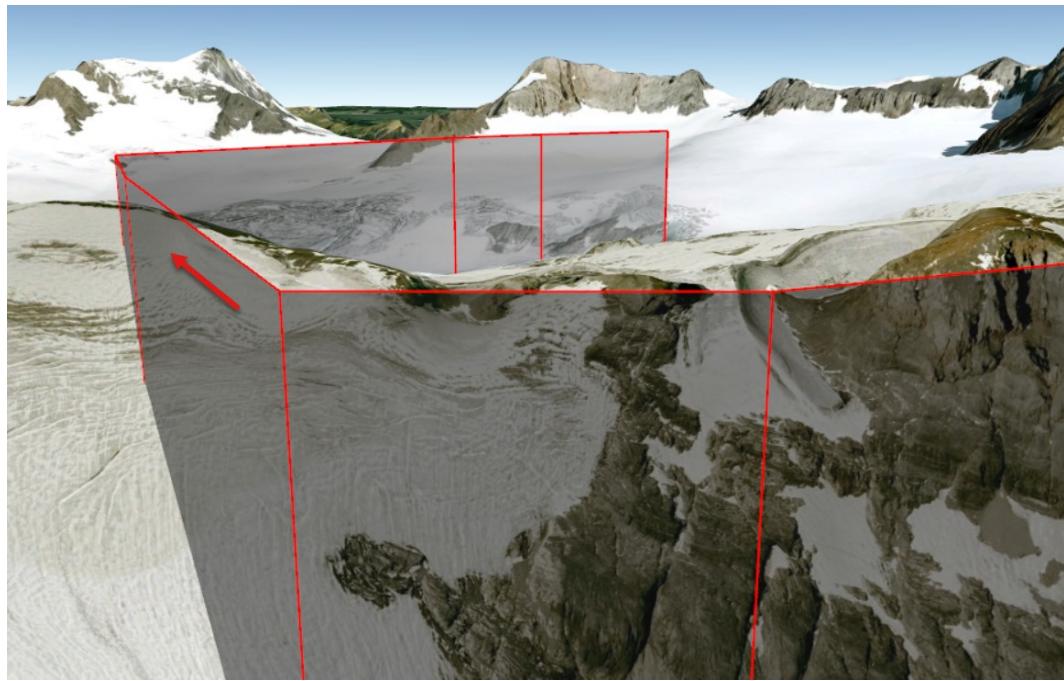
A1.18.6.6.5 Hotspot H04

**Figure 33:** Horizontal flight over the crest of the mountain ridge at an altitude of 3,045 m AMSL with a height of 84 m above ground directly below the radar flight path and 121 m above ground with respect to the lowest point of the terrain profile. Shown on Google Earth.

Figure 33 shows a choice of flight path classified as 'very high-risk', which is characterised by the following safety-related features:

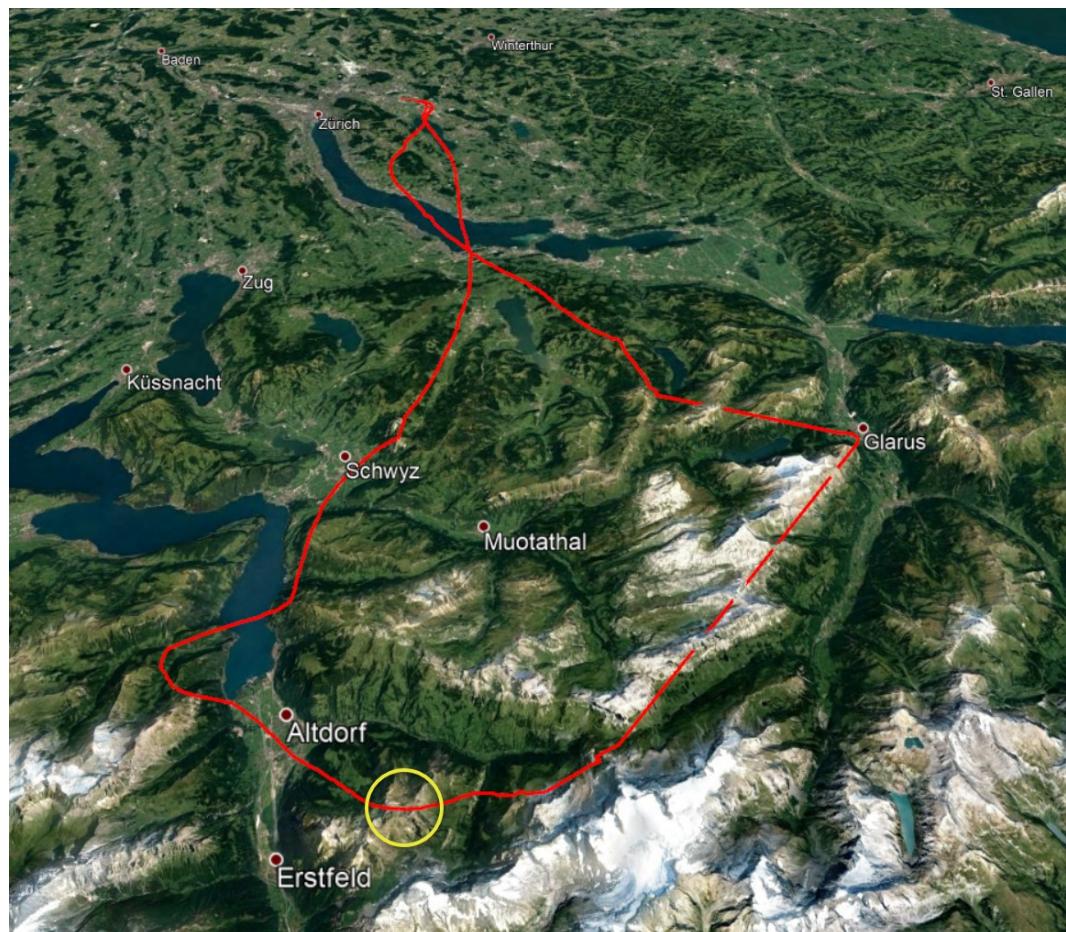
A1.18.6.7 Flight\_0712\_01\_HOS

**Figure 34:** Overview of the flight path including hotspot (yellow circle). Shown on Google Earth.

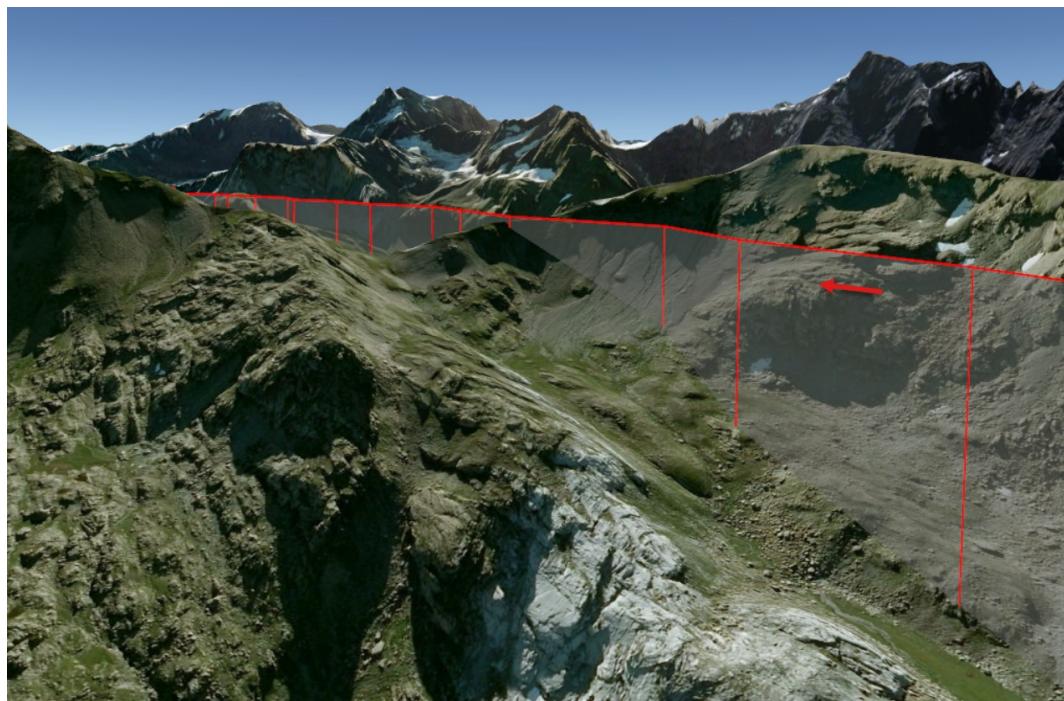
A1.18.6.7.2 Hotspot

**Figure 35:** Horizontal overflight at 90 degrees to the crest of the mountain ridge at an altitude of 2,375 m AMSL with a height of 9 m above ground directly below the radar flight path and 42 m above ground with respect to the lowest point of the terrain profile. Shown on Google Earth.

Figure 35 shows a choice of flight path classified as 'very high-risk', which is characterised by the following safety-related features:

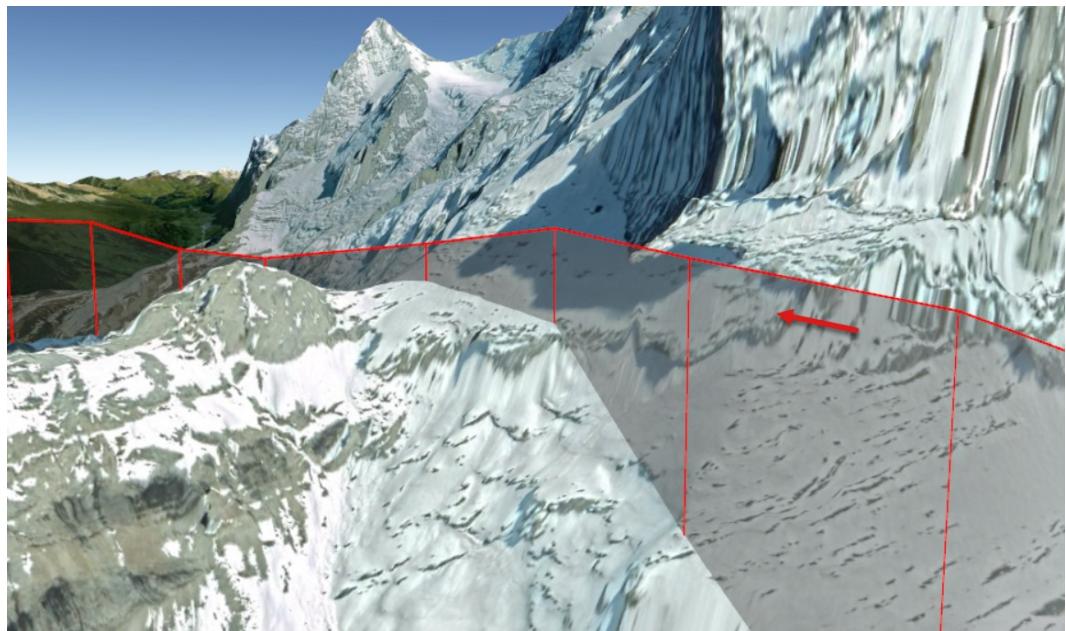
A1.18.6.8.3 Hotspot H01

**Figure 38:** Descending overflight at almost 90 degrees to the crest of the mountain ridge at an altitude of 2,720 m AMSL with a height of 58 m above ground directly below the radar flight path and 71 m above ground with respect to the lowest point of the terrain profile. Shown on Google Earth.

Figure 38 shows a choice of flight path classified as 'high-risk', which is characterised by the following safety-related features:

- Limited possibility of an alternative flight path;
- Very low-level flight over the terrain.

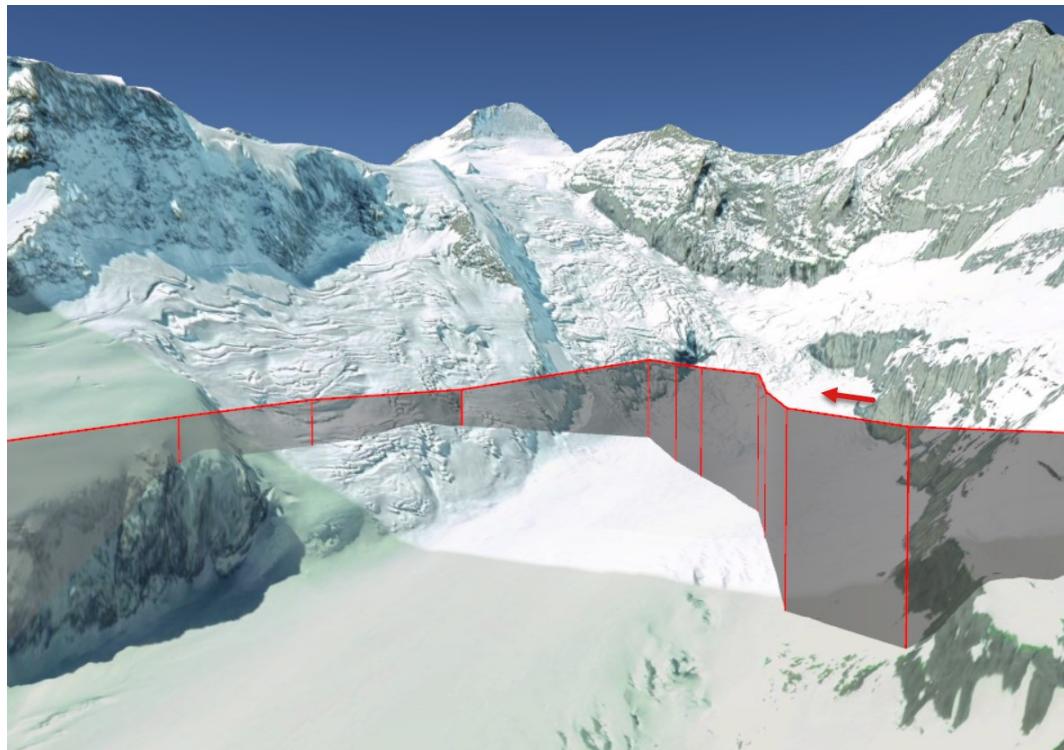
A1.18.6.8.4 Hotspot H02

**Figure 39:** Descending overflight at an altitude of 2,908 m AMSL with a height of 95 m above ground directly below the radar flight path and 178 m above ground with respect to the lowest point of the terrain profile. Shown on Google Earth.

Figure 39 shows a choice of flight path classified as 'moderate-risk', which is characterised by the following safety-related features:

In addition, when turning into a left turn, the 'belly to the wall' flight attitude bears the risk of the pilots not being able to assess the aircraft's position in space due to missing vertical and horizontal visual references in the terrain.

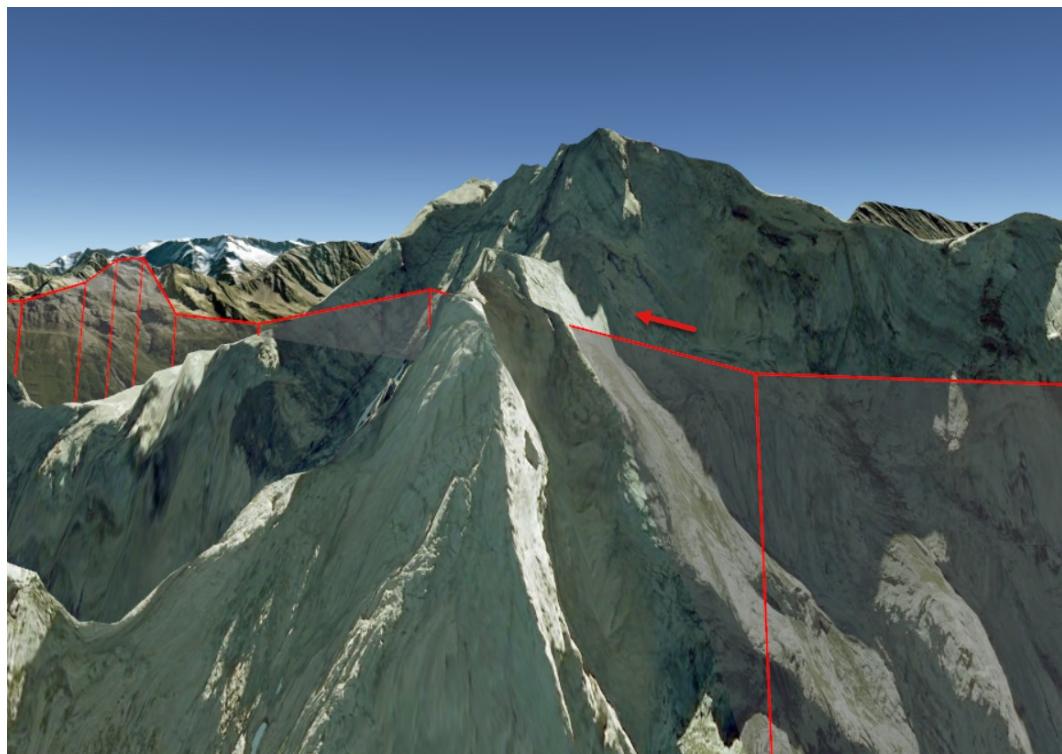
A1.18.6.8.5 Hotspot H03

**Figure 40:** Horizontal flight over the crest of the mountain ridge at an altitude of 2,623 m AMSL with a height of -35 m above ground directly below the radar flight path and 43 m above ground with respect to the lowest point of the terrain profile. Shown on Google Earth.

Figure 40 shows a choice of flight path classified as 'high-risk', which is characterised by the following safety-related features:

Due to leeway in the lateral position of the radar flight path, the flight path intersects the terrain here. The overflight therefore took place close to the terrain.

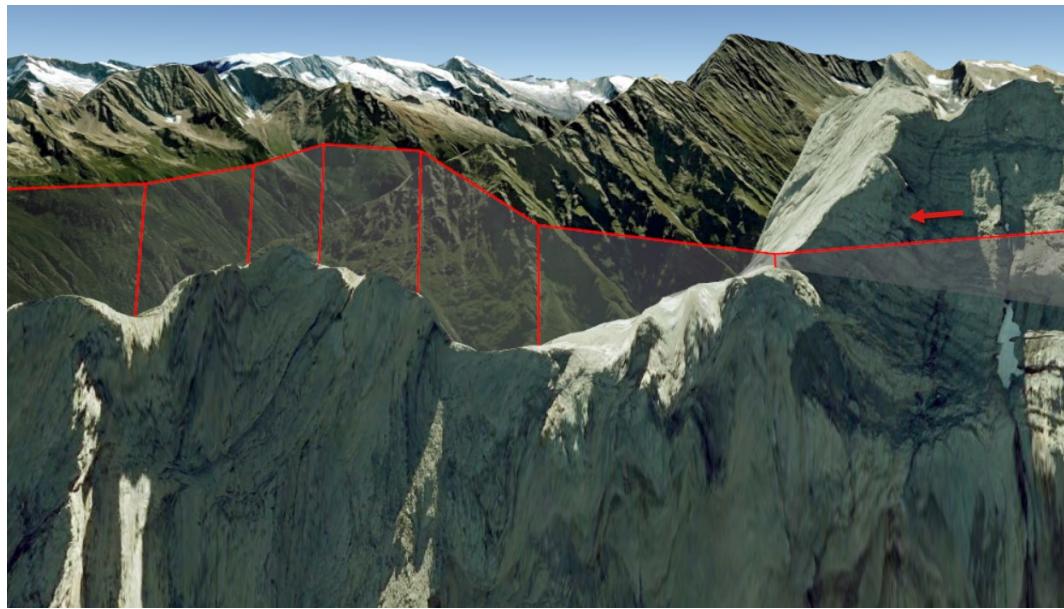
A1.18.6.8.6 Hotspot H04

**Figure 41:** Horizontal flight over the crest of the mountain ridge at an altitude of 2,623 m AMSL with a height of 5 m above ground directly below the radar flight path and 58 m above ground with respect to the lowest point of the terrain profile. Shown on Google Earth.

Figure 41 shows a choice of flight path classified as 'high-risk', which is characterised by the following safety-related features:

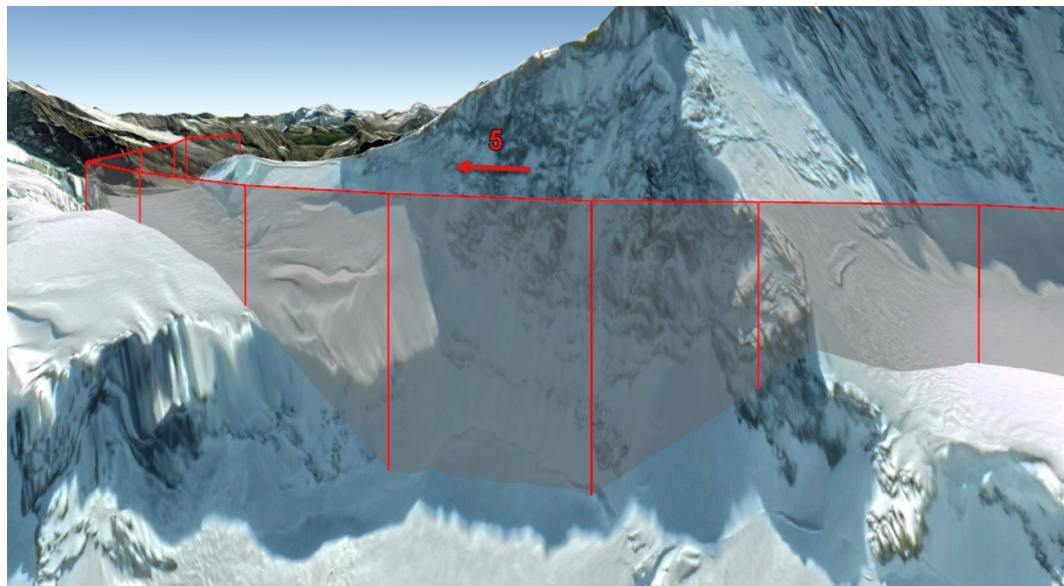
A1.18.6.9.3 Hotspot

**Figure 44:** Horizontal flight over the terrain at an altitude of 3,539 m AMSL with a height of 74 m above ground directly below the radar flight path and 74 m above ground with respect to the lowest point of the terrain profile. Shown on Google Earth.

Figure 44 shows a choice of flight path classified as 'very high-risk', which is characterised by the following safety-related features:

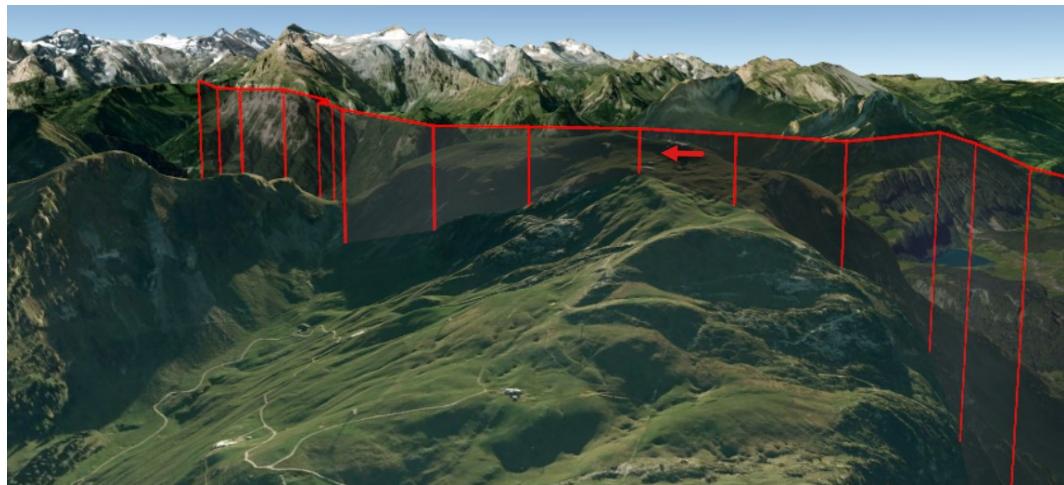
A1.18.6.10.2 Hotspot H01

**Figure 46:** Horizontal flight over the terrain at an altitude of 1,951 m AMSL with a height of 98 m above ground directly below the radar flight path and 177 m above ground with respect to the lowest point of the terrain profile. Shown on Google Earth.

Figure 46 shows a choice of flight path classified as 'moderate-risk', which is characterised by the following safety-related feature:

- Low-level flight over the terrain.

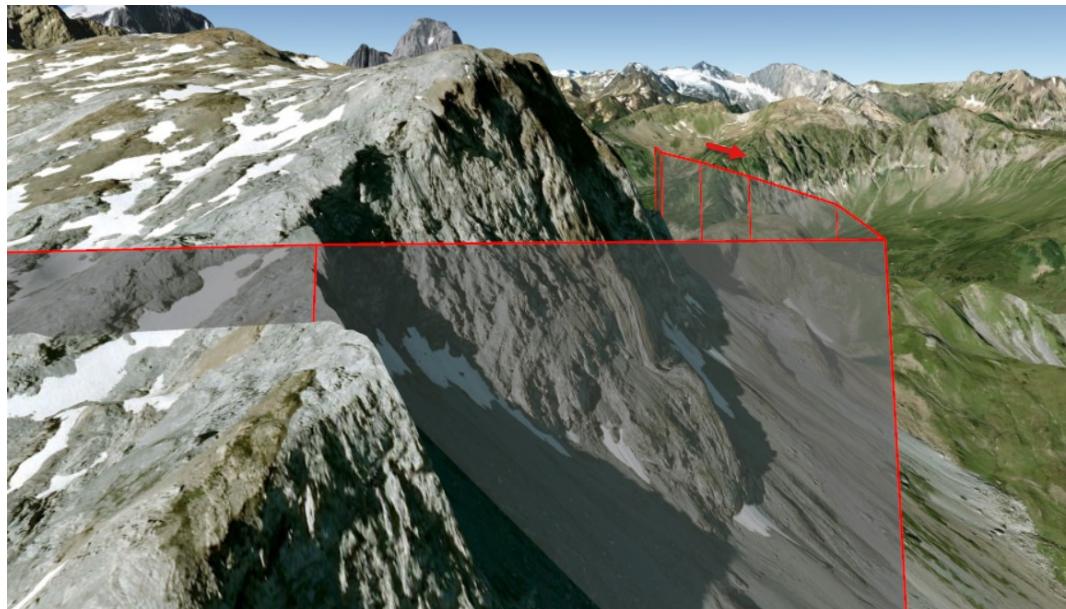
A1.18.6.10.3 Hotspot H02

**Figure 47:** Climbing overflight at almost 90 degrees to the crest of the mountain ridge at an altitude of 2,525 m AMSL with a height of 45 m above ground directly below the radar flight path and 58 m above ground with respect to the lowest point of the terrain profile. Shown on Google Earth.

Figure 47 shows a choice of flight path classified as 'high-risk', which is characterised by the following safety-related features:
