## A1. Factual information

### A1.16 Tests and research results

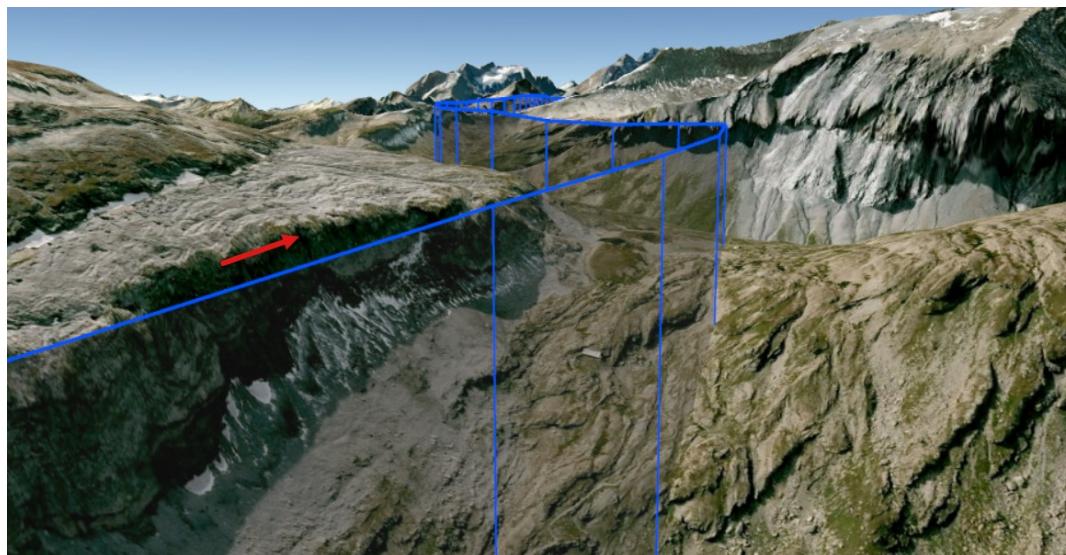
A1.18.6.11.3 Hotspot H01

**Figure 50:** Climbing overflight at almost 90 degrees to the crest of the mountain ridge at a GPS altitude of 2,545 m AMSL with a height of 141 m above ground directly below the GPS flight path and 141 m above ground with respect to the lowest point of the terrain profile. Shown on Google Earth.

Figure 50 shows a choice of flight path classified as 'very high-risk', which is characterised by the following safety-related features:

- Rising terrain in the direction of flight;
- Low-level flight over the terrain;
- Approaching an obstacle whilst climbing;
- No possibility of an alternative flight path for a prolonged period of time.

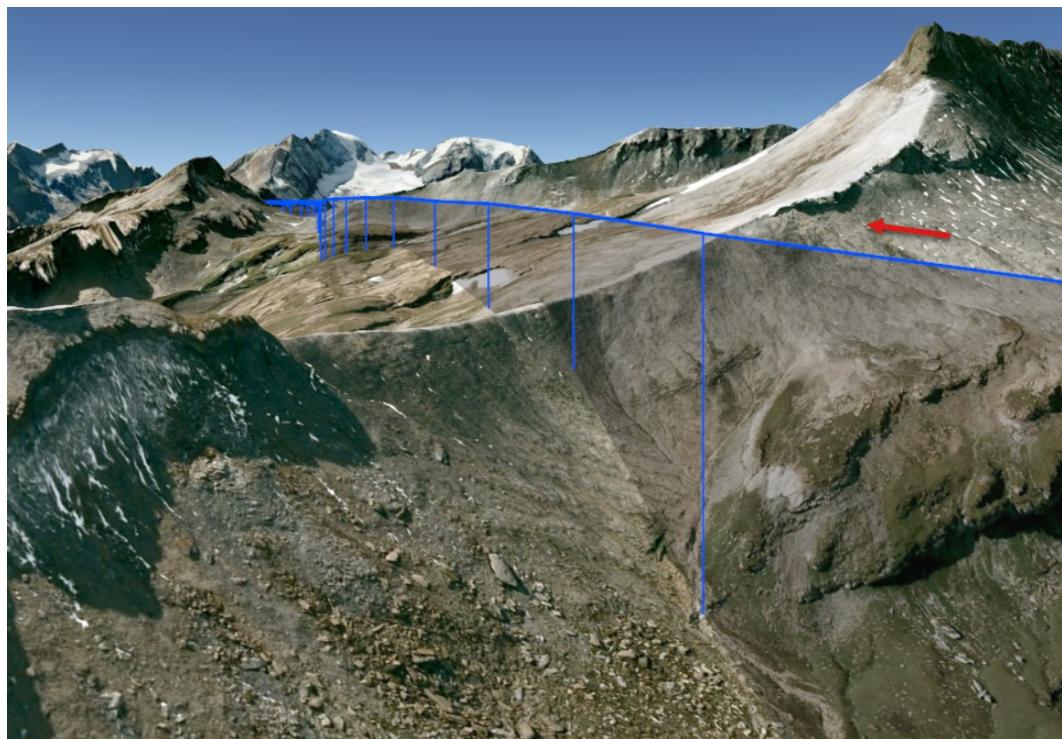
A1.18.6.11.4 Hotspot H02

**Figure 51:** Climbing overflight at 90 degrees to the crest of the mountain ridge at a GPS altitude of 2,610 m AMSL with a height of 75 m above ground directly below the GPS flight path and 84 m above ground with respect to the lowest point of the terrain profile. Shown on Google Earth.

Figure 51 shows a choice of flight path classified as 'very high-risk', which is characterised by the following safety-related features:

- Rising terrain in the direction of flight;
- Low-level flight over the terrain;
- Restricted view of the following section of terrain;
- Limited possibility of an alternative flight path;
- Approaching an obstacle whilst climbing.

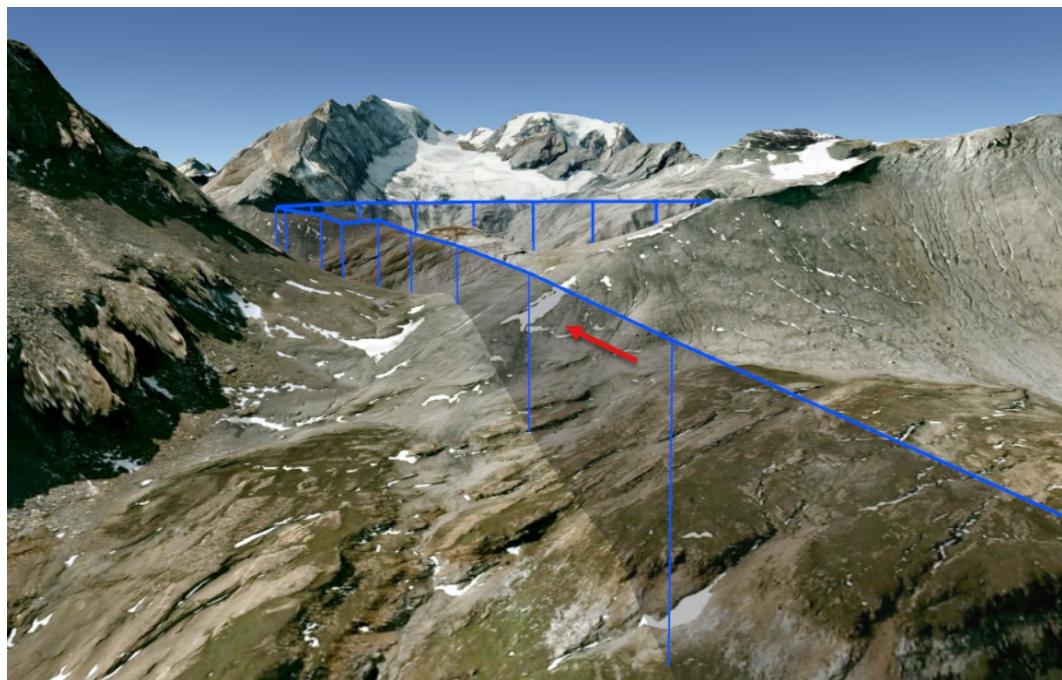
A1.18.6.11.5 Hotspot H03

**Figure 52:** Climbing overflight at 90 degrees to the crest of the mountain ridge at a GPS altitude of 2,624 m AMSL with a height of 48 m above ground directly below the GPS flight path and 58 m above ground with respect to the lowest point of the terrain profile. Shown on Google Earth.

Figure 52 shows a choice of flight path classified as 'very high-risk', which is characterised by the following safety-related features:

- Rising terrain in the direction of flight;
- Restricted view of the following section of terrain;
- Approaching an obstacle whilst climbing;
- Very low-level flight over the terrain;
- No possibility of an alternative flight path for a prolonged period of time.

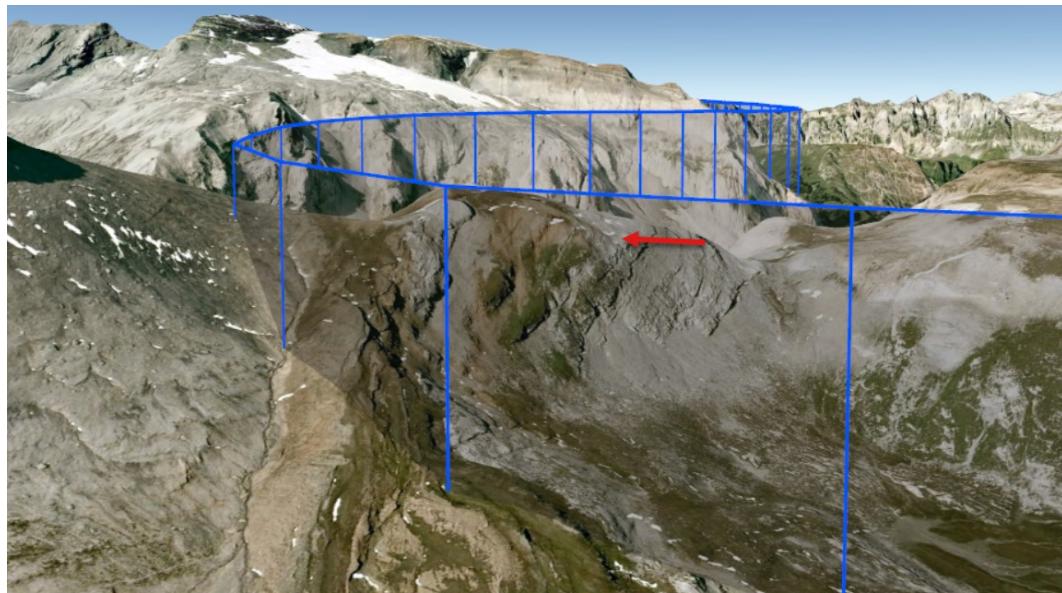
#### A1.18.6.11.6 Hotspot H04

**Figure 53:** Horizontal overflight at 90 degrees to the crest of the mountain ridge at a GPS altitude of 2,642 m AMSL with a height of 64 m above ground directly below the GPS flight path and 84 m above ground with respect to the lowest point of the terrain profile. Shown on Google Earth.

Figure 53 shows a choice of flight path classified as 'high-risk', which is characterised by the following safety-related features:

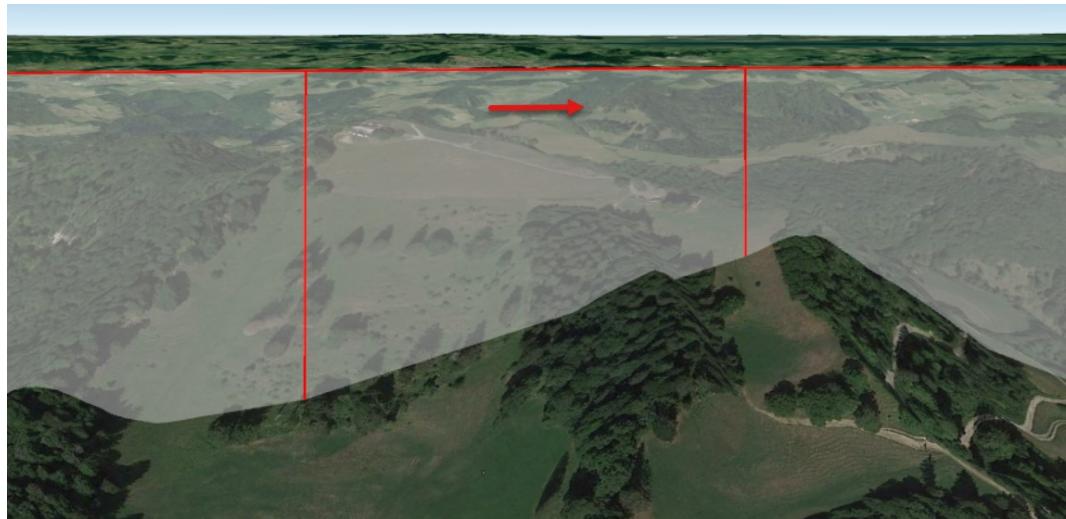
A1.18.7.2.2 Hotspot H01

**Figure 55:** Horizontal flight over the terrain at an altitude of 1,189 m AMSL with a height of 107 m above ground directly below the radar flight path and 165 m above ground with respect to the lowest point of the terrain profile. Shown on Google Earth.

Figure 55 shows a choice of flight path classified as 'moderate-risk', which is characterised by the following safety-related feature:

- Low-level flight over the terrain.

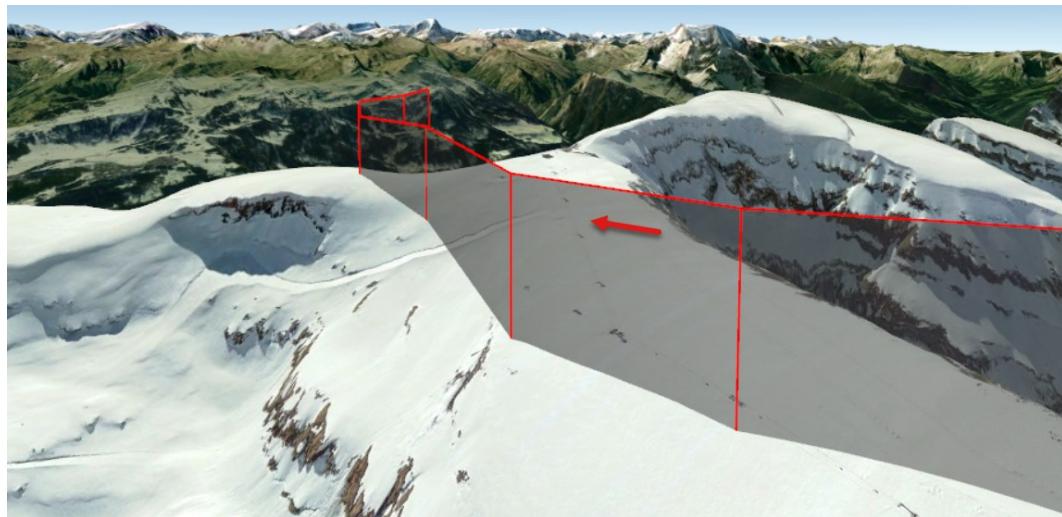
A1.18.7.2.3 Hotspot H02

**Figure 56:** Horizontal overflight at almost 90 degrees to the crest of the mountain ridge at an altitude of 2,310 m AMSL with a height of 74 m above ground directly below the radar flight path and 85 m above ground with respect to the lowest point of the terrain profile. Shown on Google Earth.

Figure 56 shows a choice of flight path classified as 'high-risk', which is characterised by the following safety-related features:

- Restricted view of the following section of terrain;
- Limited possibility of an alternative flight path;
- Very low-level flight over the terrain.

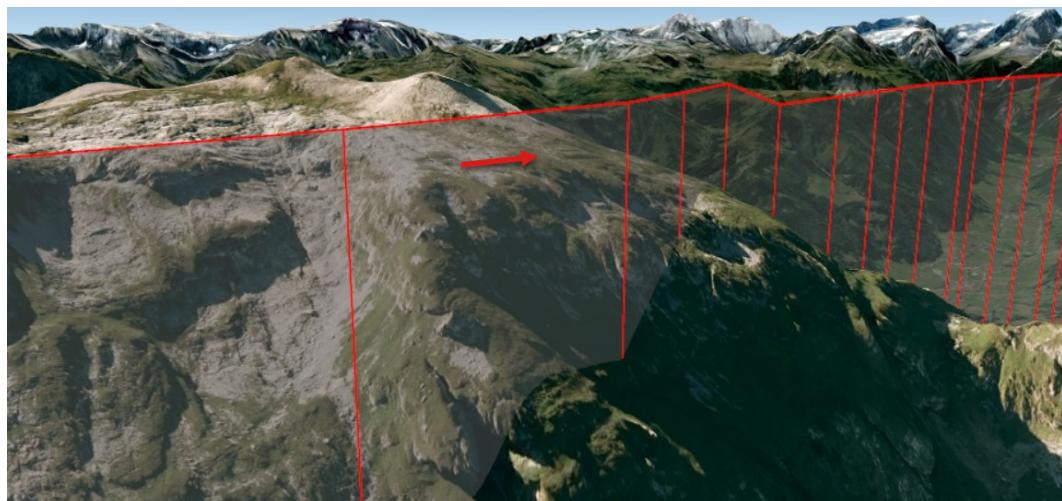
A1.18.7.2.4 Hotspot H03

**Figure 57:** Horizontal overflight at 90 degrees to the crest of the mountain ridge at an altitude of 2,269 m AMSL with a height of 111 m above ground directly below the radar flight path and 219 m above ground with respect to the lowest point of the terrain profile. Shown on Google Earth.

Figure 57 shows a choice of flight path classified as 'moderate-risk', which is characterised by the following safety-related feature:

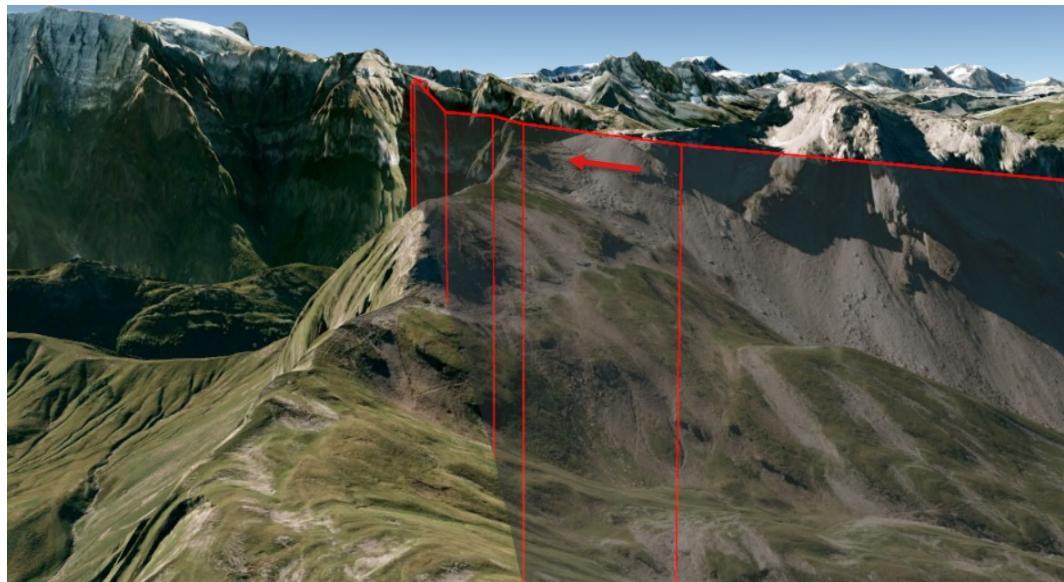
#### A1.18.7.3.2 Hotspot H01

**Figure 59:** Climbing flight over the terrain at an altitude of 2,285 m AMSL with a height of 129 m above ground directly below the radar flight path and 190 m above ground with respect to the lowest point of the terrain profile. Shown on Google Earth.

Figure 59 shows a choice of flight path classified as 'moderate-risk', which is characterised by the following safety-related features:

- Low-level flight over the terrain;
- Approaching an obstacle whilst climbing.

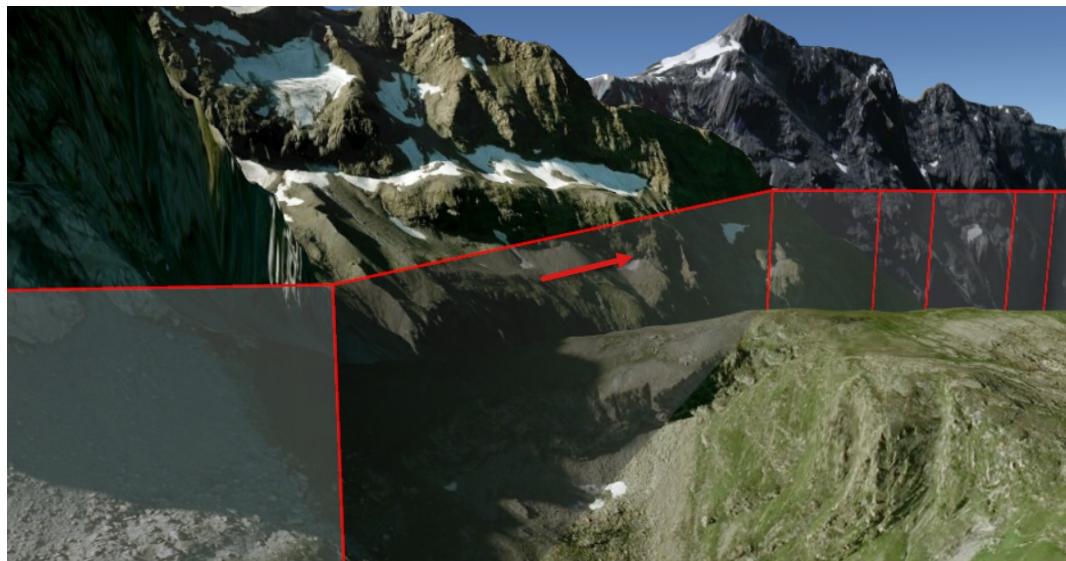
#### A1.18.7.3.3 Hotspot H02

**Figure 60:** Horizontal flight over the terrain at an altitude of 2,412 m AMSL with a height of 75 m above ground directly below the radar flight path and 115 m above ground with respect to the lowest point of the terrain profile. Shown on Google Earth.

Figure 60 shows a choice of flight path classified as 'moderate-risk', which is characterised by the following safety-related feature:

- Low-level flight over the terrain.

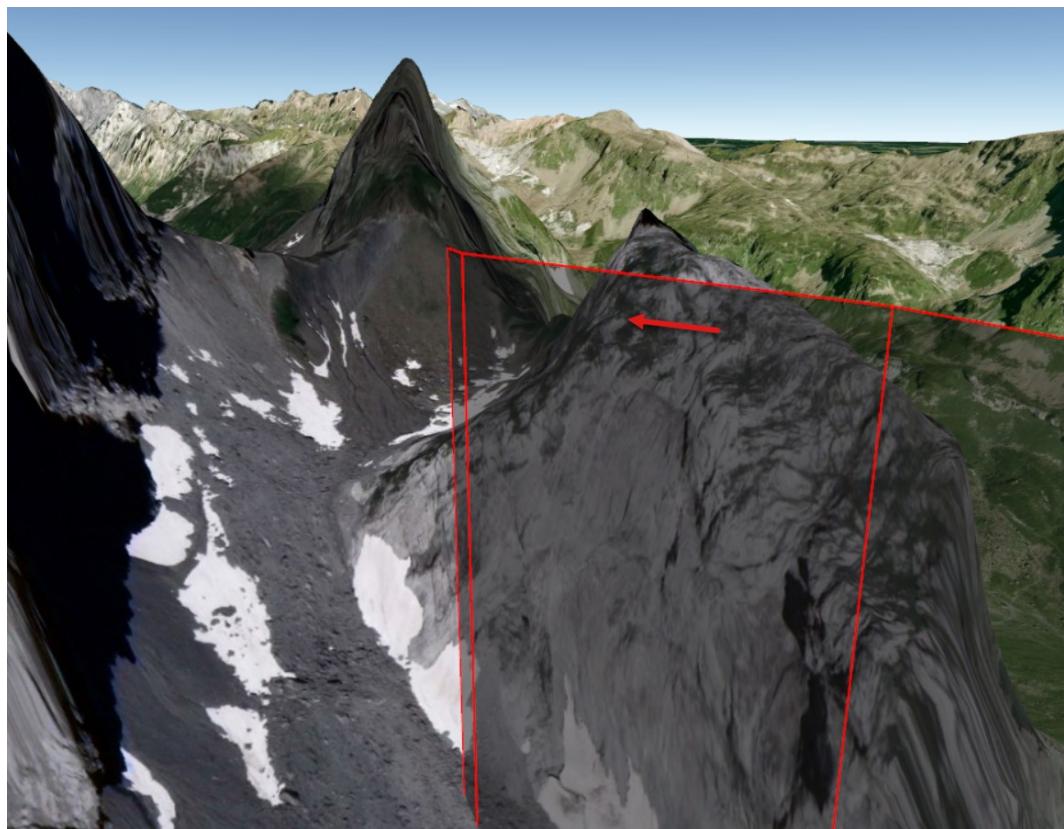
A1.18.7.3.4 Hotspot H03

**Figure 61:** Horizontal flight over the crest of the mountain ridge at an altitude of 2,413 m AMSL with a resulting height at a constant flying altitude of 78 m above ground directly below the radar flight path and 80 m above ground with respect to the lowest point of the terrain profile. Data extrapolated by the radar system were omitted. Shown on Google Earth.

Figure 61 shows a choice of flight path classified as 'very high-risk', which is characterised by the following safety-related features:

- Rising terrain in the direction of flight;
- Low-level flight over the terrain;
- Restricted view of the following section of terrain;
- No possibility of an alternative flight path for a prolonged period of time.

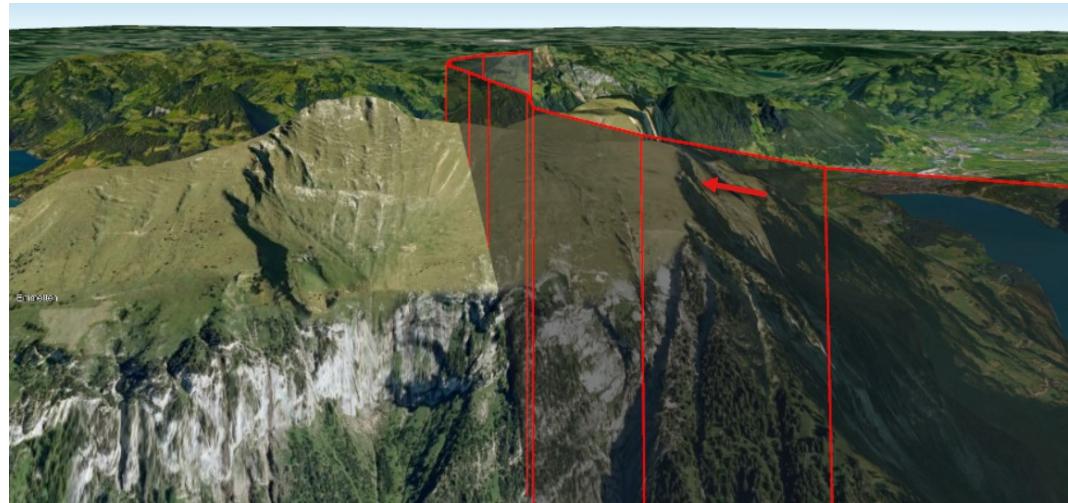
A1.18.7.3.5 Hotspot H04

**Figure 62:** Horizontal overflight at 90 degrees to the crest of the mountain ridge at an altitude of 2,170 m AMSL with a height of 110 m above ground directly below the radar flight path and 127 m above ground with respect to the lowest point of the terrain profile. Shown on Google Earth.

Figure 62 shows a choice of flight path classified as 'moderate-risk', which is characterised by the following safety-related feature:

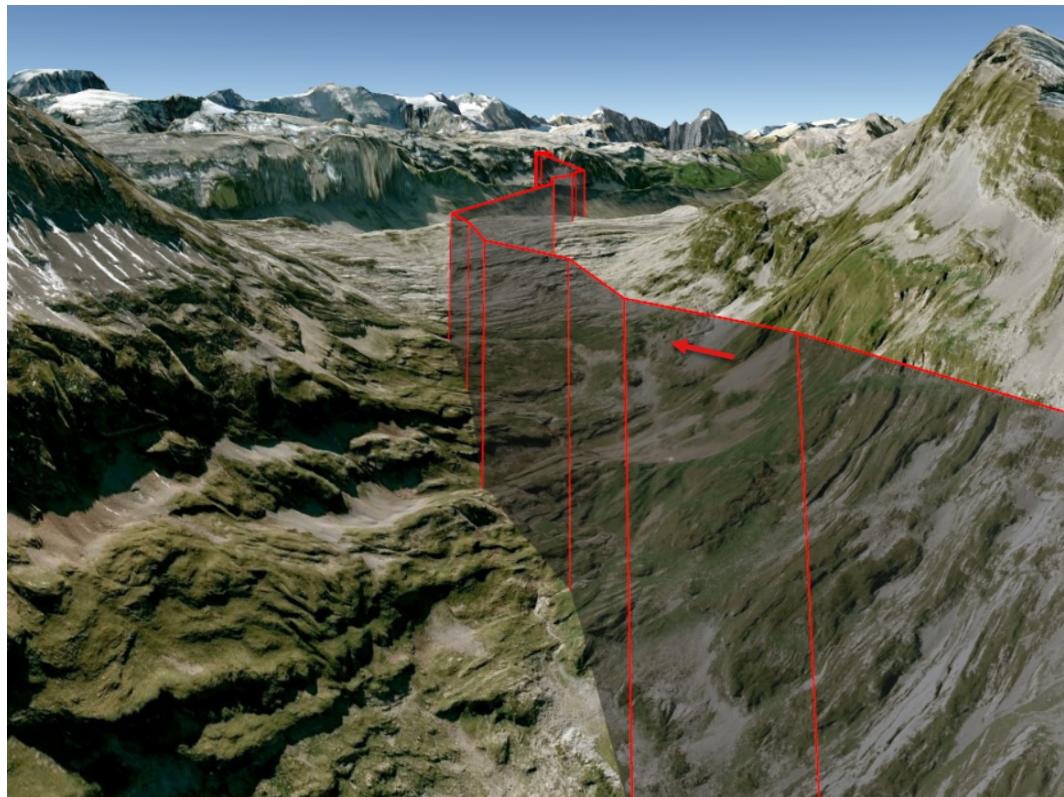
A1.18.7.4.2 Hotspot H01

**Figure 64:** Climbing flight over the terrain at an altitude of 2,313 m AMSL with a height of 107 m above ground directly below the radar flight path and 127 m above ground with respect to the lowest point of the terrain profile. Shown on Google Earth.

Figure 64 shows a choice of flight path classified as 'very high-risk', which is characterised by the following safety-related features:

- Rising terrain in the direction of flight;
- Low-level flight over the terrain;
- Approaching an obstacle whilst climbing;
- No possibility of an alternative flight path for a prolonged period of time.

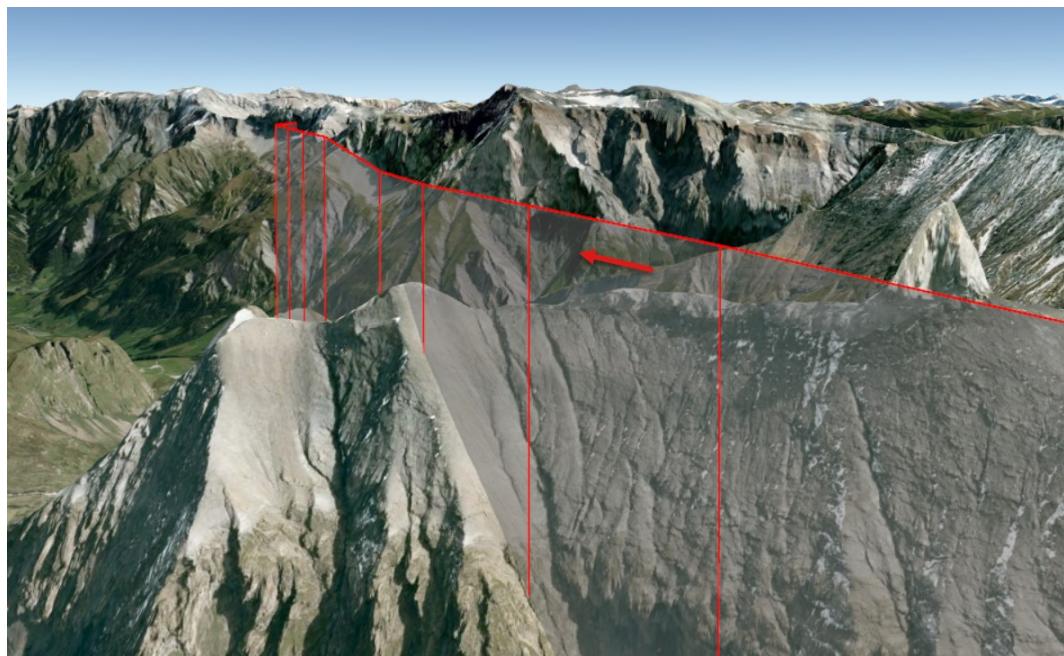
A1.18.7.4.3 Hotspot H02

**Figure 65:** Horizontal flight over the terrain at an altitude of 2,811 m AMSL with a height of 106 m above ground directly below the radar flight path and 153 m above ground with respect to the lowest point of the terrain profile. Shown on Google Earth.

Figure 65 shows a choice of flight path classified as 'moderate-risk', which is characterised by the following safety-related features:

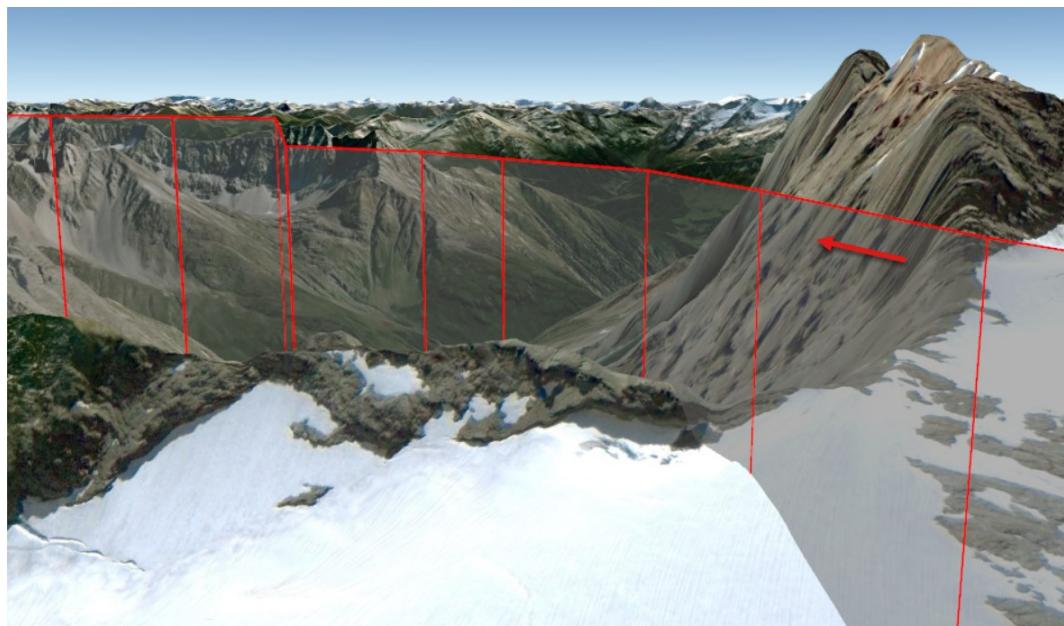
**Figure 67:** Climbing flight over the crest of the mountain ridge at an altitude of 3,060 m AMSL with a height of 163 m above ground directly below the radar flight path and 194 m above ground with respect to the lowest point of the terrain profile. Shown on Google Earth.

Figures 67, 68 and 69 show that during the FOCA inspection flight, the Ju-Air aircraft was also flown in mountainous areas well below the safety margin of at least 1,000 ft AGL (300 m above ground). Furthermore, basic principles for safely flying in mountainous areas were disregarded. The choice of flight path clearly contradicted the guidelines for flights in the Alps drawn up by FOCA itself, as published in the Aeronautical Information Publication (AIP) of Switzerland, VFR guide RAC 6-3 (see section [A1.17.6.2.2](#)).

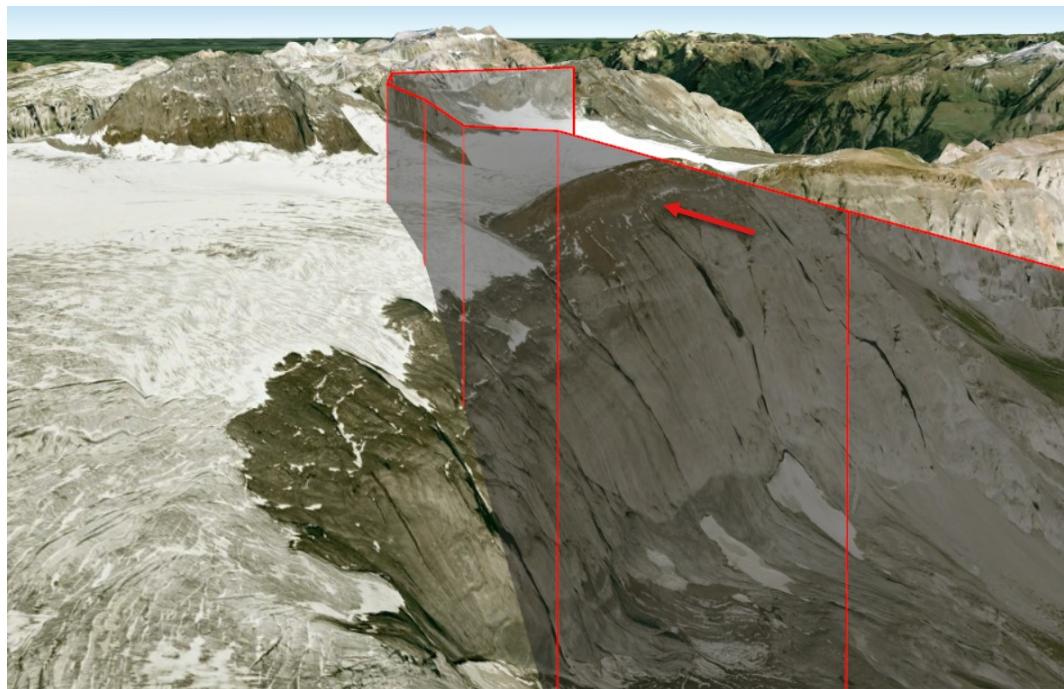
A1.18.7.5.3 Hotspot H02

**Figure 68:** Descending overflight at an altitude of 3,060 m AMSL with a height of 185 m above ground directly below the radar flight path and 218 m above ground with respect to the lowest point of the terrain profile. Shown on Google Earth.

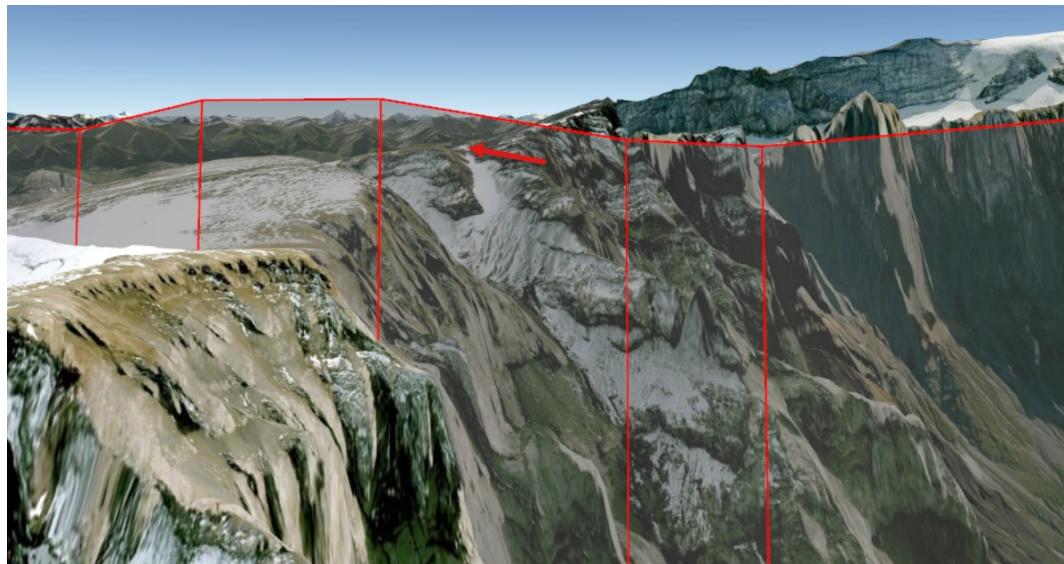
A1.18.7.5.4 Hotspot H03

**Figure 69:** Horizontal overflight at 90 degrees to the crest of the mountain ridge at an altitude of 3,027 m AMSL with a height of 141 m above ground directly below the radar flight path and 142 m above ground with respect to the lowest point of the terrain profile. Shown on Google Earth.

Figure 69 shows a choice of flight path classified as 'moderate-risk', which is characterised by the following safety-related feature:

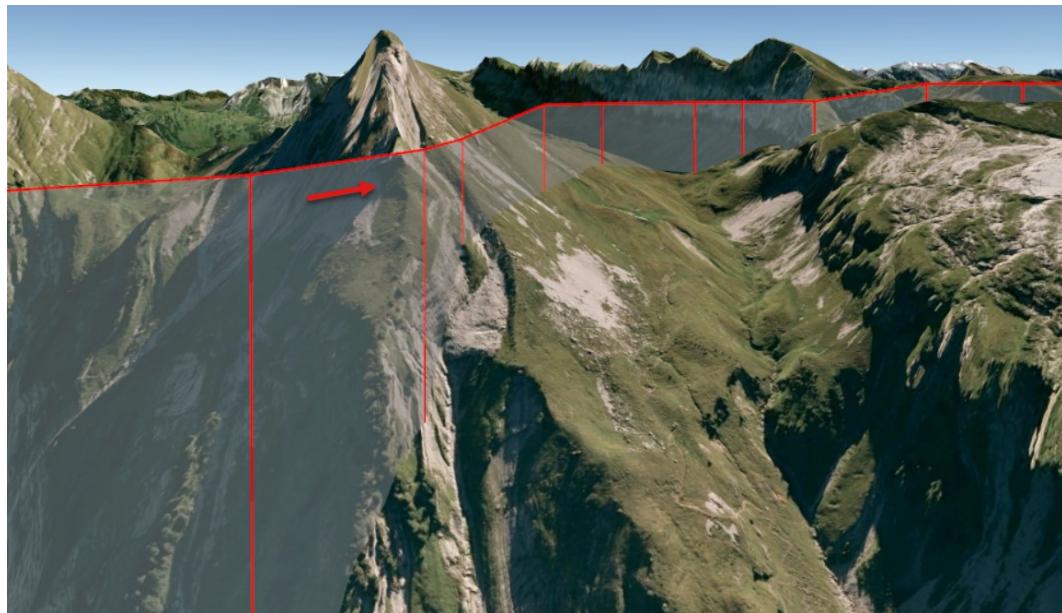
A1.18.7.6.2 Hotspot H01

**Figure 71:** Horizontal overflight at almost 90 degrees to the terrain feature at an altitude of 1,994 m AMSL with a height of 104 m above ground directly below the radar flight path and 111 m above ground with respect to the lowest point of the terrain profile. Shown on Google Earth.

Figure 71 shows a choice of flight path classified as 'very high-risk', which is characterised by the following safety-related features:

- Rising terrain in the direction of flight;
- Low-level flight over the terrain;
- Restricted view of the following section of terrain;
- No possibility of an alternative flight path for a prolonged period of time.

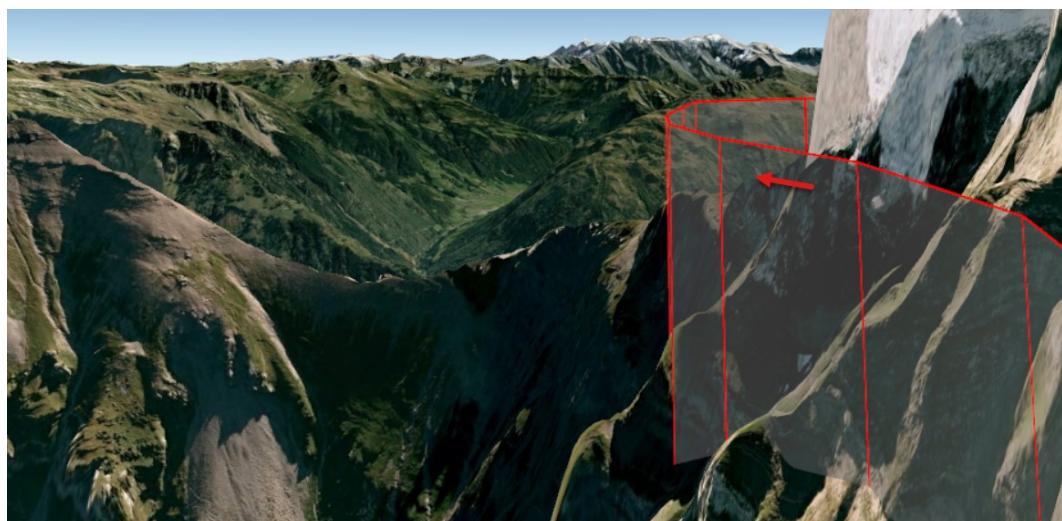
A1.18.7.6.3 Hotspot H02

**Figure 72:** Horizontal overflight at almost 90 degrees to the terrain feature at an altitude of 2,362 m AMSL with a height of 100 m above ground directly below the radar flight path and 184 m above ground with respect to the lowest point of the terrain profile. Shown on Google Earth.

Figure 72 shows a choice of flight path classified as 'very high-risk', which is characterised by the following safety-related features:

- Low-level flight over the terrain;
- Restricted view of the following section of terrain;
- No possibility of an alternative flight path for a prolonged period of time.

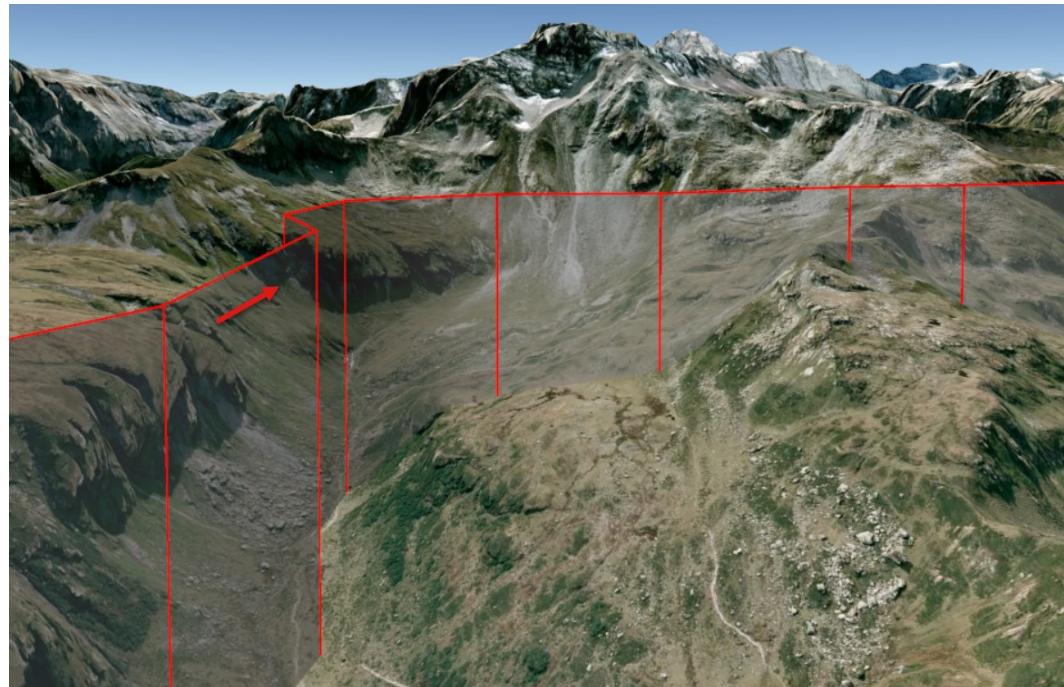
#### A1.18.7.6.4 Hotspot H03

**Figure 73:** Horizontal flight over the terrain at an altitude of 2,298 m AMSL with a height of 93 m above ground directly below the radar flight path and 149 m above ground with respect to the lowest point of the terrain profile. Shown on Google Earth.

Figure 73 shows a choice of flight path classified as 'moderate-risk', which is characterised by the following safety-related feature:

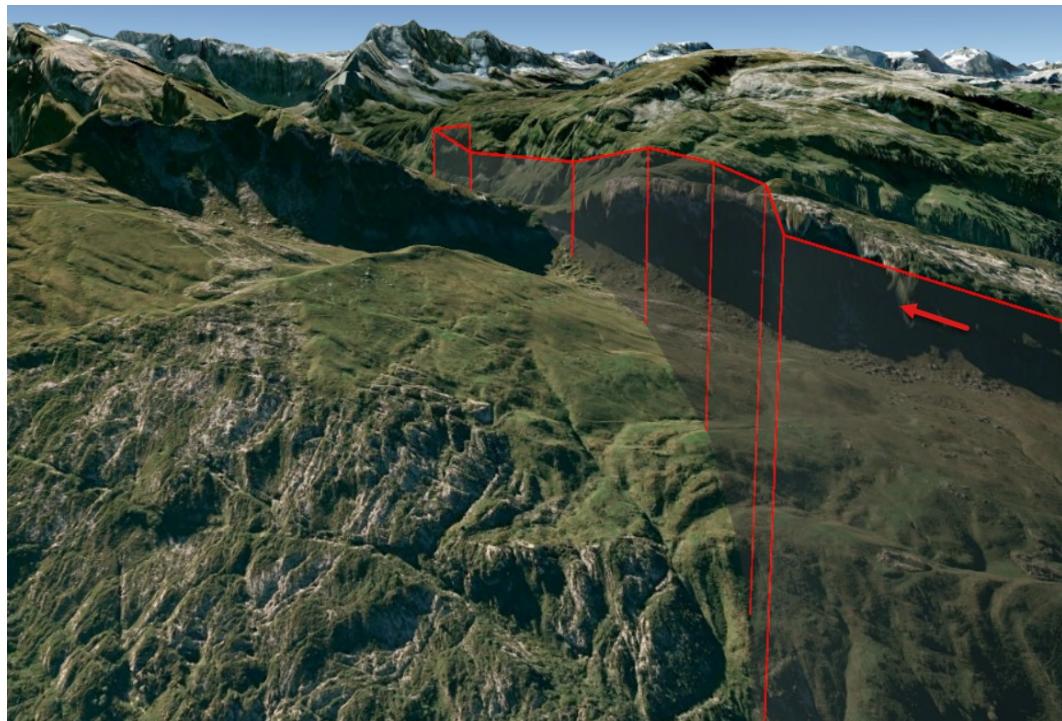
A1.18.7.7.2 Hotspot

**Figure 75:** Descending overflight at almost 90 degrees to the terrain feature at an altitude of 1,901 m AMSL with a height of 78 m above ground directly below the radar flight path and 81 m above ground with respect to the lowest point of the terrain profile. Shown on Google Earth.

Figure 75 shows a choice of flight path classified as 'high-risk', which is characterised by the following safety-related features:

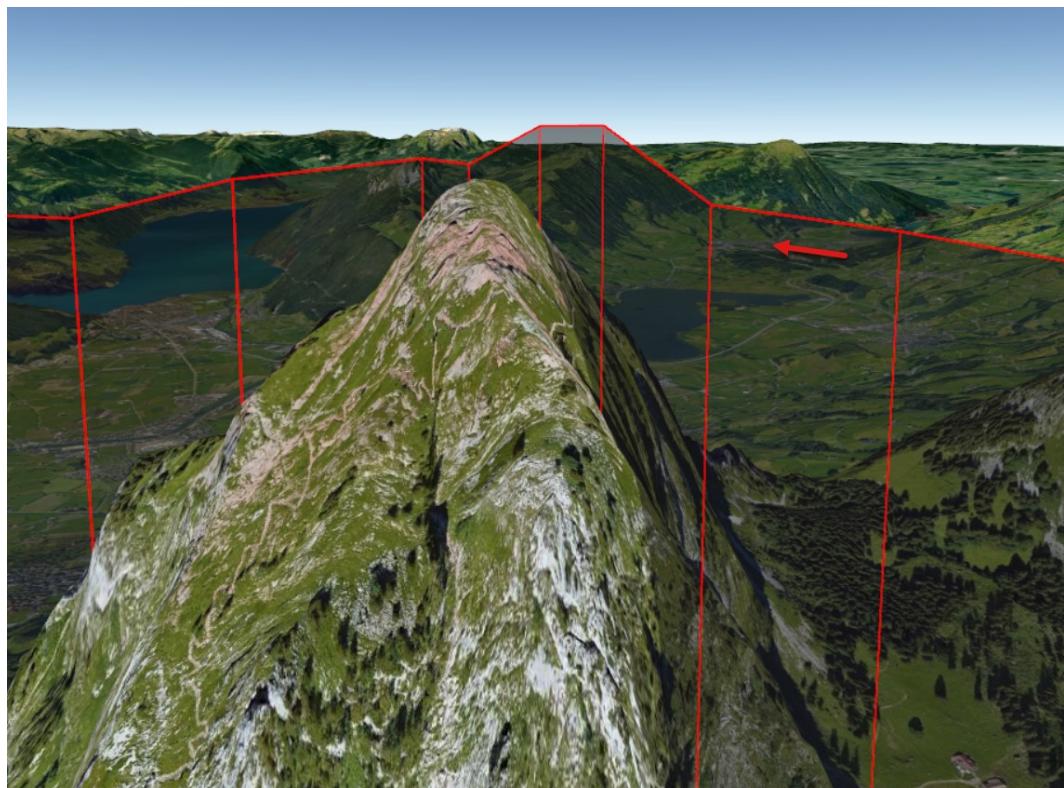
A1.18.7.8.2 Hotspot

**Figure 77:** Climbing flight over the terrain at an altitude of 1,944 m AMSL with a height of 87 m above ground directly below the radar flight path and 353 m above ground with respect to the lowest point of the terrain profile. Shown on Google Earth.

Figure 77 shows a choice of flight path classified as 'high-risk'<sup>4</sup>, which is characterised by the following safety-related features:

<sup>4</sup> Chosen flight path classified as 'very high-risk' due to the instrument meteorological conditions at the time

The radar flight path (see figure 77) shows the climbing and very high-risk approach to Gross Mythen, with an approach up to the summit cross under temporary instrument meteorological conditions (IMC). A descent is initiated after passing the summit cross. In addition, screenshots from a video file show the level of visibility prevailing on that day and the Ju-52's near-terrain fly-by at Gross Mythen (see figures 79 and 80). During the daytime, visual flight rules (VFR) operations for aircraft in class Golf airspace are to be conducted in such a way that the aircraft is outside of the clouds with a constant view of the ground or water.

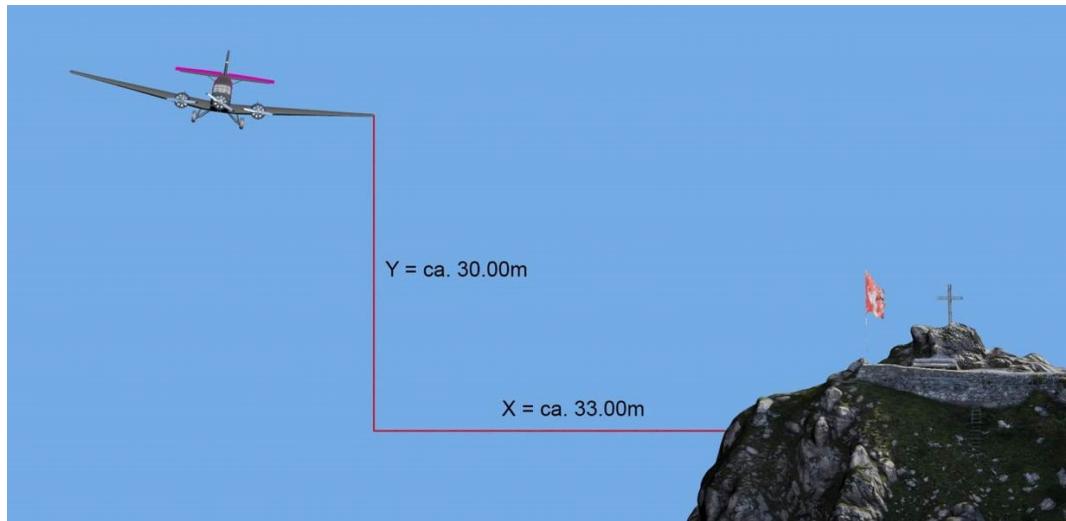
The lateral distance from the rocky outcrop when passing Gross Mythen was approximately 33 m (see figure 78).

**Figure 78:** Reconstructed position and attitude using a three-dimensional model of an aircraft flying past Gross Mythen. Lateral distance from the rocky outcrop approximately 33 m, with a vertical distance of approximately 30 m.

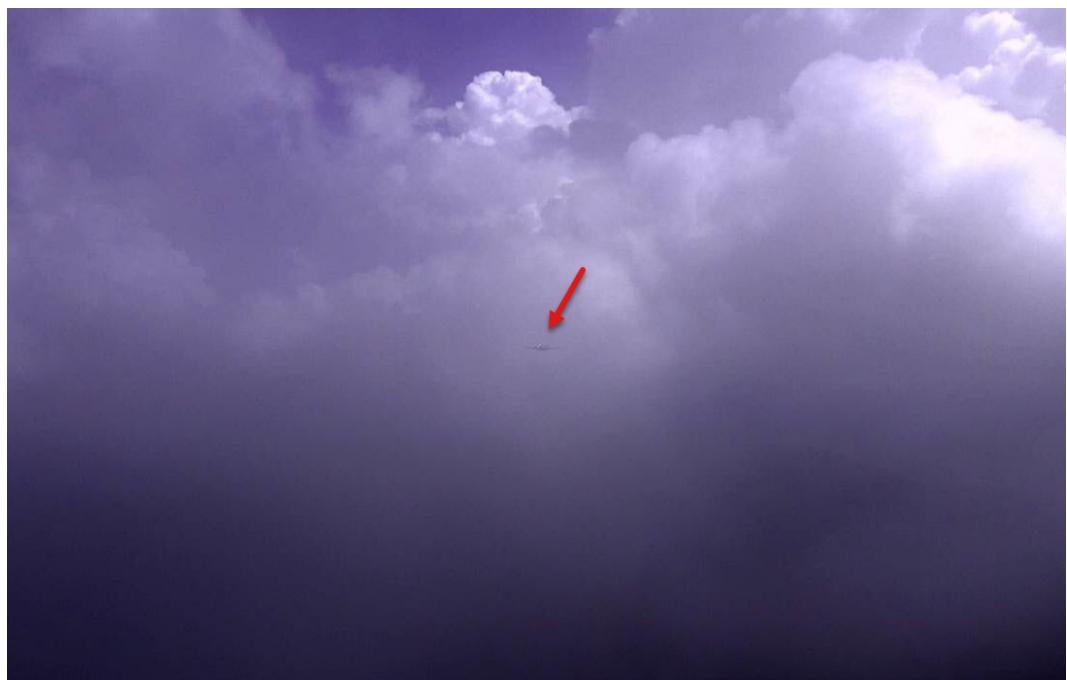
**Figure 79:** The faintly visible silhouette of an approaching Ju 52/3m g4e (red arrow) travelling towards Gross Mythen (image contrast increased). Footage provided by private individual.

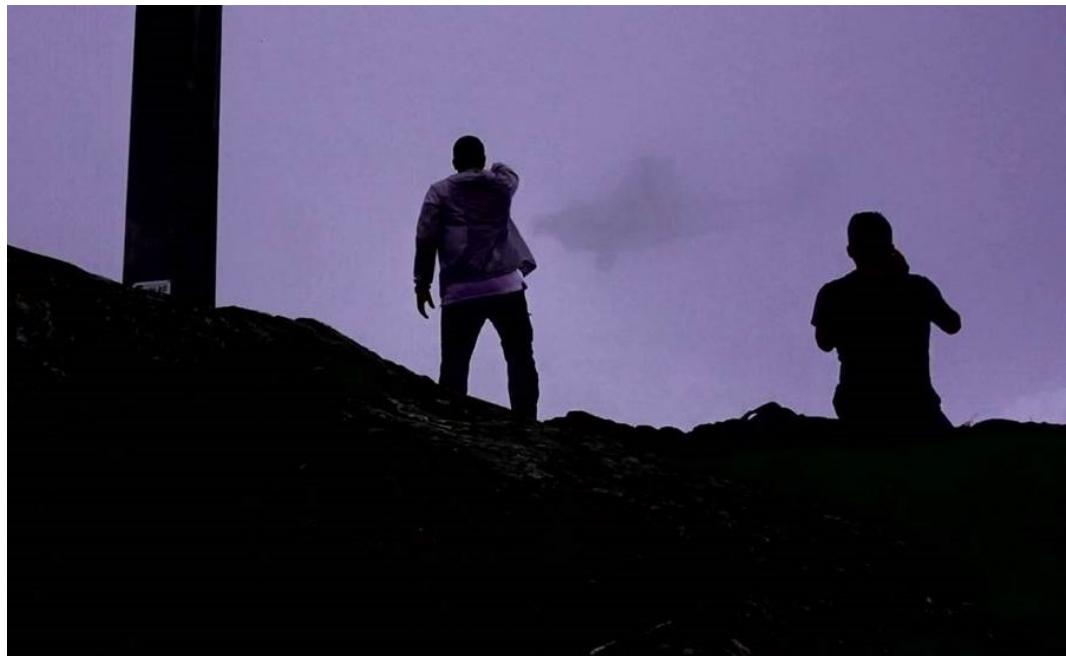
**Figure 80:** The Ju 52/3m g4e flying past the summit cross is only faintly visible due to the weather conditions at Gross Mythen (image contrast increased). Footage provided by private individual.

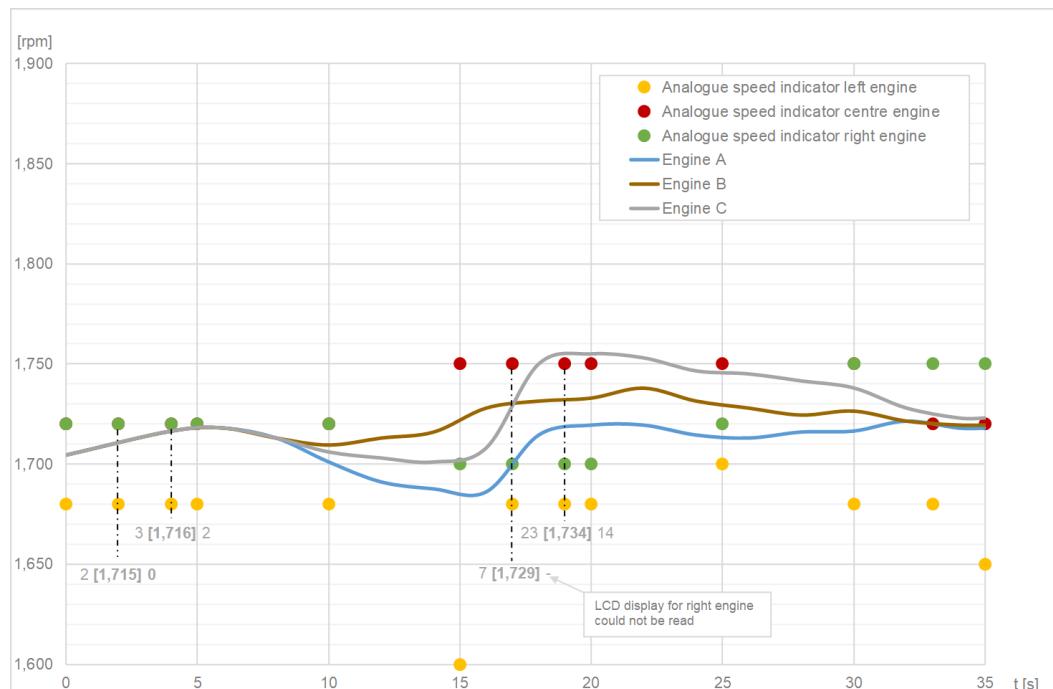
Figure 5 shows a graph of the three engine speeds from HB-HOT during its flight past Mount Rigi on 3 August 2018. The yellow, red and green dots indicate the rpm speeds of the three engines read from the analogue gauges in the still images over the course of the fly-by. In some still images, it was also possible to see the digital displays of the tachometers. These are shown as numbers on the graph. The numbers in the square brackets relate to the speed of the centre engine, the numbers to the left and right of these brackets correspond to the speed differences of the left and right engine in relation to the centre engine.

**Figure 5:** Graph of the engine speeds from HB-HOT over the course of the video footage recorded whilst flying past Mount Rigi on 3 August 2018.

In the first phase of the fly-by, the engine speeds were between 1,700 and 1,720 rpm. After 15 seconds, the speeds of engines A and C were increased by 20 to 30 rpm, now ranging between 1,720 and 1,750 rpm. The speed of engine A never exceeded 1,720 rpm.
