## SUMMARY REPORT

<b>HCL 49/99      Incident</b>	
Aircraft:	Boeing 767-383
Engines:	2 Pratt & Whitney PW 4060
Crew:	10 – no injuries
Place:	Copenhagen Airport (EKCH)
Registration:	OY-KDN
Operation:	Scheduled, IFR
Passengers:	181 – no injuries
Date & time:	24.08.1999 kl.1403 (UTC)

### **Synopsis**

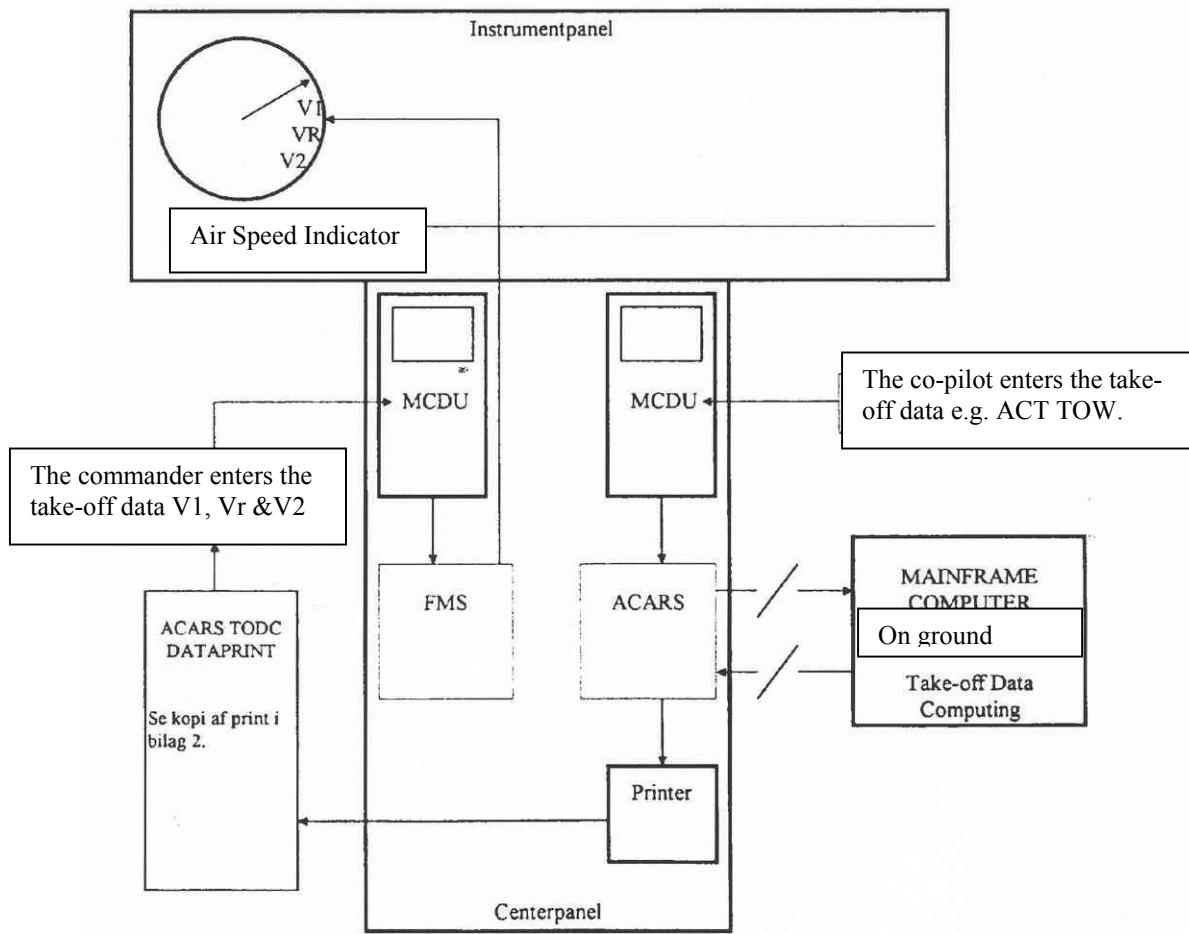
Appendix 1. Process-diagram indicating the data-route from the MCDU to V1, Vr and V2 indication on the flight instruments.

Multifunction Control Display Unit (MCDU)  
 Aircraft Communication And Reporting System (ACARS)  
 Flight Management System (FMS)  
 Take Off Data Computing (TODC)
