QTR_04
12

A QUARTERLY PUBLICATION
BROUGHT TO YOU BY
THE BOEING EDGE

AERO

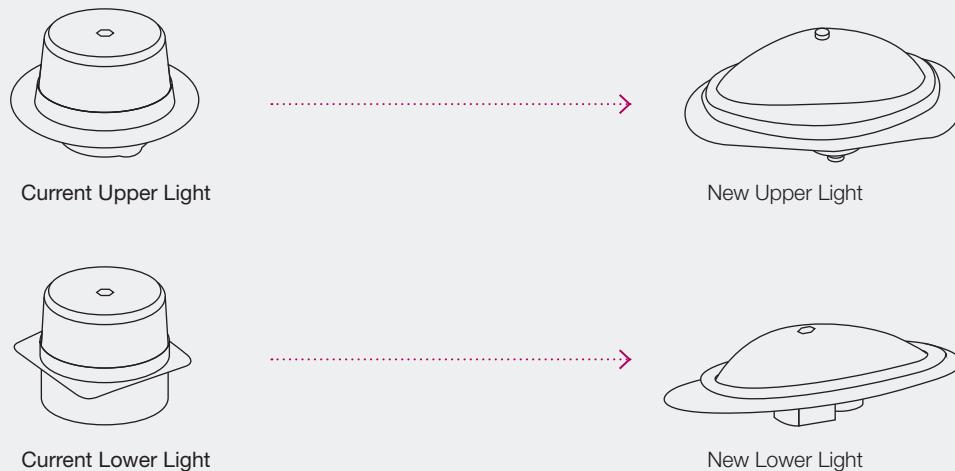
Figure 1: Aerodynamic-shaped anti-collision (AC) lights

New AC lights (right) are more aerodynamic than the previous lights (left).

Aerodynamic AC lights. Replacing the upper and lower red AC light assemblies with a more aerodynamically designed shape reduces airplane drag (see fig. 1). The upper skin was revised, and no electrical interface changes were required to accommodate the new AC lights.

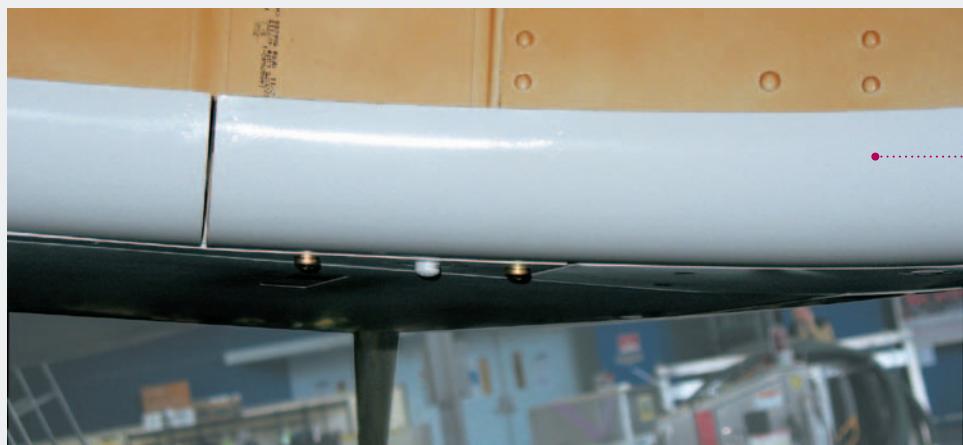
Figure 4: Ski-jump wheel-well fairings

The PIP includes five new contoured panels on the aft side of the wheel wells.

Wheel-well fairings. The five aft wheel-well fairing assemblies have been recontoured to smooth the airflow near the main landing gear, reducing airplane drag (see fig. 4).

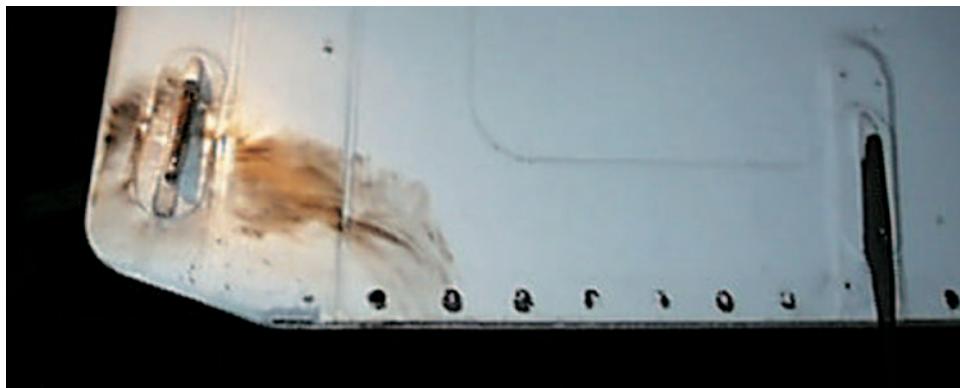
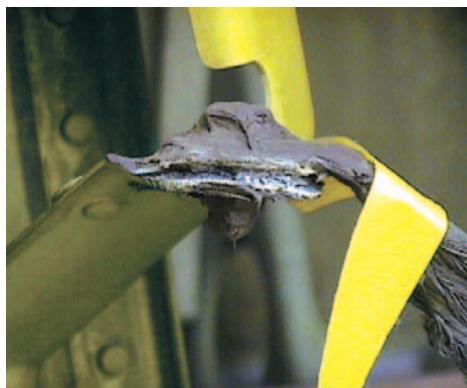
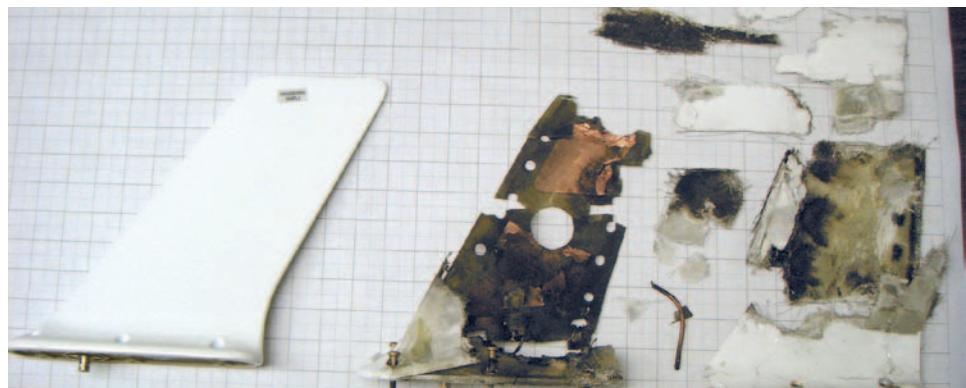
Figure 5: Lightning protection and strike damage

Clockwise from upper left: Lightning damage to a horizontal stabilizer, rudder, antenna, and bond jumper.

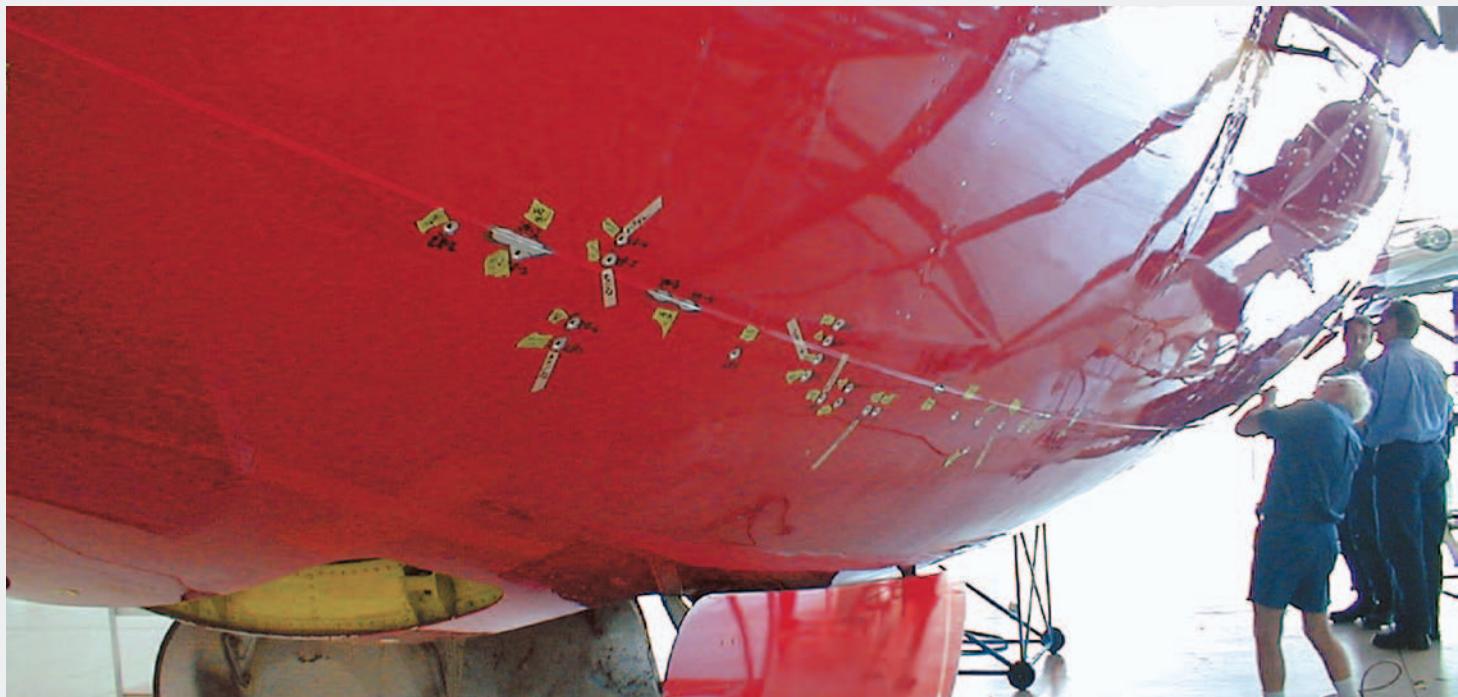
Figure 6: Damage caused by lightning moving along an airplane

When a lightning strike moves along an airplane, it can cause “swept stroke” damage.

Because the airplane flies more than its own length during the time it takes a strike to begin and finish, the entry point will change as the flash reattaches to other spots aft of the initial entry point. Evidence of this is seen in strike inspections where multiple burns are seen along the airplane's fuselage (see fig. 6).
