**S**tudy

**on Aeroplane State Awareness  
during Go-Around**

**BEA**

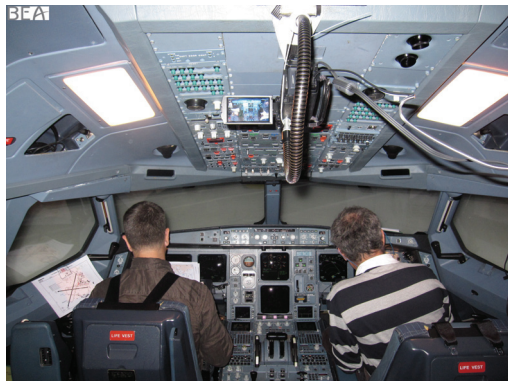
A HD camera fitted in the cockpit, with an extension link for images and sound, allowed specialists not present in the simulator to observe the sessions live. The rapid sequence of events specific to a go-around could be studied by analysing the video recording.

Figure 9 :  
The camera installed in the A330 simulator

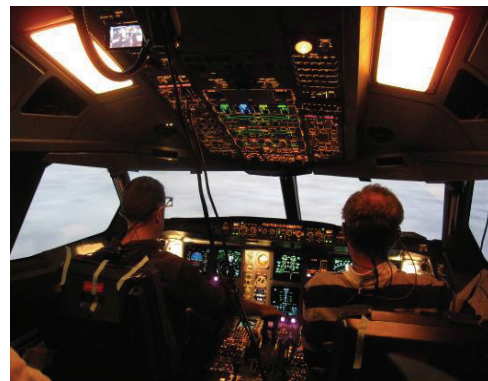
Figure 10 :  
The camera installed in the A330 simulator

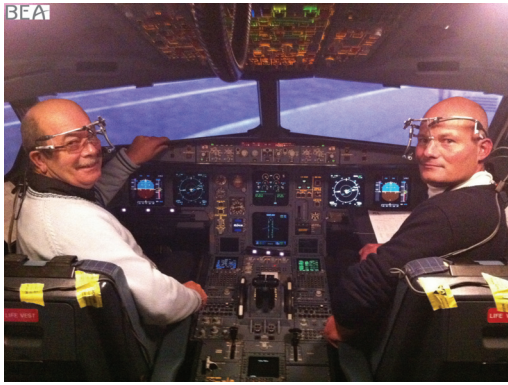
The study of the visual scan required an eye-tracking system to be installed on each member of the crew. The system consisted of a camera focused on the eye which detected the position of the pilot's pupil (50 Hz) and a head-mounted camera which filmed straight ahead. By correlating the measured position of the pupil with the point focused on by the head-mounted camera, the system identified the point of gaze. Software tools were used to characterise the pilots' fixations on the various zones in their field of vision, called zones of interest. Consequently, it is possible to determine the time spent looking at a particular zone (instrument, control, etc.). Other data can be generated by these tools.

Figure 12 : System installed on a flight crew

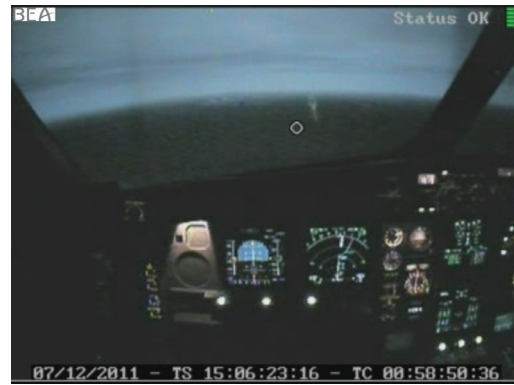
Figure 13 : Eye tracking image

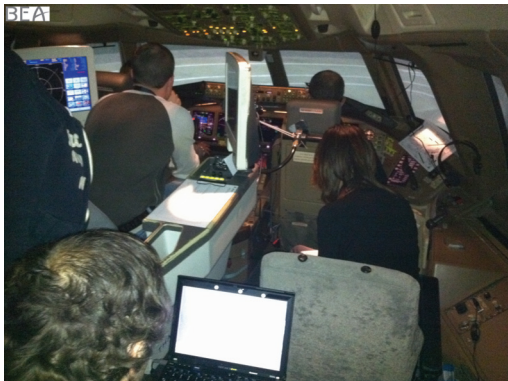
During the sessions, five people were present in the simulator: the two pilots, the instructor, an eye-tracking system specialist and an HF specialist. Moreover, BEA investigators participated and interacted with the cockpit from outside the simulator via an external link to the HD camera.

Figure 14 : General view of the simulator

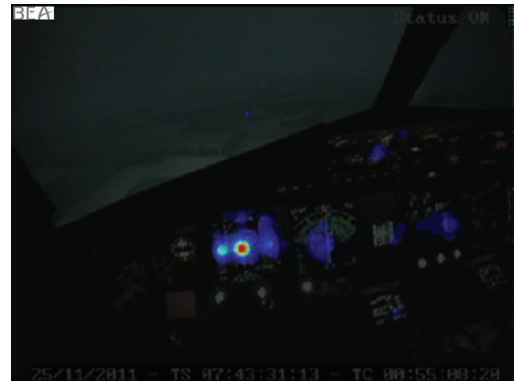
- Heat maps, which provide a qualitative representation of the points of gaze during a specified period of time (take-off, approach, etc.)
- The number of times the gaze focused on a zone of interest
- The average and minimum durations of the fixations on a zone of interest.

Figure 15 : Heat map

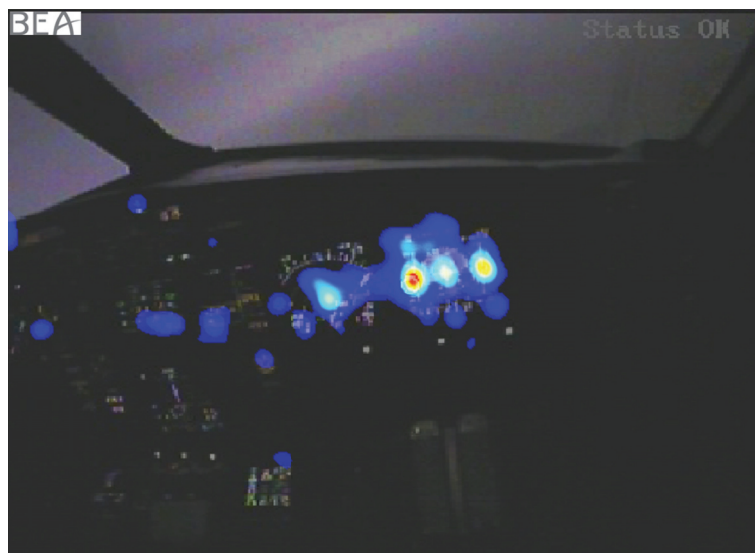
Heat maps reflect the "density" of gaze fixations<sup>9</sup> in the cockpit during the go-around period. The colour gradient of the heat map produced by each pilot is deliberately different, and the region with the highest gaze density is systematically shown in red. It is therefore important not to compare one heat map with another based on the colour of a zone.

Figure 18 : Heat map for a PNF/PM during a go-around

*Note: the colour gradient from blue (cold) to red (hot) represents the "degree" of interest on a display of information. The longer the fixation on a display, the more the colour changes towards red, and the greater the probability that the pilot has paid attention to*

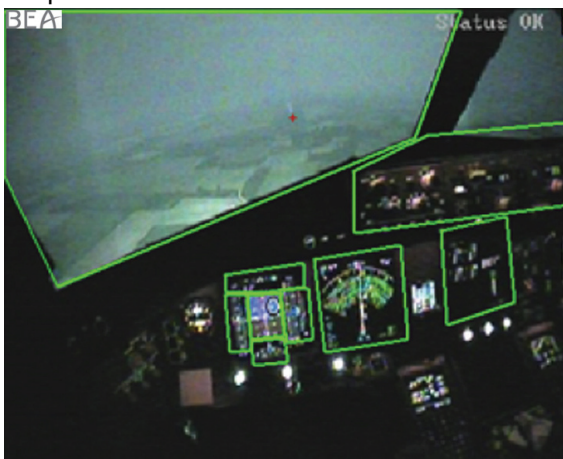
The ZI were selected based on the requirements of the study, on the initial observations and on the limitations of the Eye Tracker tool. The ZI are the framed areas indicated in the photos below.

Figure 19 : definition of the zones of interest in the cockpit

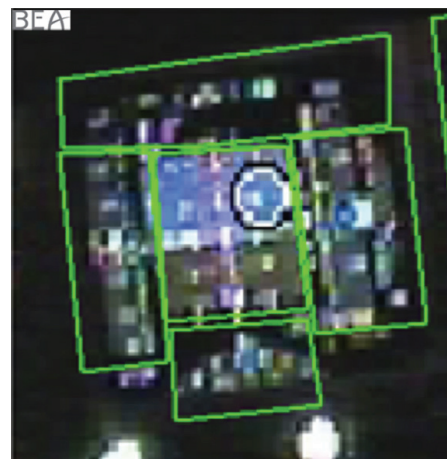
Figure 20 : definition of the zones of interest on the PFD

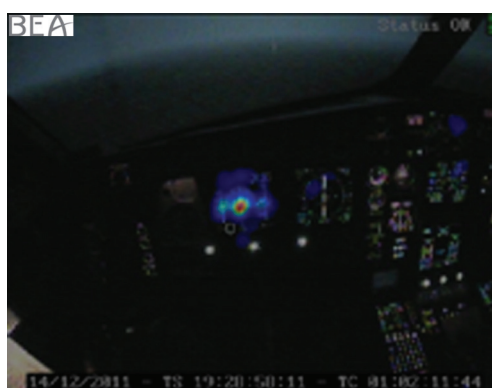
Figure 23 : Representative heat maps for GA1  
PF

The above heat maps are representative for GA1, PF& PNF/PM. The figure 23 show that the PF's attention is generally focused on the basic flight control information displayed on the PFD whereas the PNF/PM's attention is more varied and widespread compared with the PF on the figure 24.

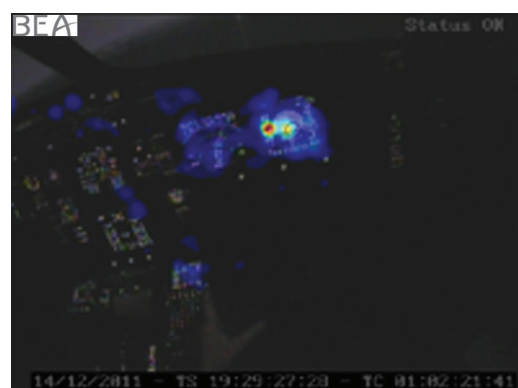
Figure 24 : Representative heat maps for GA1  
PNF

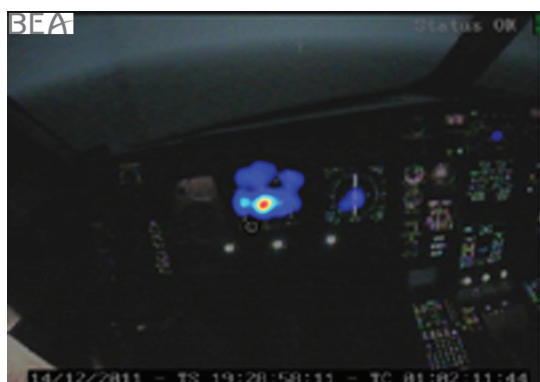
Figure 26 : Representative heat maps for GA2  
PF

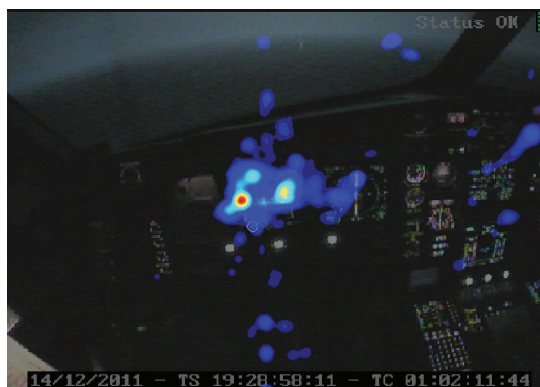
Figure 29 : Representative heat maps for GA3 PNF/PM

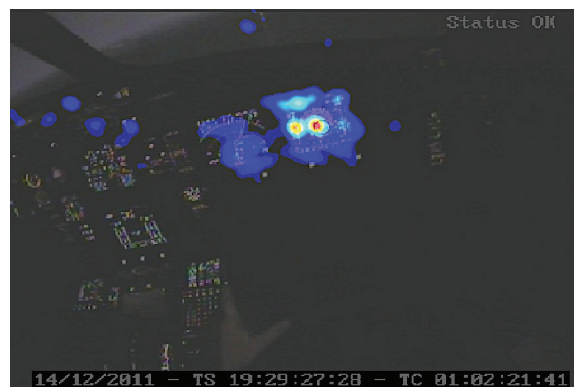
Figure 30 : Representative heat maps for GA3 PF

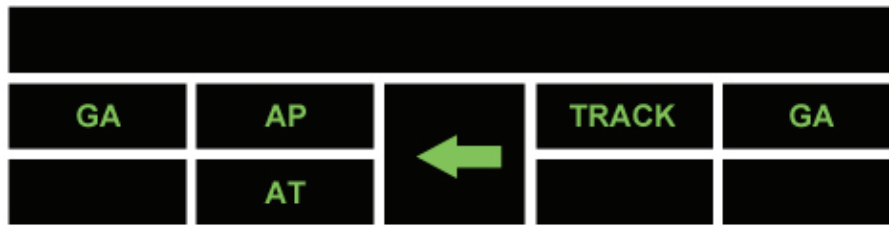
Figure 38 : FMA mode on EMB170

The option to go around with the AP is conditional on this display. If the display is not correct, the pilot must disengage the automatic systems and perform a manual go-around (based on the usual parameters: pitch attitude and thrust). The "bird" provides information about the energy status and indicates the climbing flight path with a pitch attitude which is 8° in manual. As in a final approach, the pitch attitude is close to 5°; the risks of somatogravic illusions are thus limited.

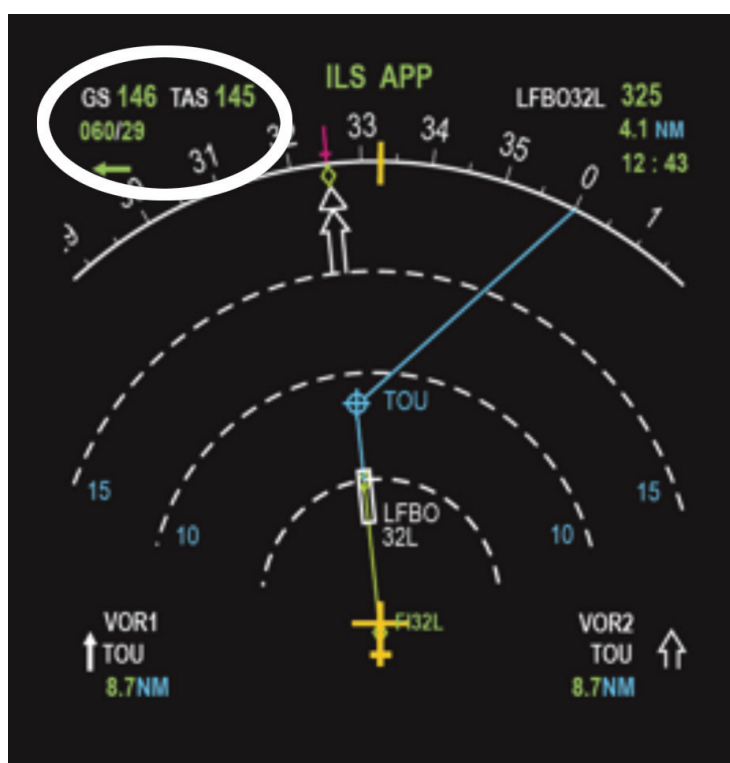
Figure 39 : a navigation display on A330

The wind speed and direction is indicated on both pilots' navigation displays (ND), in the top left corner, by an arrow accompanied by numerical values in the form DDD/SS (where DDD is the wind direction in magnetic degrees and SS the speed in knots).

In normal operations, the wind indicated by the left ND is the wind calculated by ADIRU 1 and the wind indicated in the right ND is calculated by ADIRU 2.

The wind is calculated by each of the 3 ADIRU based on the difference between the ground speed vector (calculated by the inertial unit) and the airspeed vector (calculated by the air data computer, assuming zero side-slip).

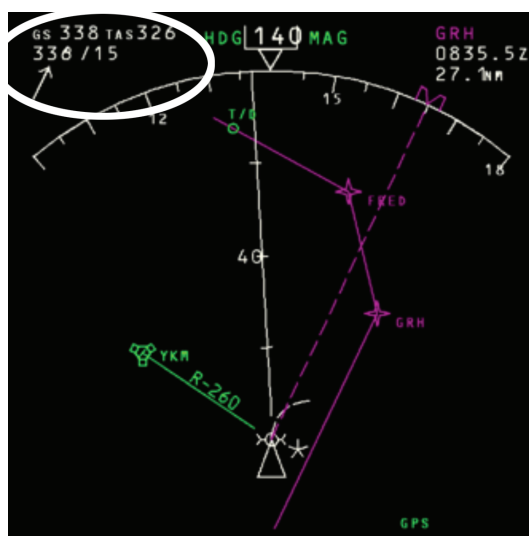
Figure 40 : a navigation display on B777

The wind speed and direction is displayed on both pilots' navigation displays (ND), in the top left corner, by an arrow accompanied by numerical values in the form DDD°/SS (where DDD is the wind direction in magnetic degrees and SS the speed in knots).

In normal operations, the wind indicated by the ND is the wind calculated by the FMC. If it is invalid, the wind calculated by the ADIRU is presented instead. The wind is only indicated if its speed is greater than 5 kt.

The FMC's ground speed vector is corrected based on the variation in GPS position, which means that it is more accurate than the ADIRU's ground speed vector.
