# Mind the gap... Keeping aircraft operations safe during runway construction works

by Gaël Le Bris

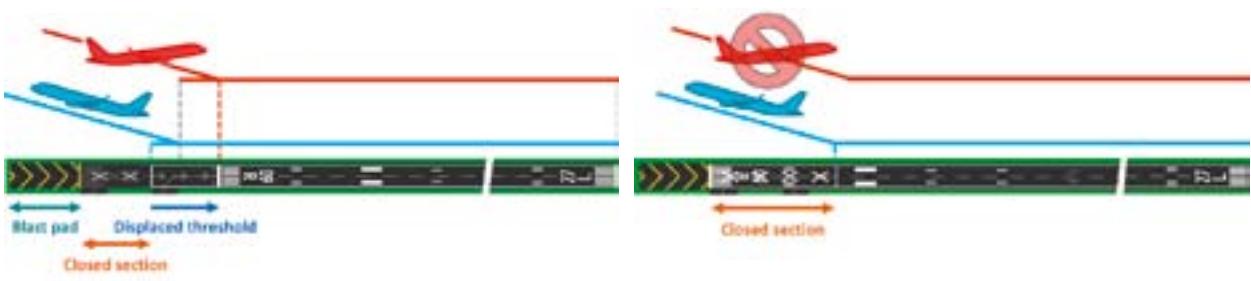
Fig. 1 – An example of shortened runway (left) and a typical displaced threshold (right)

Temporarily shortened runways, especially if the threshold is displaced may avoid the closure of the runway. This concept is used at airports of all volumes of traffic, fleet mix, and location. They have been deployed equally at general aviation, civilian/military, and commercial airports.
