The Airbus Safety **Magazine**

Edition February 2010

- A320 Family/
Evolution of ground spoiler logic
- Incorrect pitch trim setting
at takeoff
- Technical Flight Familiarization
- Oxygen safety

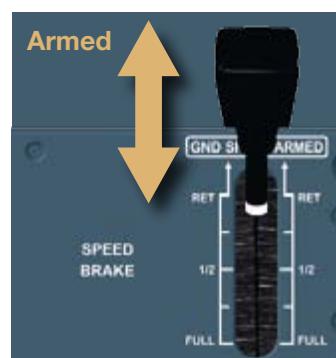
Figure 1

- Ground spoilers armed (fig. 1)
 - Both main landing gears seen on ground.
 - Both thrust levers at or below Idle notch (fig. 2).

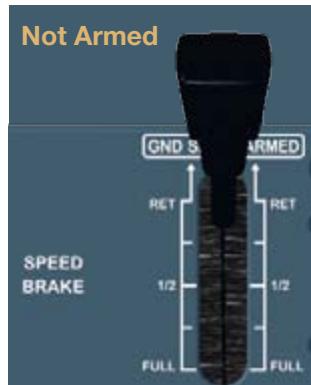
| Figure 3

- Ground spoilers not armed (fig. 3)
 - Both main landing gears seen on ground.
 - Reverse is selected on at least one engine (the other thrust lever must be at or below Idle notch, fig. 4).

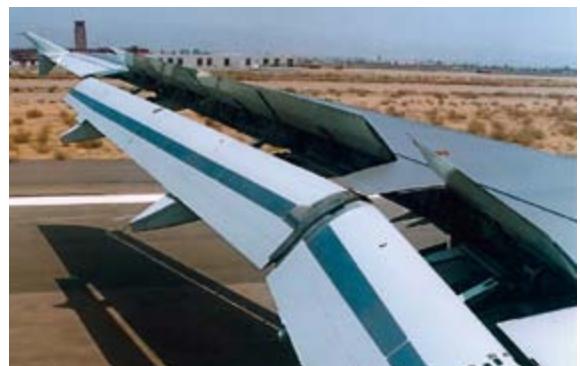
| Figure 5

| Full ground spoiler extention

The ground spoilers were not armed

- The speed brake lever was in a non retracted position (fig. 5).
- One engine throttle was not in the area that authorized ground spoiler extension (fig. 6).

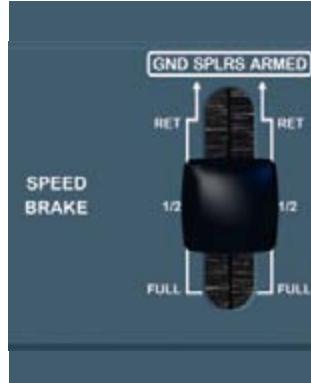
| Figure 6

The spoilers could not extend

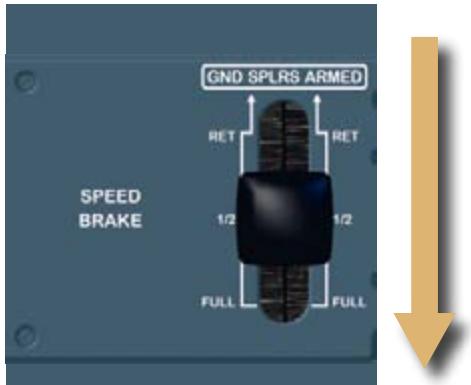
Figure 8
Expanded ground spoiler arming condition based on more tolerant speed brake lever position.

- Ground spoilers armed or speed brake lever in non retracted position (fig. 8).

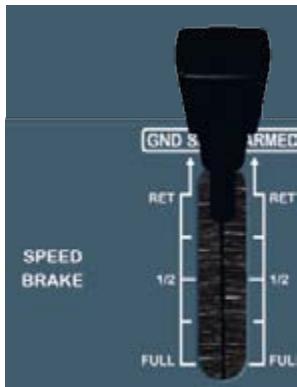
Figure 10
Expanded ground spoiler extension condition based on more tolerant thrust lever position

- Ground spoilers not armed (fig. 9)
 - Both main landing gears seen on ground.
 - Reverse is selected on at least one engine (**the other thrust lever must be below the Maximum Continuous - MCT - notch, fig. 10**).

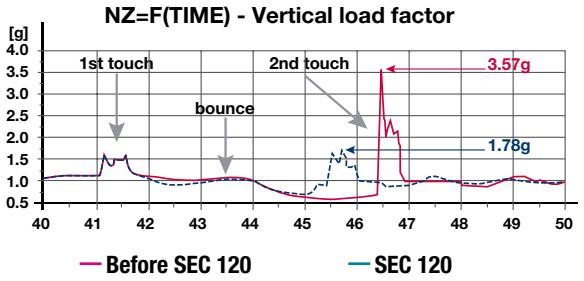
Example of typical hard landing event

A statistical analysis has revealed that a significant bounce ($Nz > 1.6g$) occurs in about 50% of the hard landing events. In about half of those cases (i.e. 25% of all hard landings), the second impact is harder than the first one.

With the SEC 120 modification allowing partial ground spoiler extension on ground even with thrust levers on Climb (ATHR) notch, the average load factor at the second touchdown is reduced to about 1.7g.

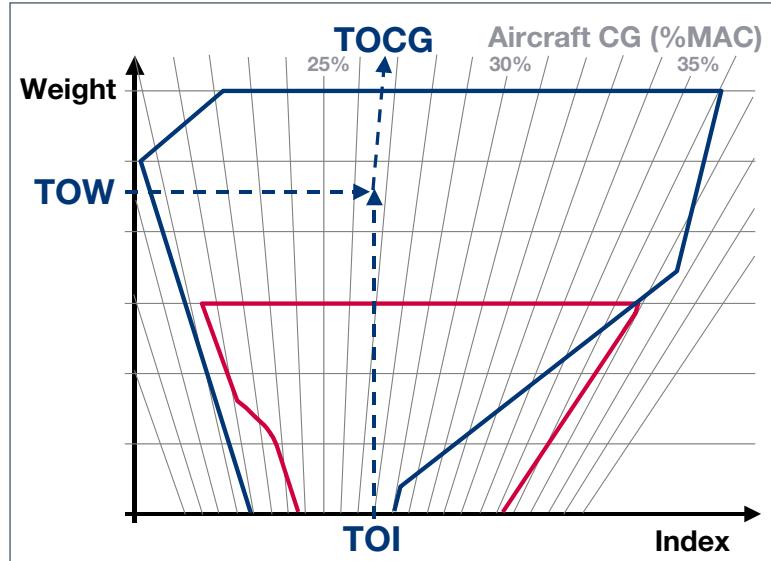
Figure 1
Determination of the
TOCG

To determine the TOCG (expressed in percent of the Mean Aerodynamic Chord, %MAC) it is necessary to determine the Takeoff Weight (TOW) and the Takeoff Index (TOI) (fig 1).

$$\begin{aligned} \text{TOI} = & \text{Zero Fuel Index} \\ & + \text{Takeoff Fuel Index} \end{aligned}$$

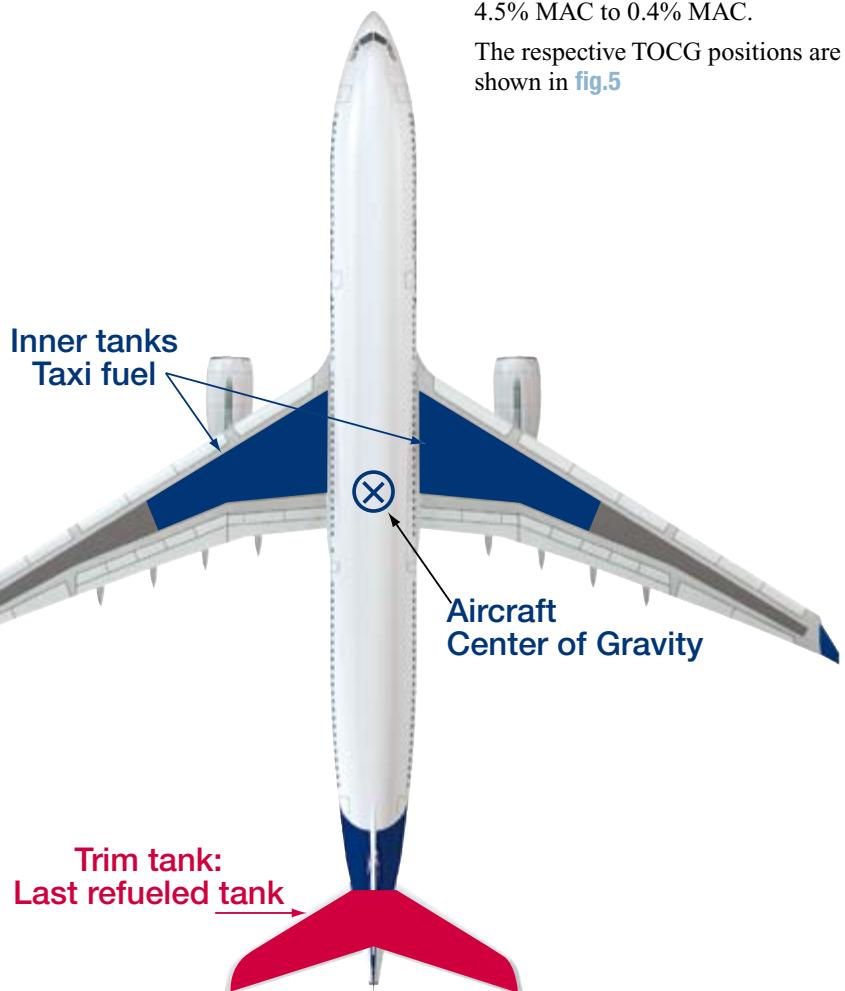
Figure 3
A330 fuel tank configuration

On the A330 example mentioned in the introduction, the Ramp Fuel was 39 tons and the Taxi Fuel was 2.6 tons. In this configuration, the last refueled tank is the trim tank, and the taxi fuel is burnt from the inner tanks, as shown in fig.3.

On Airbus aircraft the taxi fuel is consumed from:

- The inner/wing tanks on the A300/A310/A318/A319/A320/A321/A330/A340.
- The feed tanks on the A380.

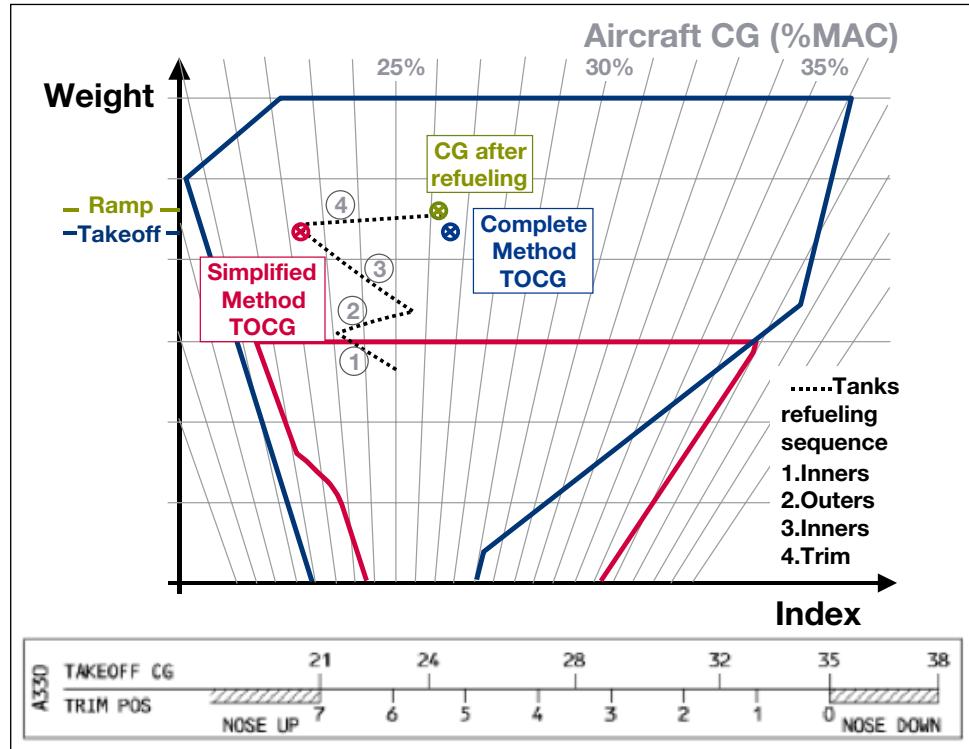
Figure 4
TOCG positions using the simplified and complete calculations

The respective TOCG positions are shown in fig.4.

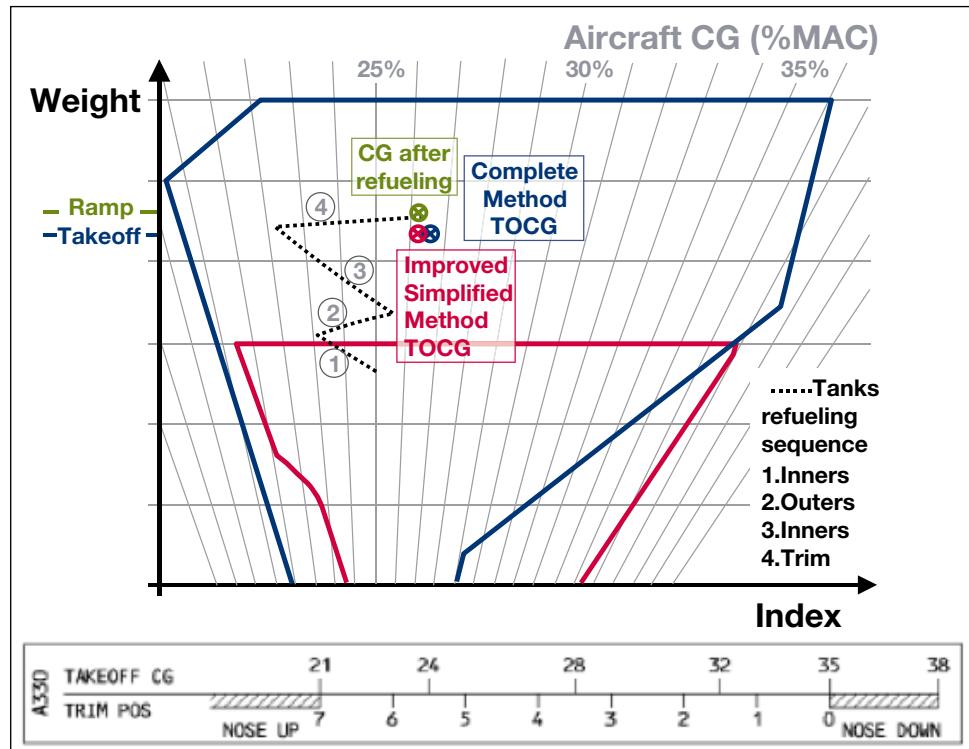
Figure 5
TOCG positions using the improved simplified and complete calculations

With the improved simplified TOCG calculation, the difference between the calculated TOCG and the real TOCG decreases from 4.5% MAC to 0.4% MAC.

The respective TOCG positions are shown in fig.5

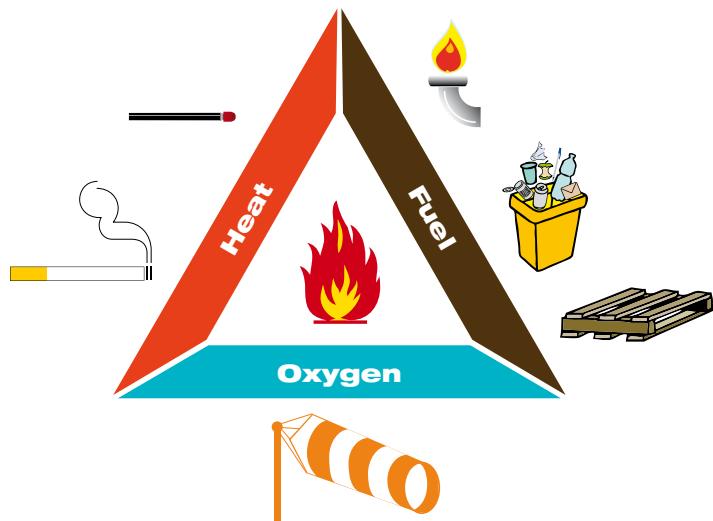
Figure 1
The fire (chemical reaction) can start if there is enough heat, fuel and oxygen.

The third element, in the form of heat or spark, is needed to trigger the combustion (fig.1).

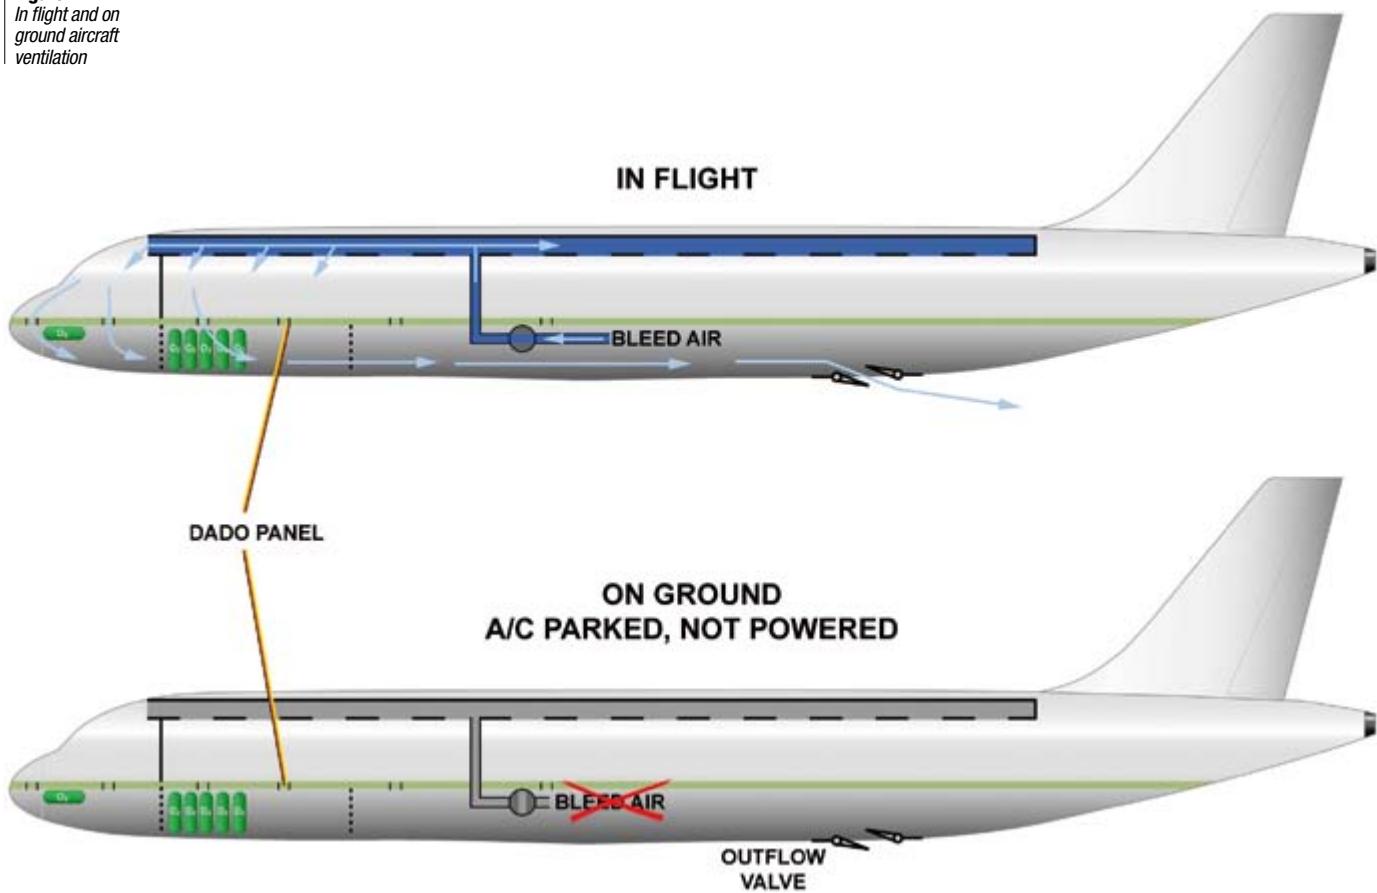
Figure 2
In flight and on
ground aircraft
ventilation

The oxygen bottles are located in confined areas (avionics bay, vicinity of cargo compartments etc...). When the aircraft is flying, these areas are ventilated and leaking oxygen is expected to be evacuated by the aircraft's air conditioning system, through the outflow valve(s) (fig.2).

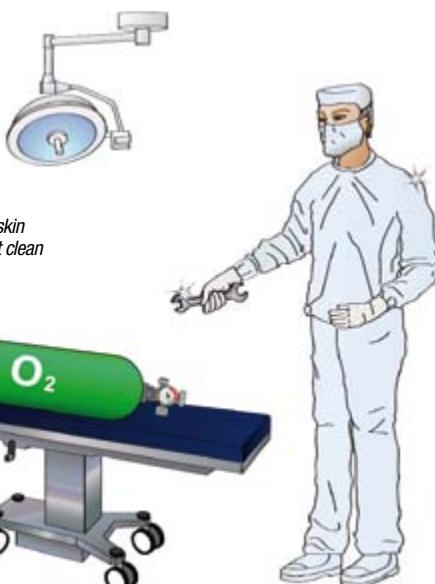
Figure 7
Keep Clothes, skin and equipment clean

- The oxygen components, as well as the area around them, must always be cleaned with approved cleaner; before and after any work done on the system.
- Clothing, skin and equipment (tools, rags etc...) should be clean and free from oil, grease and hydrocarbons in general.
- Keep your hands clean (if possible, wear cotton gloves). Do not touch connection ends nor the inside of oxygen components with bare hands, as skin oil and bacteria are a source of contamination (fig.7).
- Stop all procedures that use flammable material such as cleaning and de-icing materials.
- Stop all refueling and all repairs on fuel and hydraulic systems.
- Keep all hydrocarbons (fuels, corrosion protection compounds, lubricants, etc.) away from sources of oxygen (fig.8).

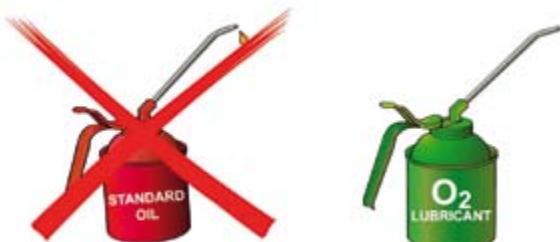
Figure 8
Use only oxygen systems approved lubricant

WARNING: NEVER USE STANDARD OIL TO LUBRICATE THE CONNECTOR THREAD. ONLY USE LUBRICANTS AND THREAD COMPOUNDS SPECIFICALLY APPROVED FOR OXYGEN SYSTEMS.

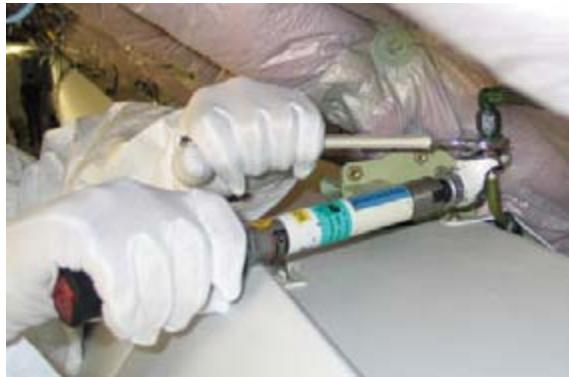
Figure 9
Use two wrenches during disconnection/reconnection of connectors and torque at right value

► During disconnection/reconnection of an oxygen line connector use two wrenches, one for the nut and one for the counter nut, to avoid force onto the material (risk of rupture and leakage) (Fig. 9).
