Landing below minima due to fog involving Boeing 737s, VH-YIR and VH-VYK

Mildura Airport, Victoria | 18 June 2013

ATSB Transport Safety Report
Aviation Occurrence Investigation
AO-2013-100
Final – 31 May 2016

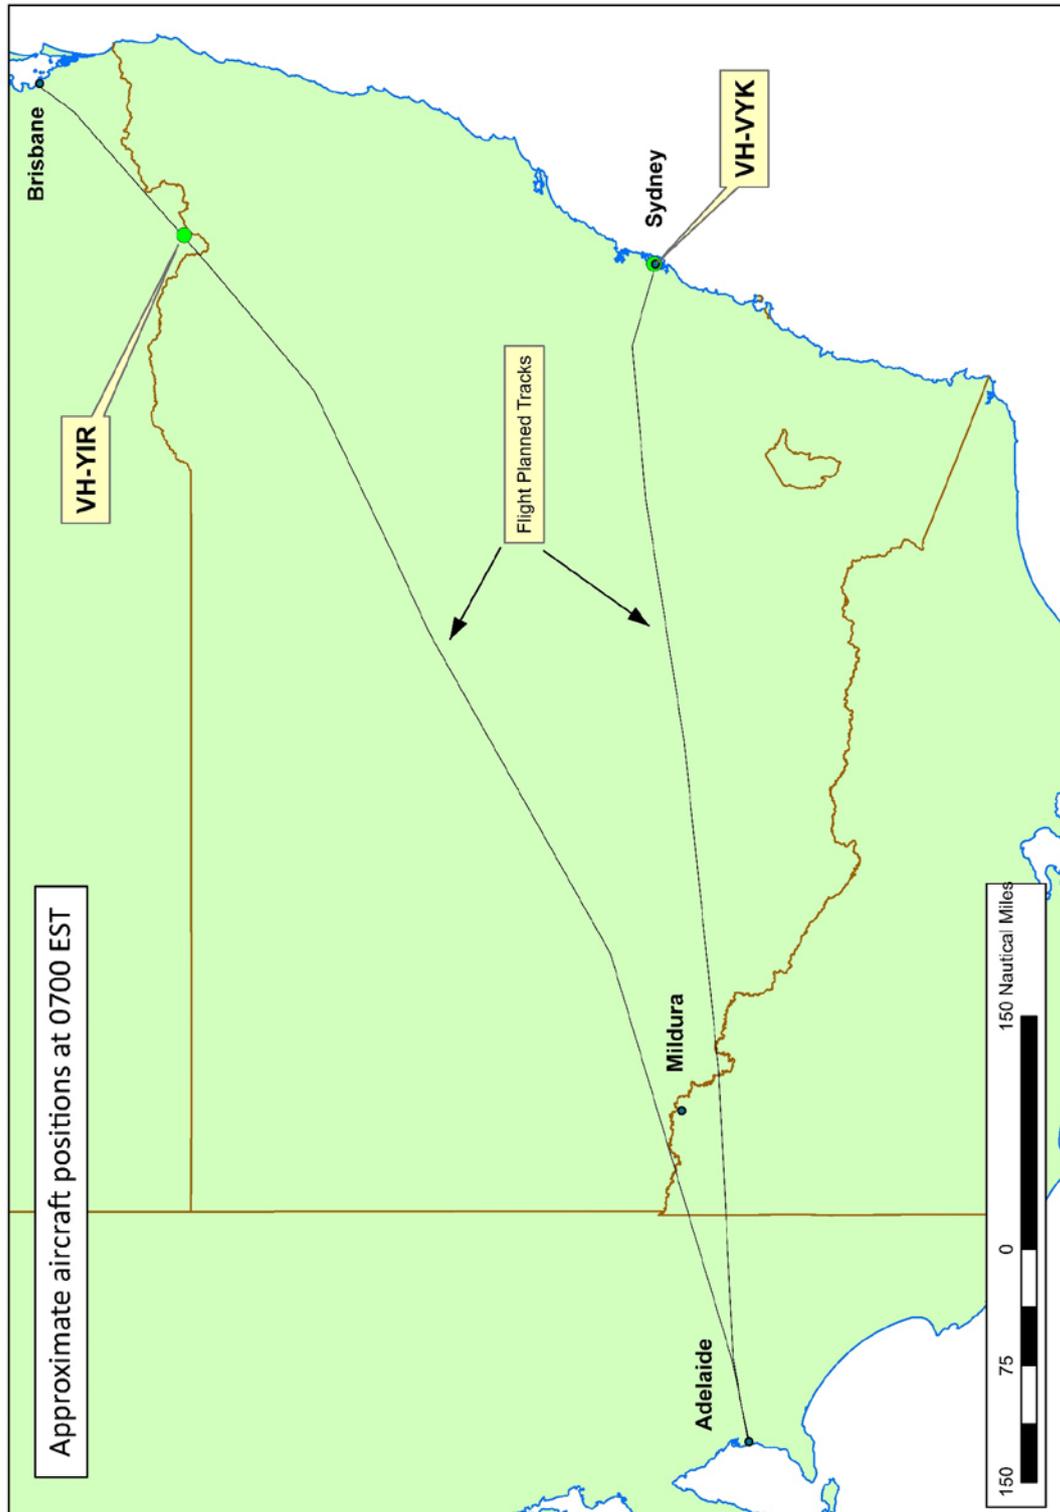
Figure 1: Approximate aircraft positions at 0700, when the amended forecast for Adelaide was issued with a 30 per cent probability of fog

At 0700, the Bureau of Meteorology (BoM) issued an updated aerodrome forecast (TAF)³ for Adelaide, which indicated a 30 per cent probability of fog developing. For an understanding of the aircrafts' positions at this time, see Figure 1. At 0800, the BoM issued an updated trend forecast (TTF)⁴, which showed that fog had reduced visibility at Adelaide and was expected to clear by 0900. See Figure 2 for the aircrafts' positions at that time.

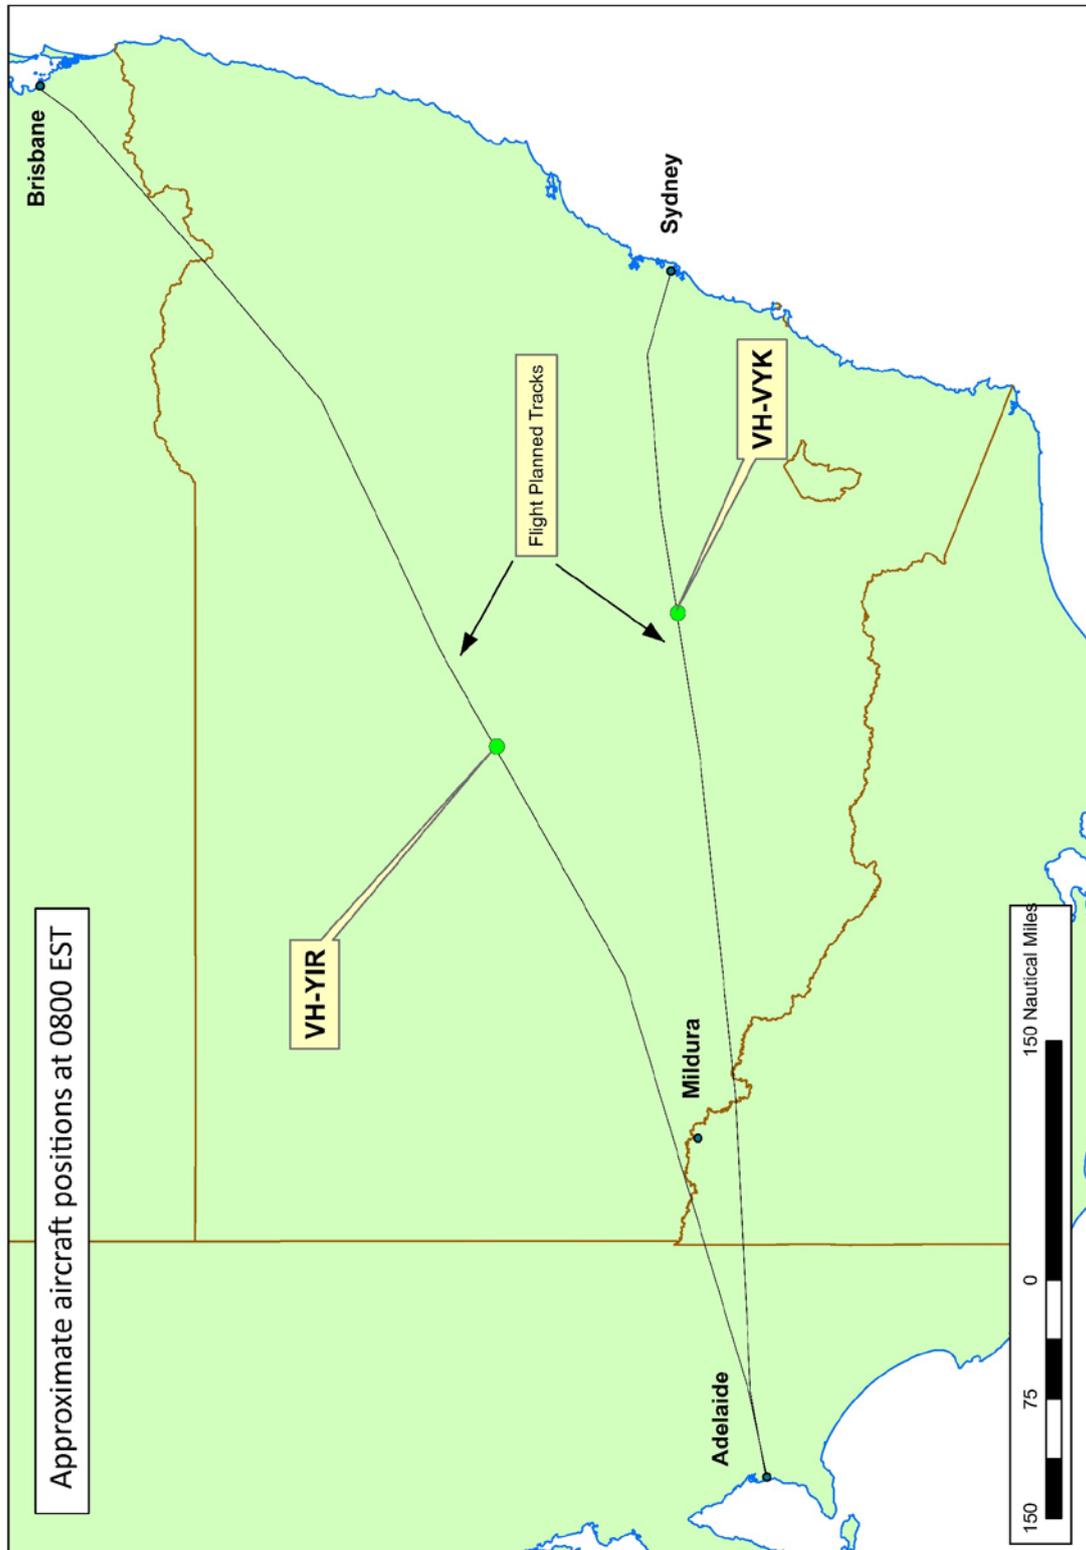
Figure 2: Approximate aircraft positions at 0800, when the trend forecast for Adelaide was issued with fog conditions forecast to lift at 0900

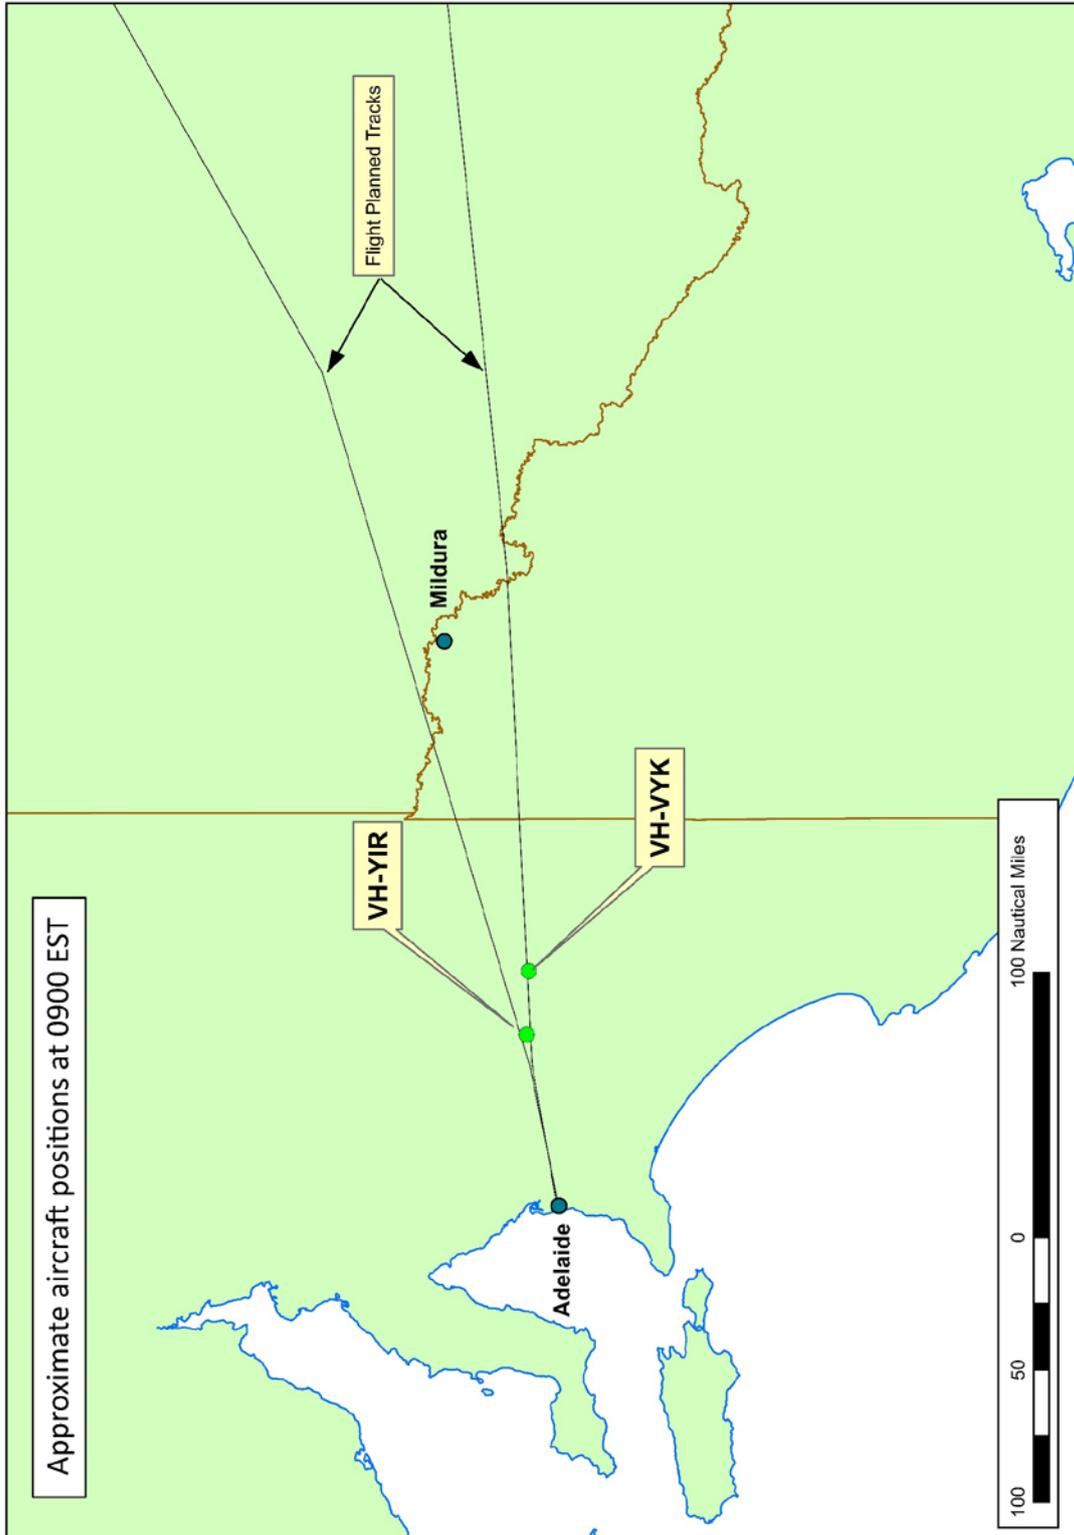
Figure 3: Approximate aircraft positions at 0900, just prior to initiating the diversion to Mildura

At this stage, the crew of Qantas 735 were aware of the changes to the TTF and continued to Adelaide on the basis that the fog would clear prior to their arrival. In addition, they had sufficient fuel to hold for about 45 minutes should the fog last longer than forecast and land with required fuel reserves. The crew of Velocity 1384 were not aware of the changes to the forecast. They were advised of fog at Adelaide by Air Traffic Control (ATC) at 0844, once they changed to the en route sector frequency immediately prior to the Adelaide terminal area airspace. Figure 3 shows the aircraft's approximate positions at 0900.

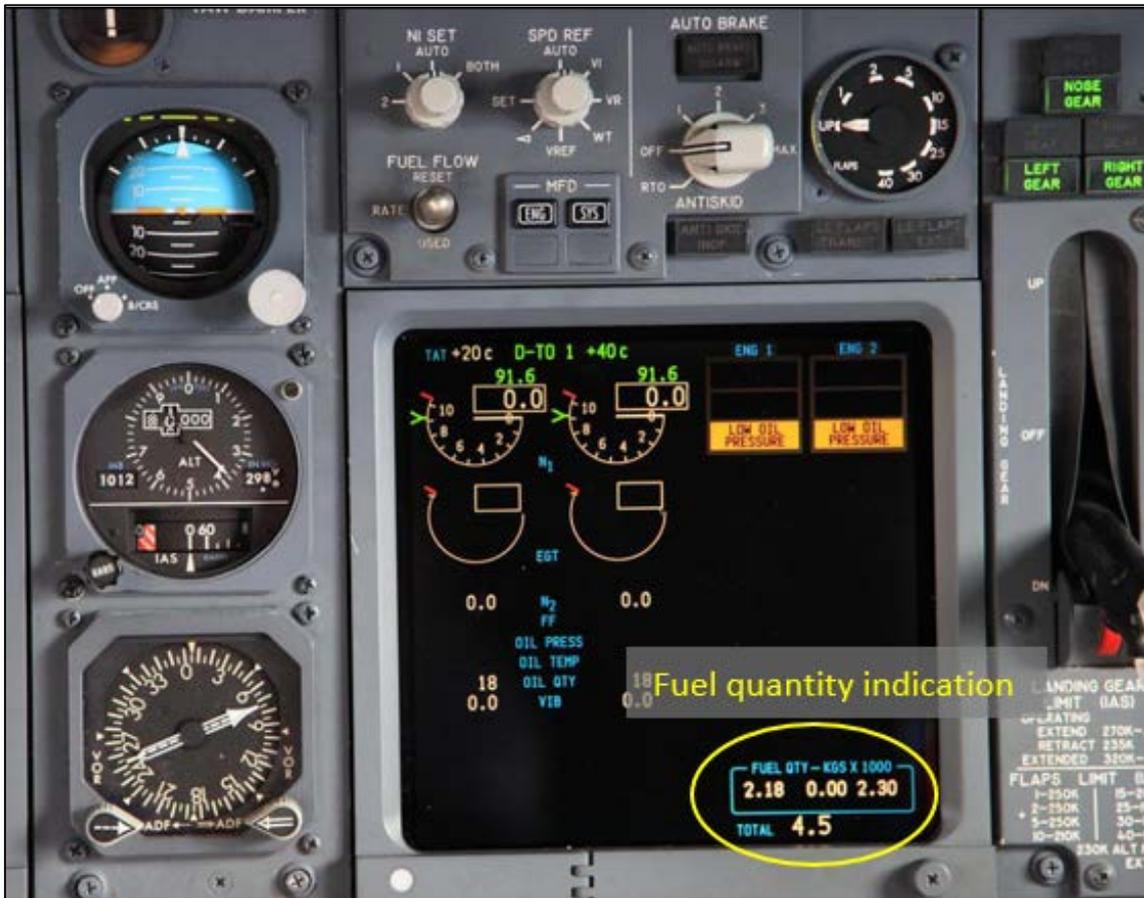
Figure 4: Location of the fuel quantity indication on the upper display unit (circled in yellow)

The fuel quantity remaining is indicated in tonnes on the upper display unit (Figure 4). This display, together with an explanation of the LOW FUEL, FUEL CONFIGURATION and FUEL IMBALANCE indications, is expanded at Figure 5.

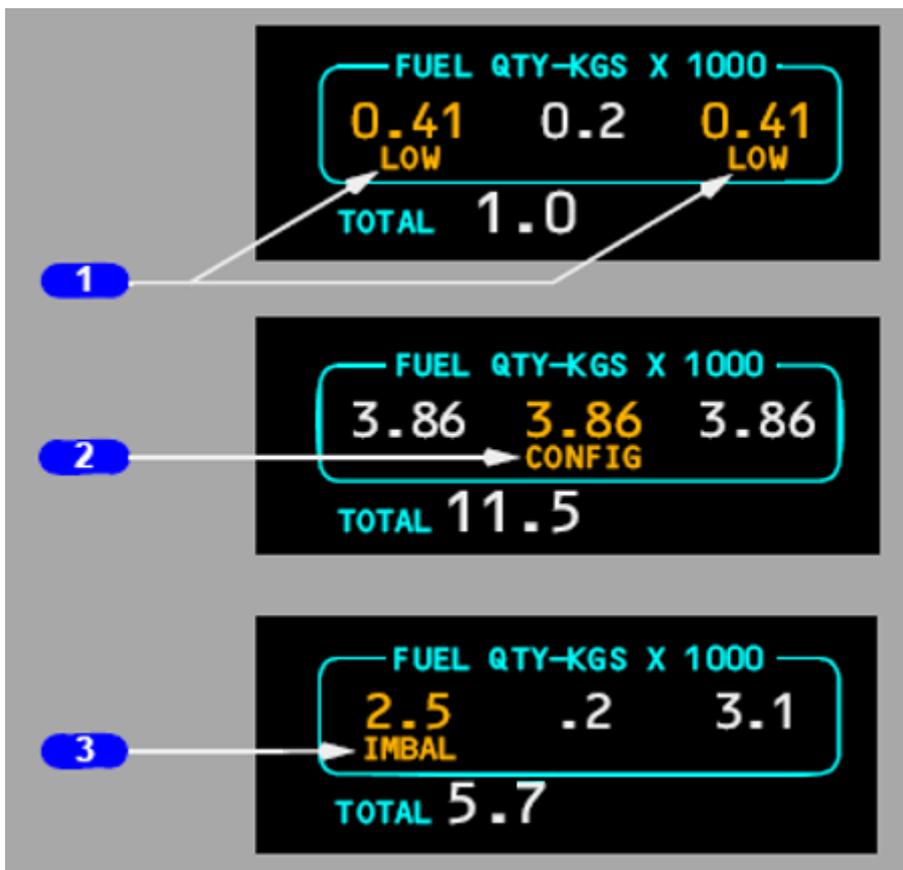
Figure 5: Fuel quantity display in detail with an explanation of the LOW FUEL, FUEL CONFIGURATION AND FUEL IMBALANCE indications

1. LOW FUEL INDICATION

- Occurs when fuel quantity is less than 907 kg (2,000 lbs) in the related main wing tank.
- Digits on tank(s) with low fuel quantity turn amber.
- Displayed until quantity is increased to 1,134 kg (2,500 lbs).

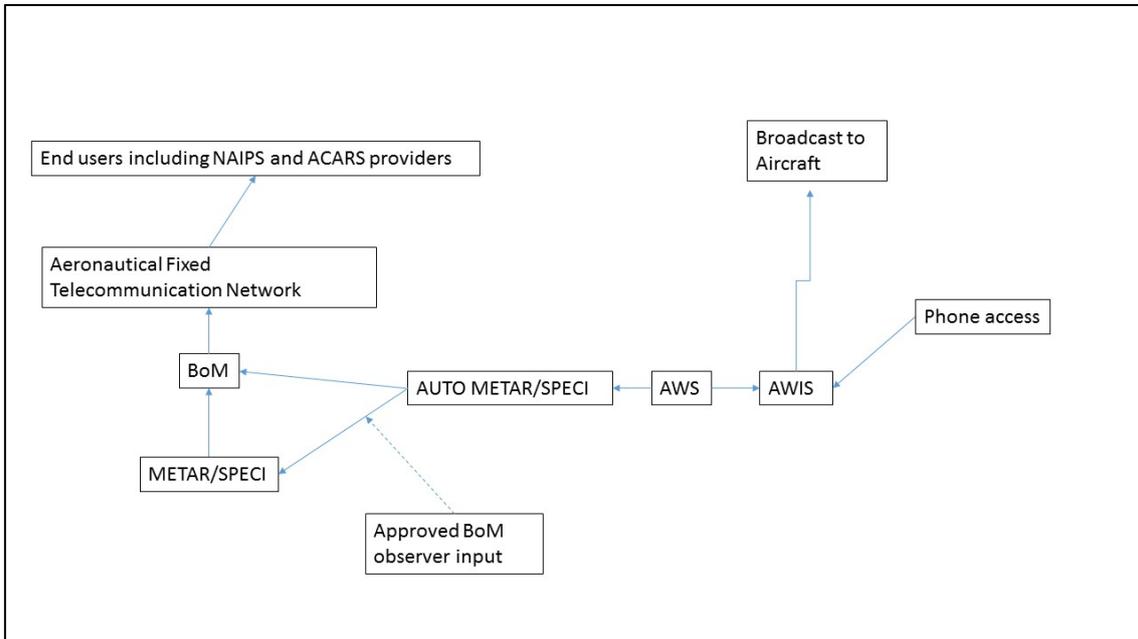
Figure 6: Overview of the Automatic Weather Station outputs and end user products.
Note that the approved BoM observer input is optional and, if not actioned, will result in an ‘AUTO’ METAR or SPECI

As with the broadcast of weather observations via ATIS, an AWIS does not append the words 'METAR' or 'SPECI' to weather observations that are broadcast via AWIS. However, the information provided by an AWIS is generated from the associated automatic weather station (AWS), which is the same data source used by BoM to create a METAR or SPECI report (Figure 6).
