**THE AIRCRAFT ACCIDENT INVESTIGATION BOARD/NORWAY  
(AAIB/N)**

**REP.: 07/99**

**REPORT ON THE ACCIDENT TO VNUKOVKO AIRLINE'S  
TUPOLEV TU-154M RA 85621 NEAR SVALBARD AIRPORT  
LONGYEAR, NORWAY ON 29 AUGUST 1996**

**SUBMITTED NOVEMBER 1999**

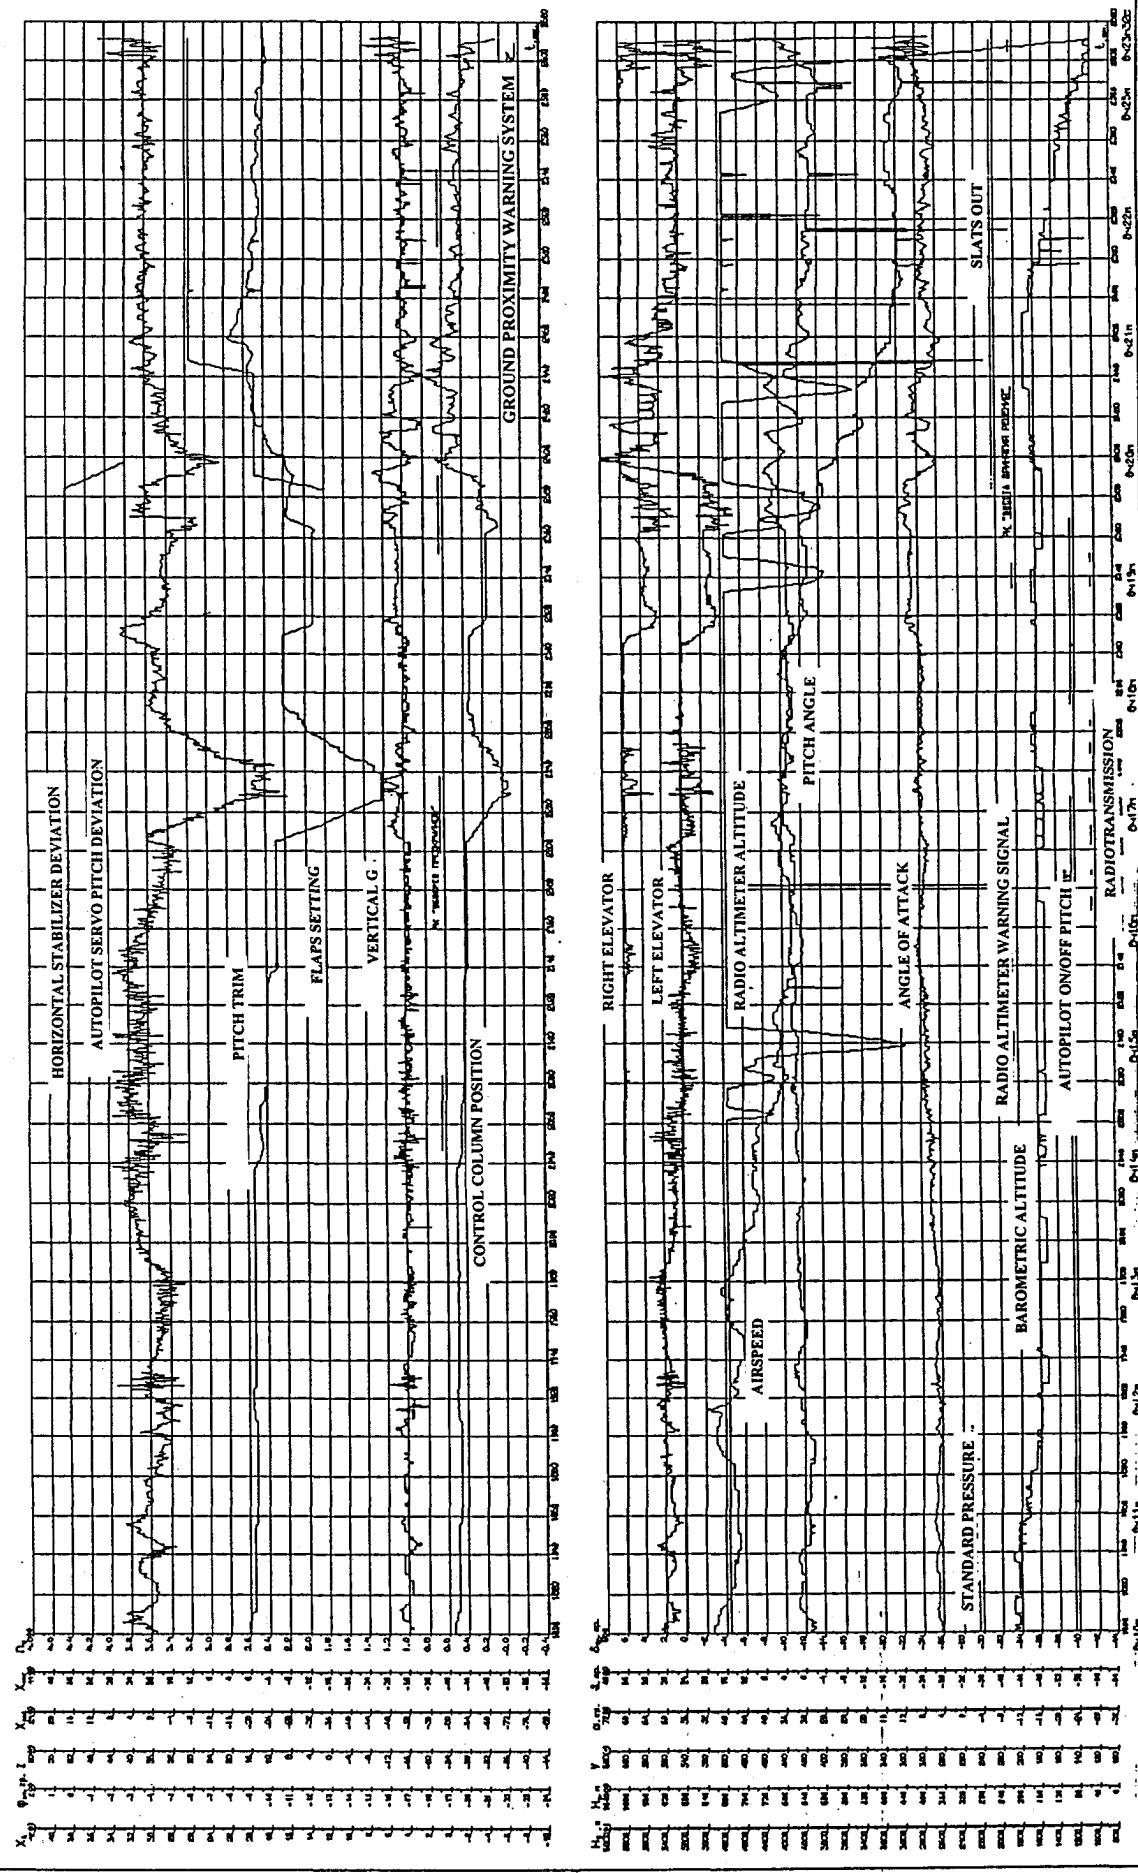
Рис. 4. ПАРАМЕТРЫ ПОЛЕТА САМОЛЕТА ТУ-154Н RA-85621 29.08.1996г. (предварительная обработка)

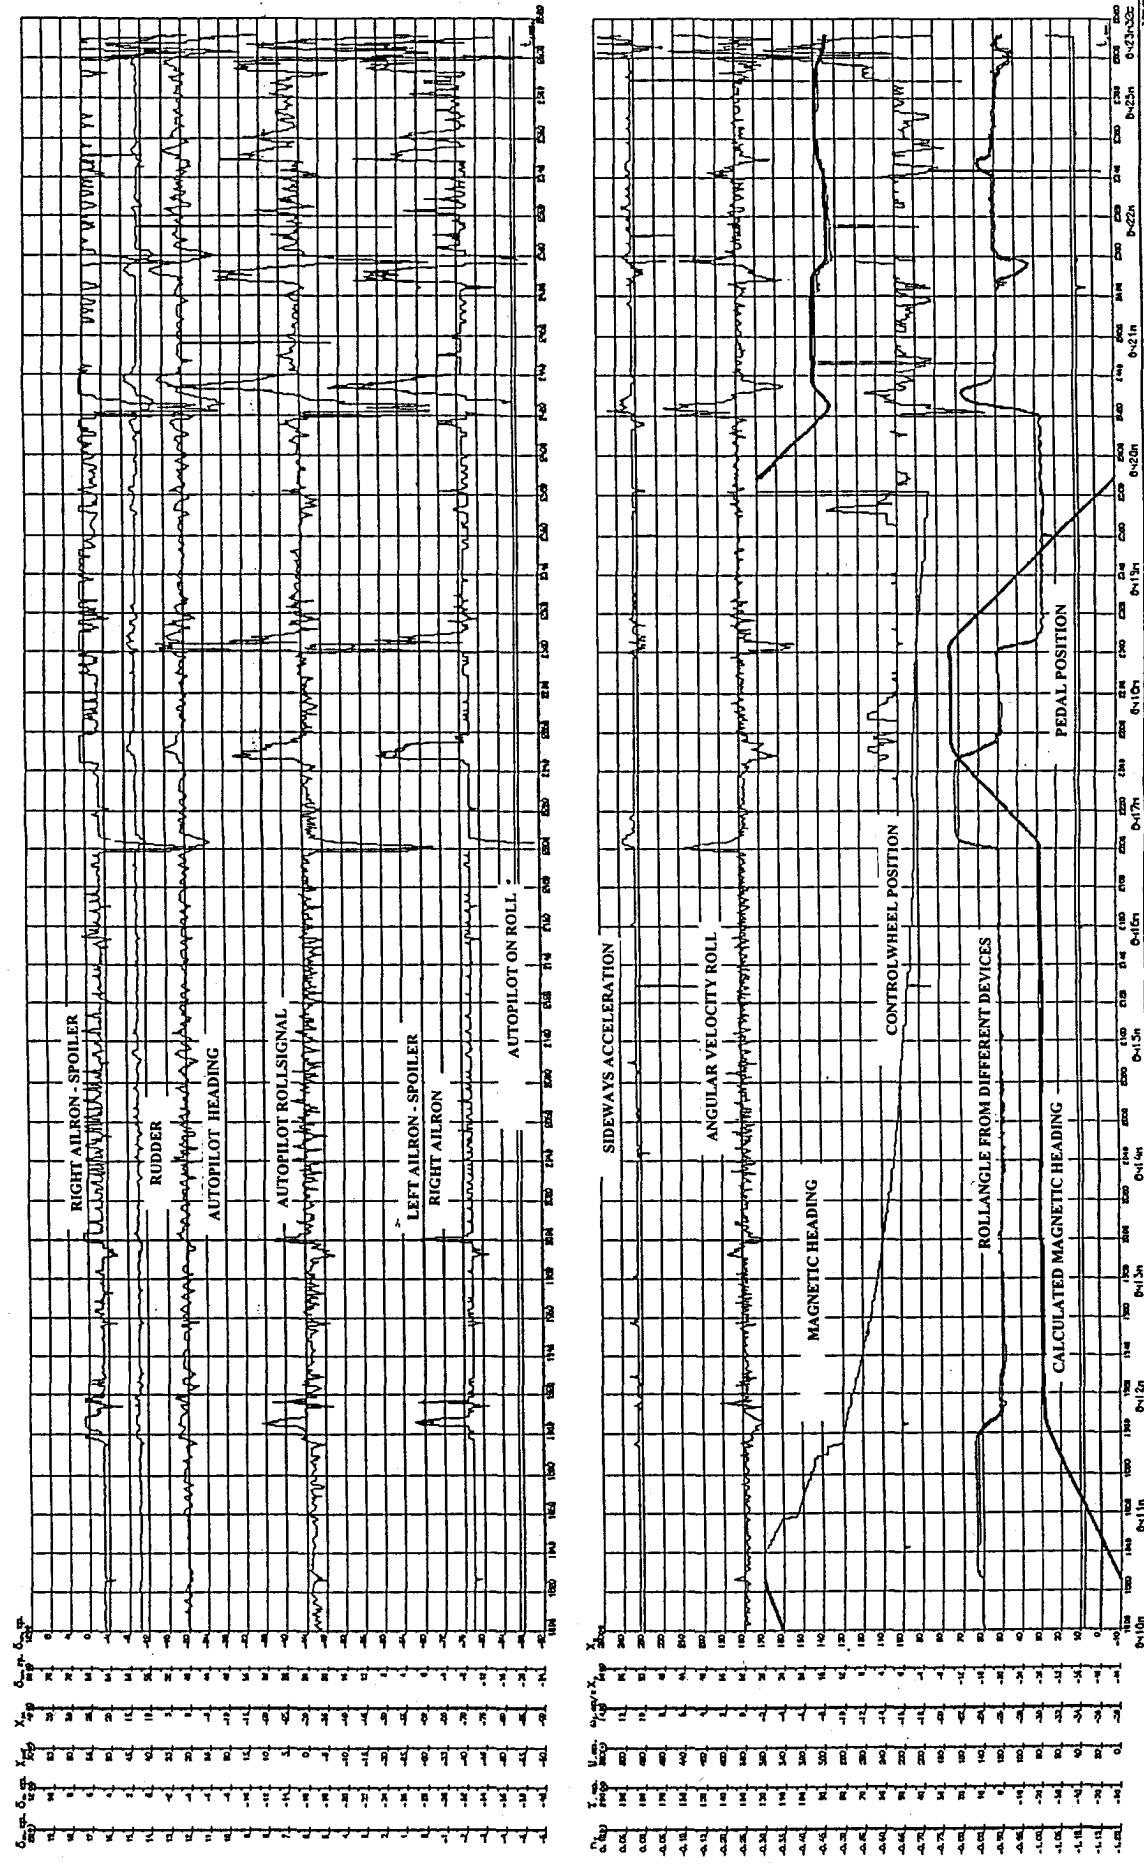
Рис. 2 ПАРАМЕТРЫ ПОЛЕТА САМОЛЕТА ТУ-154М RA-85621 29.08.1996г. (предварительная обработка)

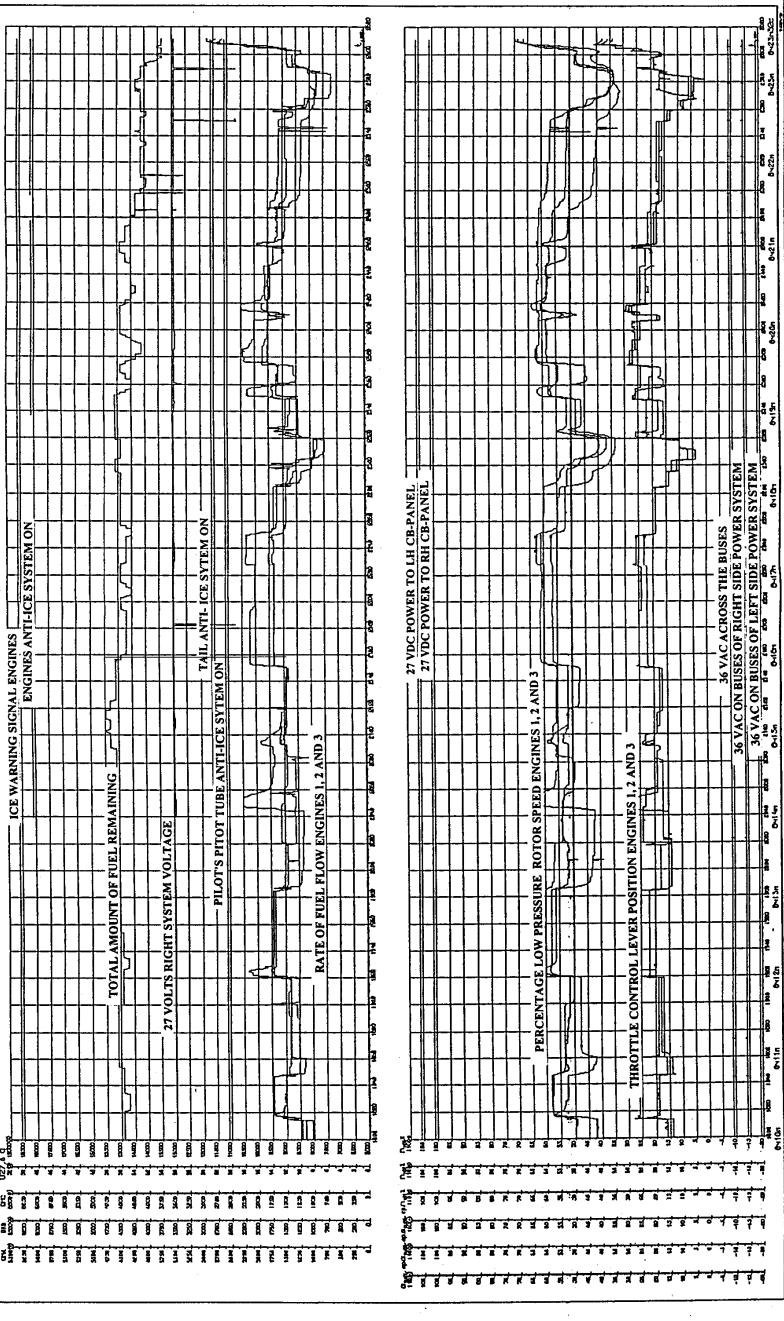
Рис. 3. ПАРАМЕТРЫ ПОЛЕТА САМОЛЕТА ТУ-154Н RA-85521 29.08.1996г. (предварительная обработка)
