# OVERFLIGHT OF DENSELY POPULATED AREAS BY AIRCRAFT IN EMERGENCY

The overflight of densely populated areas by aircraft in an emergency raises a number of questions concerning routeing, destination and the possible presence of dangerous cargo on board. The incident described below illustrates some of these questions, the answers to which will depend on local circumstances. This account is abridged from the official report by the UK Air Accident Investigation Board (AAIB)\*.

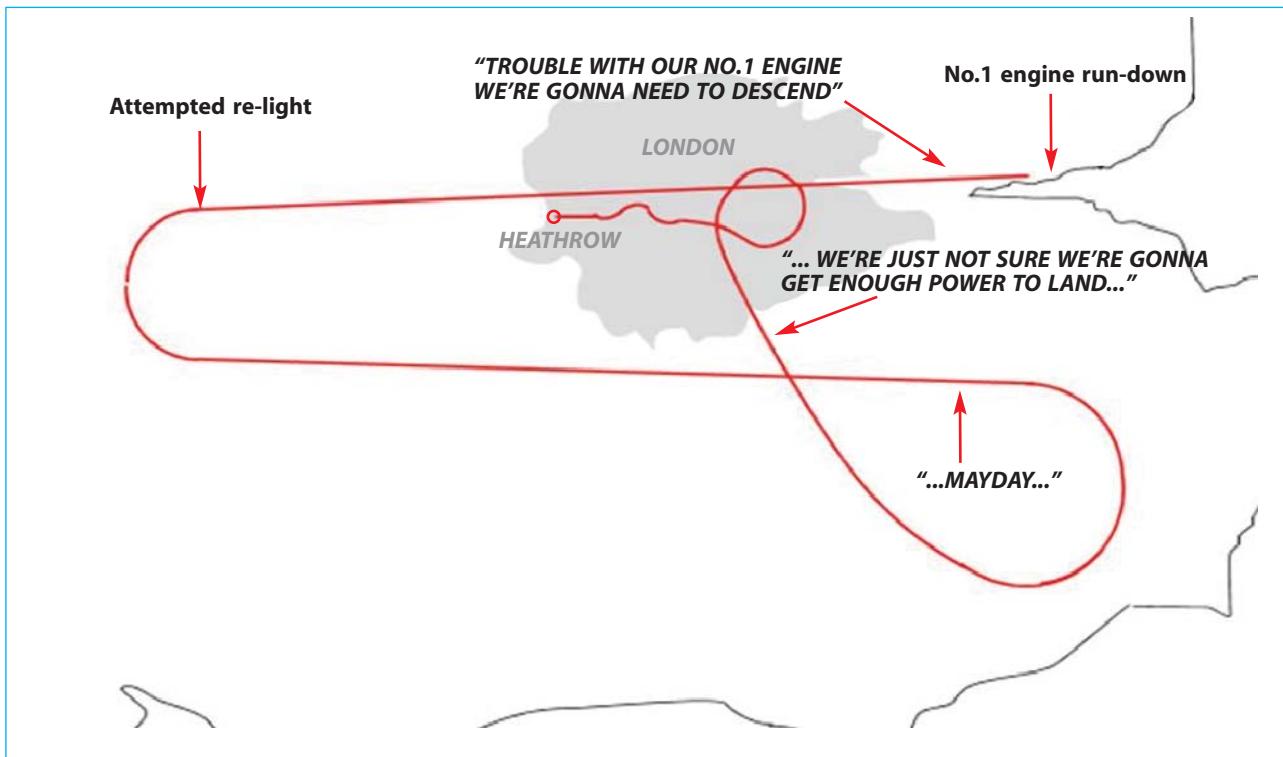
At that point the aircraft appeared to stop its rate of descent and even climb slightly before continuing the descent. Given the height of the aircraft and its close proximity to Heathrow, the radar controller instructed that a 270° turn to the right should be executed to lose the excess height and speed. The flight crew accepted this instruction and the manoeuvre was flown, rolling out on an intercept heading of 305° for the extended centreline of runway 27R. This manoeuvre took the aircraft over the centre of London.
