# **AIA / AECMA Project Report**

## **Propulsion System Malfunction Plus Inappropriate Crew Response (PSM + ICR)**

**Volume 1**

**1 November 1998**

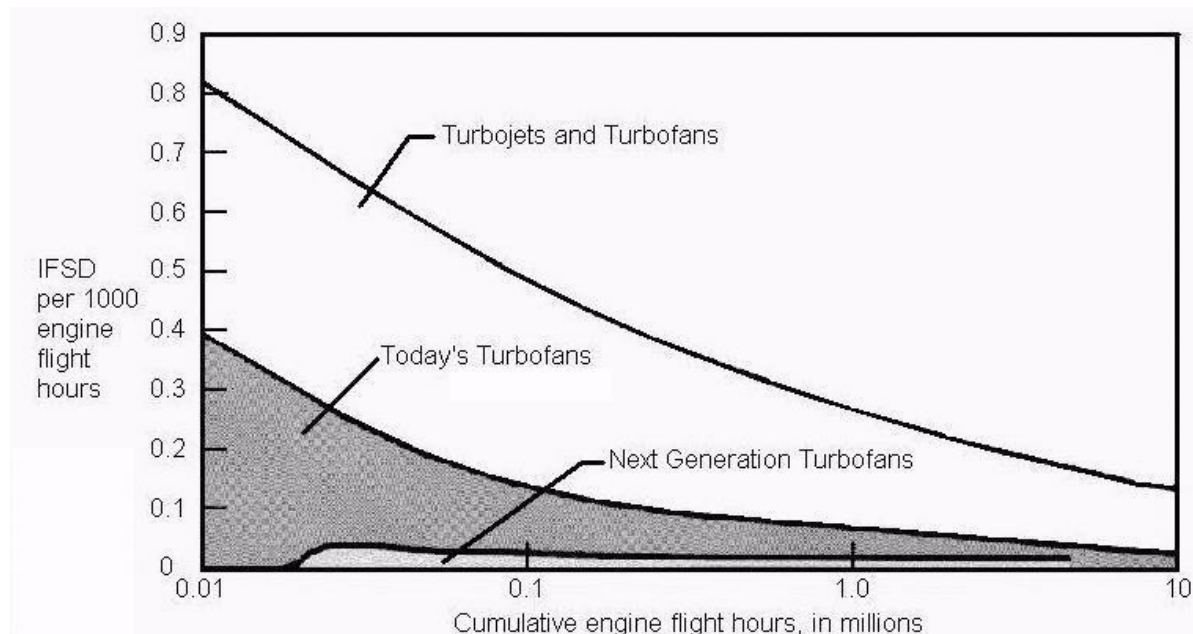
**Figure 2.1** Summary of total Inflight Shutdown (IFSD) rates for turbojets and turbofan engines since 1958 shows a clear trend toward lower IFSD rates

During the last twenty years, there has been significant improvement in propulsion system reliability as shown in Figure 2.1. Despite the significant reduction in propulsion system malfunctions, the overall PSM+ICR accident/incident rate has remained essentially constant, suggesting that the likelihood of inappropriate crew response to the propulsion system malfunction has increased. Uncontained engine failures had previously been the dominant contributor to propulsion related turbofan and turboprop airplane accidents, but with the steady effort of the industry, uncontainments have been reduced. PSM+ICR is now the dominant contributor (25% of hull loss and fatal accidents over the past 5 years) to propulsion related turbofan and turboprop airplane accidents.

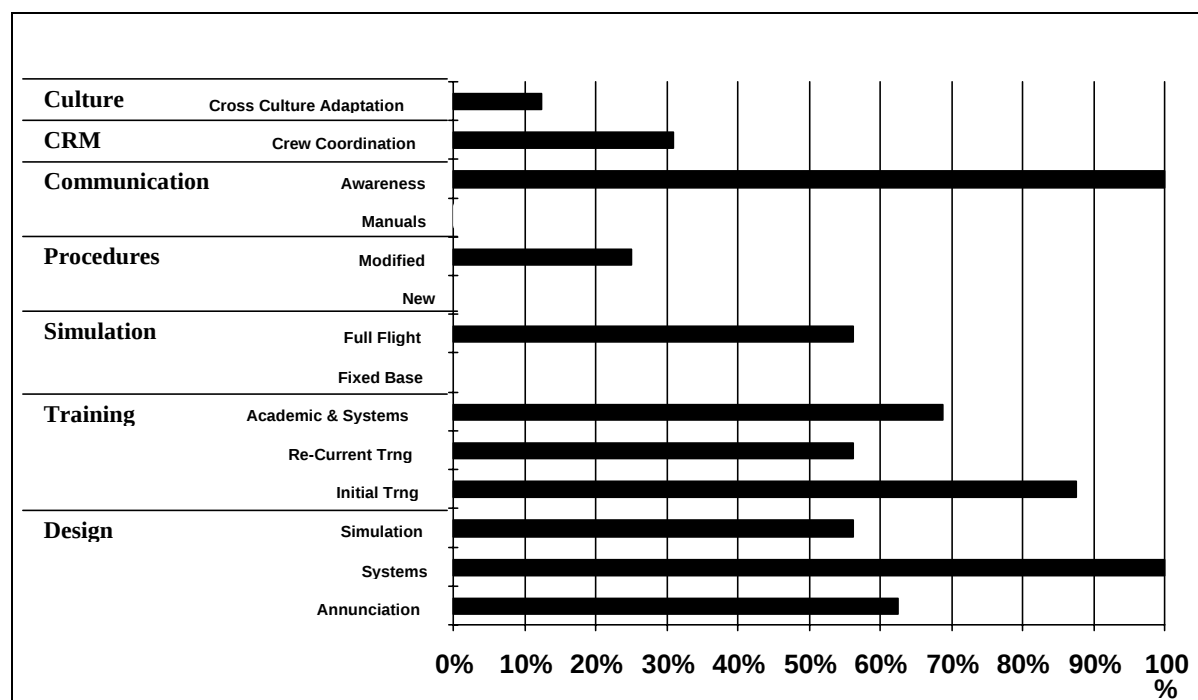
**Figure 4.1.4.1** Potential Improvement Opportunities

The data analysis team considered each event in the database and determined by consensus what were the potential areas for improvement based on each event. These potentials were then tabulated and are presented as percentages in the table below.

The areas with greatest potential improvement opportunities were those of “awareness” and “systems design”. Providing “awareness” information to flight crews on these types of events and the symptoms that the crew faced was judged by the team to be beneficial in all cases. Further, the team realized that reduction in the frequency of the initiating propulsion system malfunction/failures would also be effective (reduce the rate directly). However, the data team noted that such improvements (reducing the initiating propulsion system malfunction/failure rate) would be difficult to achieve, at least in the near term.

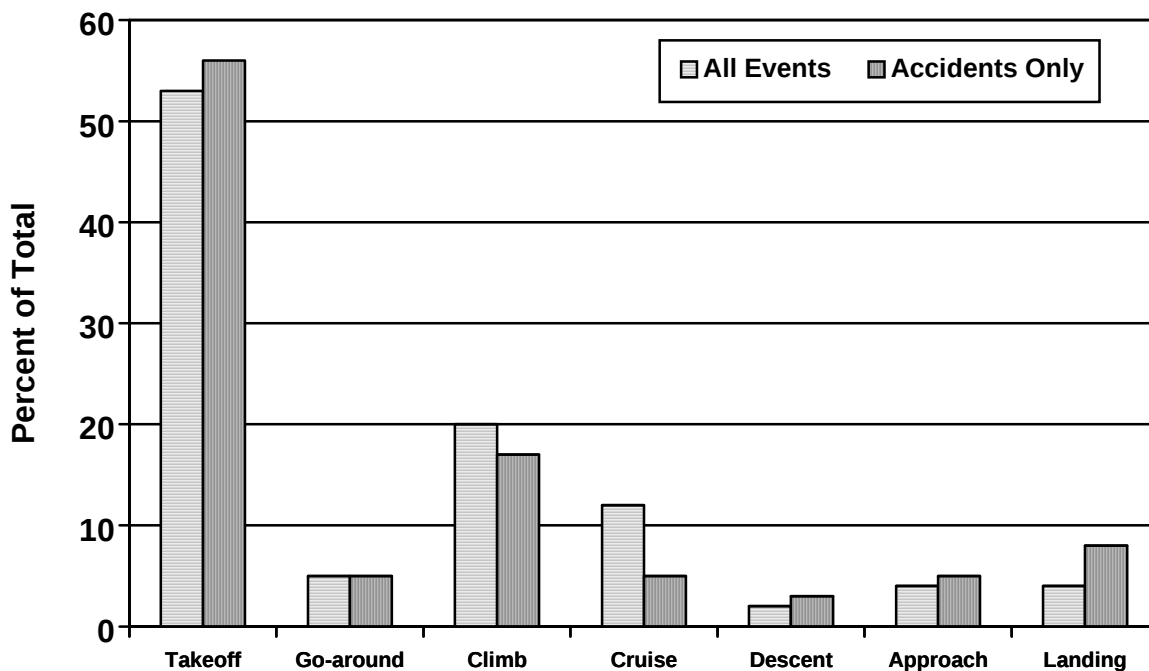
**Figure 4.1.5** Phase of flight distribution summary

The figure 4.1.5 below depicts the percentage of turbofan events as a function of flight phase. The majority of events, over 70% occur during the takeoff and climb phase of flight.

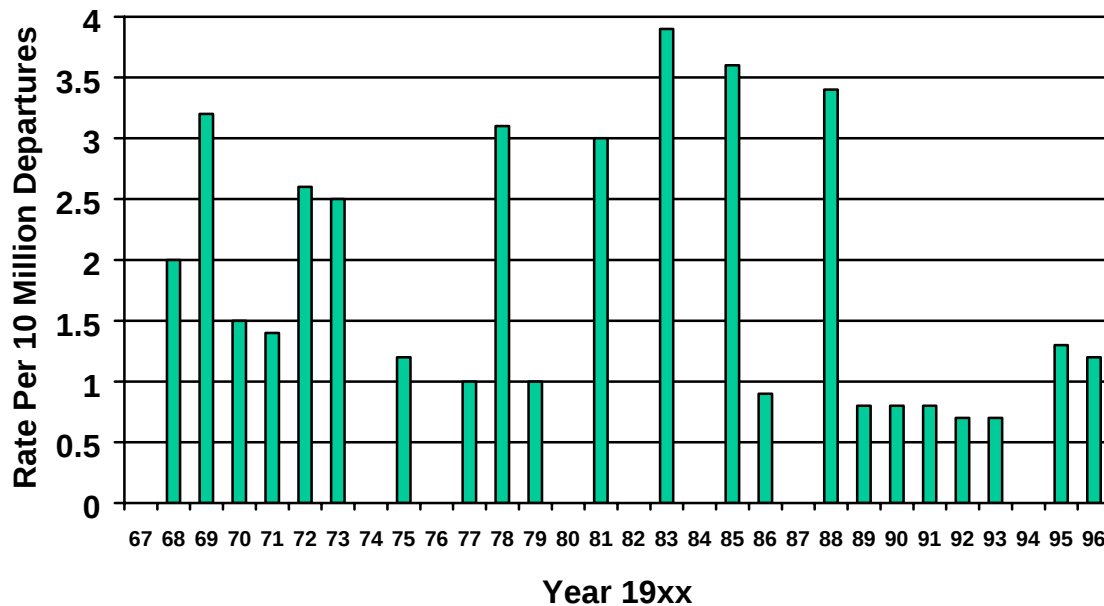
**Figure 4.1.6** Annual accident rate trend with time - Hull loss and substantial damage

The figure 4.1.6 below depicts the PSM+ICR annual accident rate per 10 million departures for the turbofan events. This rate was calculated using the number of hull loss and substantial damage type accidents per year divided by the total yearly commercial fleet airplane departures. The annual accident rate for PSM+ICR appears to be constant.

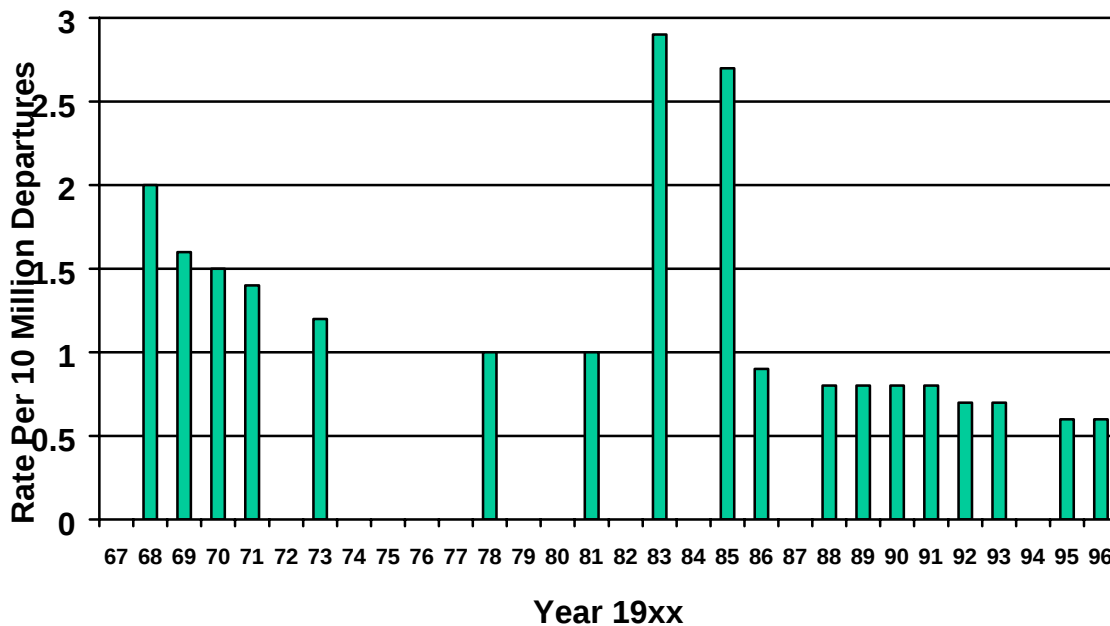
**Figure 4.1.6** Annual accident rate trend with time - Hull loss only

The figure below depicts the PSM+ICR annual Hull Loss-only accident rate per 10 million departures for the turbofan events. This rate was calculated using the total number of hull loss accidents per year divided by total yearly commercial fleet airplane departures. The annual accident rate for PSM+ICR appears to be basically constant.

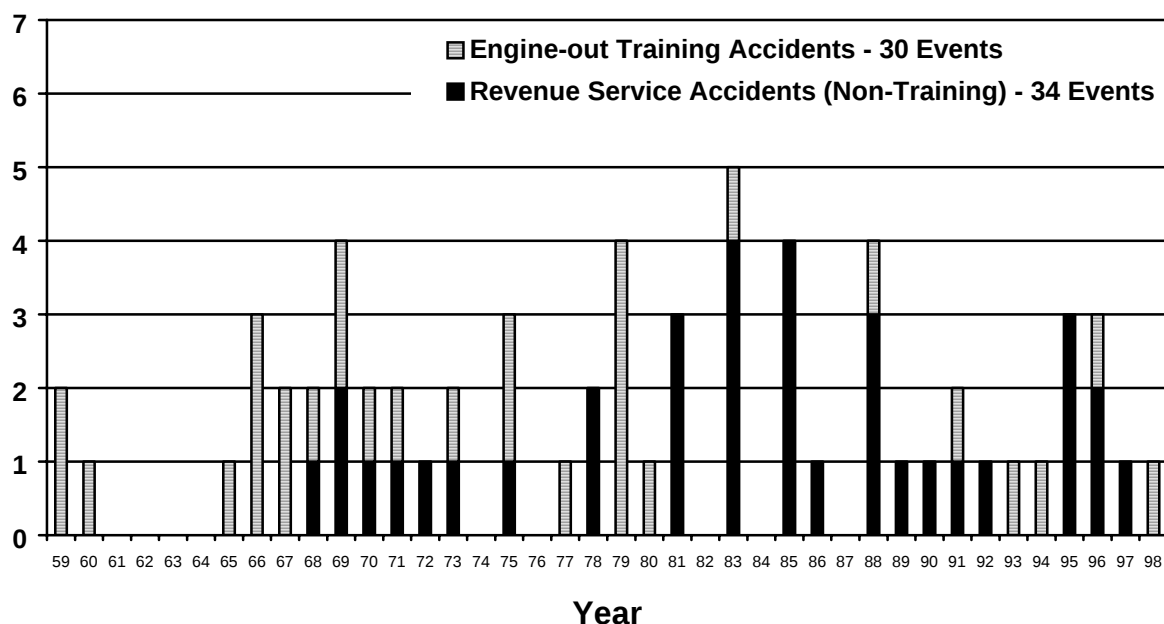
**ure 4.1.8** Comparison of PSM+ICR revenue service events versus simulated engine-out crew training events

A review of the historical accident record for western-built turbofan airplanes involving training accidents where either single or multiple engines were reduced to minimum thrust setting (simulated engine-out conditions) was conducted to examine relative frequency, phase of flight, and geographical location of the events. The following chart depicts the number of simulated engine-out training related accidents (Substantial Damage, Hull Loss, and Fatal) in comparison to the PSM+ICR accidents since the beginning of commercial jet transport service.

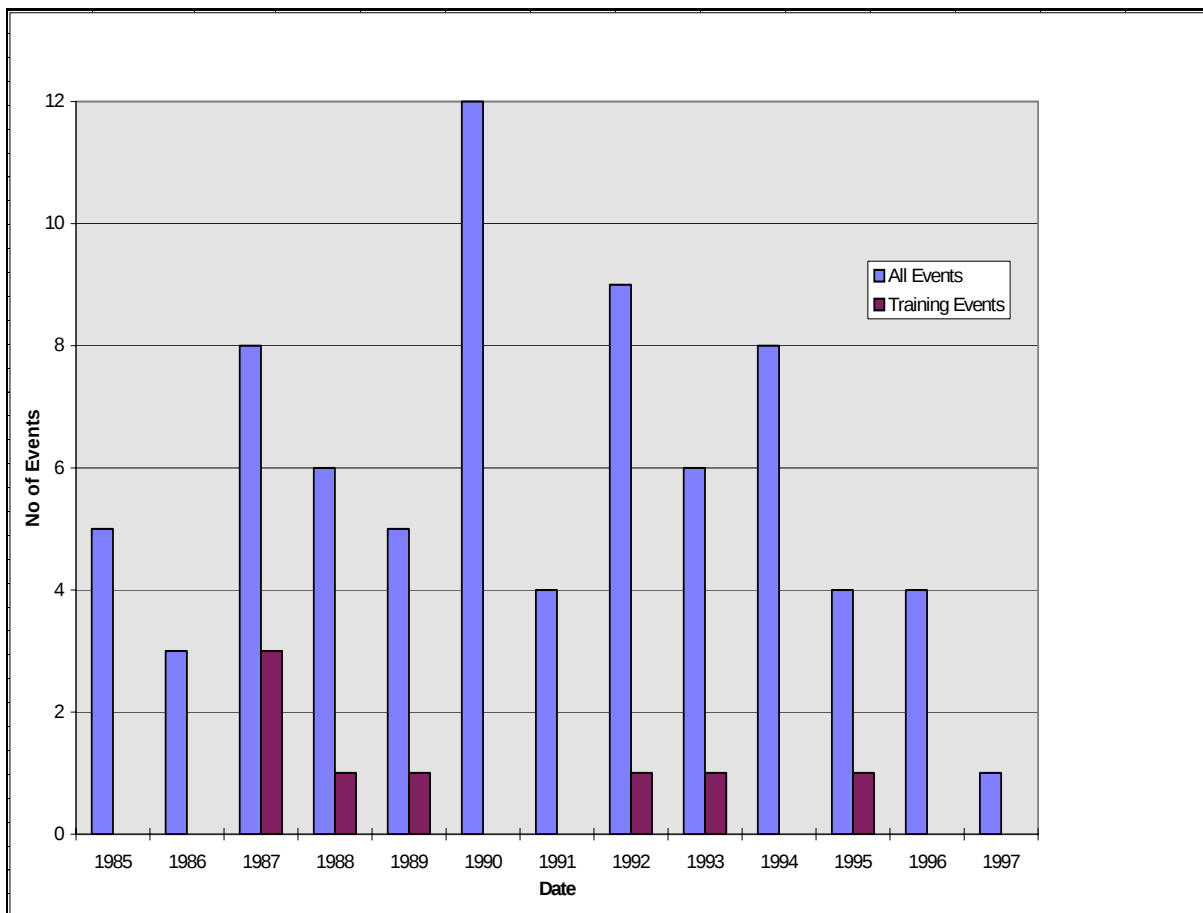
**Figure 4.2.1** Chronological Distribution of Turboprop PSM+ICR Events since 1985

The annual numbers of turboprop PSM+ICR events since 1985 are shown in Figure 4.2.1 below. It will be seen that there is no recognizable upward or downward trend in the annual numbers. However, it does show that these events continue to occur at a rate of  $6 \pm 3$  events per year, indicating that action is required if this rate is to be reduced. The data for 1997 are only partially complete.

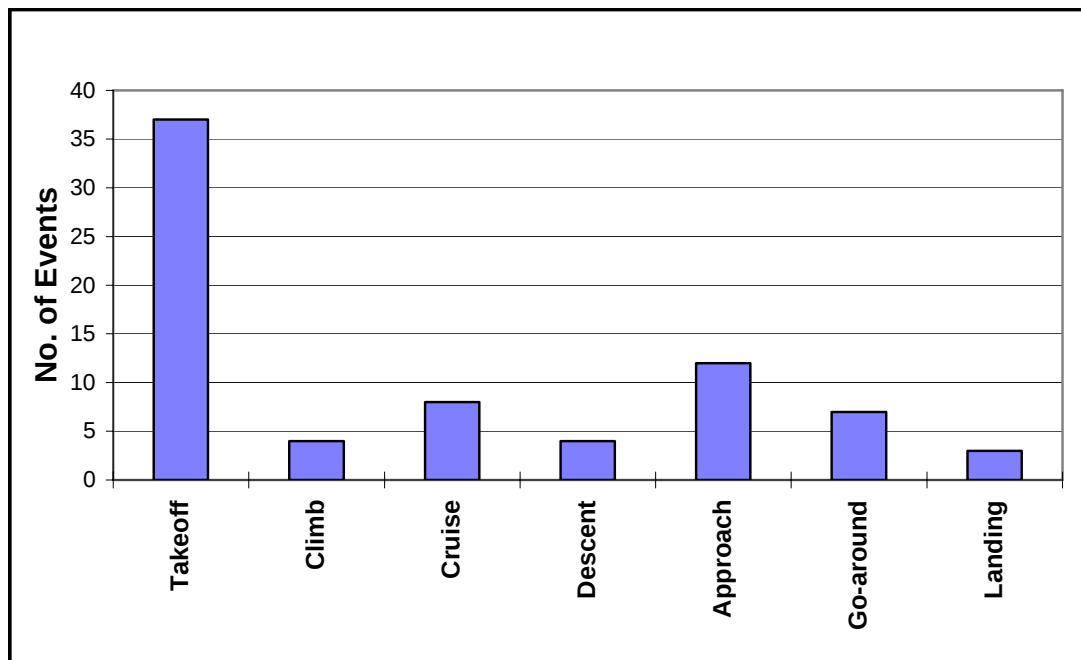
**Figure 4.2.2** All events, by phase of flight

The number of propulsion system malfunction events which occurred during a particular phase of flight is shown in Fig 4.2.2. The phases of flight are defined in Section 3.0 of this report. The dominant phase of flight for all turboprop propulsion system malfunctions is Takeoff - this

accounts for half of the accidents. The next highest flight phase in the rankings was Approach, where there were 12 events (16% of the total).

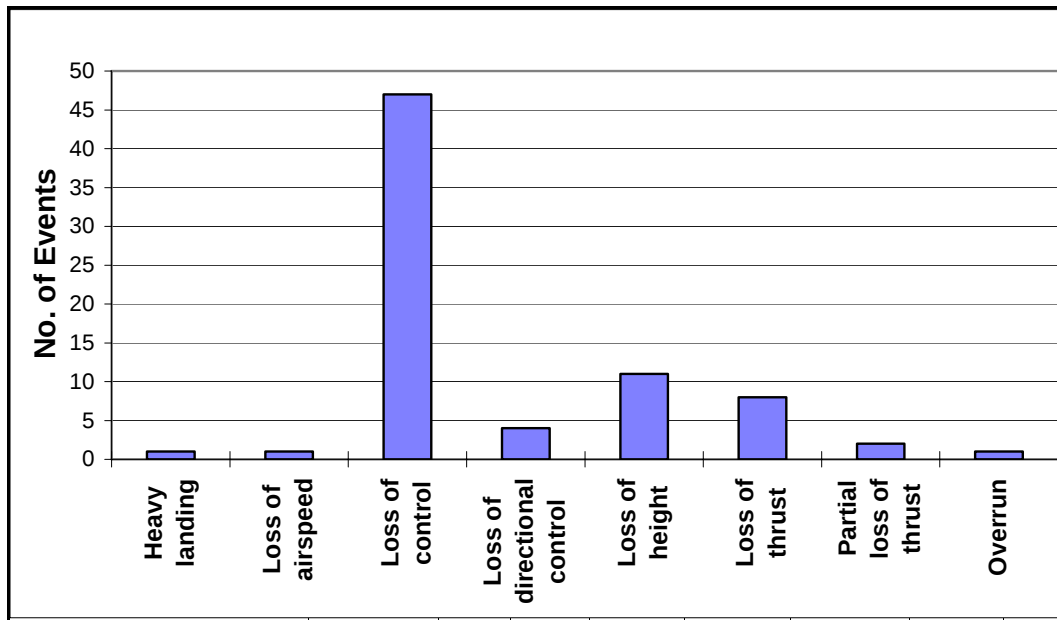
**Figure 4.2.3** All events, by category

The accidents were categorized and the results are plotted on Figure 4.2.3 below. The dominant event category is Loss of Control, accounting for 63% of all events.

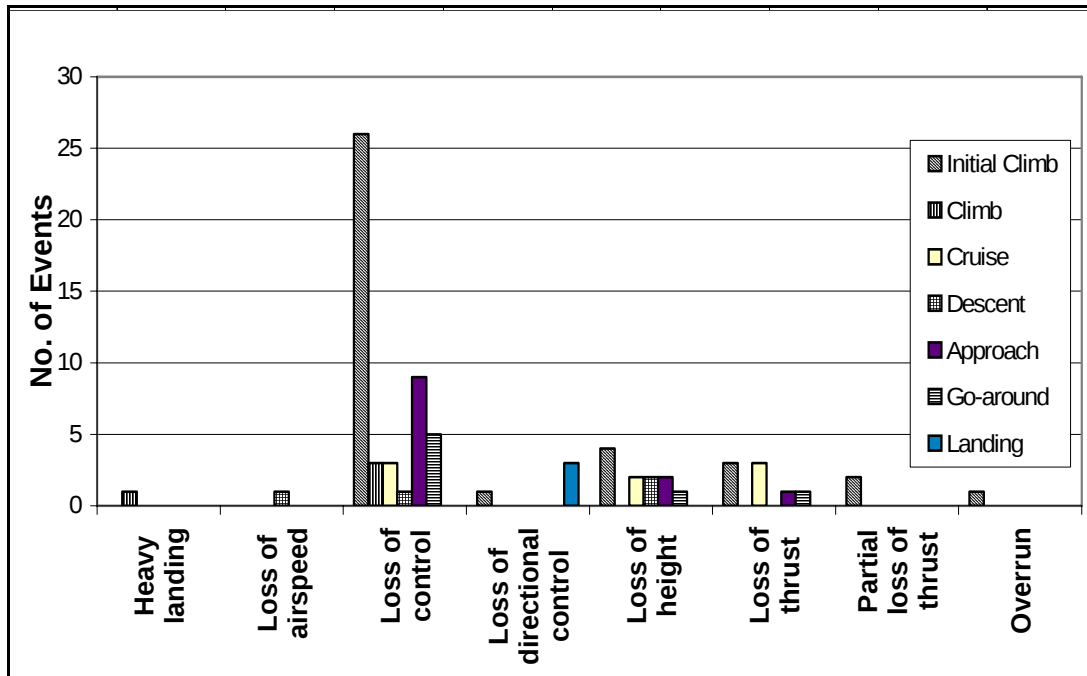
**Figure 4.2.4** All events, by category and phase of flight

Figures 4.2.2 and 4.2.3 show clearly that Takeoff and Loss of Control individually dominate their respective analyses. Figure 4.2.4 shows that these two classifications strongly coincide. A correlation of the data by flight phase and event category shows that 70% of the “powerplant malfunction during takeoff” events led to loss of control, either immediately (22 events) or on the subsequent approach to re-land (4 events). Or, put another way, 55% of the “loss of control” events occurred during the takeoff phase of flight.

It is concluded that the overwhelming majority of turboprop accidents resulting from powerplant malfunctions occur during the takeoff phase of flight and are due to the loss of control of the airplane.

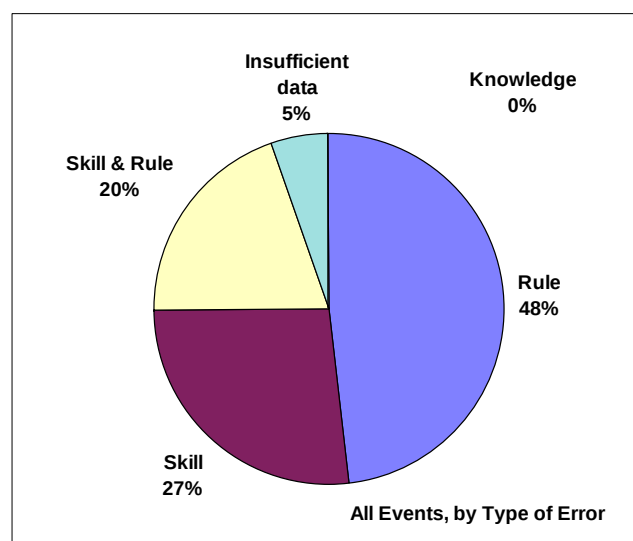
**Figure 4.2.5** All events, by type of error

Each accident was evaluated to determine the specific error type associated with the inappropriate crew response. However, the assessment was based on the opinions of the experts involved. The error types are those defined in Section 3.0 of this report. Figure 4.2.5 below shows the distribution of error types.

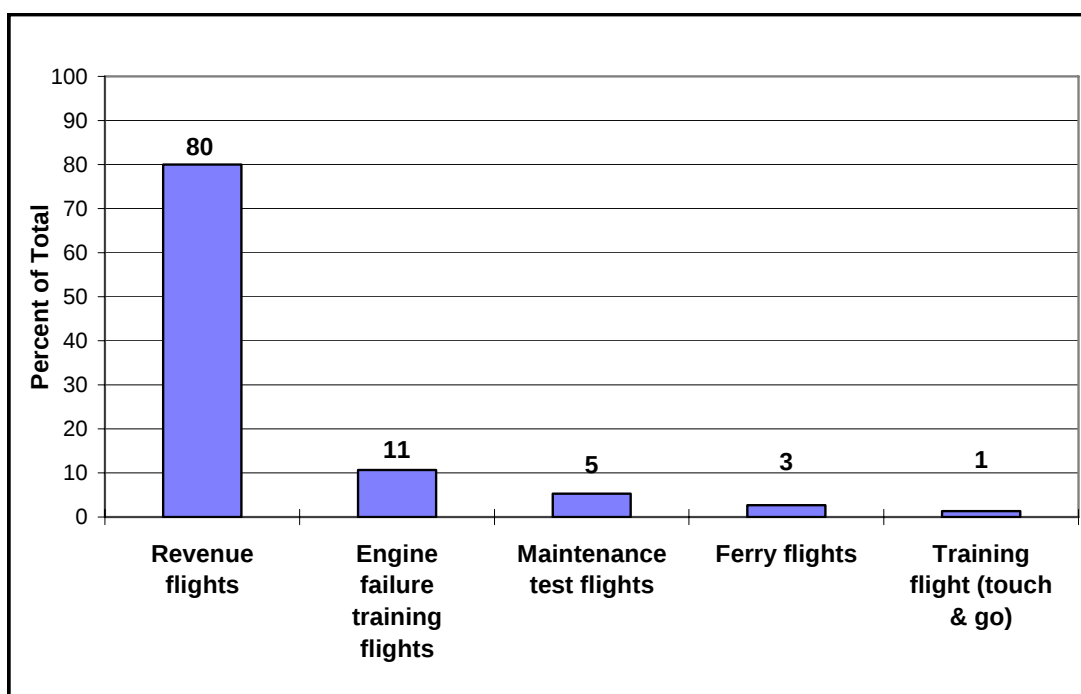
Figure 4.2.6 All events, by type of flight

The percentage of accidents for a given type of flight is shown at Fig 4.2.6. Revenue flights accounted for 80% of the events. As discussed previously, the data does not support a detailed breakdown between 14 CFR Part 121 and other operations.

A disproportionately large number of events (17%) occurred during training or test flights.

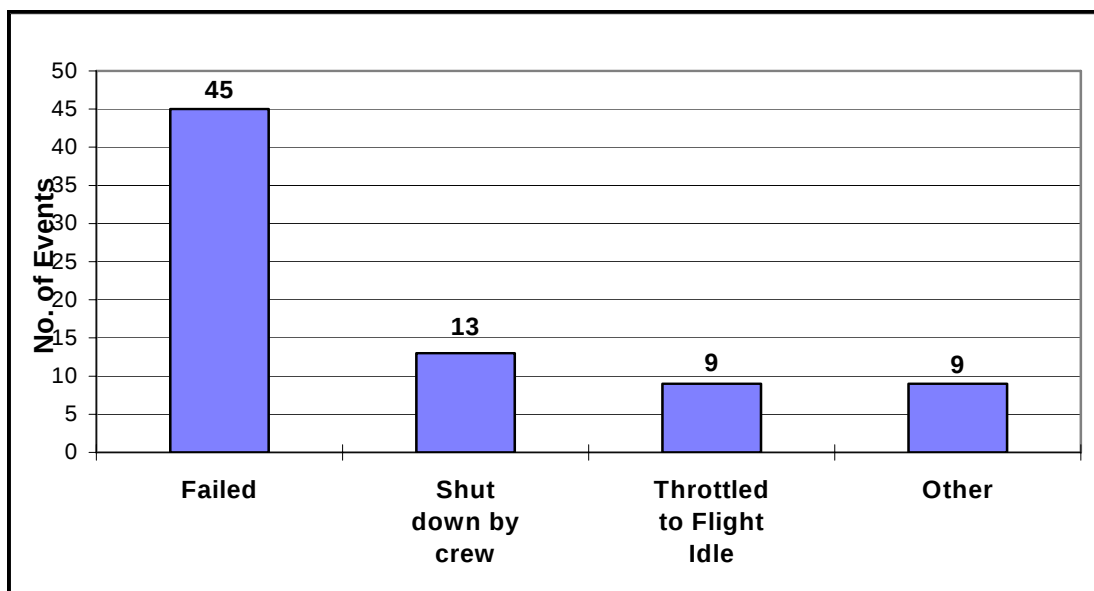
**Figure 4.2.7** All events, by type of powerplant malfunction

The types of powerplant malfunction identified as the initiating event are shown in Figure 4.2.7. Propulsion system failures resulting in an uncommanded total power loss was the dominant category. Turboprop engines seldom experience compressor stall/surge. This is significantly different from the situation on turbofans. Discussion with engine manufacturers concluded that one reason for this difference is that most turboprop engines (and some small turbofan engines) have a centrifugal stage in the compressor and hence are more tolerant to instability.

power loss/torque fluctuations etc.) and the crew then shut down that engine, or where one engine malfunctioned and the other (wrong) engine was then shut down. The distinction between “shut down by crew” and “failed” is that in the “failed” events the engine suffered a total power loss prior to any crew intervention.

There were 6 of the 13 “shut down by crew” events where the pilot shut down the wrong engine - three of which were on training flights where the instructor had deliberately throttled one engine and the student then shut down the wrong engine. Accidents where the engine was not shut down, but maintained at flight idle, identified a category where there could have been a serious misunderstanding and lack of knowledge of turboprop operations. When an engine is at idle the unfeathered propeller can give negative thrust, which, particularly at low airspeed, can result in a thrust asymmetry beyond that for which the airplane was certificated. Events in this category included training and deliberate “idle” selection by the crew. Each of these categories will be discussed later.

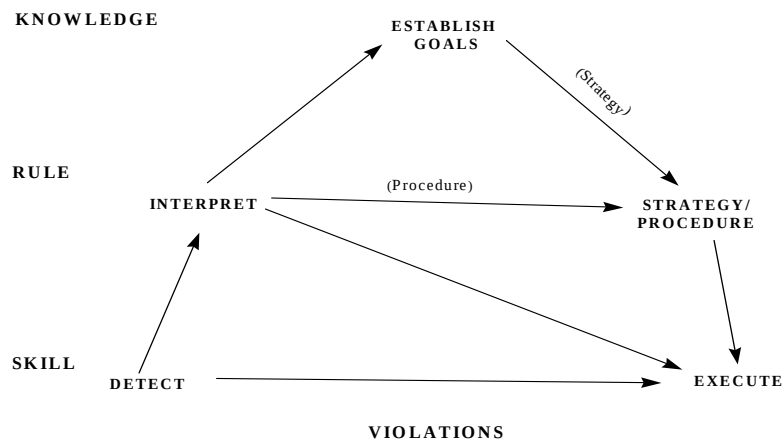
**Figure 8.4** Classification of Errors in the Presence of Propulsion System Malfunctions Which Lead to Inappropriate Crew Responses<sup>5</sup>

The rationale for using both the “strategy” and “procedure” terms is illustrated in Figure 8.4 and Figure 1 Volume 2, Appendix 14. The term “procedure” is used to refer to those situations where a formal, written procedure or widely accepted “best practice” exists, or should exist, for dealing with a PSM which has been appropriately identified. The term “strategy” is used to infer the plan of action selected by a crew when no formal procedure or best practice existed or, at least, was known to the crew. Implementation of an inappropriate strategy would be classified as a knowledge-based error, whereas selecting the wrong procedure to use with a particular PSM would be a rule-based error. For the purpose of supporting Workshop recommendations, the error classification model breaks down the types of errors leading to inappropriate crew response in the Strategy/Procedure category well beyond the rule-based/knowledge-based error classification. By doing so, the relationship between the error classification data and the recommendations of the Workshop are much clearer.

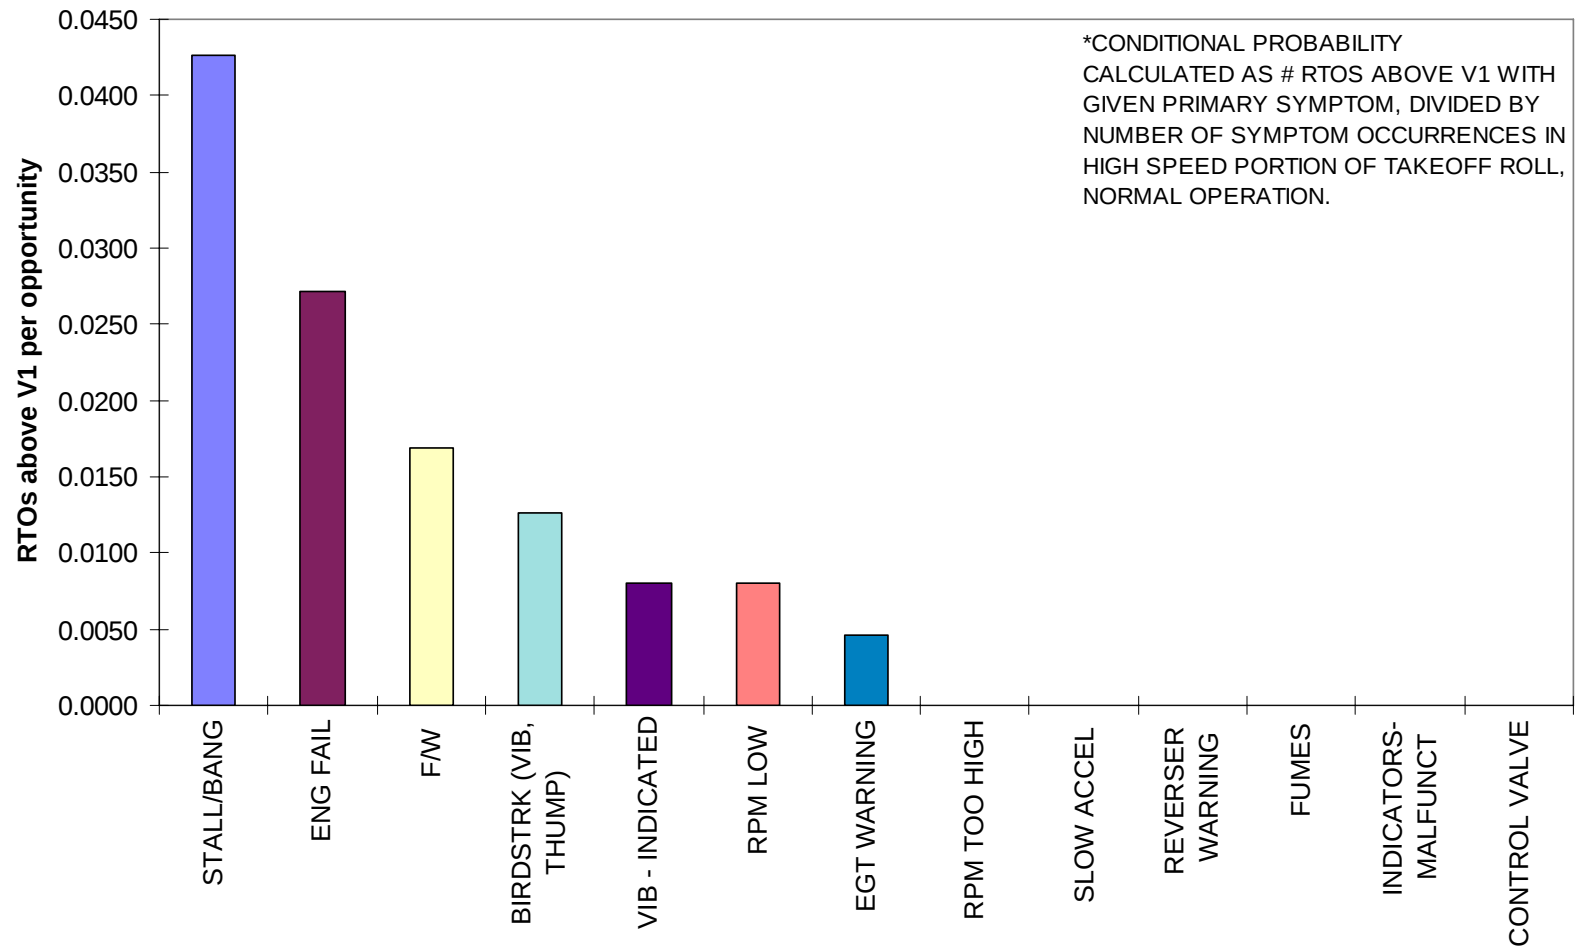
### CONDITIONAL PROBABILITY\* OF RTO ABOVE V1, BY SYMPTOM FOR A HIGH BYPASS TURBOFAN FLEET

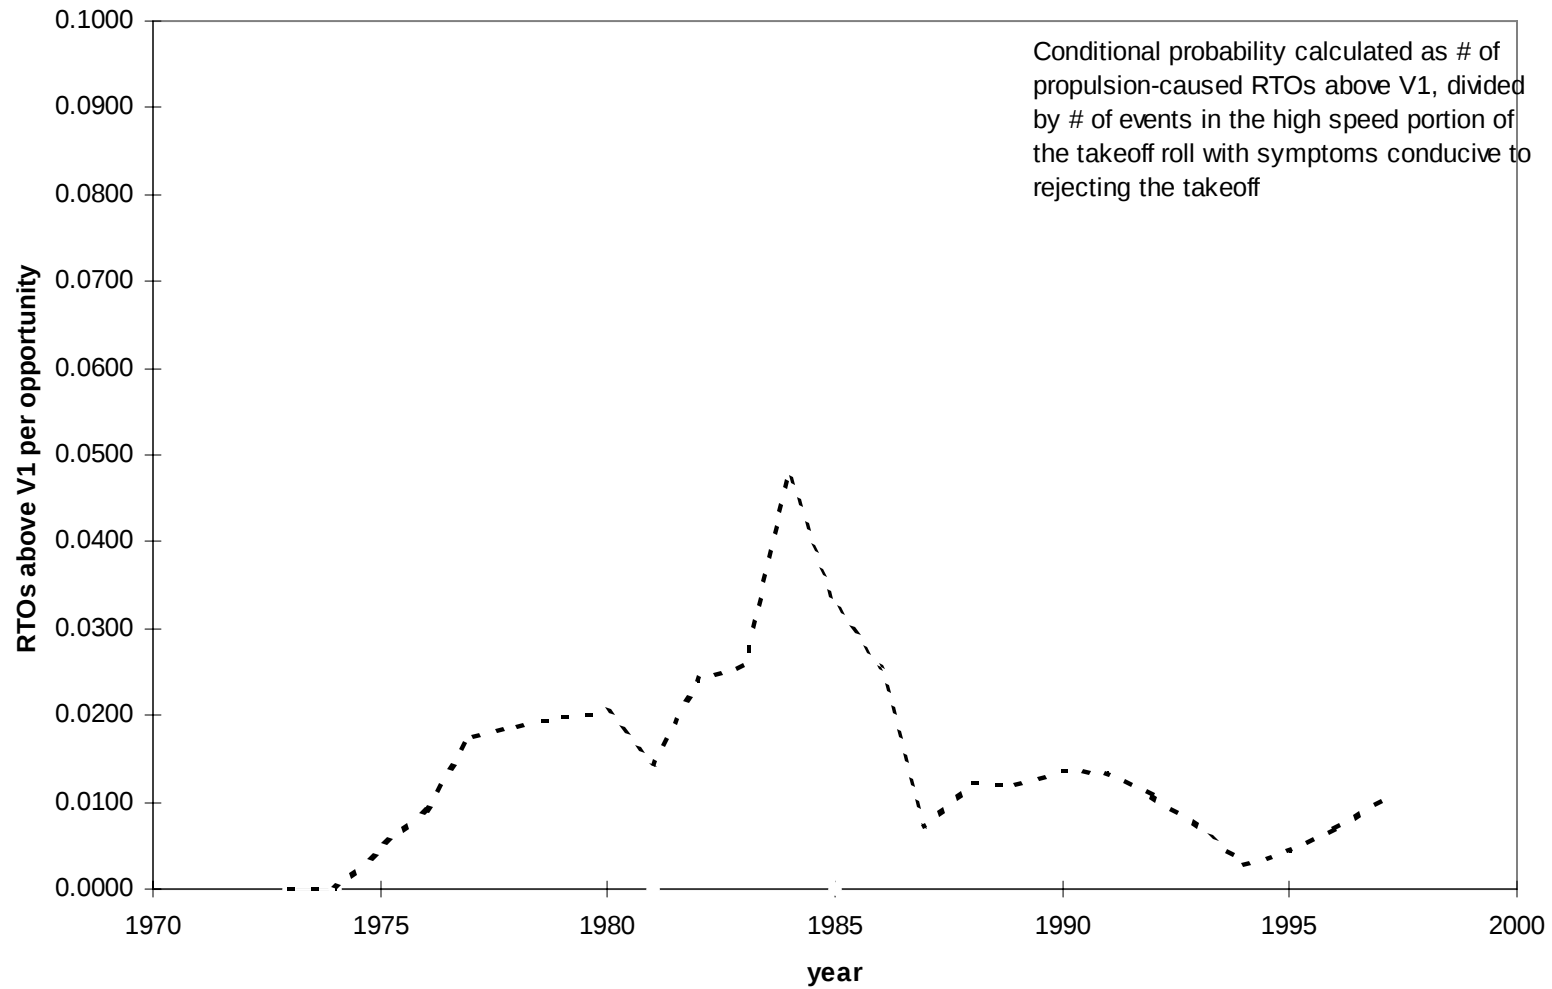
**Conditional Probability\* of RTO above V1  
showing 3 year average**

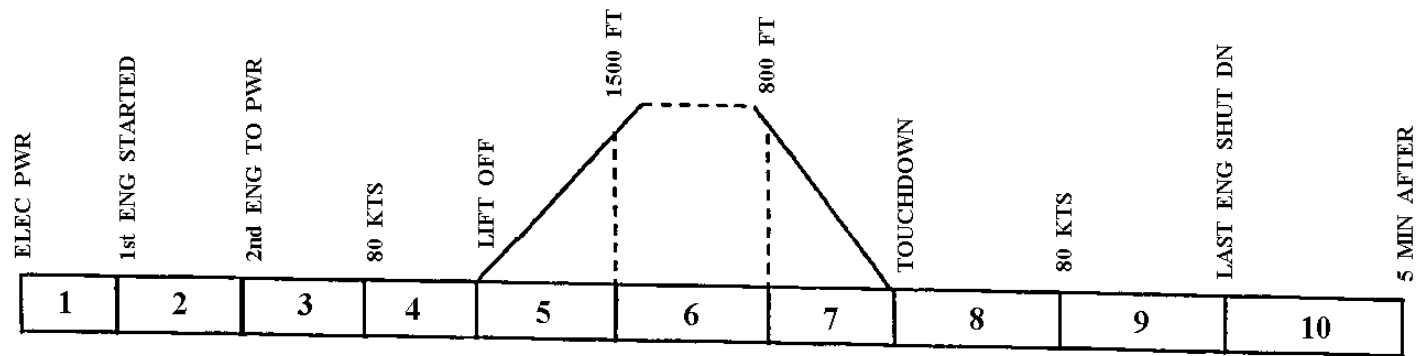
## Airbus Alert Inhibit Points

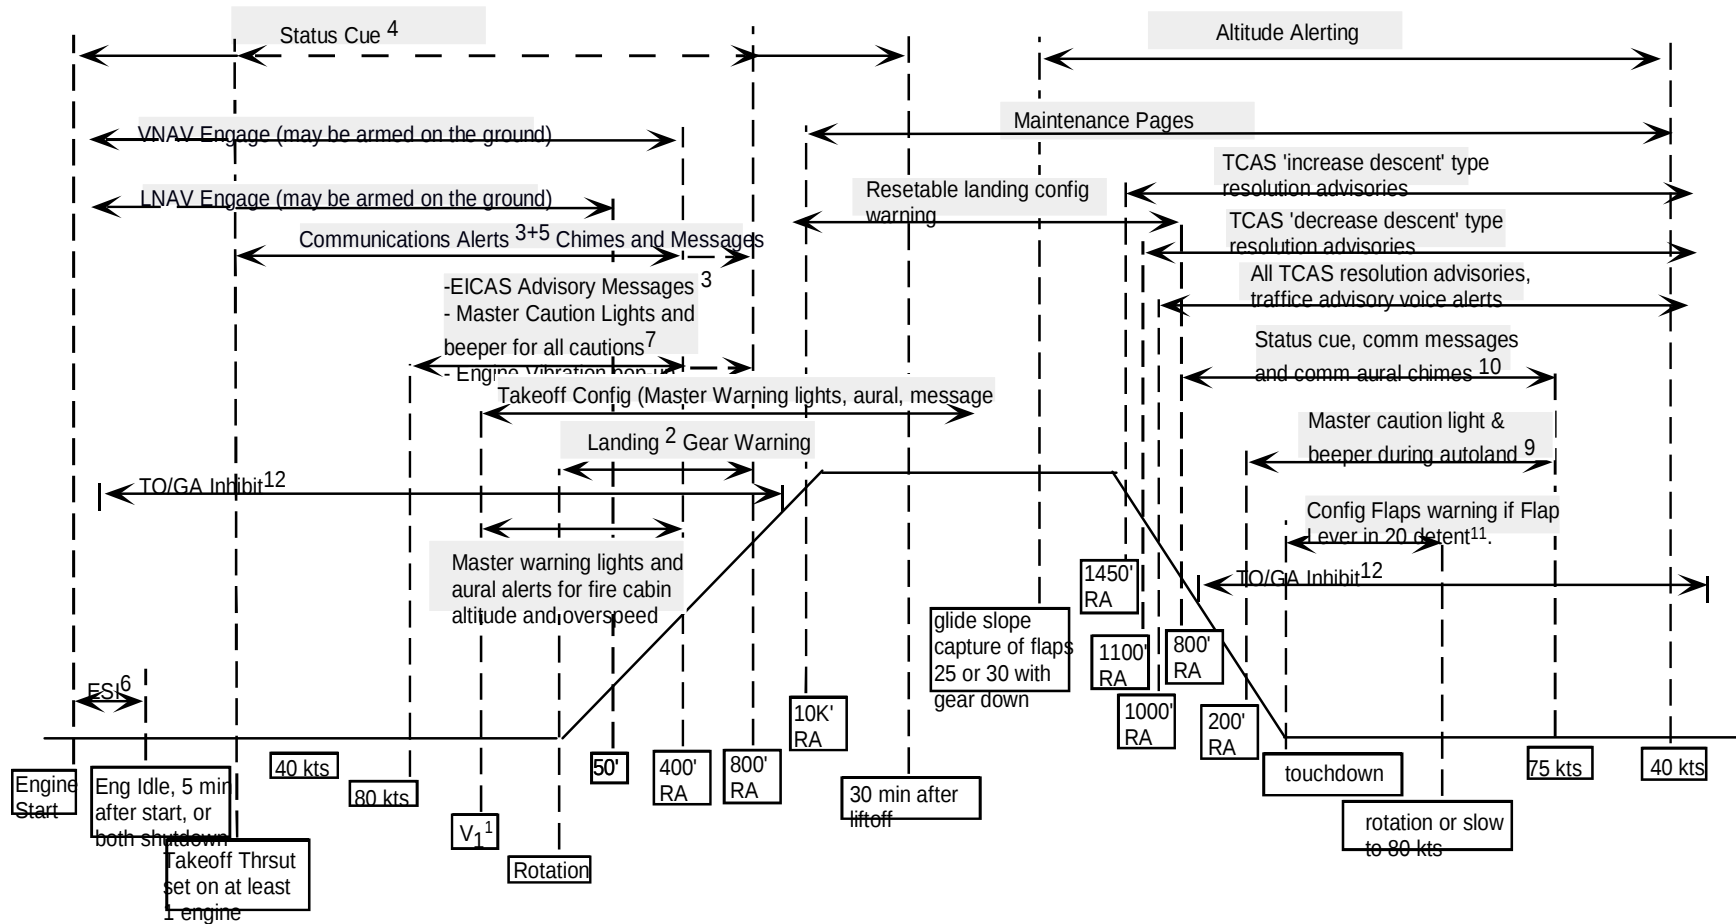
## Boeing Alert Inhibit Points.

1. Rotation through 5° pitch angle used for default if CAS not available: 80 kts if V1 not available.
2. Resettable Landing Gear Warning inhibit ends at 800' or 140 sec, whichever occurs first.
3. Inhibit option: to 800' or 30 sec after rotation.
4. Basic: any on-ground engine start to 30 min after liftoff or any eng shutdown after ESI. Option from takeoff thrust to 800' or 30 sec after rotation or groundspeed < 75 knot
5. CABIN ALERT message not inhibited
6. Engine Start Inhibit applies to all Cautions and Advisories except eng start critical msgs.
7. Inhibit option to 800' or 30 sec after rotation or groundspeed < 75 knots.

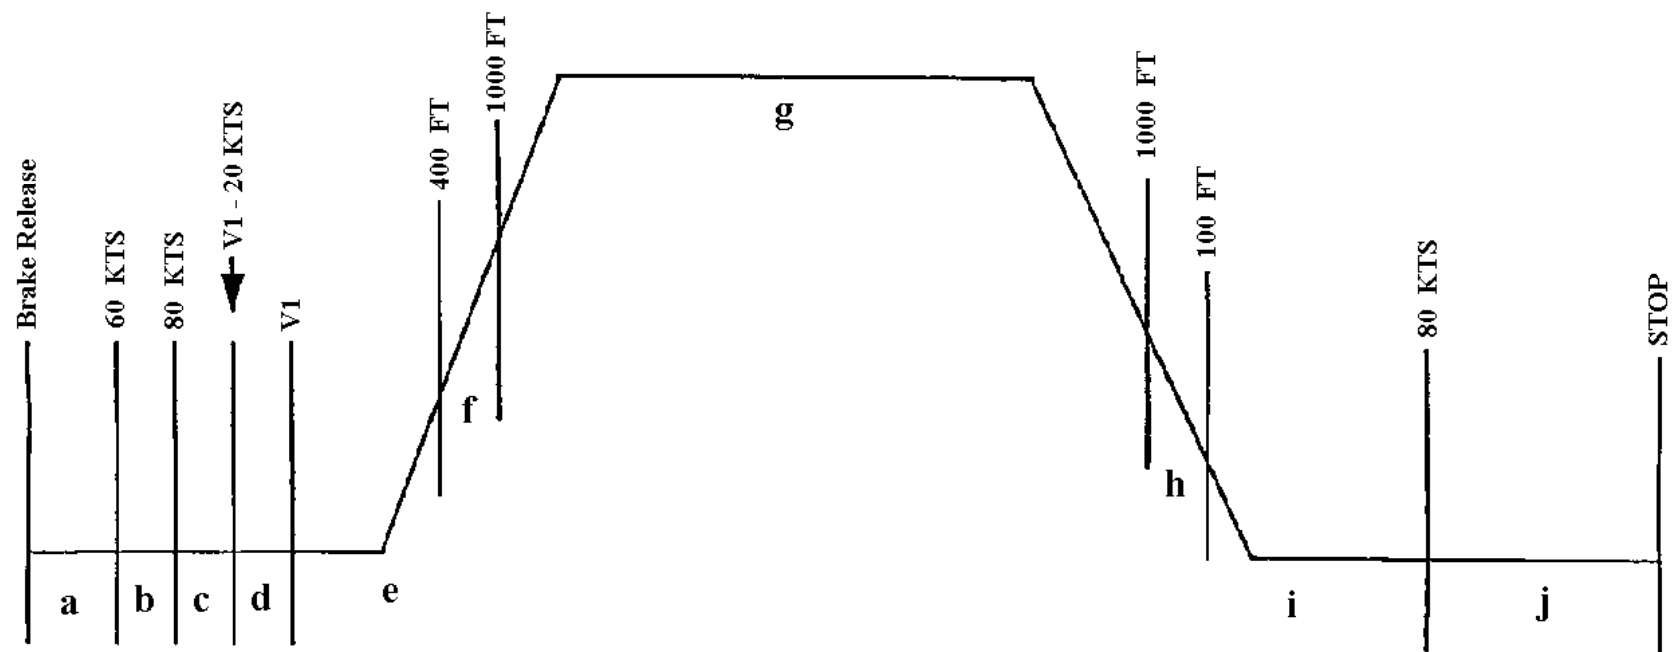
## Douglas Alert Inhibit Points

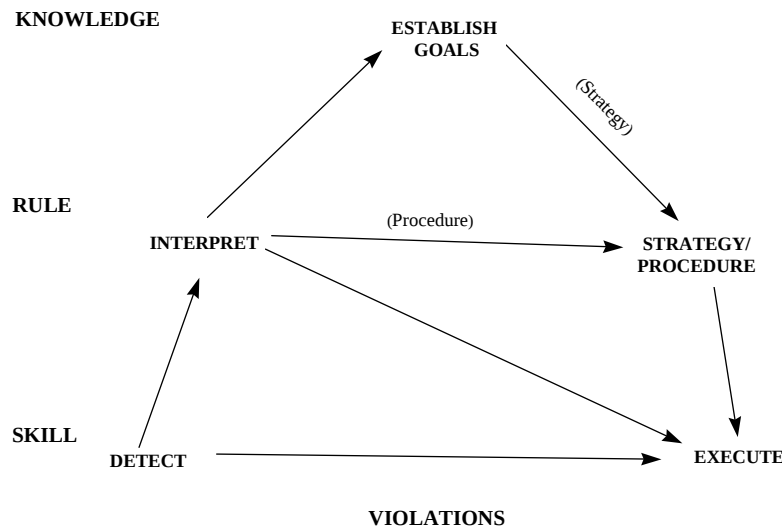
Figure 1. Classification of Errors in the Presence of Propulsion System Malfunctions Which Lead to Inappropriate Crew Responses<sup>14</sup>

The model developed is illustrated below in Figure 1. The primary error categories are represented by the terms located around an “inverted U-shaped function”. The higher-level classifications of skill-, rule-, and knowledge-based errors are shown in approximate relationship to the primary categories. The mapping of these relationships, however, is only approximate as can be seen by reviewing the detailed classification of errors as shown in the second major section of this appendix. Sub-categories within each of the primary error categories were also developed to provide for a finer-grained analysis which could support more detailed recommendations. The Turbofan-DC&ATG Summary Database contains accident/incident events which occurred between 1968 and 1996. References to time frame (early, middle, late) are made within this range without fixed boundaries. However, the time frames the terms refer to are roughly “early” (late ‘60s and ‘70s), “middle” (‘80s), and “late” (‘90s).

The attached material is an attempt to classify cognitive errors based on analysis of the Turbofan Summary Database in such a way as to support the development of detailed recommendations on solutions for addressing PSM+ICR issues. The “model” used as adapted from Rasmussen (1982) is shown in Figure 1. It illustrates the now ubiquitous error classification levels of skill-based, rule-based, and knowledge-based errors as well as Rasmussen’s inverted U components. The error categories identified within this context include only the basic cognitive functions. The transitions between functions are illustrated with arrows. Application of the model to accident/incident data has resulted in the identification of varying numbers of specific error types (sub-categories) within the basic categories. Additional error types may be defined and refinement of existing definition wording can be expected also with any future work on the model.
