Accident Investigation Board Denmark

Bulletin 2023-645

Serious incident to OY-JZN (Boeing 737-800) in Copenhagen, Kastrup (EKCH) on 21-12-2023

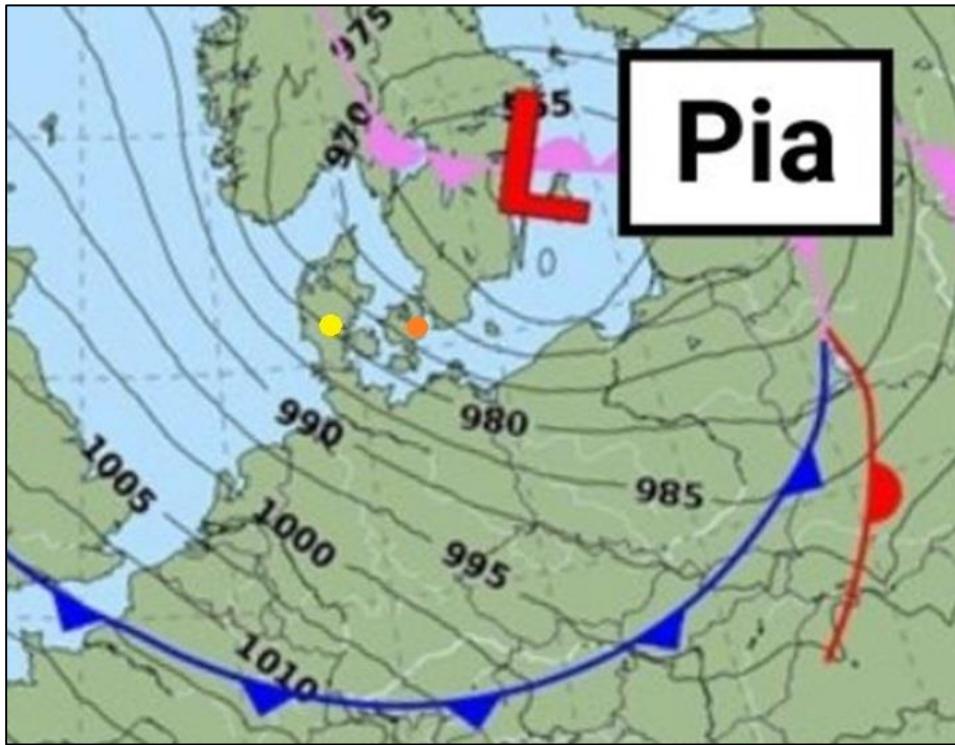
The storm was named Pia, and DMI published the below prognostic chart (in extract), valid on 21-12-2023 at 24:00 hrs:

Figure 2. DMI prognostic chart.
The AIB marked EKBI with a yellow dot and EKCH with an orange dot.
