UK AIRPROX BOARD

Analysis of Airprox in UK Airspace

**Report Number 17
July 2006 – December 2006**

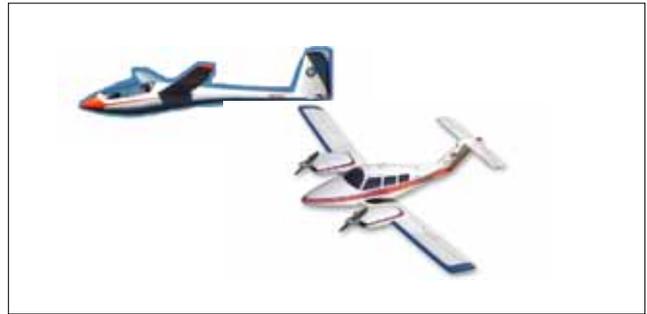
AIRPROX REPORT NO 131/06

Date/Time: 22 Aug 1130
Position: 5210N 00004W (8nm W Cambridge)
Airspace: LON FIR (Class: G)
Reporting Ac Reported Ac
Type: Pegasus Glider Beech 76
Operator: Civ Club Civ Trg
Alt/FL: 3350ft↑ 3500ft↑
(QNH) (QNH)
Weather: VMC CLBC VMC NR
Visibility: 50km >10km
Reported Separation:
0ft V/10m H ~50ft V/~20m H
Recorded Separation:
NR
