# Flight Comment

ISSUE 1, 2013

SEA KING 50<sup>th</sup>  
ANNIVERSARY

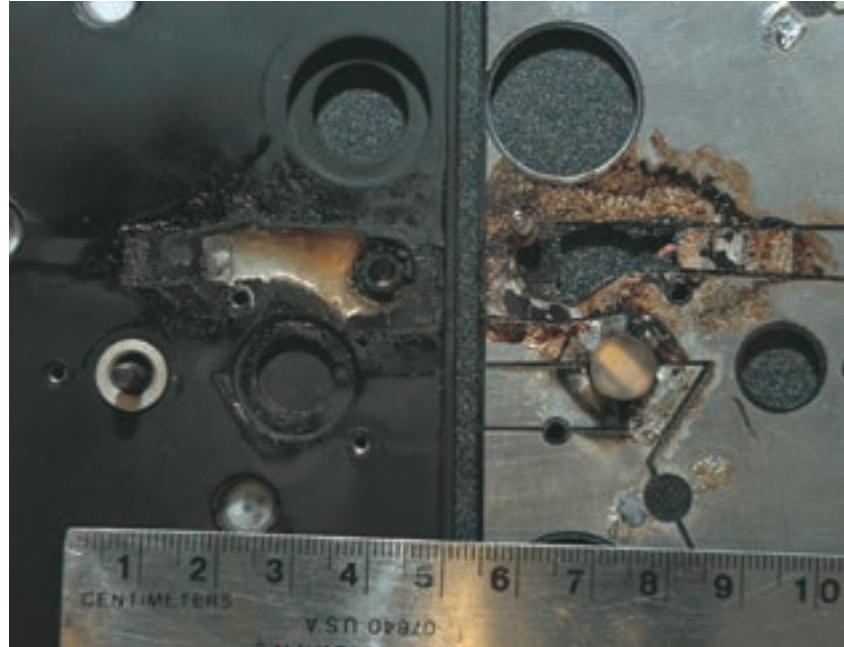
Figure 1

Following 2<sup>nd</sup> line repair of a Navigation Light Control Panel, the panel was installed on aircraft CC130334 to complete functional testing. When the aircraft power was applied, the panel began to overheat, smoke, and burn through, damaging it beyond economical repair. Power was immediately removed, and the damage was fortunately contained to the panel. The panel was then brought back to the avionics labs under flight safety quarantine for further inspection where it was noted that the damaged area extended outside of the original repair site. (Figure 1)

The avionics technician removed the circuit component in the affected area and using an external power supply, re-applied power to the panel. Immediately, the panel resumed smoking and burning despite the circuit

component removal. During follow-on troubleshooting, technicians began to suspect that the flux used during the previous repair was not suitable for electronic circuit repair and had caused the circuit to bridge and overheat.

A Flight Safety was raised (see FSOMS 151675) regarding the use of improper flux causing a fire in the cockpit of a CC130. The investigation that ensued was very enlightening and produced some noteworthy findings. Scoring high on the list of findings was the belief of many aircraft maintenance technicians that the supply chain ensures compliance of all products received, by verifying that they are in fact what was ordered. It is important to stress that this is NOT the case. Supply acts as the procurement authority for the purchase, but does not, nor can it, ensure compliance of the millions of items received.

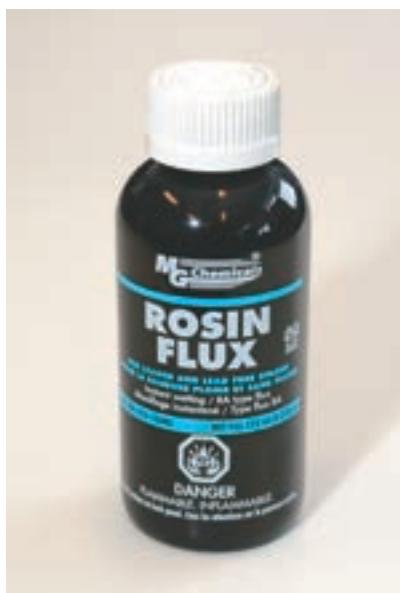
Figure 2

In this particular case, the proper product (Figure 2) was tendered, quoted, and purchased. However, the product delivered did not meet the MIL-F-14256 specification standard associated with NATO Stock Number (NSN), 3439-01-007-5494 (Flux, Soldering), found on the order form. The distributor instead shipped a soldering flux that met the standard of Fed AA51145 (Figure 3) which corresponds to a different NSN. The reference contains the detailed specification related to the flux received and contains a quote stating "This flux is not intended for use in soldering electronic or electrical circuits." The specification also indicates that the flux residue is **conductive**. The product was labelled "SOLDERING FLUX", but only close inspection by someone with comprehensive knowledge and understanding of the product would have been able to identify the discrepancy. Nowhere on the bottle

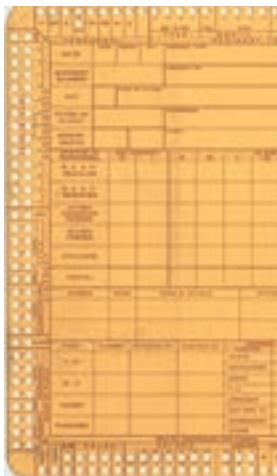
Figure 1

Over the years we have used various methods to document and track occurrences such as the RCAF Aircraft Accident Record card (Figure 1 – McBEE paper punch card). This was followed by the Aircraft Accident and Incident Reporting System (ACAIRS), which was our first computer based application. Then the Flight Safety Information System (FSIS) was developed, which evolved into FSOMS, our current system for documenting and tracking occurrences.

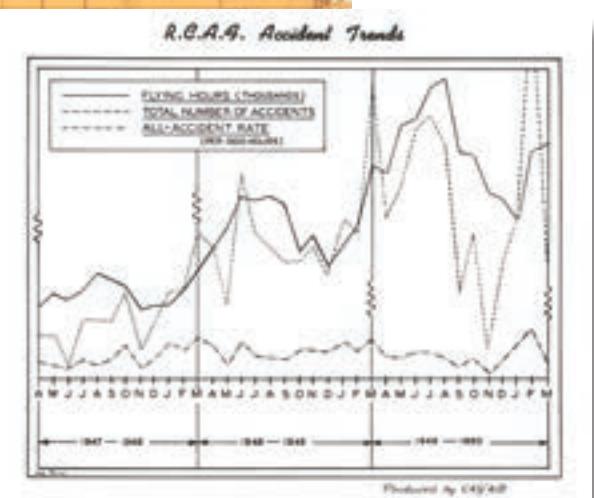
Figure 2

If we go back to the Apr/Jun 1950 edition of *Crash Comment*, *Flight Comment*'s predecessor, there are some examples of accident summaries as well as a graph depicting the RCAF accident trends over the three previous years. (Figure 2)

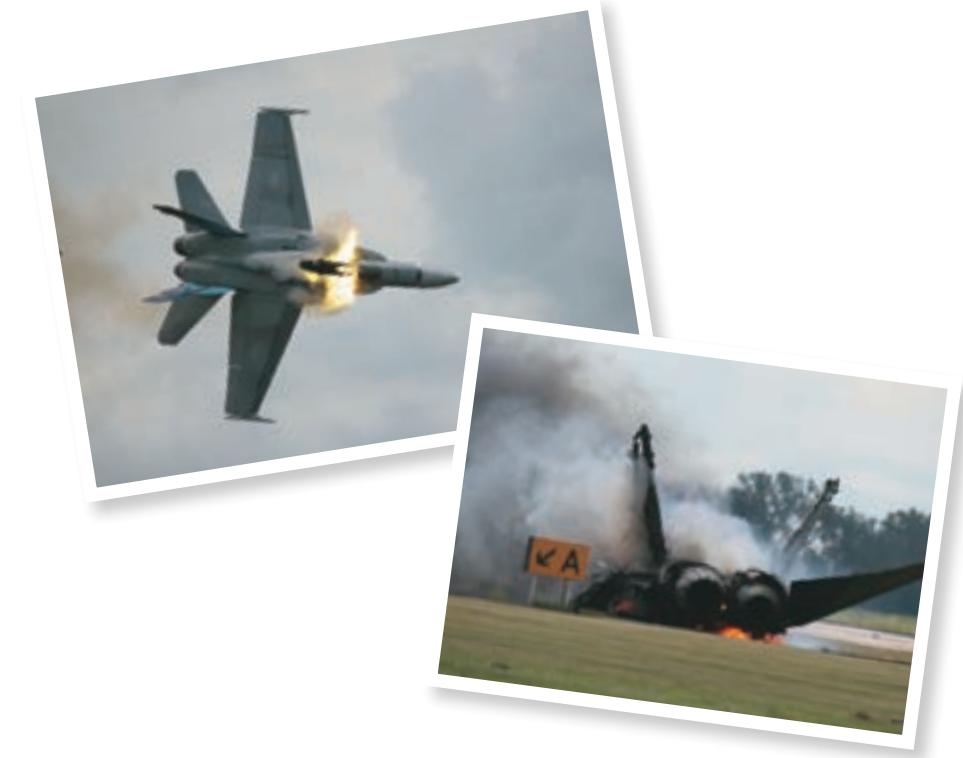
The investigation revealed a number of factors that contributed to this occurrence. The engine malfunction was likely the result of a stuck ratio boost piston in the right engine main fuel control (MFC) that prevented the engine from advancing above flight idle when maximum afterburner was selected. The large

thrust imbalance between the left and the right engines caused the aircraft to depart controlled flight and the aircraft was unrecoverable within the altitude available. Contributing to the occurrence was the subtle nature of the engine malfunction that was not detected by the pilot when the overshoot was attempted.

In response to this occurrence, the Royal Canadian Air Force (RCAF) expedited the implementation of a program to upgrade all CF188 MFCs. Additionally, the RCAF made changes to the conduct of the CF188 air show routine by increasing the high AOA pass altitude from 300 feet AGL to 500 feet AGL, improving the air show training program and ensuring that both engines of the CF188 air show aircraft have upgraded MFCs. ♦

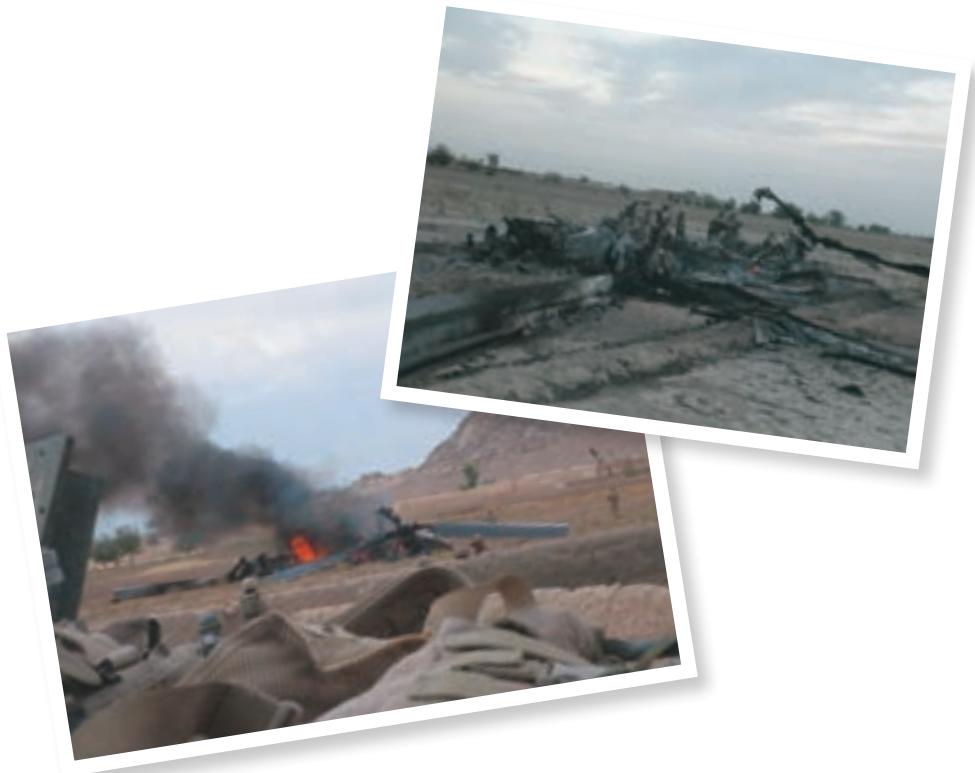
**O**n 05 August 2010, *Chinook* CH147202 was conducting a sustainment mission outside Kandahar Airfield. While transiting at low altitude between two forward operating bases, the aircraft was forced down due to an explosion and in-flight fire. The source of ignition was reported as being due to insurgent fire that was directed towards the aircraft. Following the sound of a detonation, flames and black smoke immediately began entering the cabin through the left side of the open rear cargo door. Despite the presence of dark smoke in the cockpit, the pilots were able to rapidly and successfully land the aircraft in an open field. After landing, all aircrew members and passengers exited the aircraft, although some sustained minor injuries from the fire or during egress.

The scope of the Flight Safety Investigation was limited to the review and analysis of aviation life support equipment, egress procedures, and other issues pertaining to occupant safety. Deficiencies in cabin safety standards for crashworthiness and egress highlighted the need for a comprehensive RCAF passenger and cabin safety policy, as well as the need for full scale cabin safety assessments in both new and legacy fleets, in order to identify and mitigate safety deficiencies.

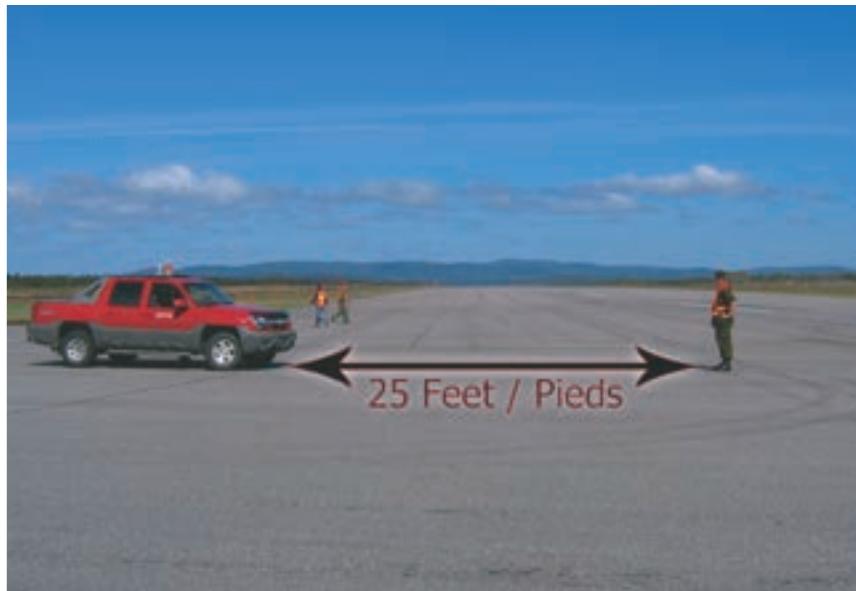
Approximate distance between the vehicle and *Beech 1900* wing tip (marked by the person).

The investigation determined that the ground controller (GC) did not use the term “negative” to issue a restriction to the vehicle operator’s (VO) request to cross the runway and that the VO did not actively scan the runway for potential traffic conflicts prior to proceeding onto the active runway. Additionally, the VO’s misinterpretation of the GC’s clearance was exacerbated by the VO’s expectancy to hear the term “proceed” or “negative.” Upon hearing “proceed,” the VO erroneously assumed that he was cleared to his requested destination. It was further determined that non-standard phraseology was used by CYYR Air Traffic Control (ATC) and that 1 Cdn Air Div publications did not define currency or specify a validity period for the Ramp Defensive Driving Course (DDC) qualification.

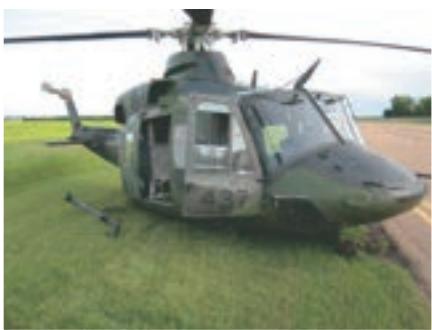
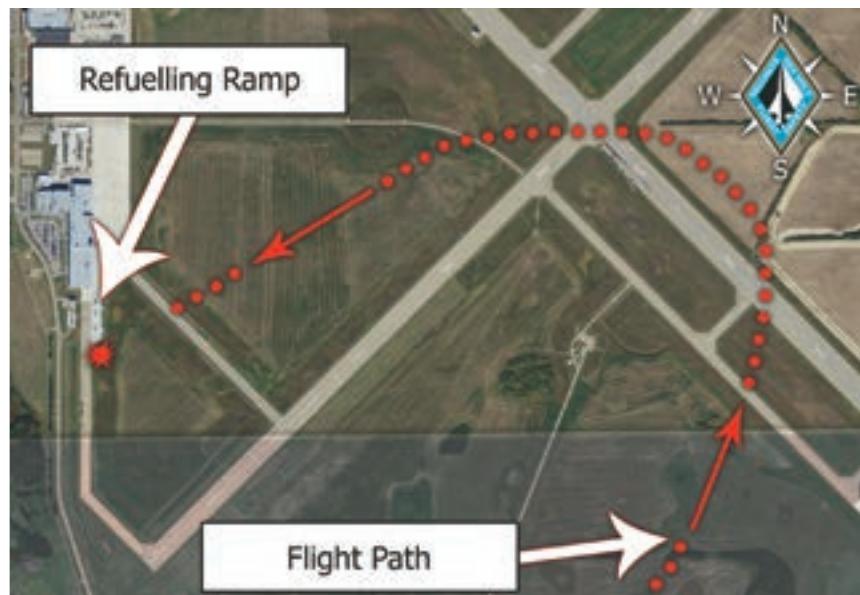
**O**n completion of a Basic Handling and Emergency training flight, Griffon CH146437 was attempting to conduct a descending, decelerating transition to the hover to a spot south of the fuel pumps with a right hand turn to a northerly heading. During this final turn, the aircraft began to sink rapidly; the First Officer (FO) raised the collective to a position which he believed to correspond with maximum mast torque (QM) but the aircraft continued to descend. Just after the FO levelled the aircraft, Griffon CH146437 landed hard and sustained "C" category damage. The Flight Engineer suffered minor injuries.

The investigation concluded that the crew entered into a settling with power situation from which they did not recover. An incorrect wind advisory by the Advisory Controller, an inadequate wind appreciation by the crew and the attempt of a descending, decelerating transition to the hover with an inadequate assessment of closure rates were factors in this accident. A significant contributing factor included poor power management; the blades were not loaded during the final approach, both pilots inaccurately assessed the collective position and they did not increase it to its maximum travel. Lastly, the aircraft captain (AC) did not recognize the point at which he needed to provide assistance to the FO.

Collective travel, corresponding QM and rotor RPM were available to slow the rate of descent and potentially prevent the accident.

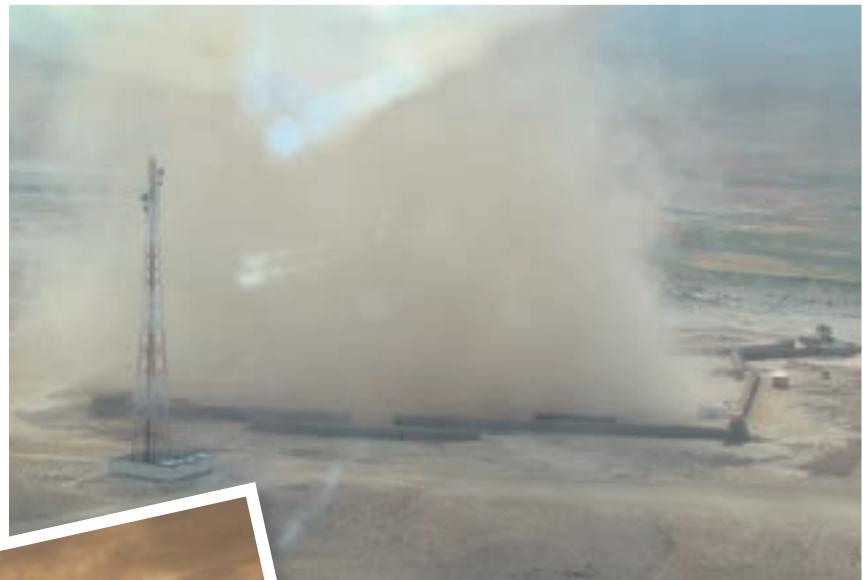
**Dustball during morning landing.**

**G**riffon 434 was tasked to transfer two passengers to and from a Forward Operating Base (FOB). As power was increased for the takeoff a very large dustball developed. Immediately after takeoff, the aircraft drifted forward and to the right, struck a barrier, rotated left, rolled onto its right side and caught fire. One pilot was unharmed, one sustained minor injuries and one passenger suffered serious injuries. The remaining three personnel tragically perished in the crash. The aircraft was destroyed.

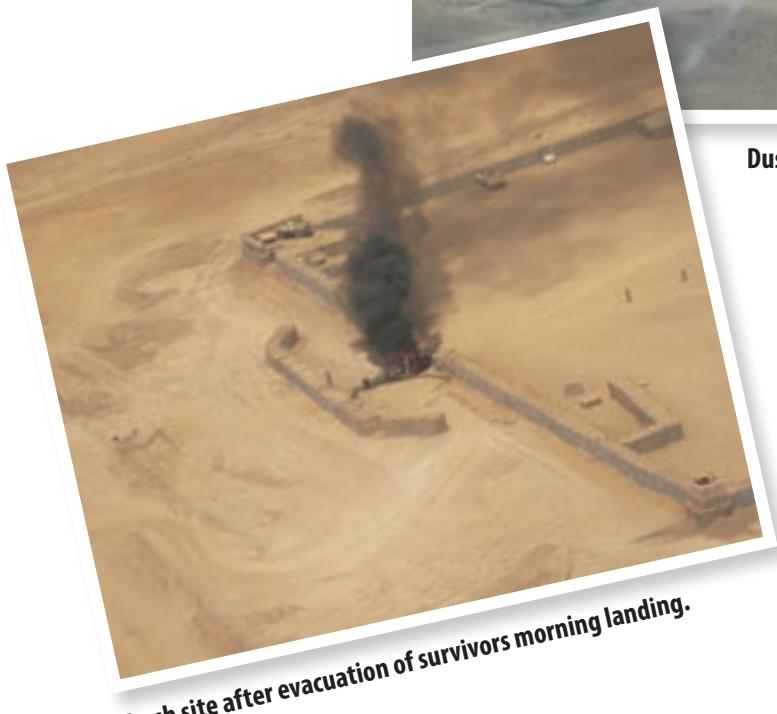
**Crash site after evacuation of survivors morning landing.**

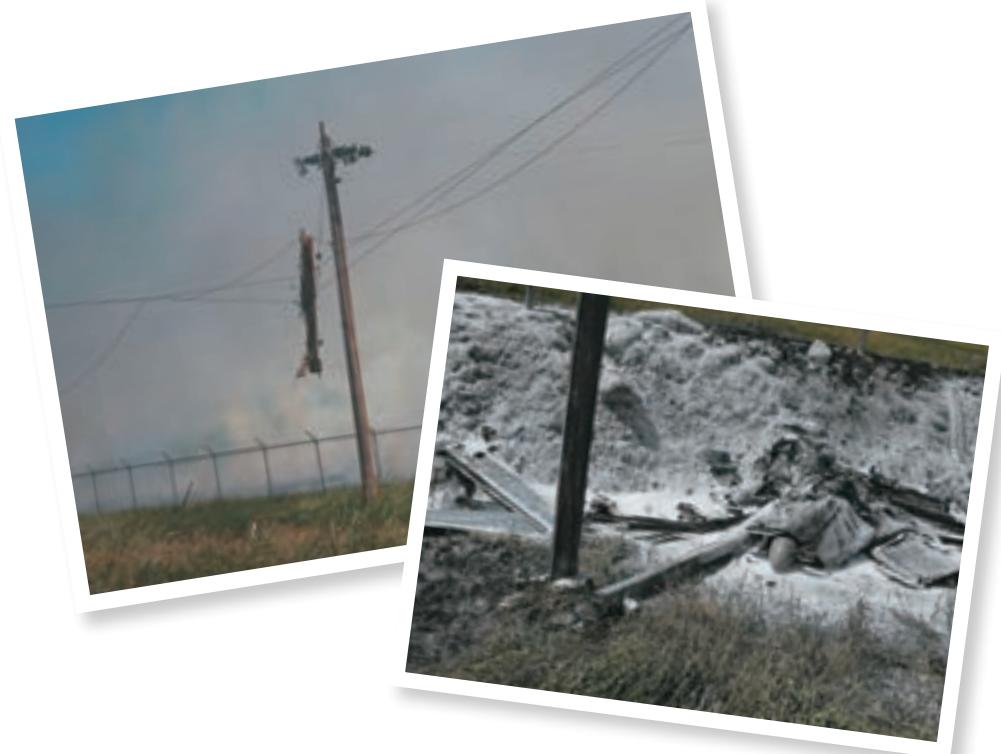
While on short final during the DGPS approach, the student Air Vehicle Operator (AVO) noticed that the UA was flying too low. While attempting to recover, the student AVO made a button selection error that required the AVO instructor to take control of the UA. The UA was in the process of retracting its landing gear and executing the overshoot when it hit an electrical pole and was destroyed in the crash. The accident caused a power outage to the town of Ralston, AB, and CFB Suffield. There were no injuries.

The investigation determined that multiple navigation system failures ultimately affected the UA's programmed altitude control. Exacerbating these component failures were the crew's poor altitude monitoring technique, inadequate system knowledge, and problem solving abilities. Their decision to overlook the checklist and ineffective employment of the vehicle's Low Altitude Warning signal also contributed to this accident.

Safety recommendations included operational directives published by MDA involving the use of the Low Altitude Warning signal and actions in the event of multiple navigation system failures. Software was updated to improve the navigation system computer interface with the DGPS system and to adjust altitude information in the event of a DGPS failure. MDA now requires that UA automated approaches are monitored by AVOs in the same manner that pilots of manned aircraft monitor their automated approaches. ♦
