## **APPENDIX A: FLIGHT DATA RECORDER TECHNICAL ANALYSIS REPORT**

# **Flight Data Recorder Readout and Analysis**

## **SA227-DC VH-TFU**

**ATSB TECHNICAL ANALYSIS REPORT 21/06**

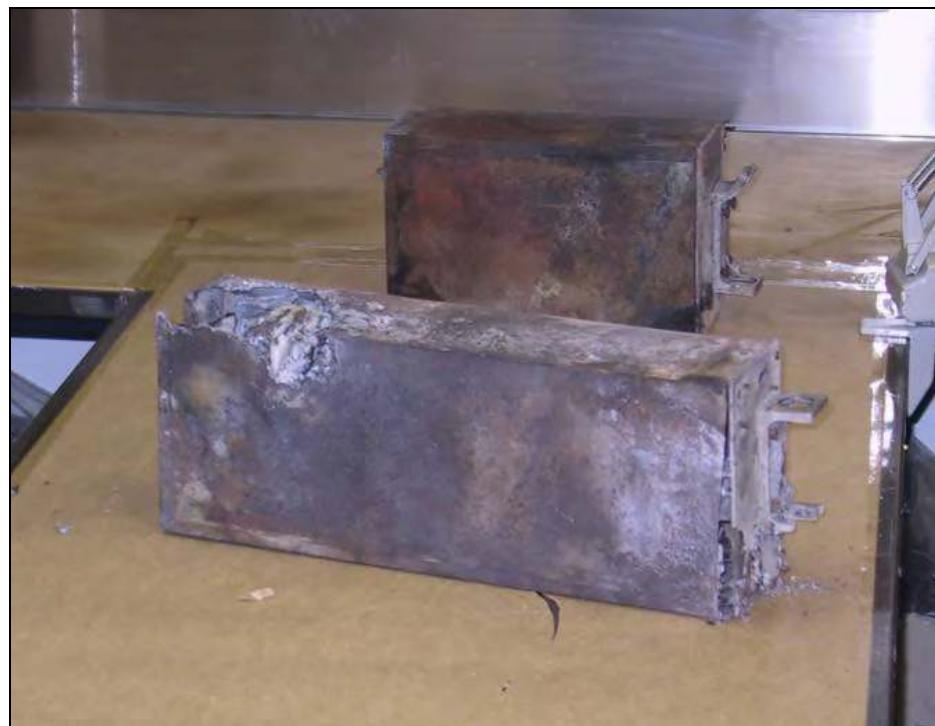
When the FDR was recovered the data plate was missing and the serial number could not be confirmed. Examination of the FDR at the ATSB confirmed that the reported model and part number were correct.

**Figure A-5: FDR (foreground) at the ATSB laboratory in Canberra**

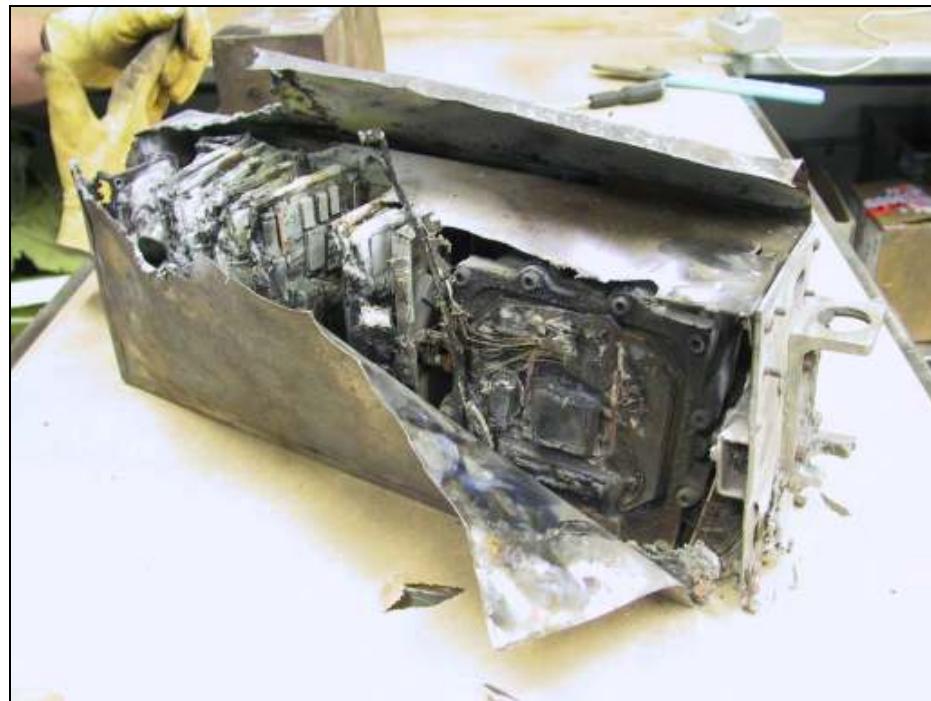
**Figure A-6: FDR with the crash-protected memory module visible**

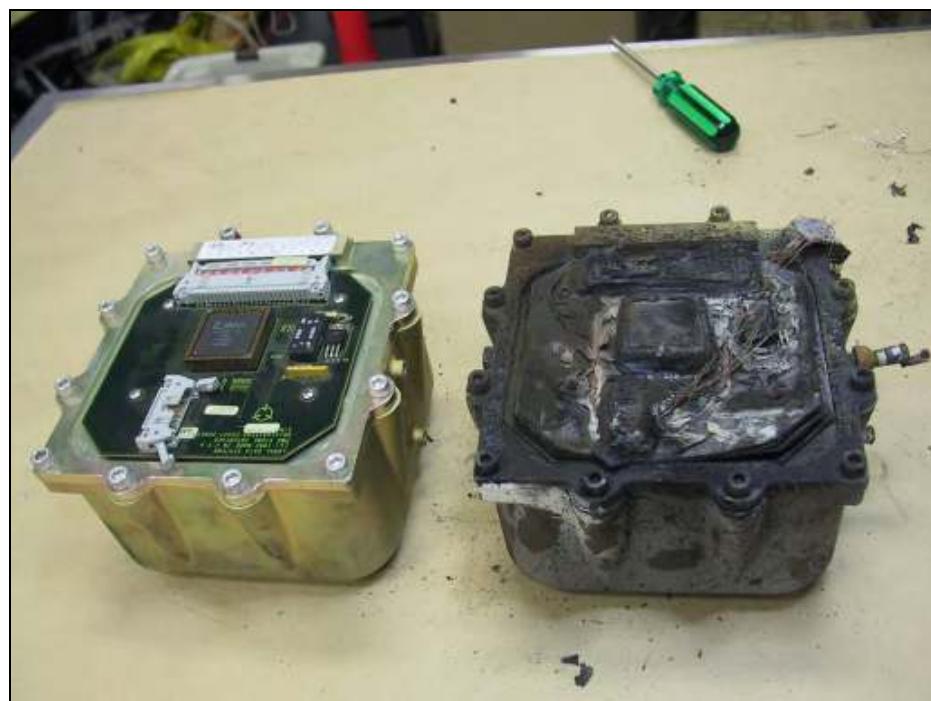
**Figure A-7: Crash-protected memory module with a comparison unit**

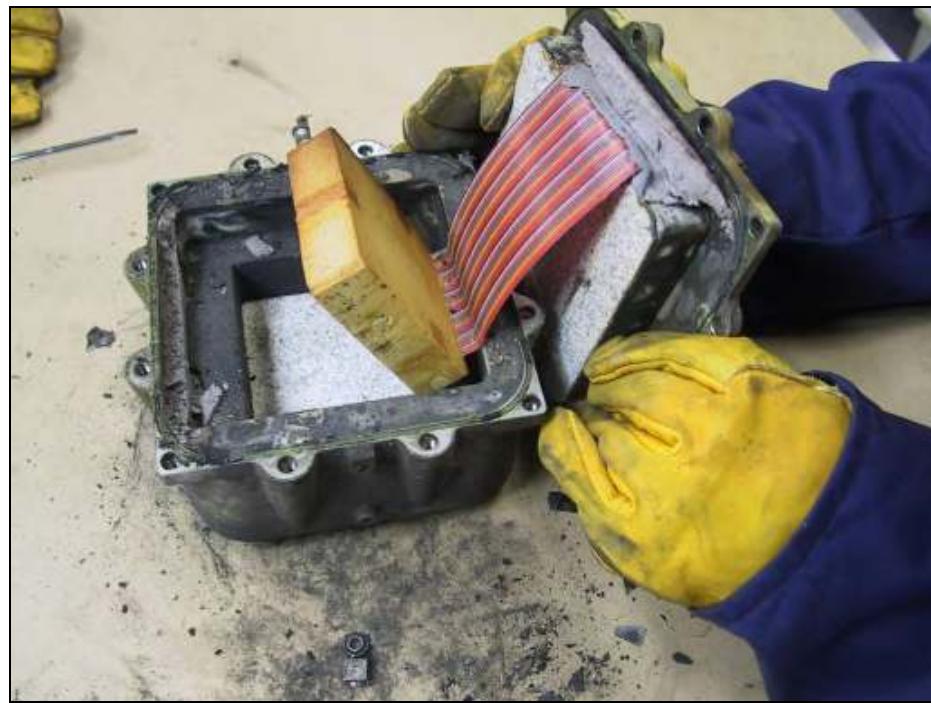
**Figure A-8: Polystyrene foam block enclosing the memory board**

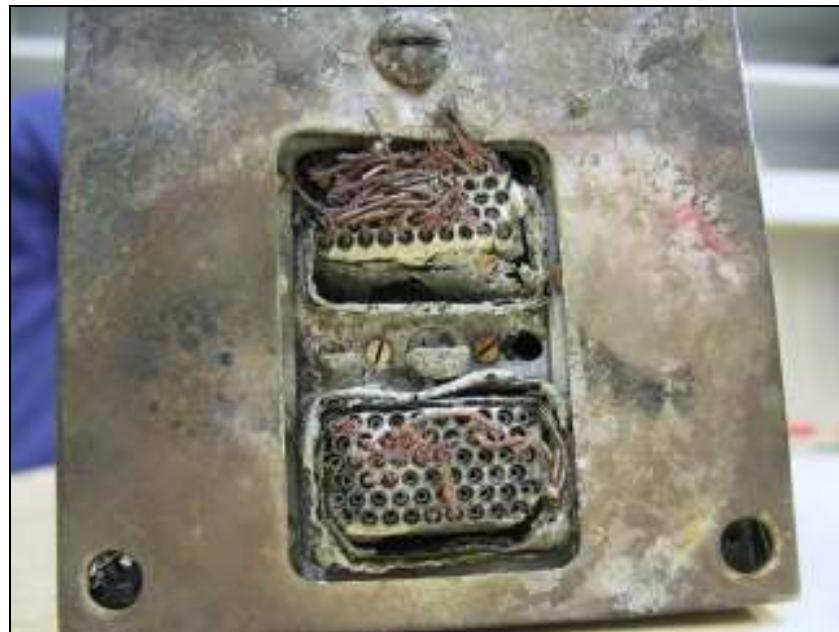
**Figure A-10: FDR rear connectors**

The FDR rear connectors (refer to A-10), as well as the raw data, were scrutinized to ensure that all the recorded engineering parameters were detected.

Examination of the rear connector showed that a trip and date encoder was not fitted.

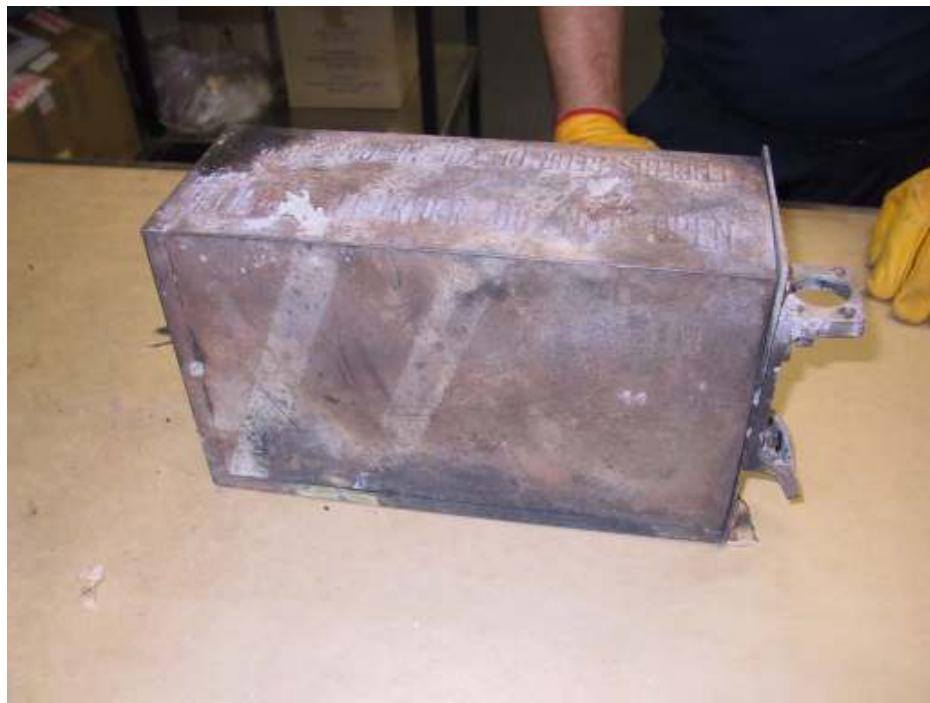
The CVR had been significantly exposed to fire with the paint on the outer casing burnt off. The pattern left from where reflective tape had been affixed, was visible. Several spots of molten metal had become fixed to the outer case. The underwater locator beacon (ULB) mount had molten metal attached. The ULB mount had been distorted during recovery at the accident site as the damaged ULB was removed from the CVR unit before transport. A photograph of the CVR as received, see Figure B-1.

**Figure B-1: L-3 Communications Aviation Recorders Fairchild model A100A CVR recovered from VH-TFU**

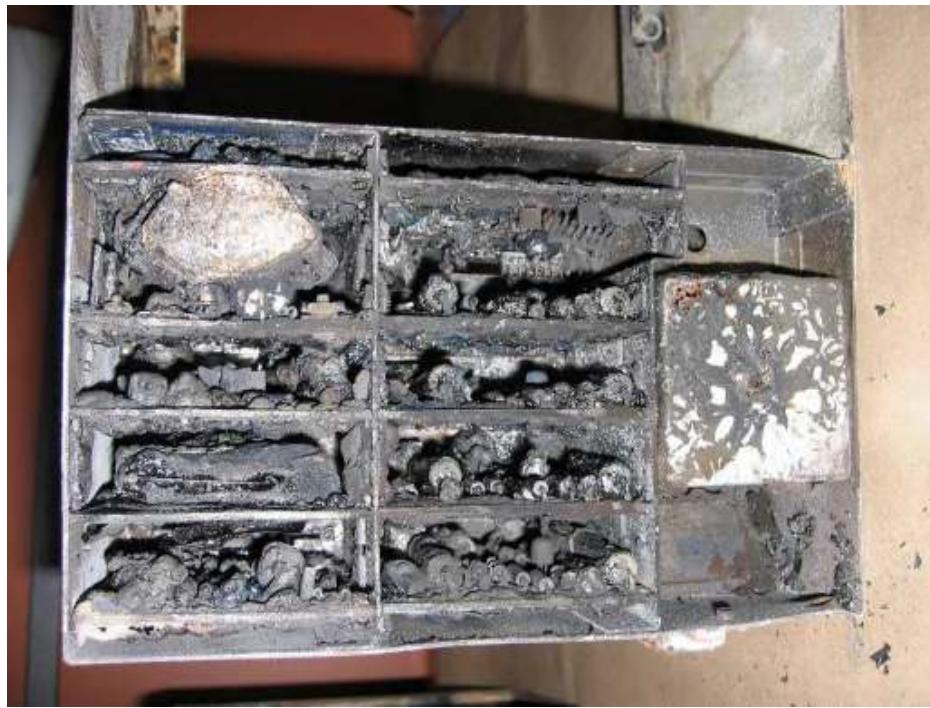
**Figure B-19: VH-TFU CVR printed circuit card assemblies**

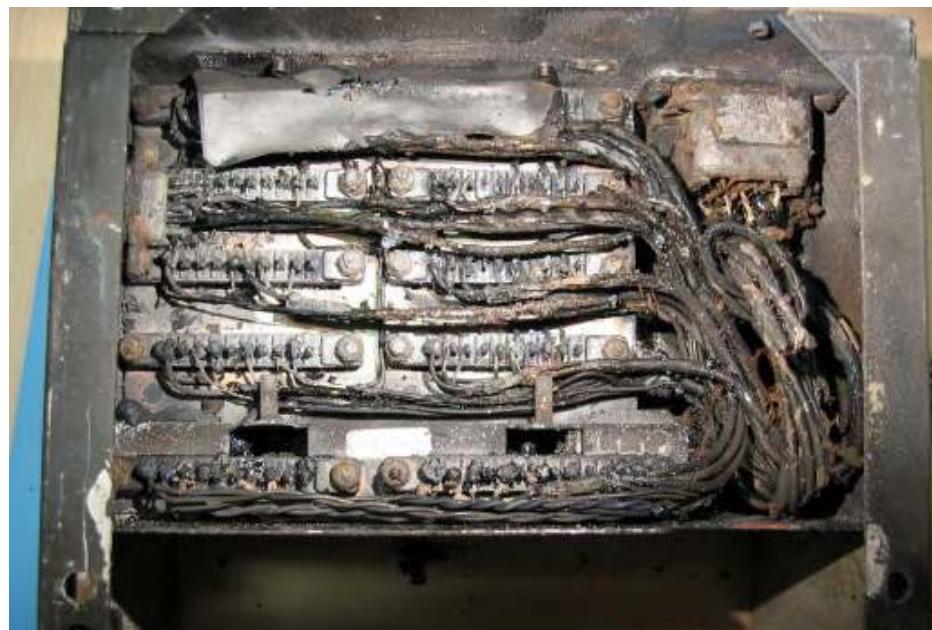
**Figure B-21: VH-TFU CVR printed circuit card assembly wiring**

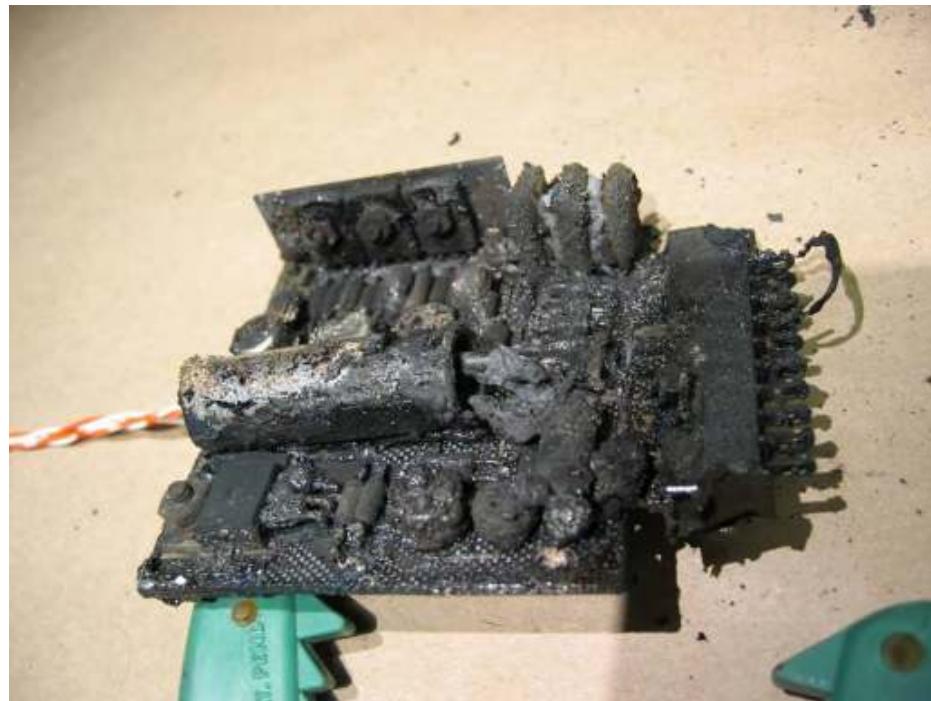
Figure B-23: VH-TFU power supply assembly

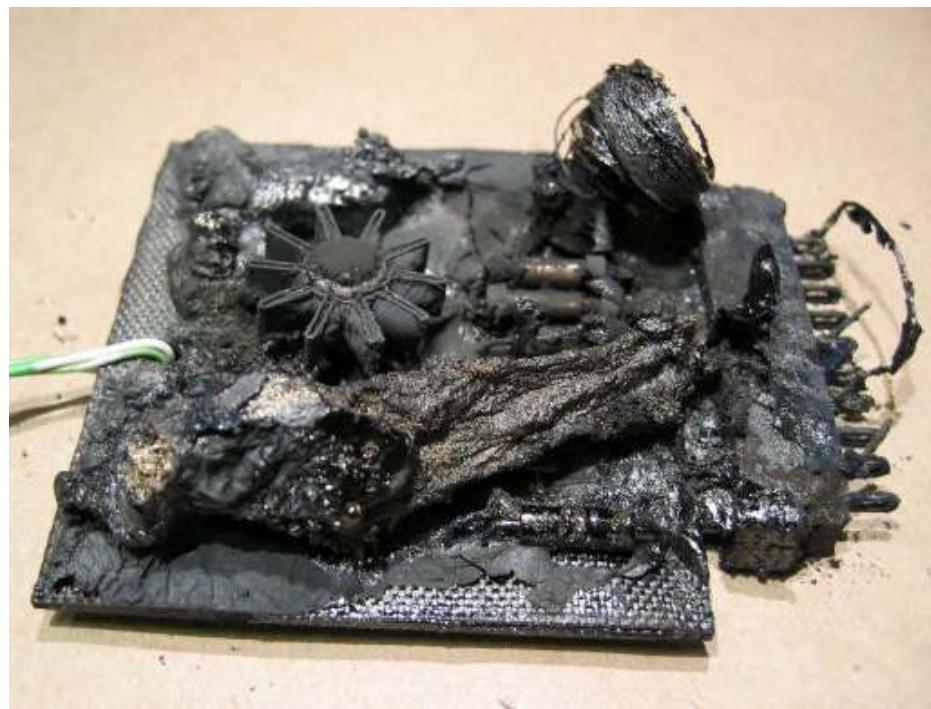
**Figure B-25: VH-TFU bias oscillator assembly**

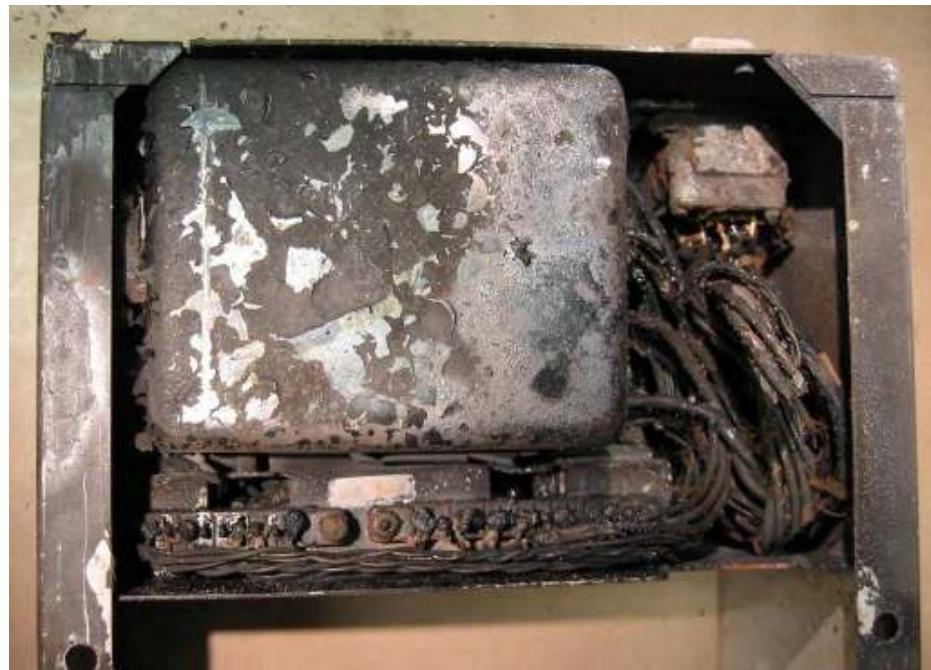
**Figure B-27: VH-TFU CVR inverter assembly**

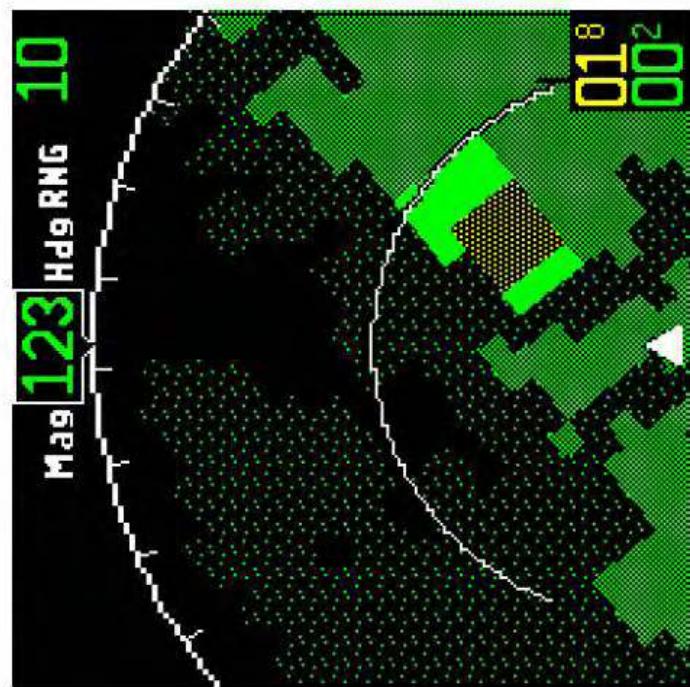
40 seconds before impact

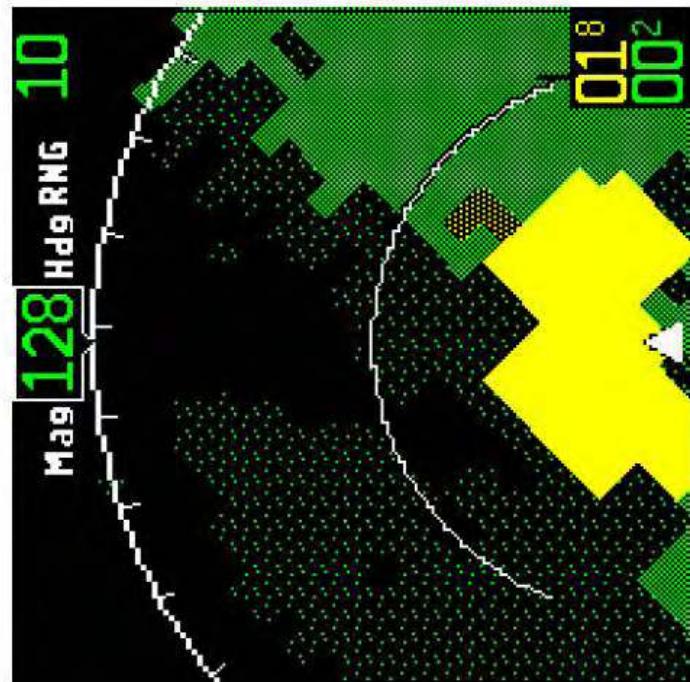
"Caution Terrain"  
32 seconds before impact

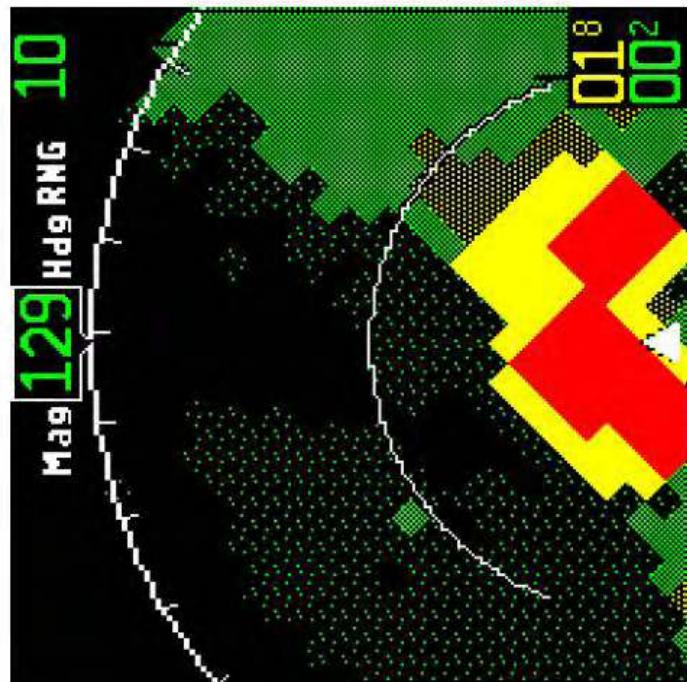
“Terrain Terrain Pull-up”  
28 seconds before impact
